# Stage 2 Structural Assessment Report

Mayo County Council

# N5 KNOCKAVRONY BRIDGE REHABILITATION WORKS

Document title: MO-N05-013.00 Knockavrony Bridge Stage 2 Assessment

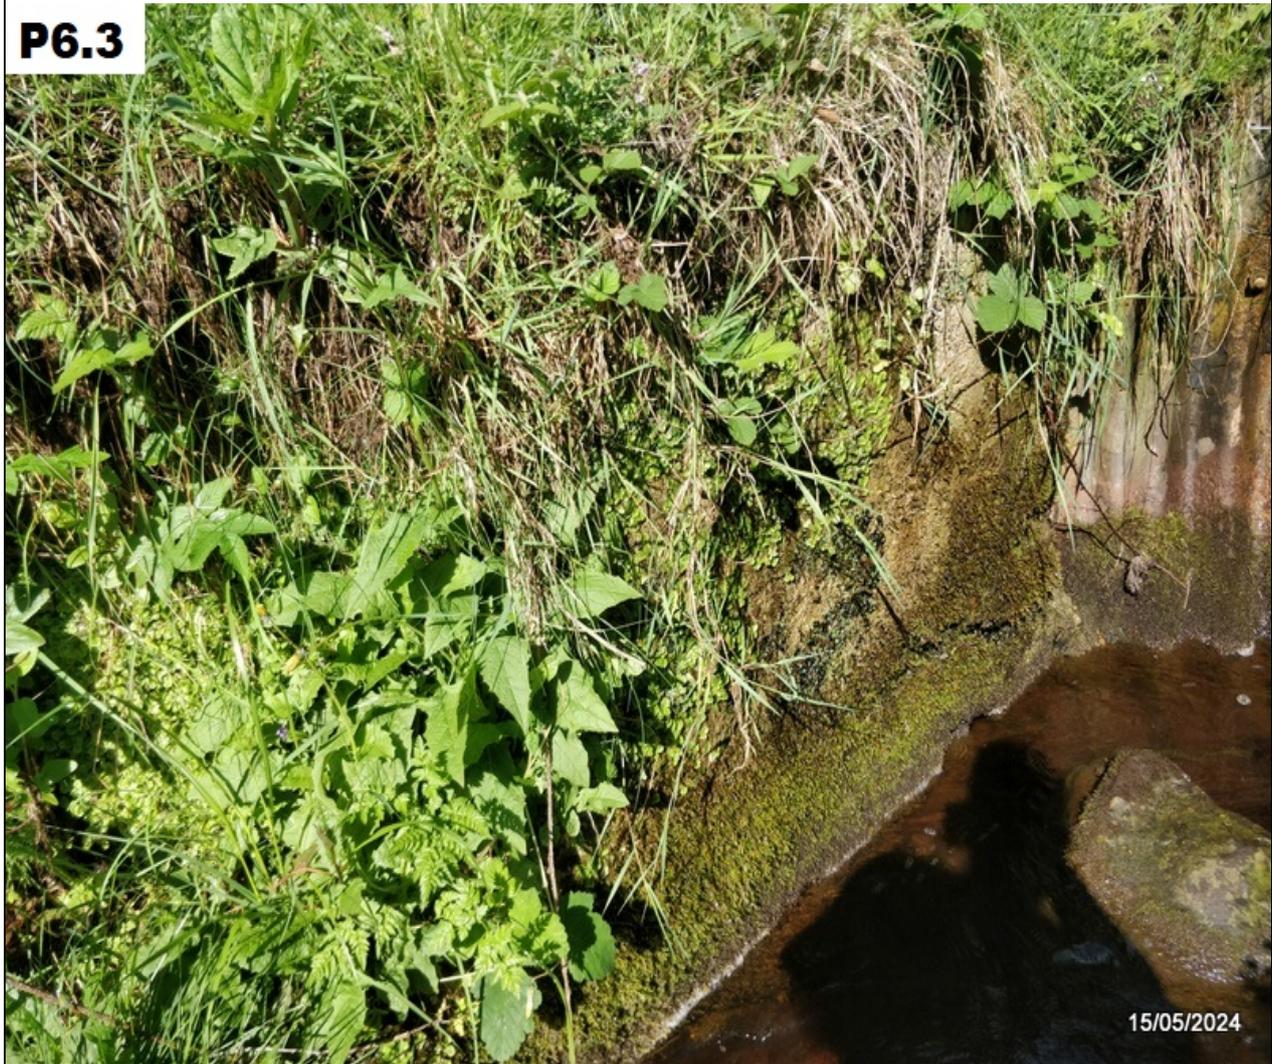
**P6.3**

Component No.	6	Wing/Spandrel/Retaining Walls
All wing walls are in good condition apart from vegetation growth which should be removed during RM. See P6.1 for a view of the southeast wing wall. There is a crack and undermining of 400mm at the southwest wing wall that should be repaired during RM, see P6.2 and P6.3 respectively.		
Condition/Mainten.	2	/ Y

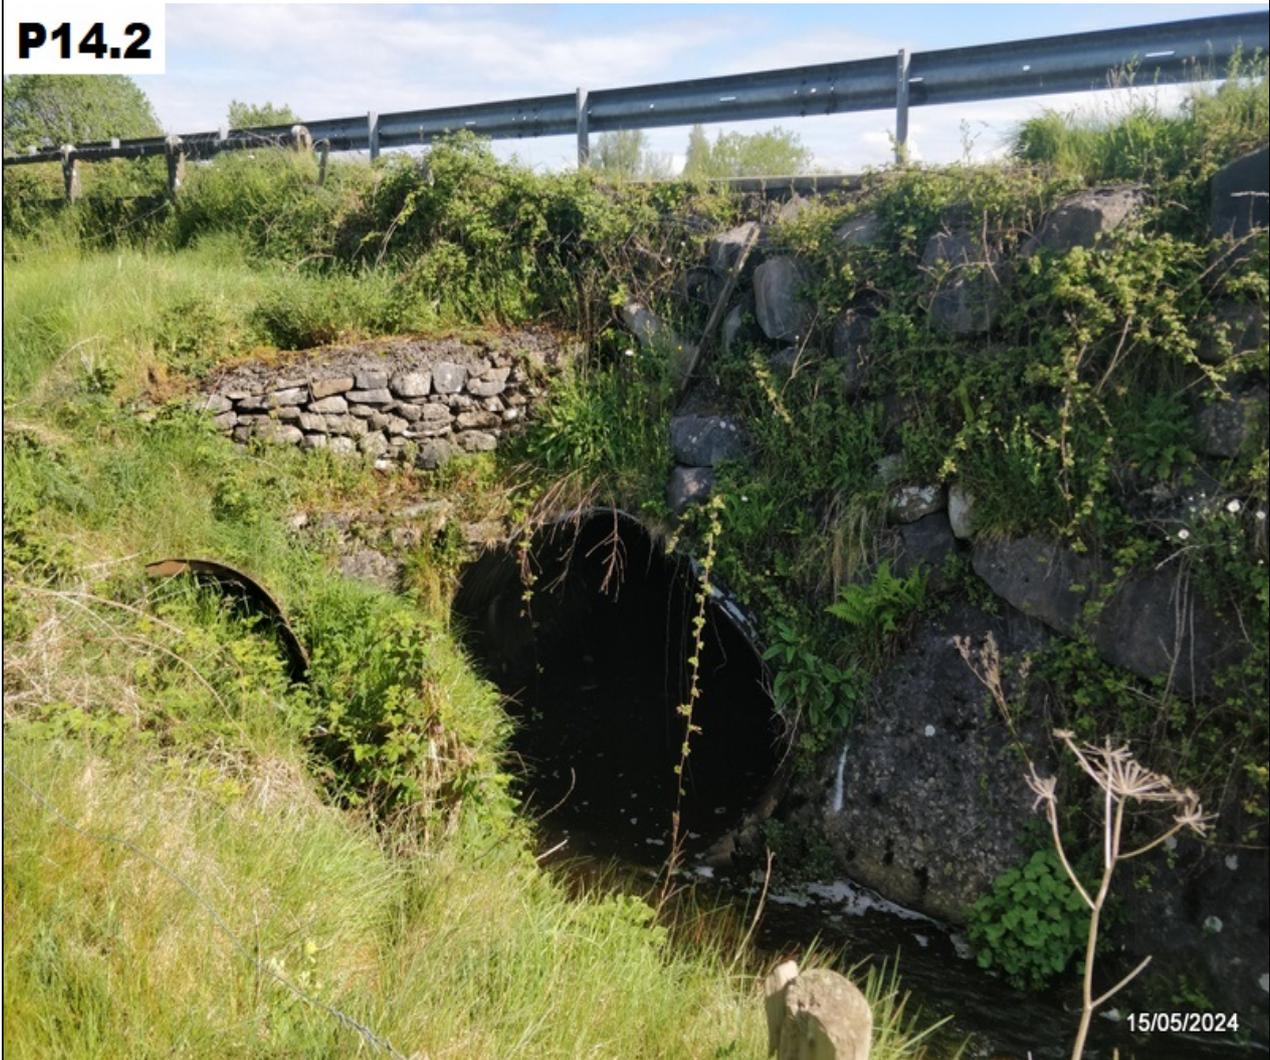
**P14.2**

Component No.	14	Structure in general
<p>The structure is in good condition overall. Minor routine maintenance is required. See P14.1 and P14.2 for views of the north and south elevations of the structure respectively.</p> <p>The inspection of the structure has been undertaken in accordance with the requirements of TII AM-STR-06039 (BD 79) outside of the normal PI schedule due to the 2005 Stage 1 Assessment Report finding that the RC slab structure was substandard with live load capacity of 0 tonnes (structure was assessed as being incapable of sustaining dead load from the embankment above). The expected mode of failure of the RC slab structure would be by yielding of steel at midspan due to bending. No evidence of failure was recorded during this PI inspection. When viewed in elevation there is an obvious permanent deflection of the slab (15-20mm) however this deflection is also visible in the elevation photos in the 2005 SI report and it does not appear that additional deflection has taken place indicating that the deflection is historic and likely to have occurred during construction.</p> <p>Condition/Mainten.            1 / Y</p>

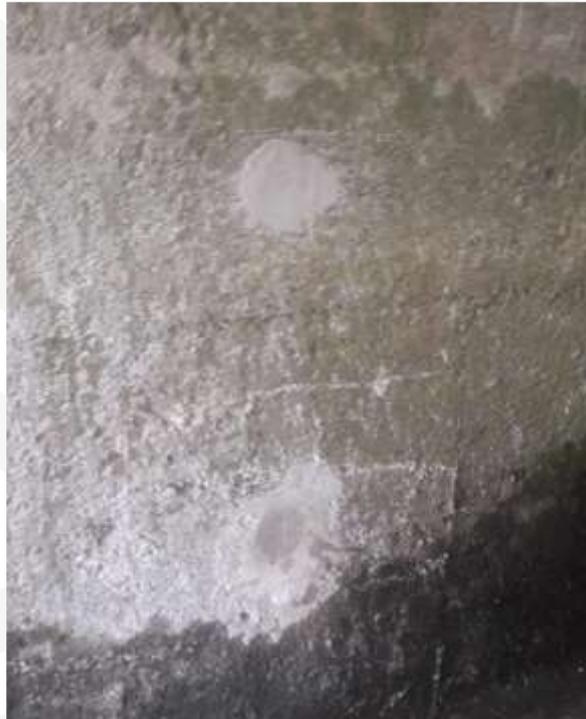
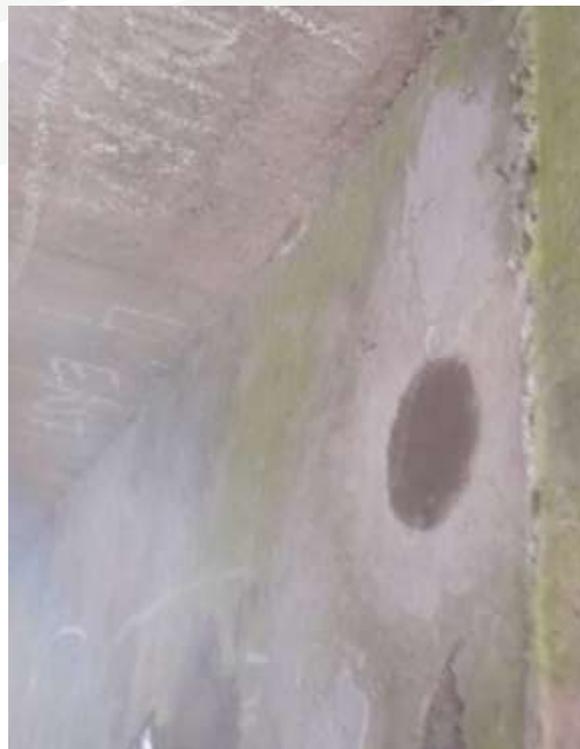
6. REINSTATEMENT PHOTOS

**Only concrete reinstatement required at this location.**

**Fosroc Renderoc HB45 was used to carry out concrete repairs to breakouts**

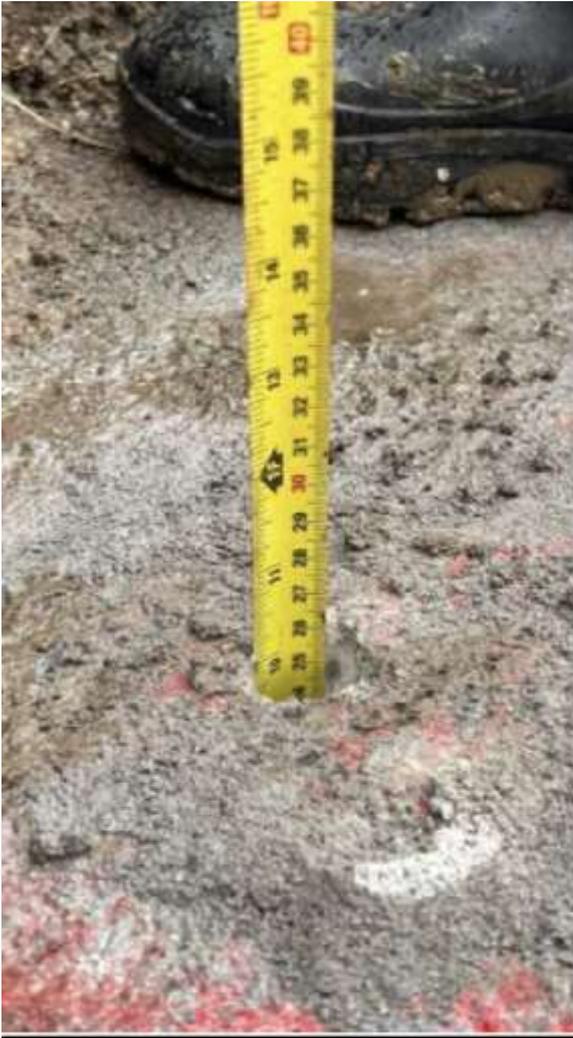
*Figure 8: Pilot hole 25mm drill bit*

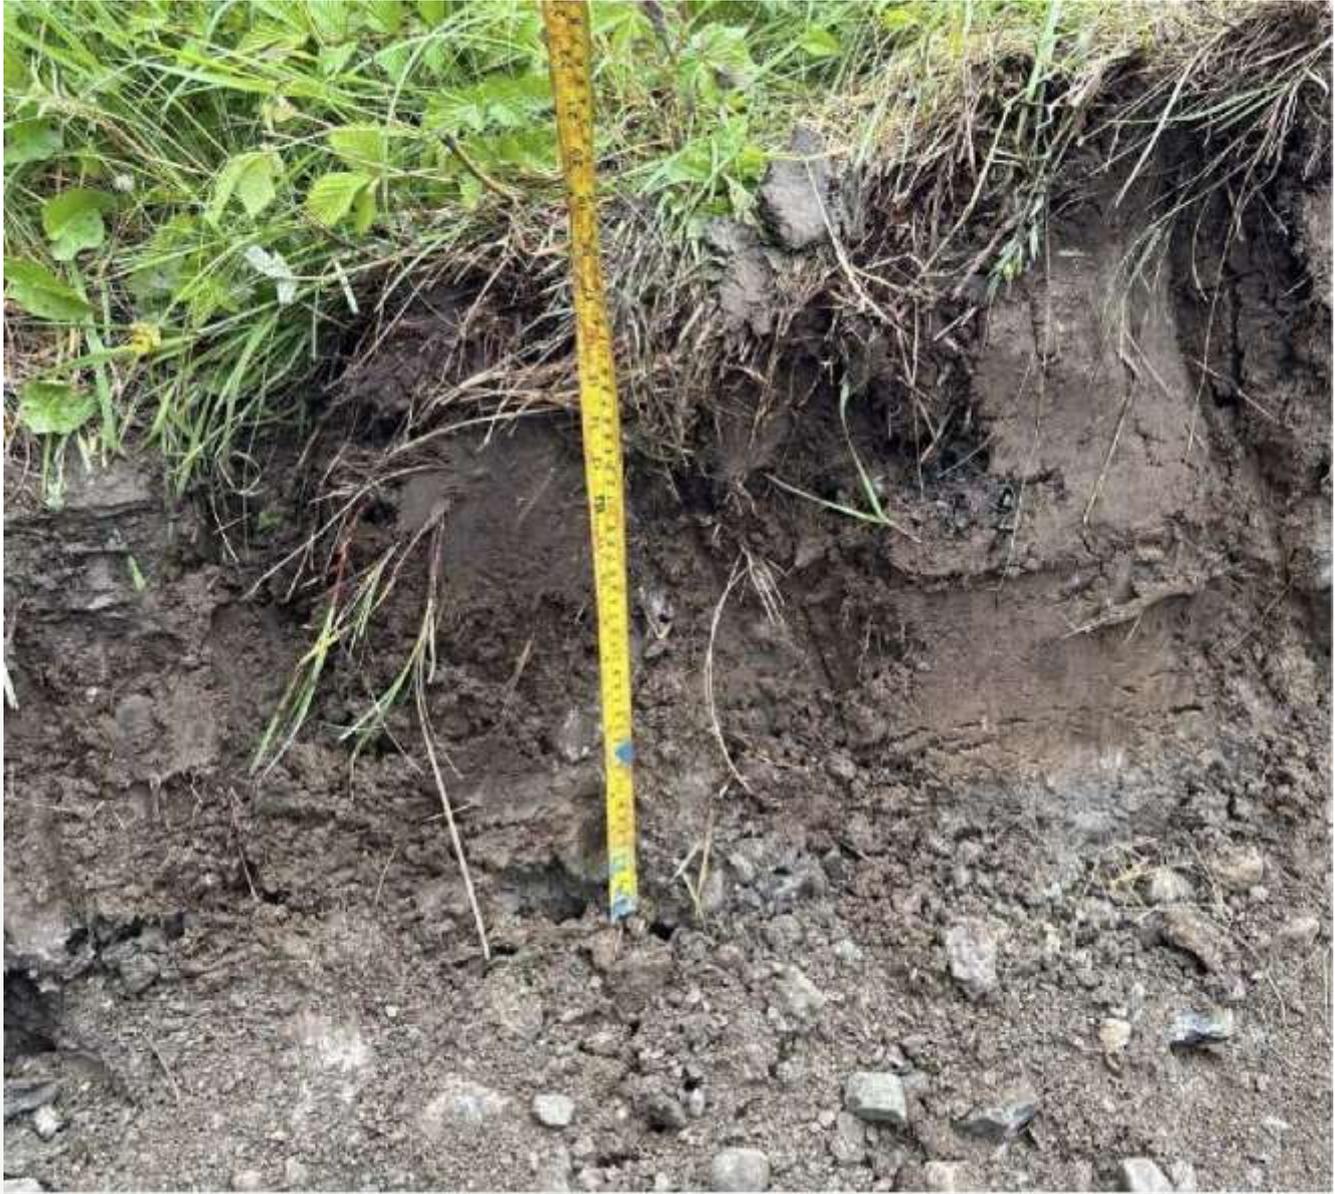
*Figure 9: Depth of fill in verge*

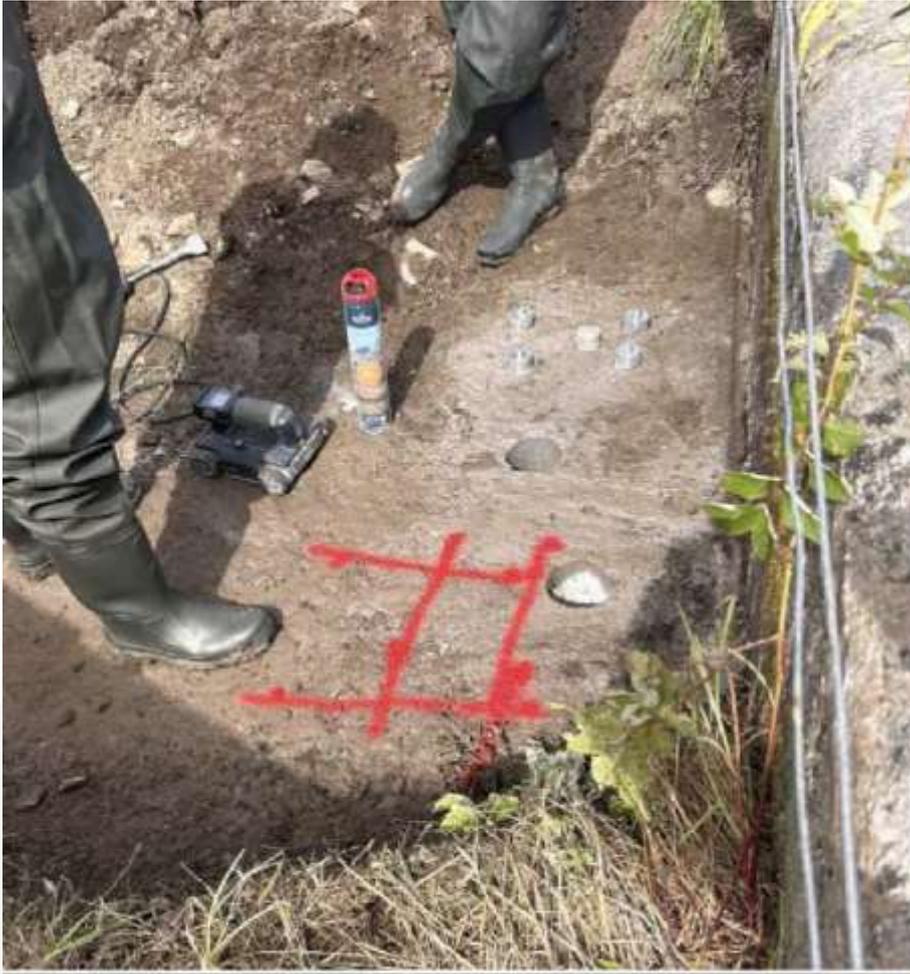
Figure 10: Ferro scan and adhesion test

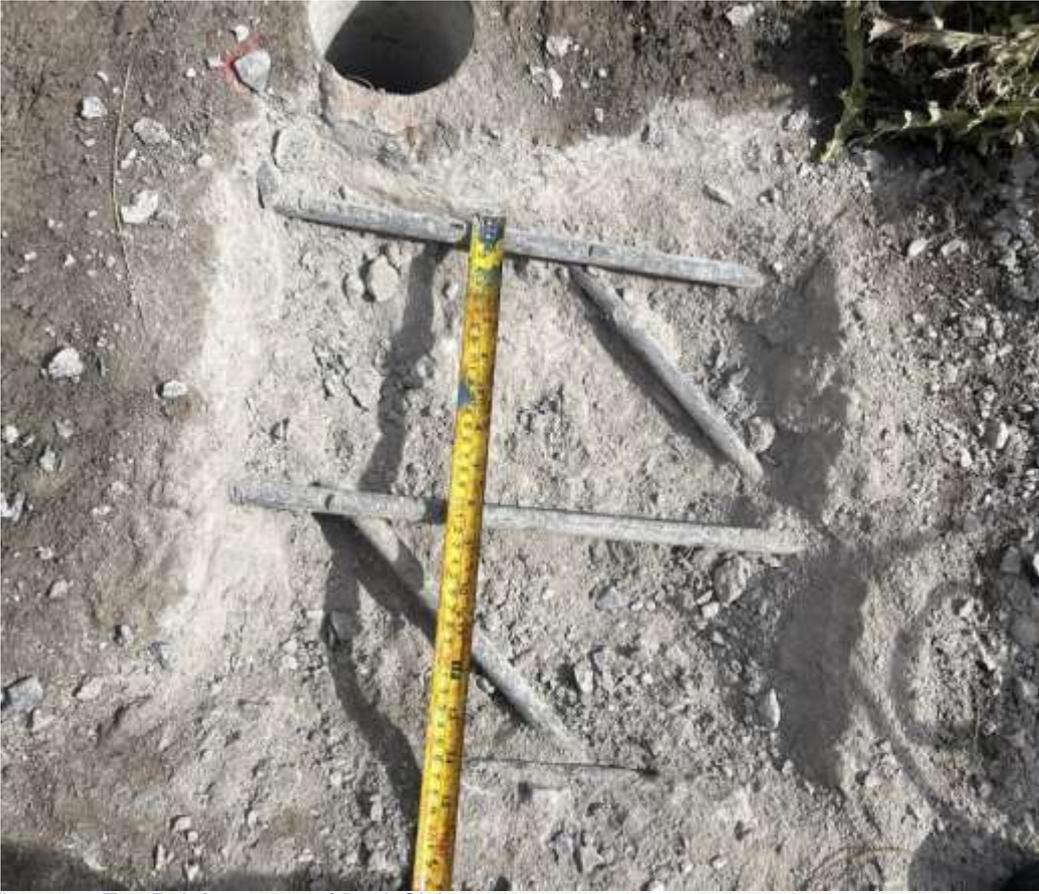
*Figure 11: Top Reinforcement of Deck Slab*

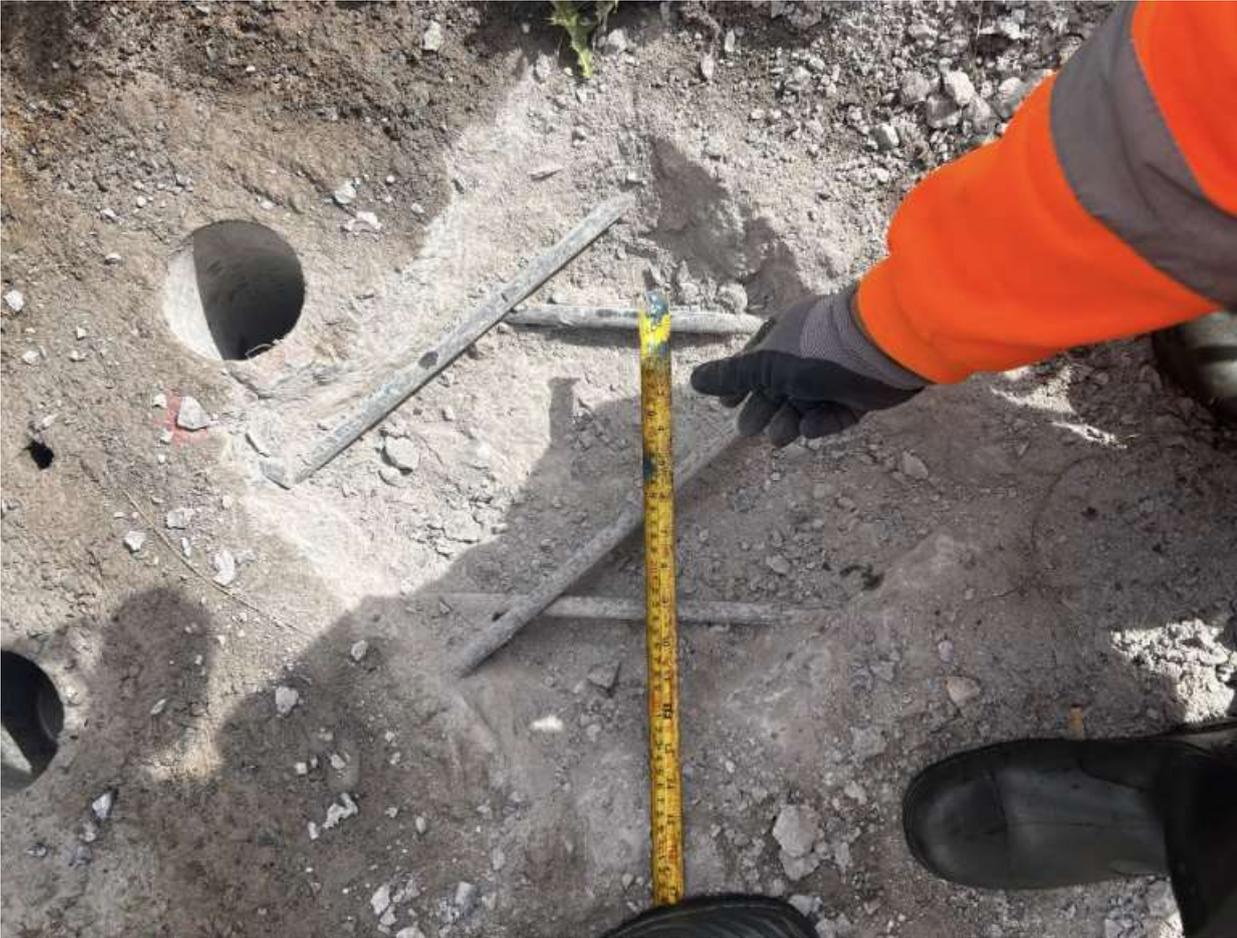
*Figure 12: Top Reinforcement of Deck Slab*

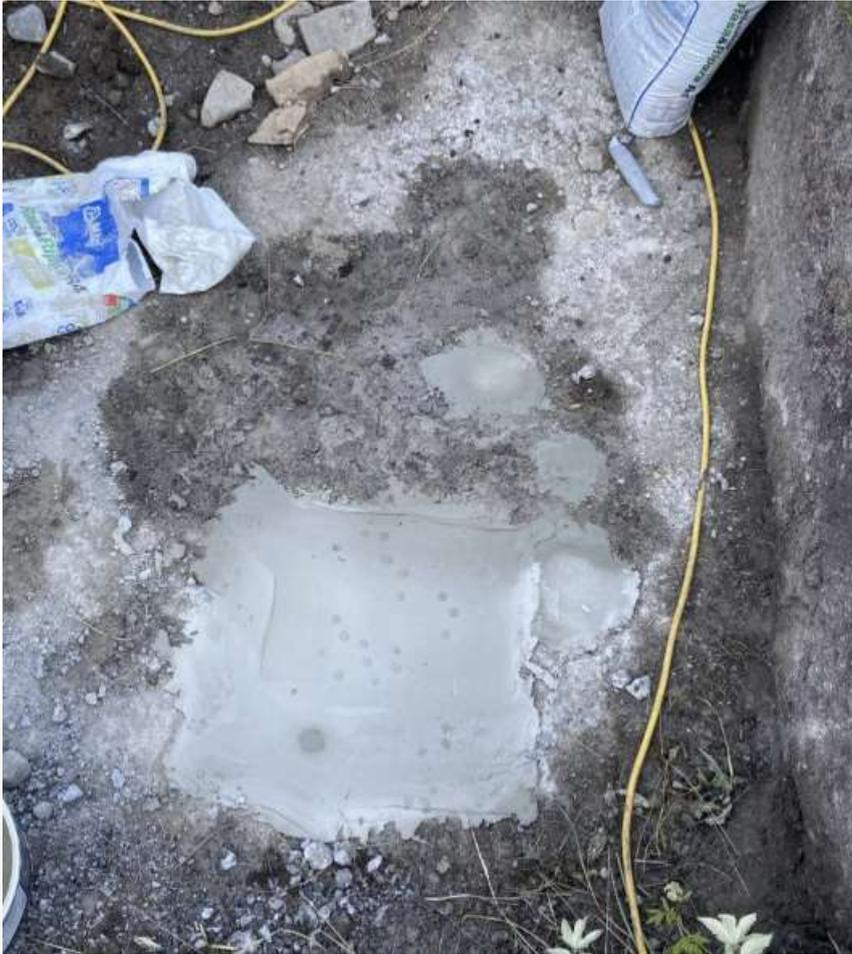
*Figure 13: Breakout and Core hole reinstatement*

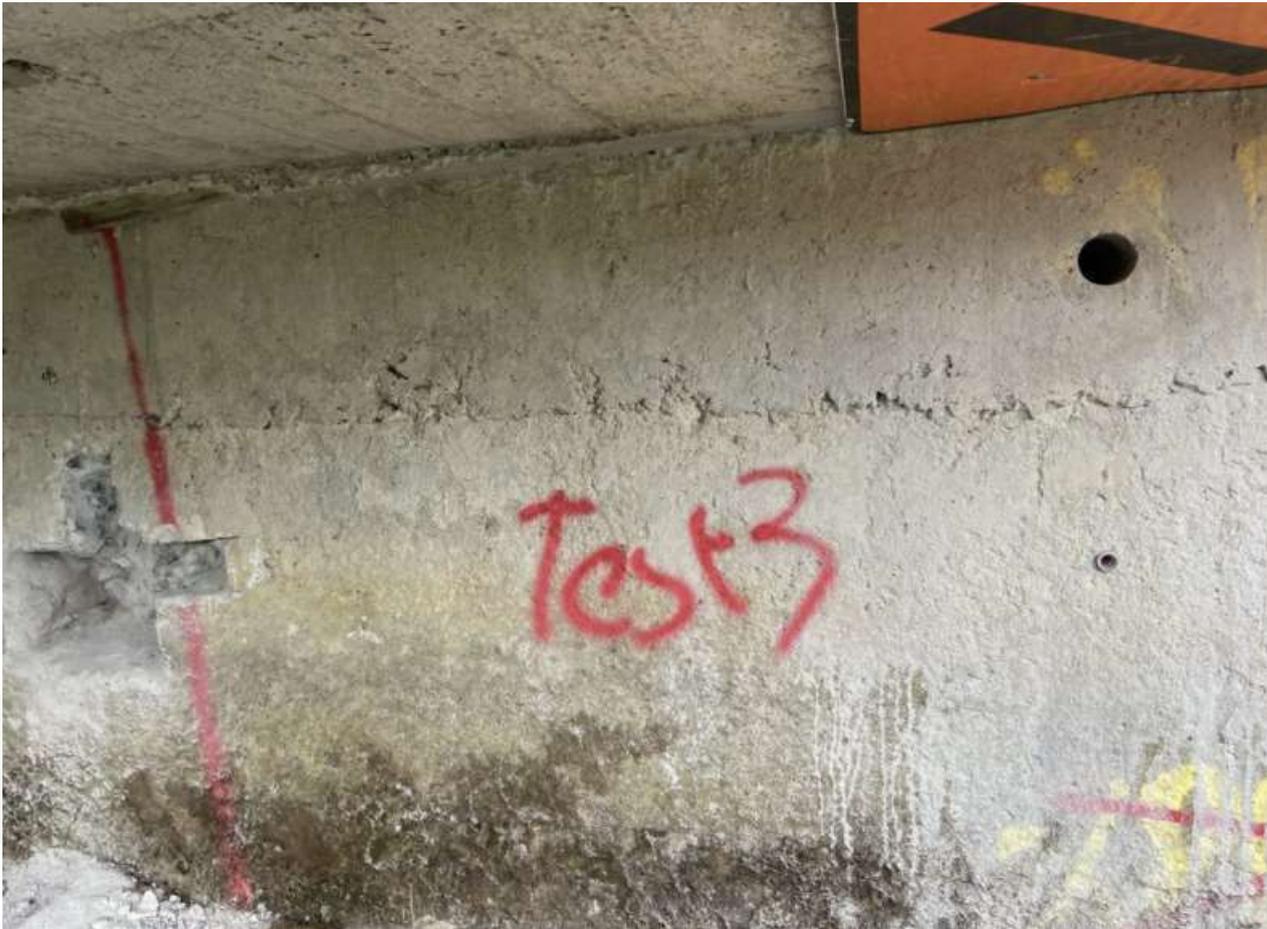
*Figure 15: West abutment showing breakout and 50mm diameter pilot hole*

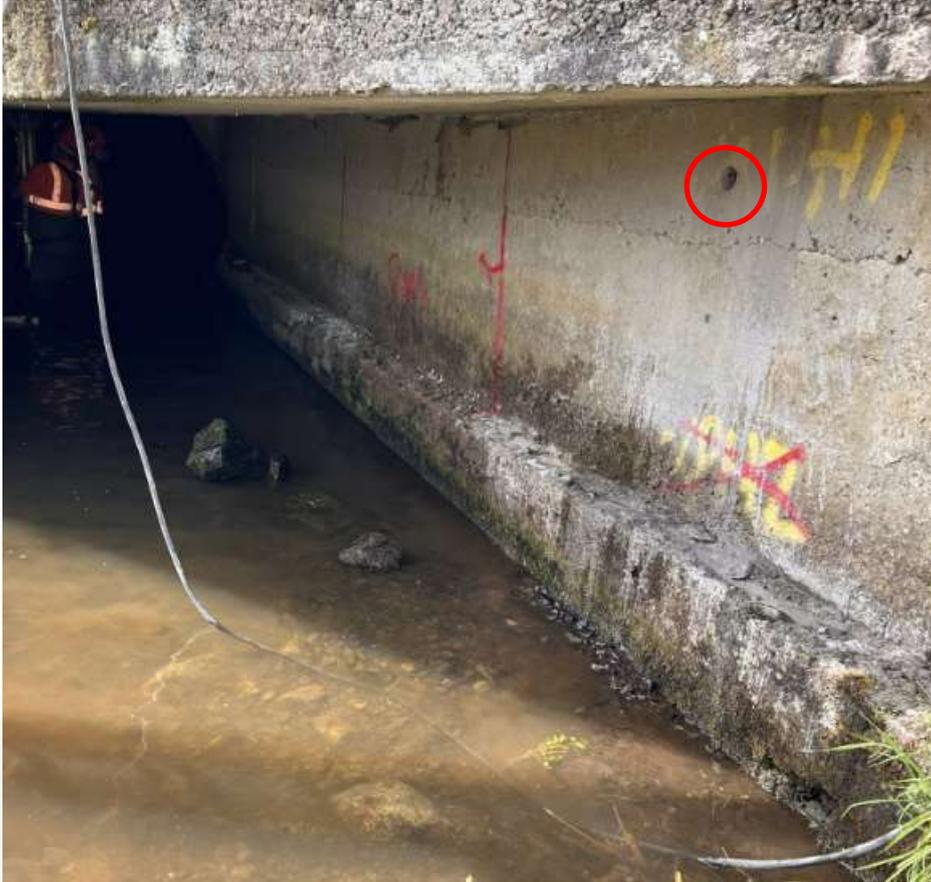
Figure 16: Pilot hole no 4 in Abutment

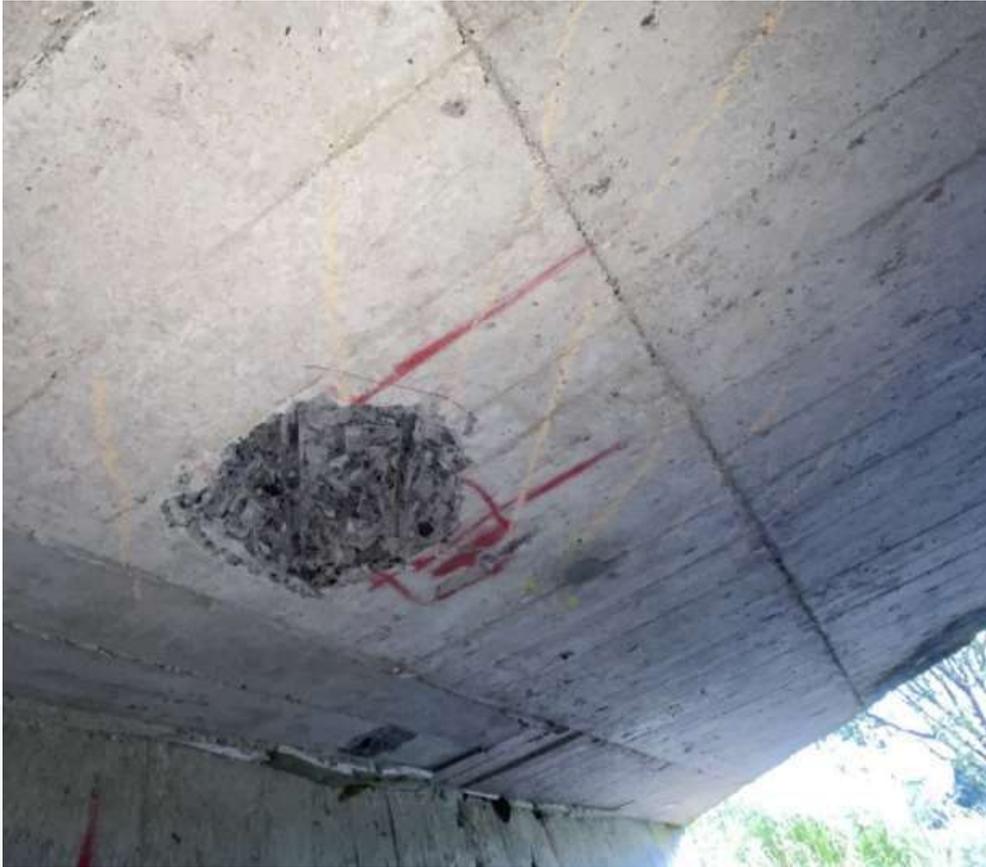
*Figure 18: Test Area 4 Reinforcement Spacing and Location*

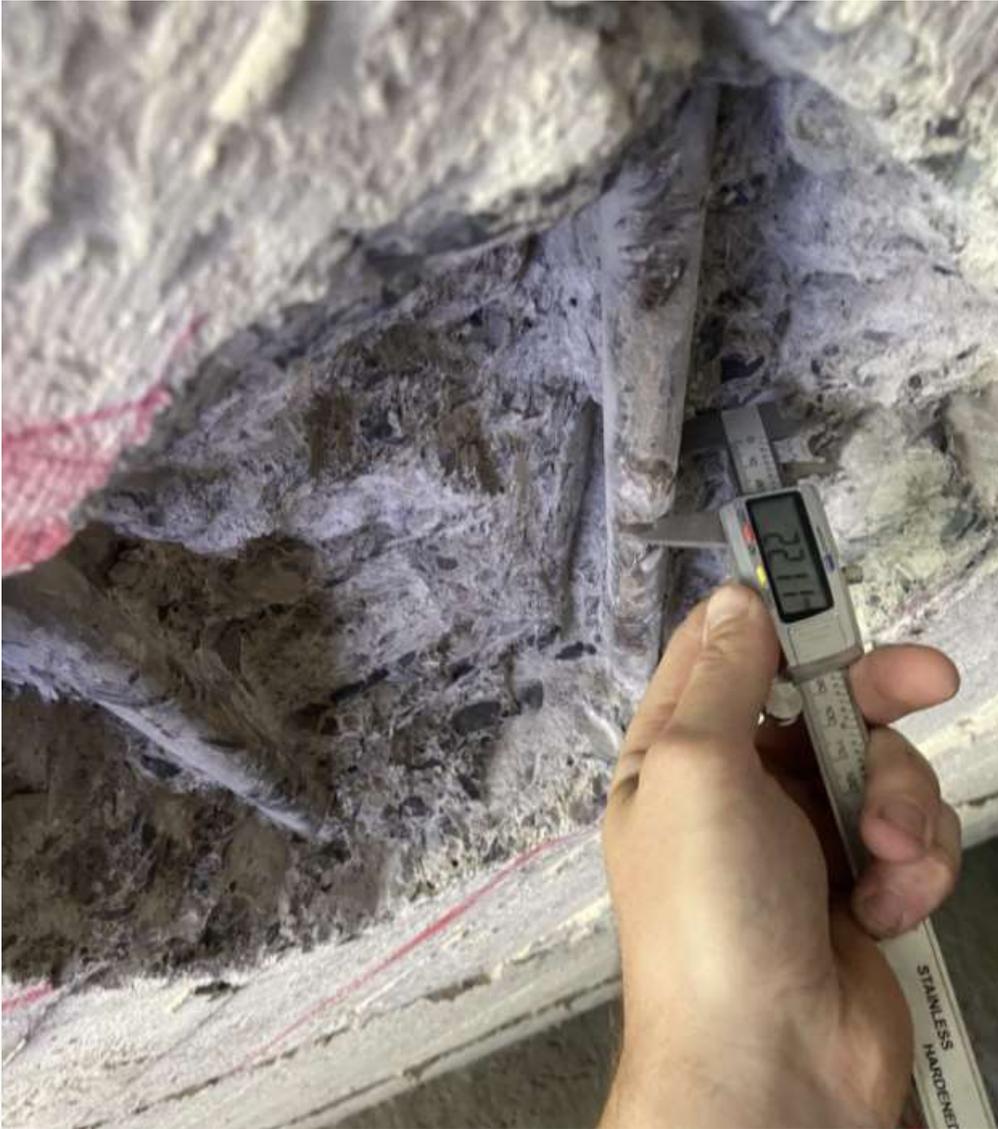
*Figure 19 : Measurement of reinforcement members*

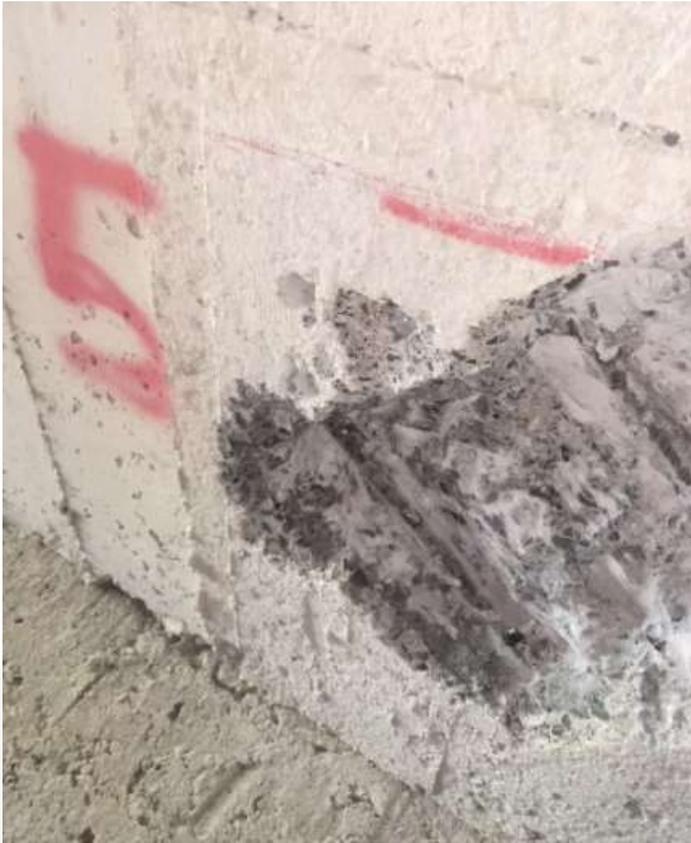
*Figure 22 : Test area 5 Breakout and reinforcement*

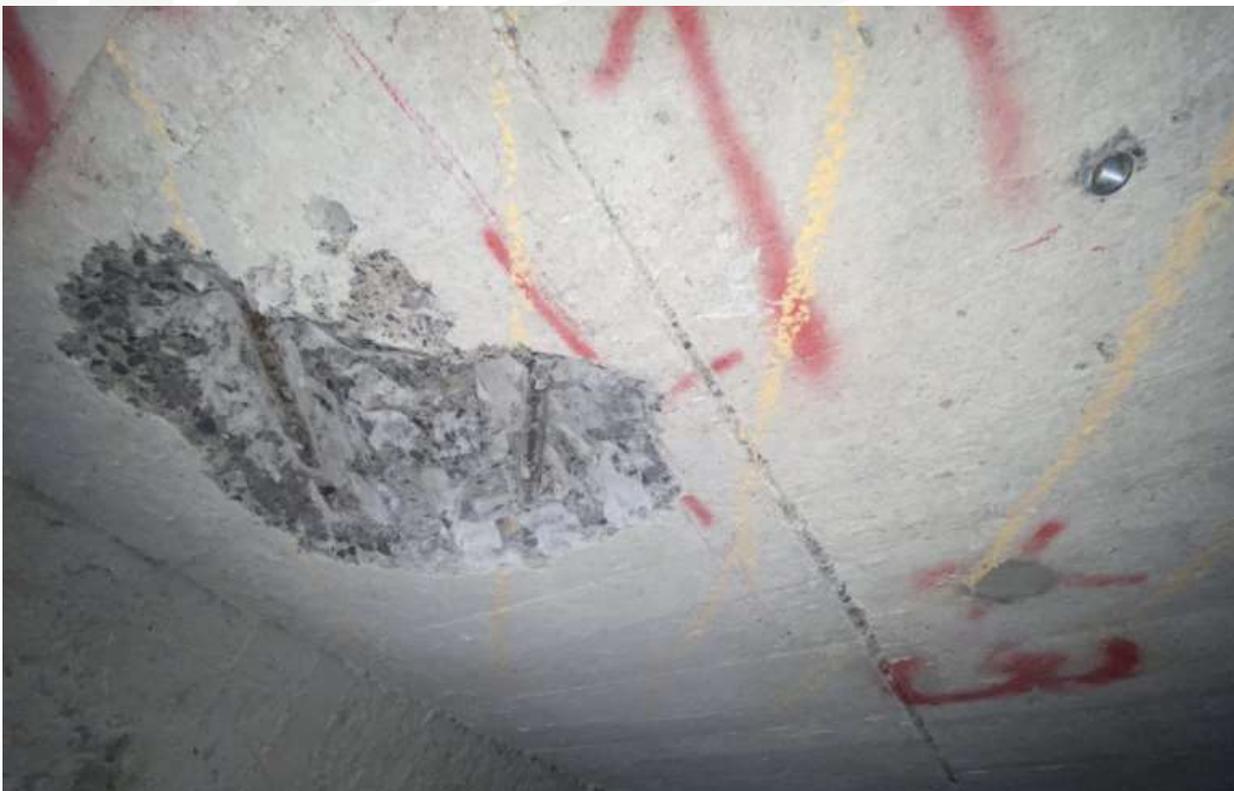
*Figure 23 : Test area 5 member spacing and location*

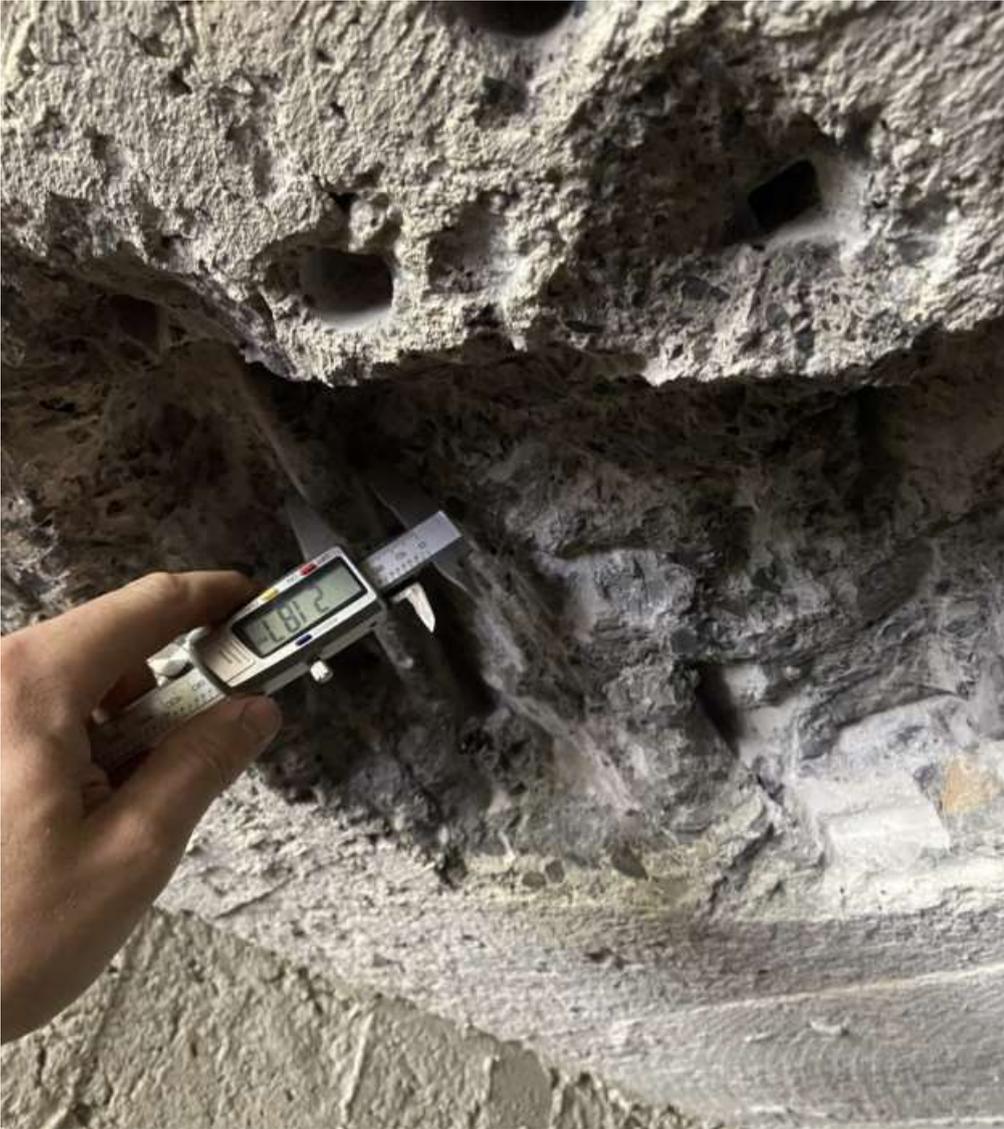
*Figure 24: Sizing of member in Test Area 5*

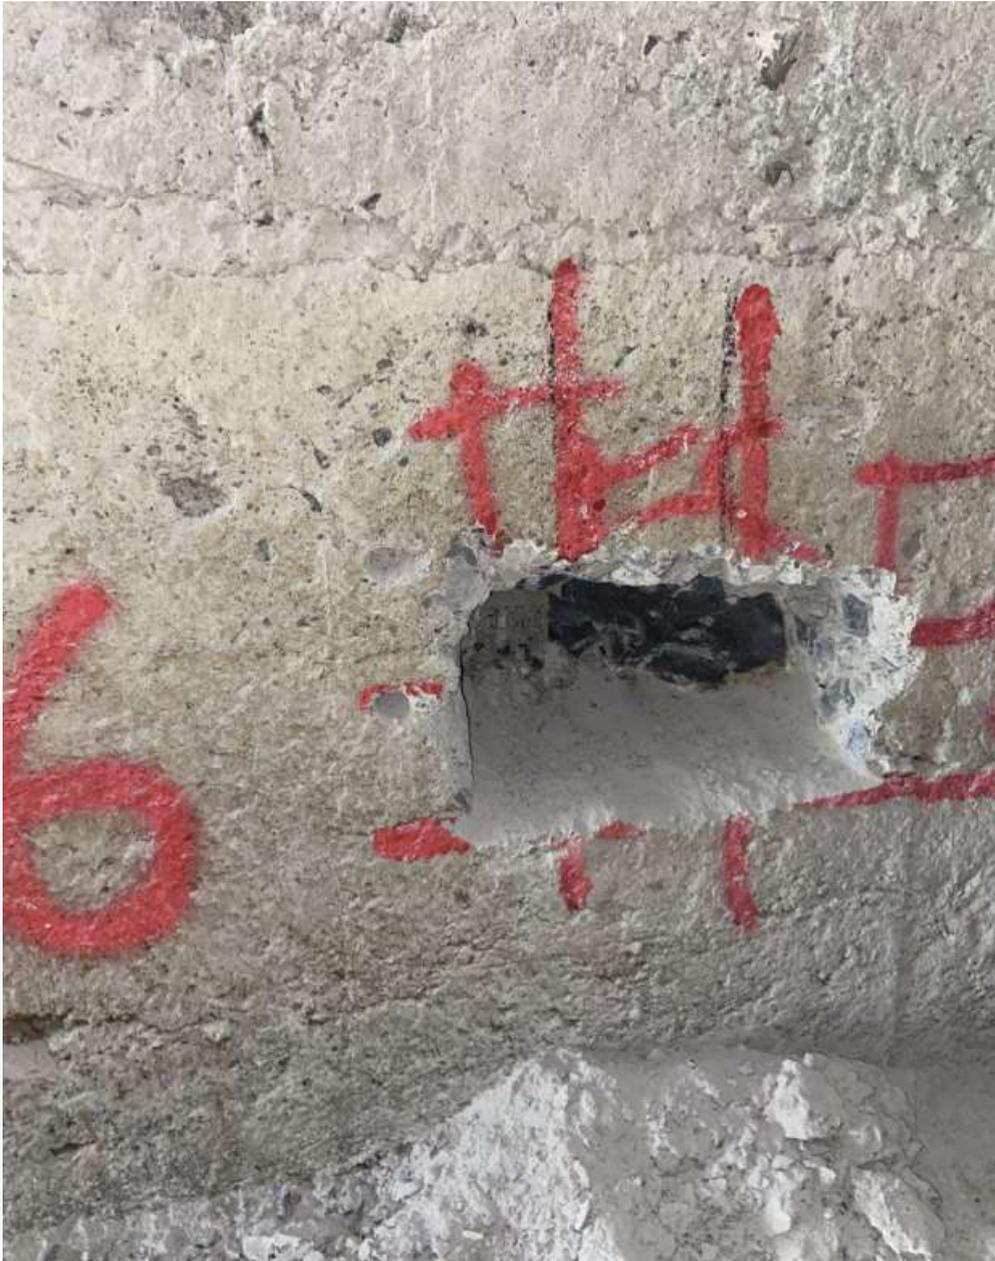
*Figure 25: Test Area 6 breakout*

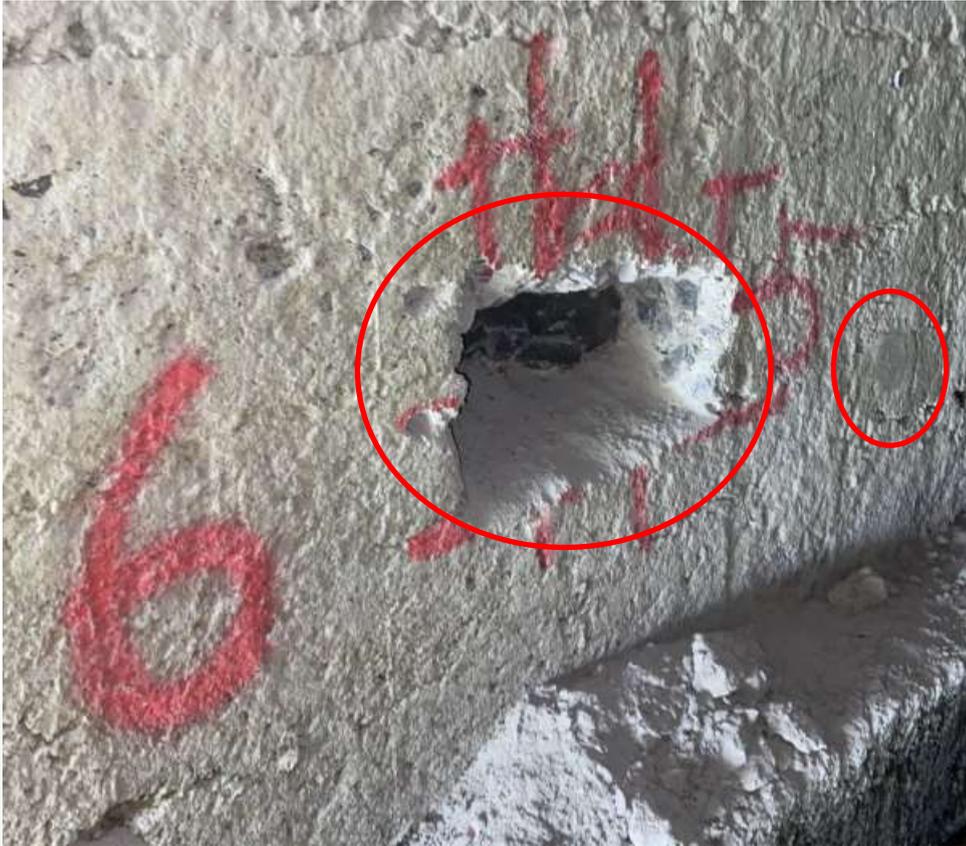
*Figure 26: Wide angle view showing reinstated pilot hole and breakout*

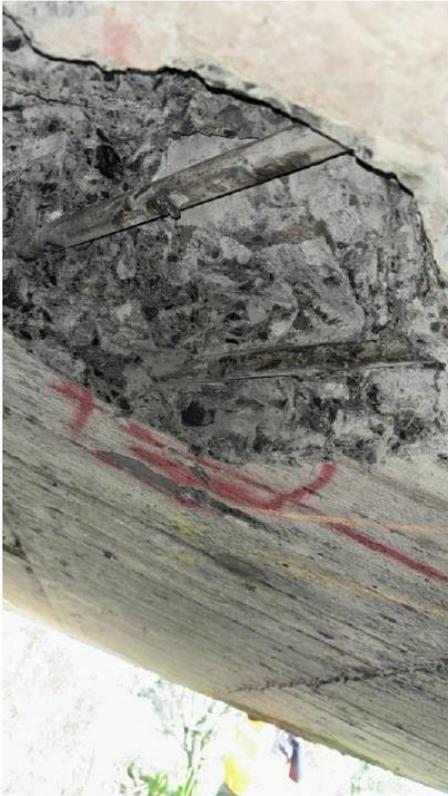
Unable to locate the transverse bars

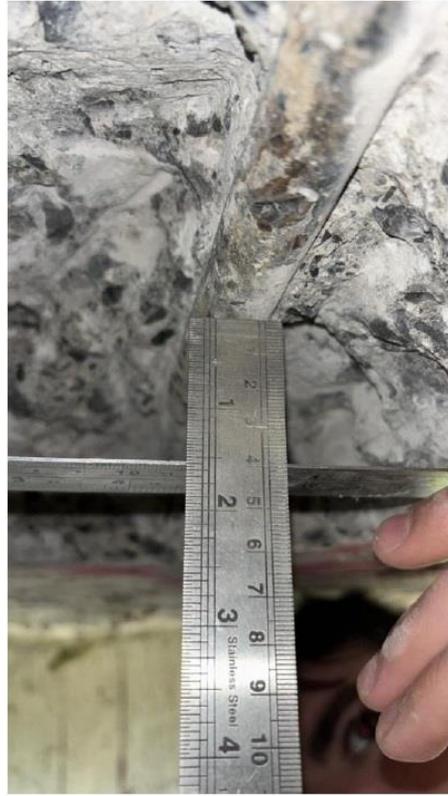
40mm cover long bars

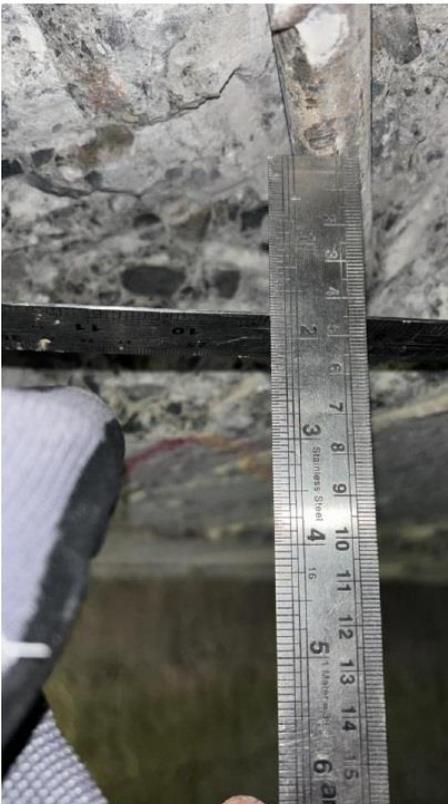
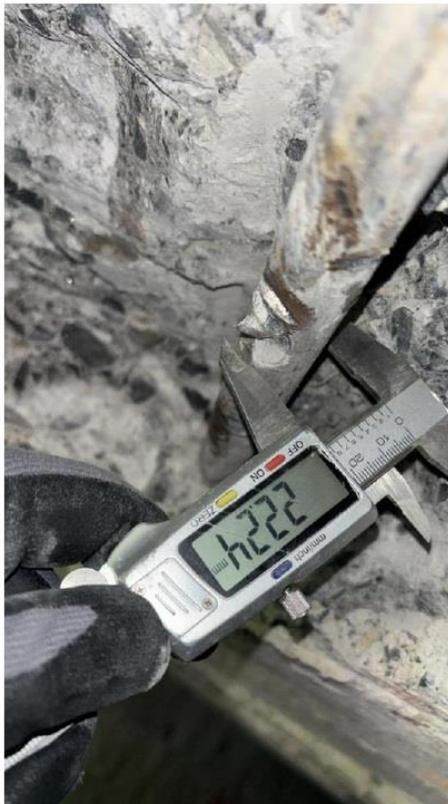
45mm cover longitudinal bar

20mm diameter longitudinal bar

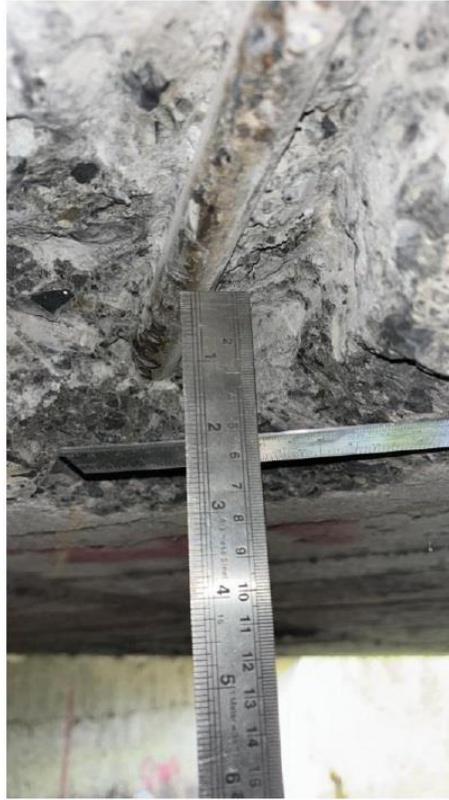
Area 5 soffit 2 - 45mm cover

Area 5 soffit 2 - 50mm cover

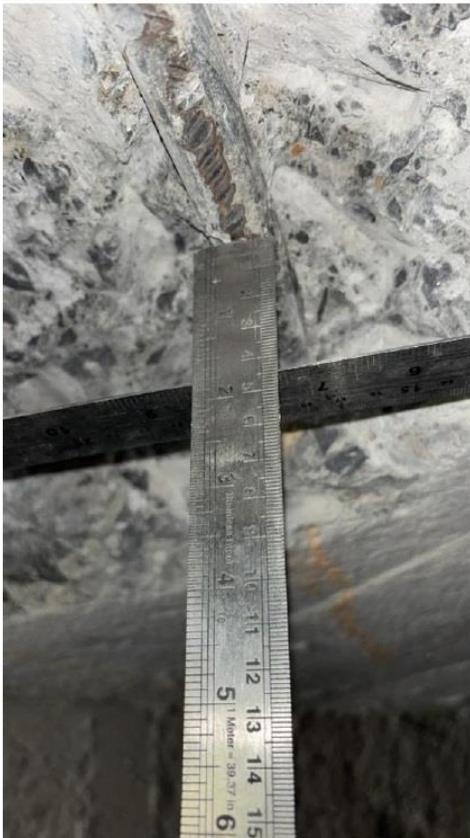
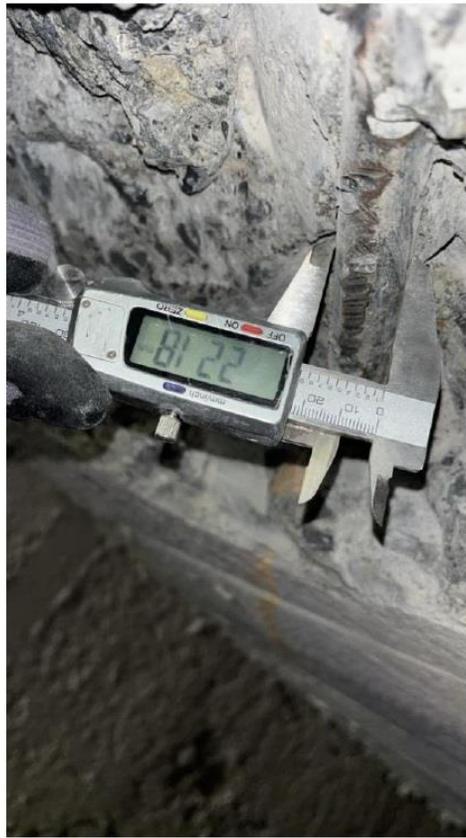
Area 5 soffit 2 - 20mm diameter bar

East abutment area 6 no reinforcement found

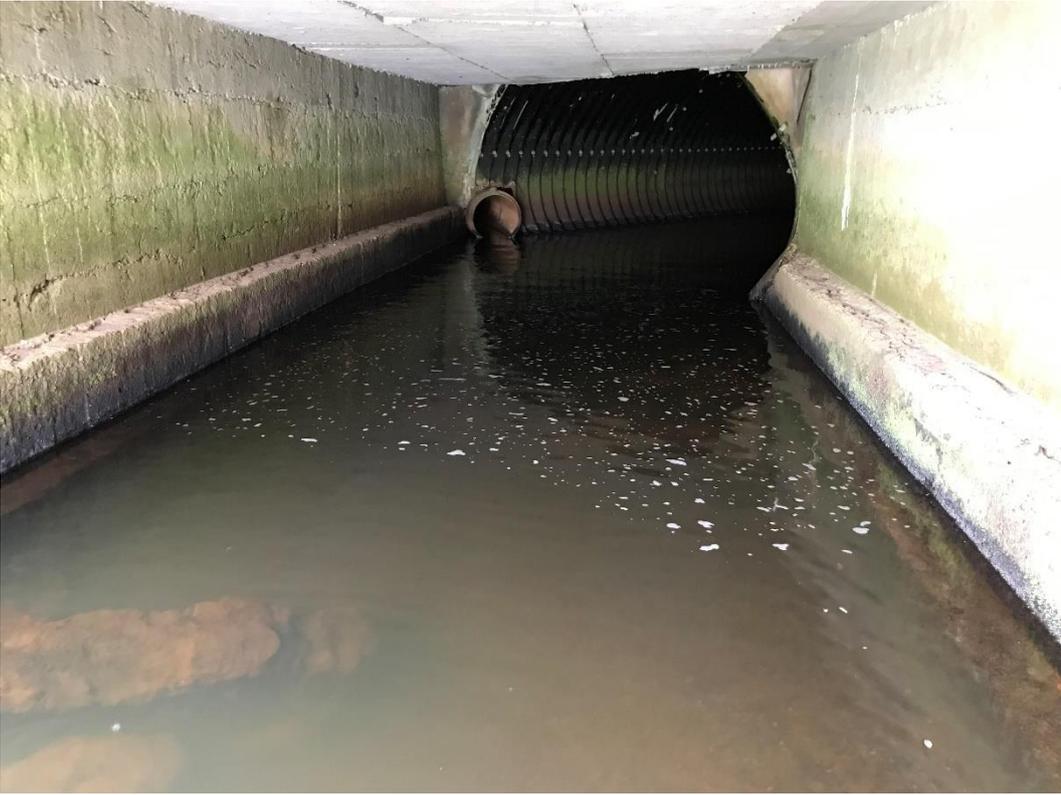
Photograph H-17 – View of the riverbed in the concrete slab section with scour evident

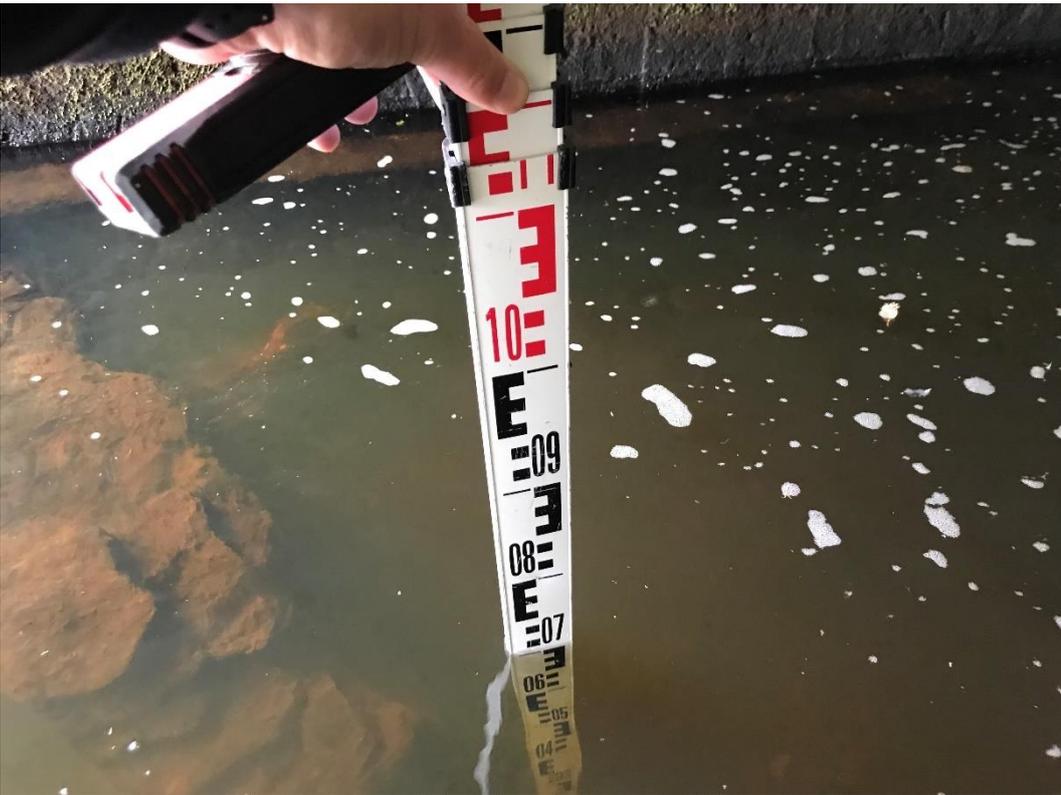
Photograph H-18 – View of the riverbed scour in the concrete deck extension
