# Stage 2 Structural Assessment Report

Mayo County Council

# N5 KNOCKAVRONY BRIDGE REHABILITATION WORKS

Document title: MO-N05-013.00 Knockavrony Bridge Stage 2 Assessment

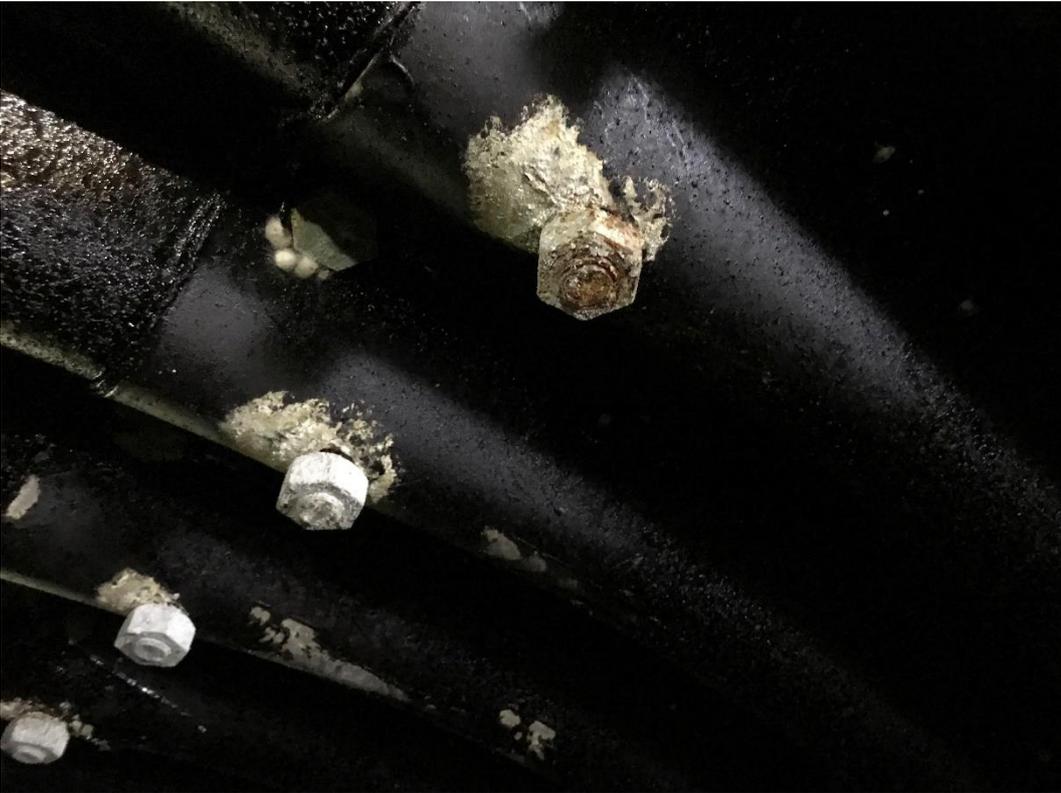
Photograph H-22 – View of the calcite forming around the bolts of the structure
