Building Record Reports

Cleeves Former Condensed Milk Factory Cleeves Riverside Quarter

Client: Limerick 2030

Date: 15th of October 2025

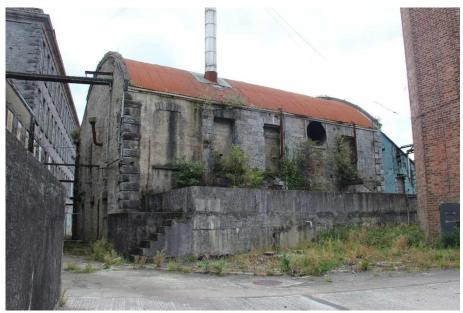
Photograph 1 - View of Engine House from northwest

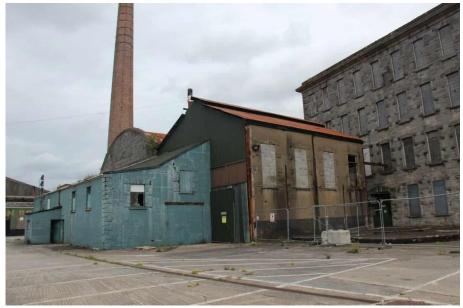
Photograph 3 General view of Building 2, with Corrugated Steel roof covering. Note split pitch of Building 3.

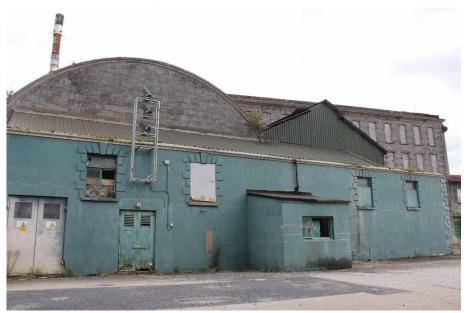
The roof covering of Building 3 is also corrugated sheeting, with the covering a split pitch, a lean to the Engine House, then a shallower pitch, mid plane, to the front wall of the extension. There is a concrete barge to the roof edge on each end elevation.

Photograph 4 General view of Building 3.

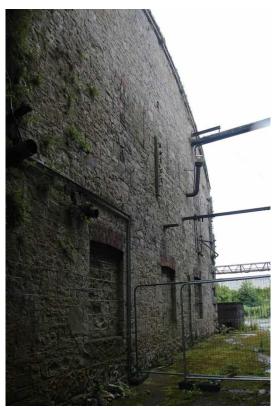
The external walls consist of margined and rusticated natural stone quoins and opening surrounds, with infill coursed random rubble natural stone panels and walls, with some areas rendered with a cementitious plaster.

Photograph 5 Northeast elevation of the Engine House, random rubble natural stone construction.

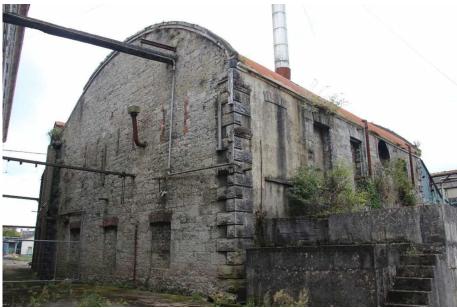
The only openings present to the Engine House externally now, are to the western elevation. These are now all infilled with masonry. (See Photograph 2 above).

Photograph 8 General view, from the northwest of the Engine House building.

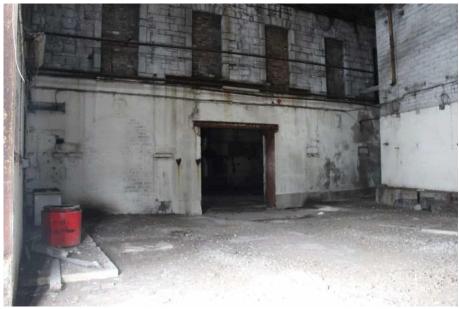
On the original eastern elevation, now internal, there were also openings, which are also infilled with masonry, with the exception of a circulation opening on the ground floor, not original to the building.

Photograph 9 Eastern elevation of the Engine House, now internal.

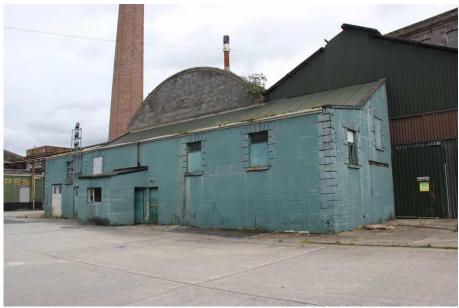
Photograph 11 General view of Building 3. Note fenestration and doors.

On the eastern elevation there are two window openings, with one assembly still in place, and one opening boarded up. There is one door opening, located on the eastern porch elevation.

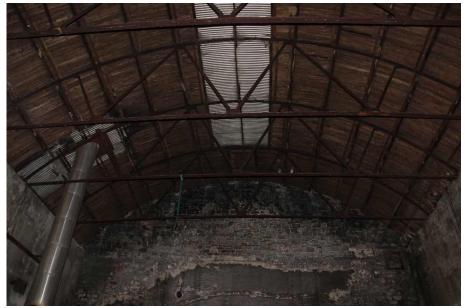
The structure of the Engine House roof is of wrought iron Belfast Trusses, with timber purlins spanning across the trusses beneath timber parging, onto which the roof covering is affixed.

Photograph 12 View of the Roof Build-up of the Engine House.

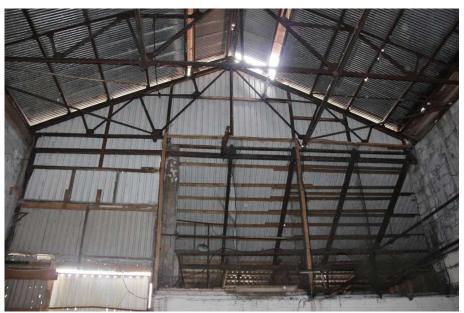
The roof structure to building 2 consists of steel fink roof trusses, with steel bracing between each truss, and purlins running over the topside of the trusses, onto which the roof covering is affixed.

Photograph 13 General view of the roof trusses to building 2.

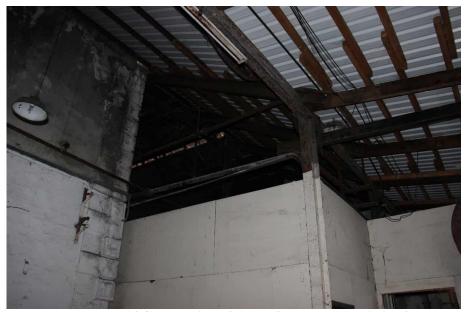
The roof structure of building 3 consists of rolled steel beams, sitting on steel frames internally, onto which timber purlins, running from beam to beam sit. The roof covering is then affixed to the timber purlins.

Photograph 14 General view of the roof structure to building 3.

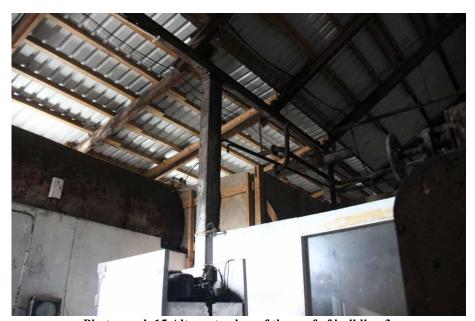
Photograph 15 Alternate view of the roof of building 3.

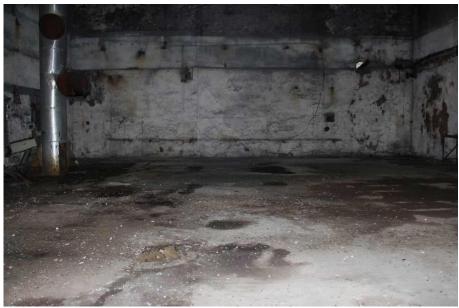
Generally an open plan interior, the internal elevations of the Engine House are of mass masonry natural limestone construction with a cementitious render applied to the lower levels of the walls.

Photograph 16 General view of an internal wall elevation to the Engine House.

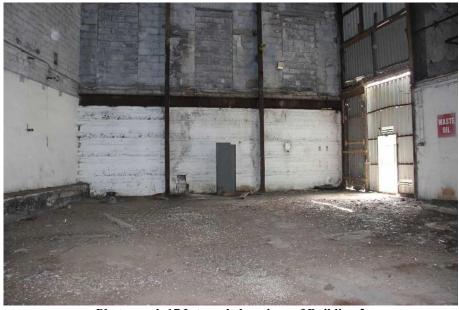
The internal elevations of the external walls are a mixture of cast insitu mass concrete (most likely the original walls) with modern concrete blockwork overhead. The northeastern rooms of the building were not accessible on the day of inspection, with the survey plans showing two rooms internally on the ground floor.

Photograph 17 Internal elevations of Building 2

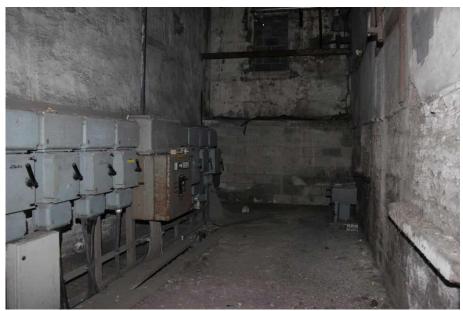
Photograph 18 Room containing electrical fuse panels.

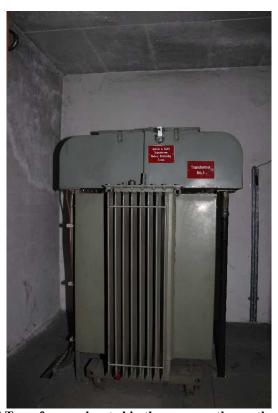
Photograph 19 Electrical Transformer, located in the room on the southern section by the porched entrance.

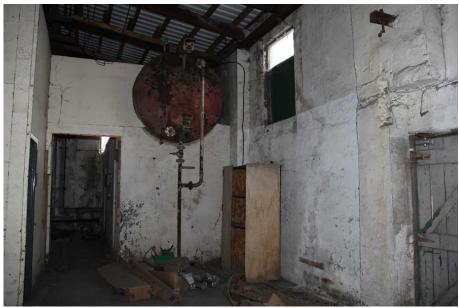
Photograph 20 Masonry support for a fuel tank, with timber partitions to the LHS.

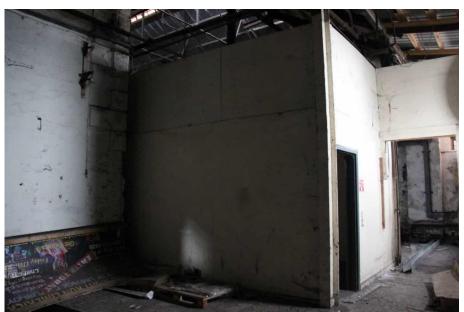
Photograph 21 Exterior of timber stud partitioned room.

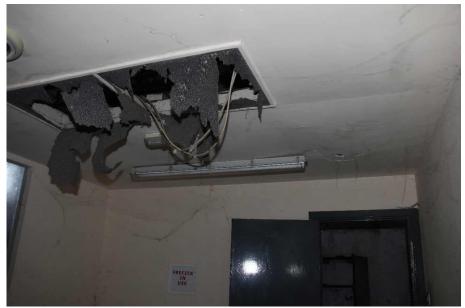
The remainder of the internal rooms have either solid masonry partition walls or stud partition walls, with two of the rooms noted to have modern plasterboard ceilings.

Photograph 22 Example of the modern plasterboard ceiling to one of the building 3 rooms.

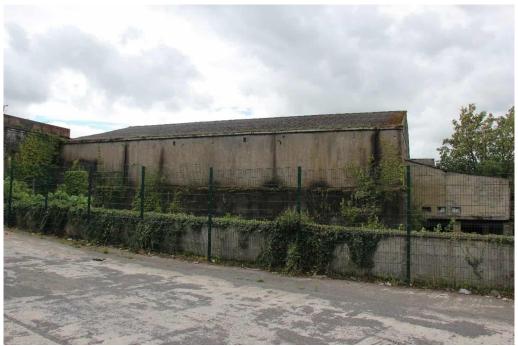
Photograph 1 - View of Infiltration Gallery from North

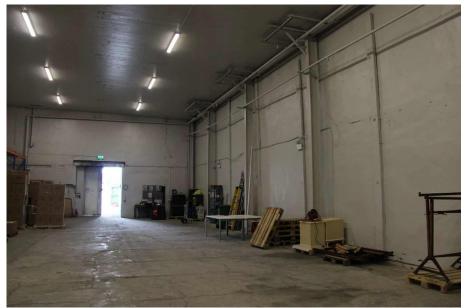
It was noted that all the visible fabric, where the wall was expected to be found, is covered over in modern built fabric e.g. modern concrete blockwork.

Photograph 4 - Current view of location of wall between the Cheese Plant and original Dye House, northern elevation.

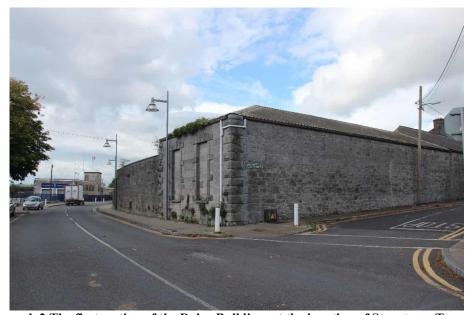
The roof covering, a hipped gable to O'Callaghan Strand, and pitched roof, thereafter, has a replacement modern pressed corrugated sheeting covering to the first section, starting at the junction of O'Callaghan Strand and Stonetown Terrace, with extruded aluminium rainwater goods.

Photograph 2 The first section of the Dairy Building, at the junction of Stonetown Terrace and O'Callaghan Strand.

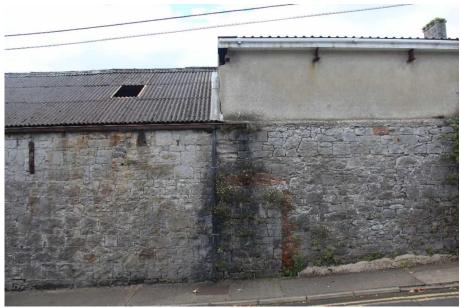
The next roof section is covered in a fibrous corrugated sheeting, also with extruded aluminium rainwater goods.

Photograph 3 View of the second and third section of the subject complex.

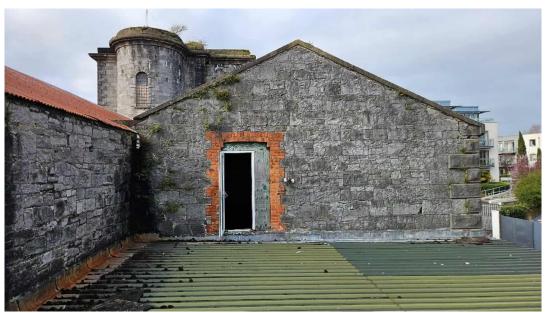
The final section, running up to the gable of the adjoining building, has had the roof pitch changed to a near flat roof covering, with a pressed corrugated sheeted covering, also with extruded aluminium rainwater goods.

Photograph 4 General view of the roof covering of section three, terminating back to the gable end of the adjoining building.

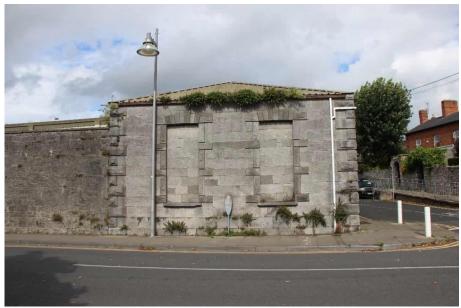
The gable, facing onto O'Callaghan Strand is of coursed Ashlar Natural Limestone, with two blind window openings, also infilled with Ashlar masonry. The Quoin stones and window surround masonry are of margined and rusticated masonry units, with tooled window cills.

Photograph 5 Gable facing onto O'Callaghan Strand.

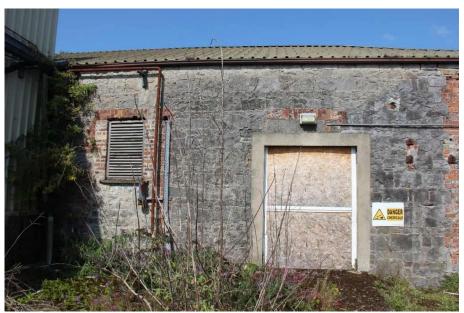
There are only two noted openings, both to the southwest elevation. One window opening with a louvered assembly, and a retrofitted door opening.

Photograph 6 General view of the opening to the SW elevation.

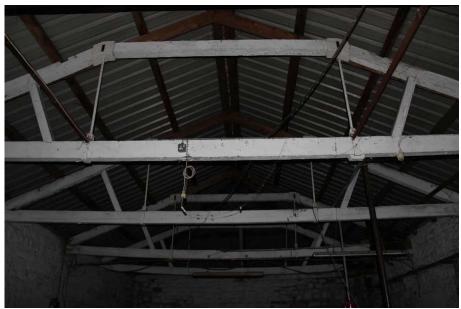
the case of these trusses are formed using a combination of cast iron plates and wrought iron bars (serving as the posts).

Photograph 7 General view of the roof structure to the first section.

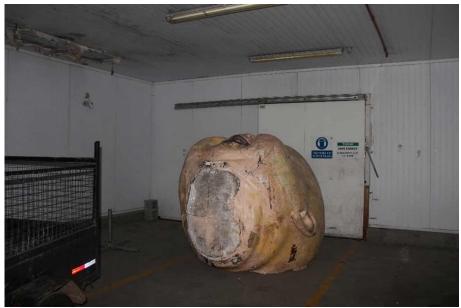
The second and third sections of the roof void were inaccessible, with the second section now a cold room, with insulated panels to the ceiling and walls. The same is true for the third section and the last room leading back to the office gable.

Photograph 8 General view of the second section of the Dairy Building, all the envelope is outside the cold room panelling.

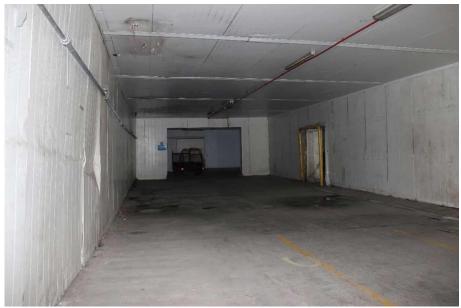
Photograph 9 General view of Section three, also a full panelled cold room.

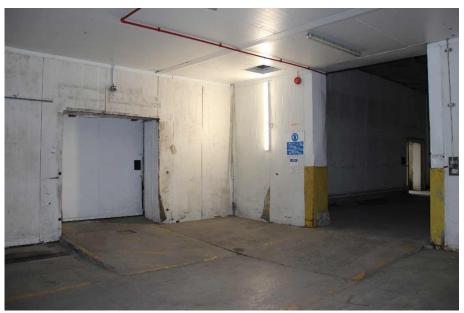
The internal floor to all three sections is a modern concrete floor, with evidence of surviving historic fabric.

Photograph 11 General view of the internal spaces, note concrete flooring.

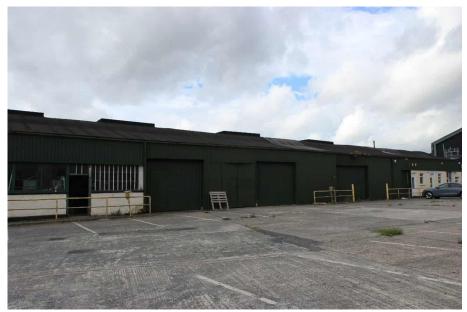
The external roof covering of the main building is finished with a modern bituminous felt. There is evidence of ventilation shafts to the roof, long covered over. The small lean-to addition to the eastern elevation is covered with a modern pressed metal corrugated sheeting.

Photograph 2 General view of the northern elevation of the workshop. Note the bitumen felt roof covering.

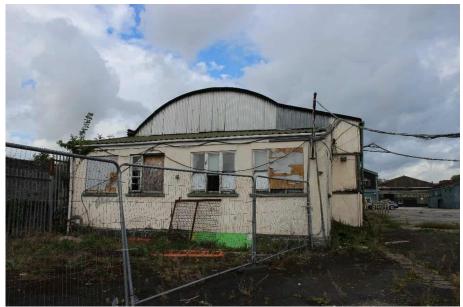
Photograph 3 Lean to building, eastern elevation. With a pressed metal roof covering.

The main roof has cast iron rainwater goods. The lean to has PVC rainwater goods.

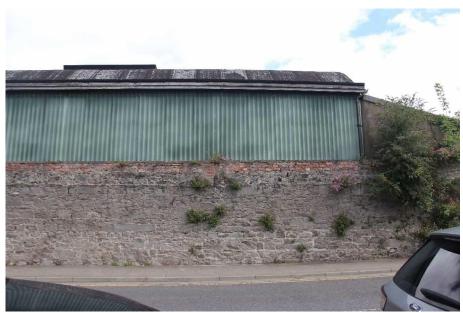
The elevation facing onto the North Circular Road corrugated sheeting cladding, the western gable end is also finished in a corrugated sheeted cladding, with the lower level rendered mass masonry.

Photograph 4 Example of the external wall cladding to the southern elevation.

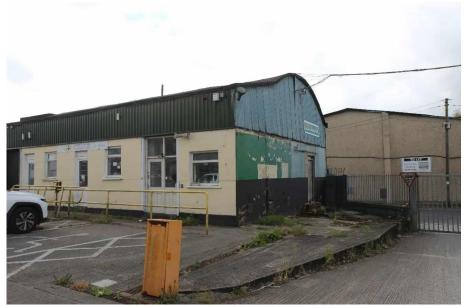
Photograph 5 Western section of the Workshop building, with the west elevation also on view.

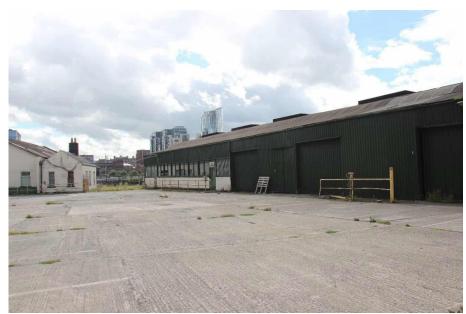
Photograph 6 View to the mid and eastern section of the northern elevation, note the different finishes present.

The eastern elevation is a modern masonry lean to add on, with concrete cills.

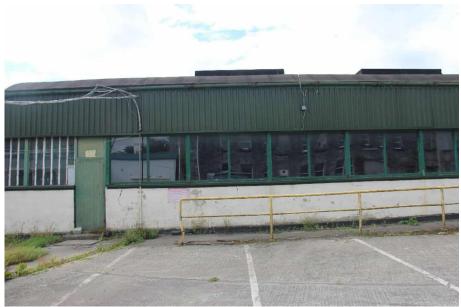
Photograph 7 Example of the fenestration to the eastern section of the northern elevation.

On the northern elevation, there are three window openings, consisting of modern PVC window assemblies. There are three door openings, one a timber assembly with timber and glazed surrounding screen, the remaining two are modern PVC assemblies.

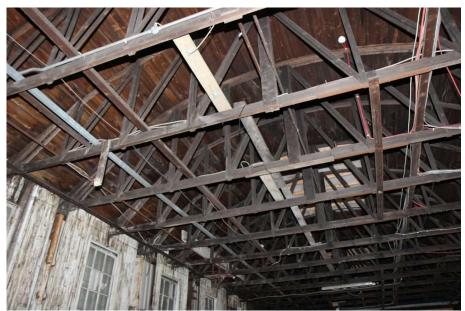
Photograph 8 View of the roof structure, an array of Belfast trusses. Note the underside of the timber sarking boards.

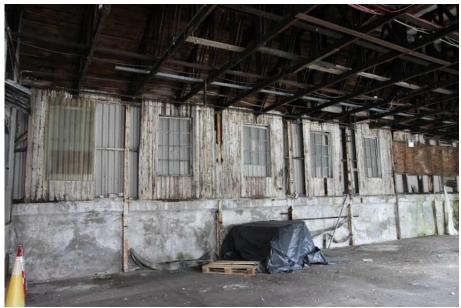
Photograph 9 Internal elevation view of the southern external wall.

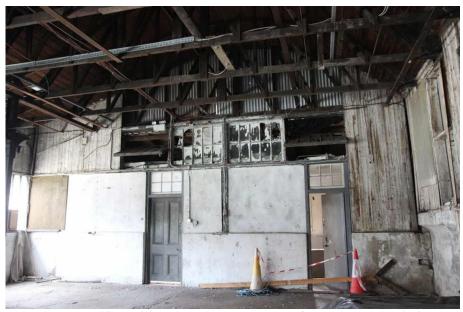
Photograph 10 Partition screen to eastern end of the workshop building.

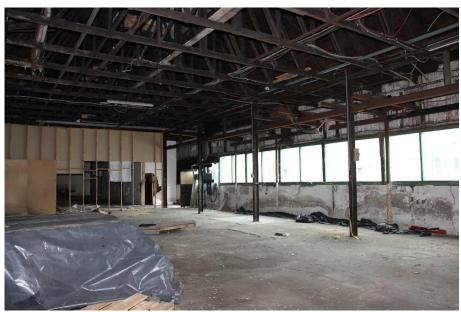
Photograph 11 View, facing westwards. Note concrete infill to the lower section of the northern wall.

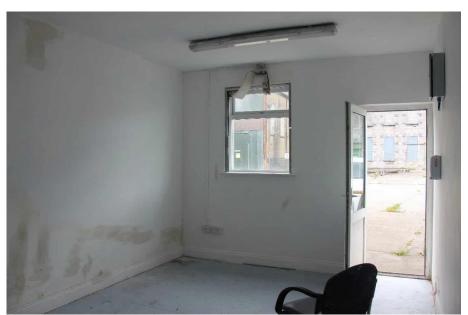
Photograph 12 Internal view of one of the rooms to the northwest section of the building. All modern finishes and detailing.

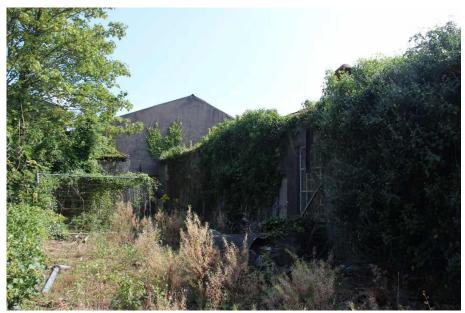
Photograph 1 - View of Cheese Plant from North

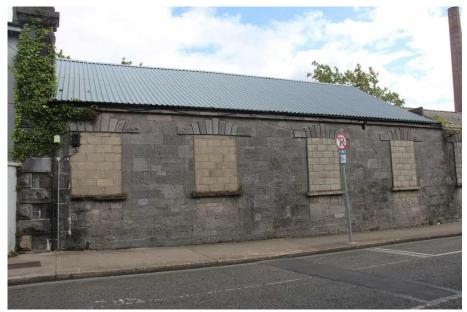
The front elevation roof plane is clad in a pressed metal corrugated sheeting, the rear roof plane, or north roof plane, is covered with fibre cement slate.

Photograph 2 North Circular Road elevation of the end section of the Cheese Plant. Note pressed metal sheeted roofing.

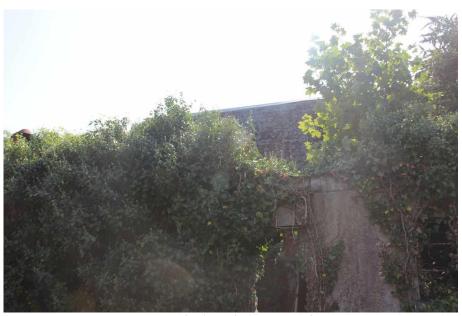
Photograph 3 View of the rear roof plane.

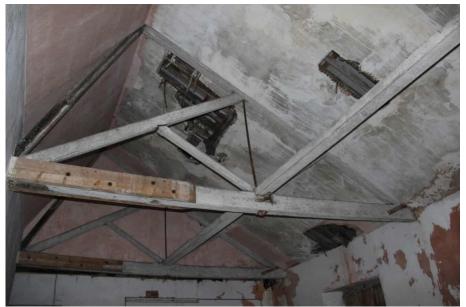
Photograph 5 Internal view of the splayed ceiling in the first section of the subject building.

The northlight roof plane is filled in with modern skimmed plaster slabs internally. There is no surviving evidence of the windows which would once have been present here.

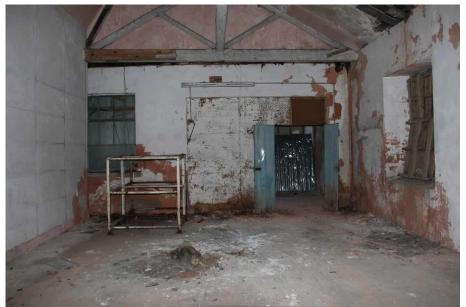
The internal walls of the building, where accessible are finished in a modern gypsum-based plaster throughout.

Photograph 7 General view of the internal of the first section of the subject building.

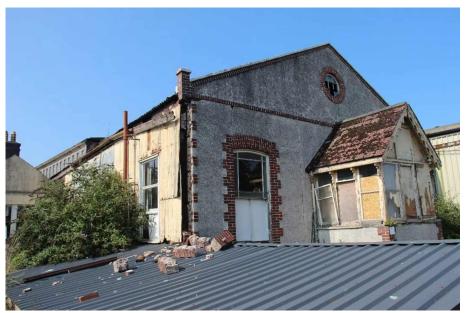
Photograph 1 - View of Admin & Labs Building from South

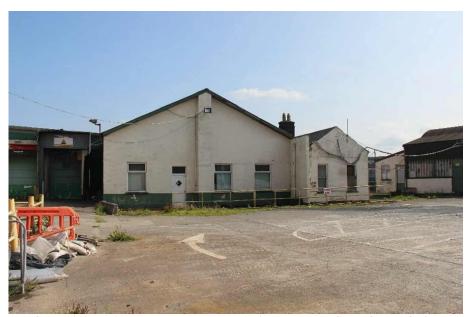
Photograph 2 Administration and Laboratory building to the LHS, welfare building to the RHS

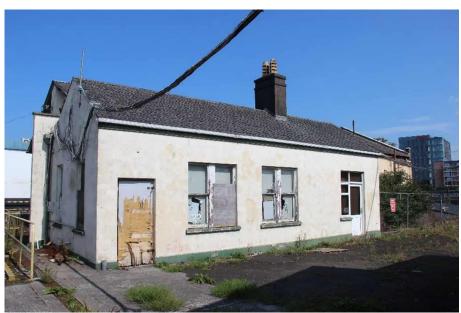
The roof to the welfare building comprises a single cementitious rendered chimney stack, protruding from the ridge line of the roof, with two clay pots. There is visible rolled lead sheet counter flashing to the chimney abutments, onto a gable to gable pitched roof, covered with fibre cement slate.

Photograph 3 General view of the "welfare" building.

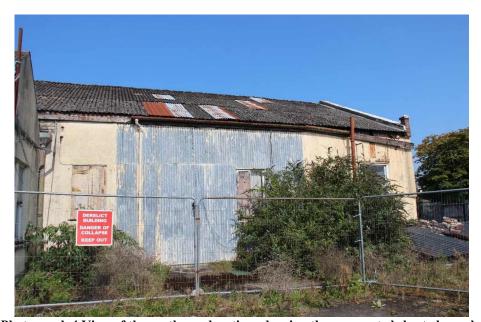
The external walls of the Administration and Laboratory building are finished in multiple materials, namely cementitious render to the western gable and northern return, with some natural stone exposed, albeit painted. The southern elevation, to the east of the welfare building, is finished in a mixture of cementitious render finishes with corrugated sheeted panels to the rear section of this elevation.

Photograph 4 View of the southern elevation, showing the corrugated sheeted panels.

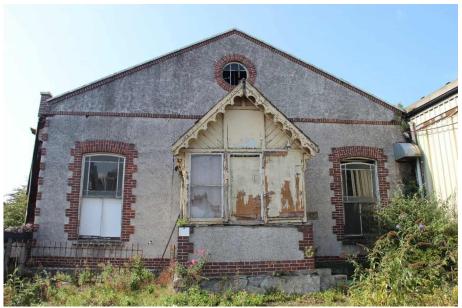
There is a decorative porch to the eastern elevation, with a fibre cement roof covering, decorative gable fascia's, a full bay fenestration of sash up down window assemblies and masonry plinth walls. The remainder of the gable has brick on edge banding at eaves, to the pitched gables, and decorative brick surrounds to the openings, with brick quoins and gable piers.

Photograph 5 Eastern gable of the Administration and Laboratory Building.

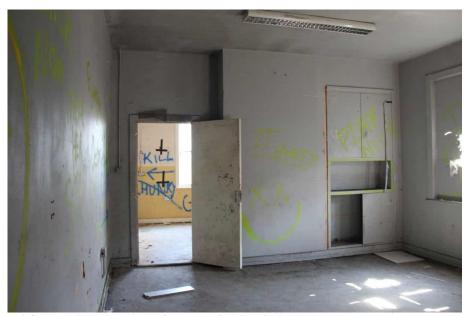
Photograph 6 General internal view of the "welfare" building, with a modern plaster slab ceiling, and modern plaster slabbed drylined internal walls.

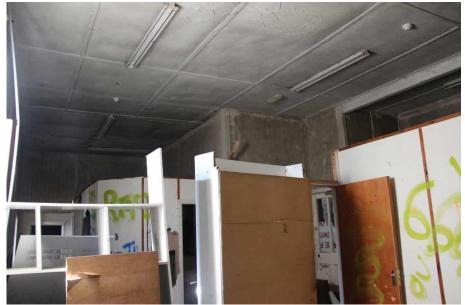
The administration and laboratory building is noted to be finished with a mid-twentieth century ceiling application, which has the appearance of "beauty board." This is present throughout the Administration and Laboratory building.

Photograph 7 Example of the ceiling to the Administration and Laboratory building.

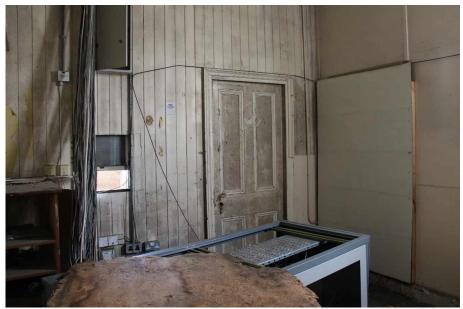
Photograph 9 Example of the variance of internal wall finishes, with T&G Panelling visible and more recent "beauty board" panelling.

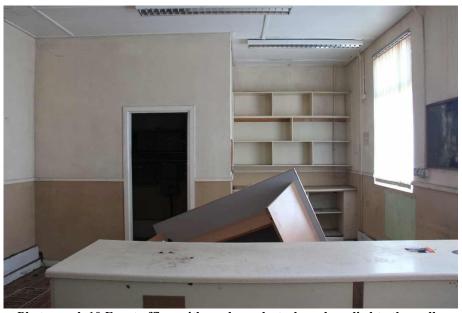
In the front offices there are modern plaster slabs fitted to both the external walls and internal walls, these may be directly onto the original panelling however (as with the laboratory).

Photograph 10 Front office, with modern plasterboard applied to the walls.

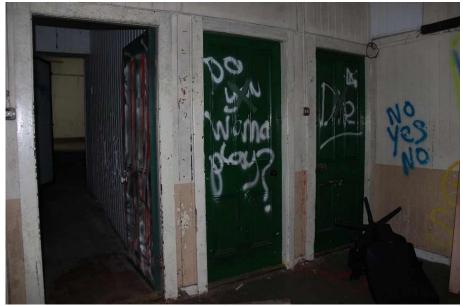
Photograph 11 Examples of panelled doors, to the toilet area of the main building.

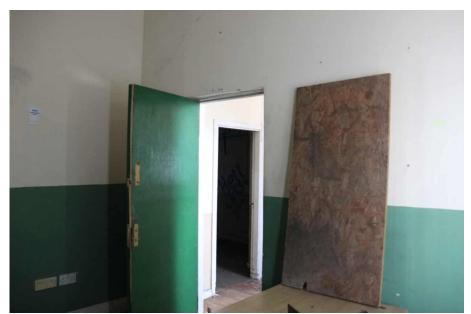
Photograph 12 Example of a hollow core door leaf, found mostly to the western section of the main building.

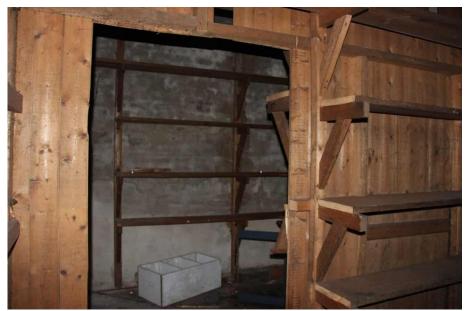
Photograph 13 Timber panelled and shelved storage room.

There are a number of surviving joinery and unit installations however, with a timber panelled and timber shelved storage room, in good repair and the shelving and units of the offices and laboratory still extant in the respective rooms.

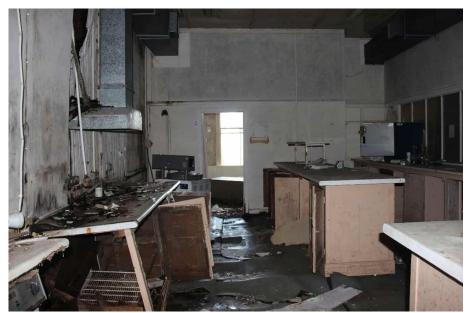
Photograph 14 General view of the laboratory and the surviving units therein.

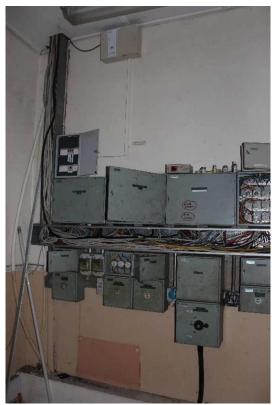
The services installations are noted to be mostly modern, with fluorescent tubed fittings throughout the buildings, modern electrical sockets and light switches mounted to the walls etc. With telecom points and fire detection systems etc also present.

Photograph 16 Surviving fuse boxes, meters, alarm systems etc.

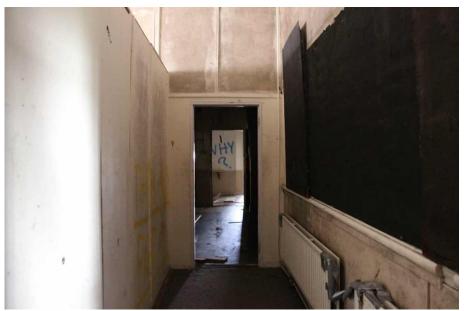
From a heating perspective, there are modern radiators (water heated), also noted throughout.

Photograph 17 Rear Hallway with modern hot water rads installed.

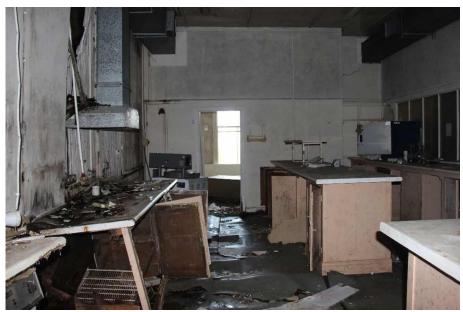
The remnants of foul air extraction systems are also present within the laboratories.

Photograph 18 General view of the laboratory, note extraction ducting.

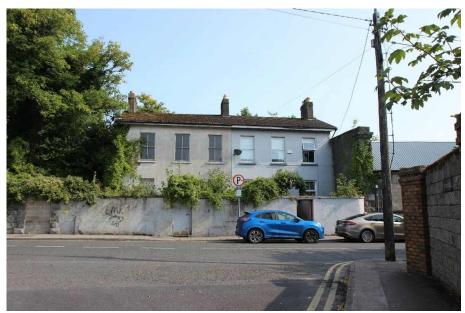
Photograph 2 - Front façade Building A (LHS)

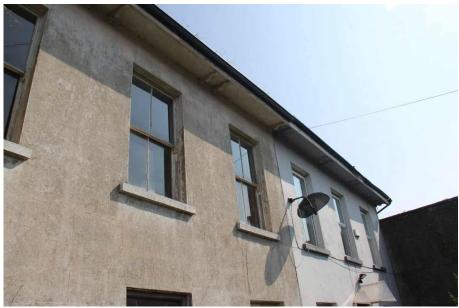
Photograph 3 - Cementitious render ruled and lined.

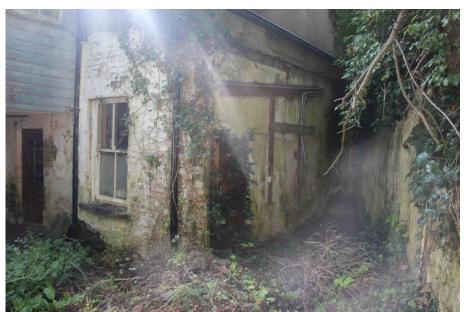
Photograph 4 - Rear and gable end elevations indicating former lean-to and door to kitchen.

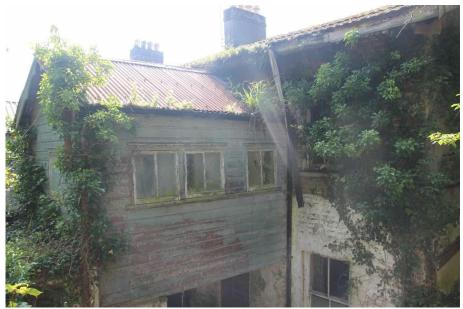
Internal structural elements within the outbuilding suggest that the Return Annex was supported on cast iron columns and perhaps the outbuilding was retrofitted later.

Photograph 5 - Timber clad Return Annex with corrugated iron room and painted brick to main building.

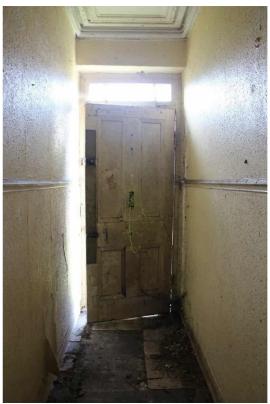
Main entrance door is a four-panel timber door and may be original. On the external side it is faced with ply sheeting with brass knob protruding. The door frame is still in place and paint layers, now peeling, reveal earlier paint coats. The overhead transom light is intact and appears original. The rear door is timber three panelled door with two lower timber panels and an upper glazed series of panes, that are stained glass. The upper section of this feature matches the transom light at the main entrance door. There is a third door from the kitchen that would have led into a lean-to extension (no longer extant). This is of timber vertical boards with a brass knob.

Photograph 6 - Internal face of Entrance door.

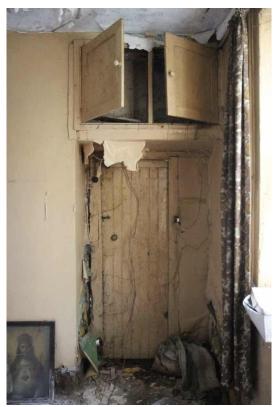
Photograph 8 - Internal face of door from exiting Kitchen into former lean-to.

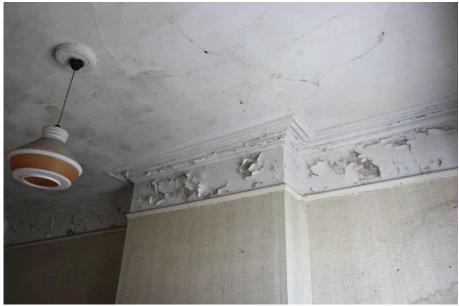
Photograph 9 - Wallpapered and painted ceiling to front room. Coving intact.

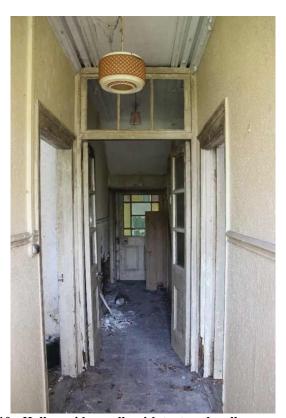
Photograph 10 - Hall corridor walls with textured wallpaper and dado rails.

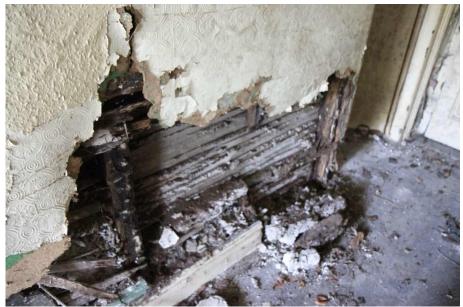
Photograph 11 - Lath-and-plastered stud wall to hall corridor.

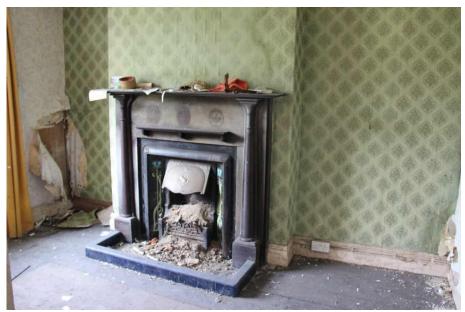
Photograph 12 - Fireplace front room 1st LHS.

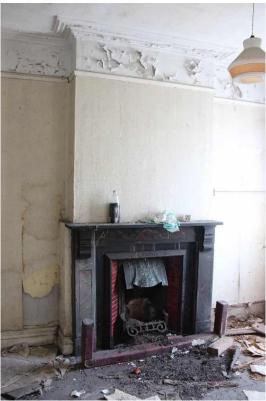
Photograph 13 - Fireplace front room 1st RHS.

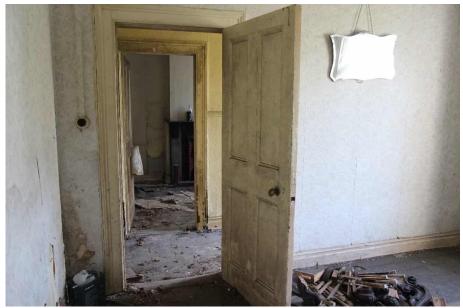
Photograph 14 - Internal doors to front room - 4 panel solid timber with oval brass handle.

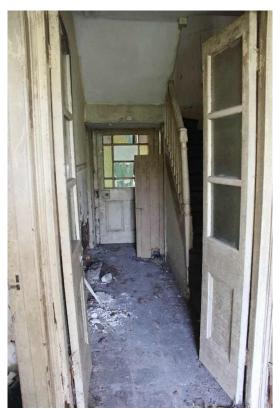
Photograph 15 - Double leaf door used to separate front of house from rear.

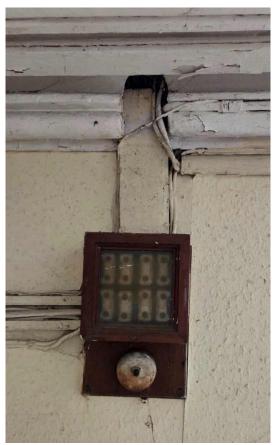
Photograph 16 - Early room service electric bell ring.

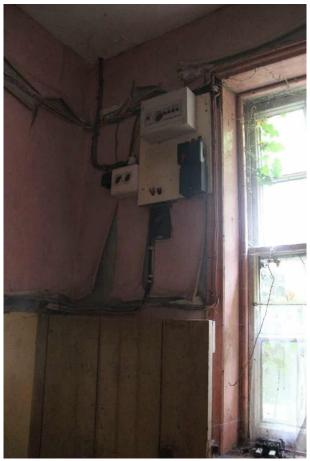
Photograph 17 - Modern fuse box located in home office.

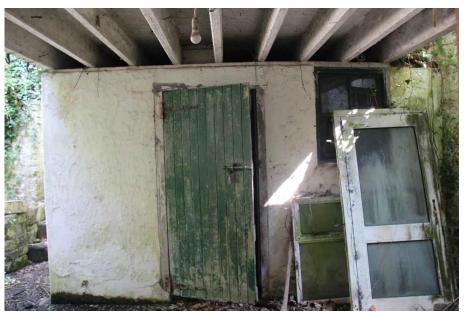
Photograph 18 - Outbuilding front facade with exposed joists to underside of Return Annex.

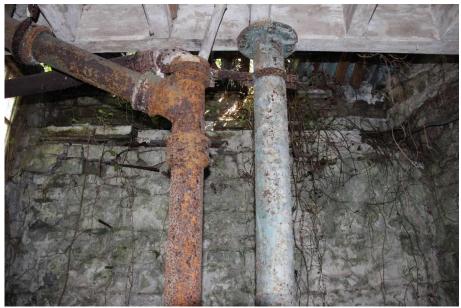
Photograph 19 - Cast iron support system for Return Annex floor.

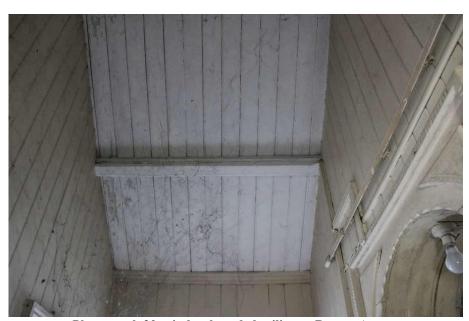
Photograph 20 - timber boarded ceiling to Return Annex.

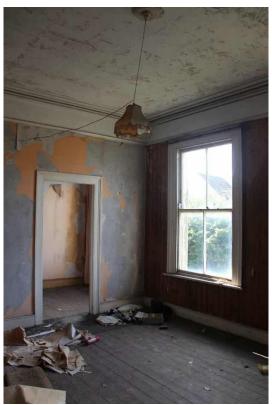
Photograph 21 - Lath-and-plaster ceilings to front room.

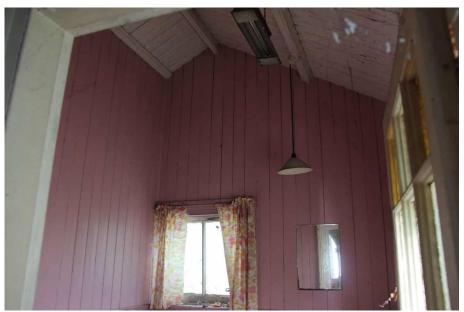
Photograph 22 - Timber boarding to Return Annex walls.

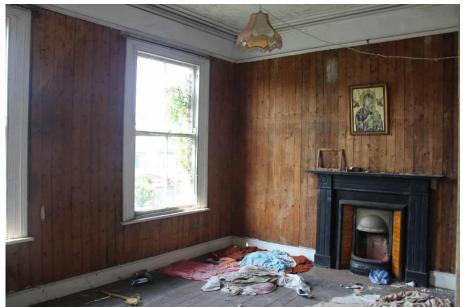
Photograph 23 Front room internal partition and inner face of external wall finished in timber boarding.

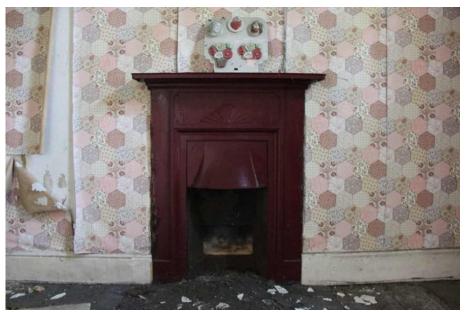
Photograph 24 - Original cast iron fireplace to rear bedroom.

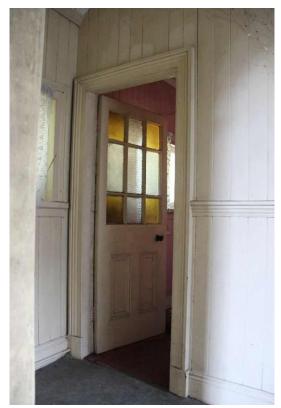
Photograph 25 - Return Annex timber door with glazed upper section.

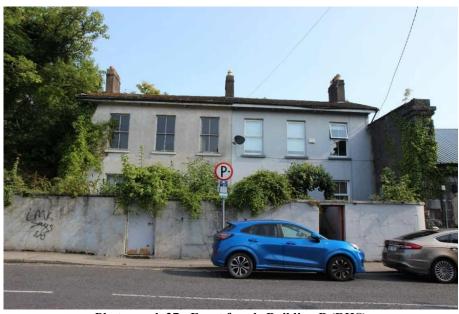
Photograph 27 - Front facade Building B (RHS)

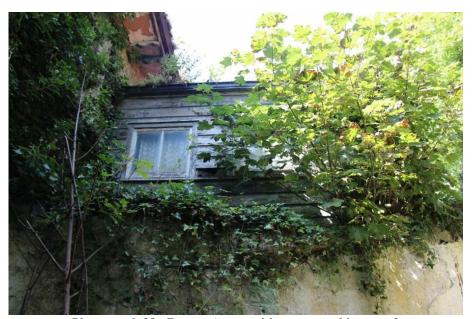
Photograph 28 - Return Annex with corrugated iron roof.

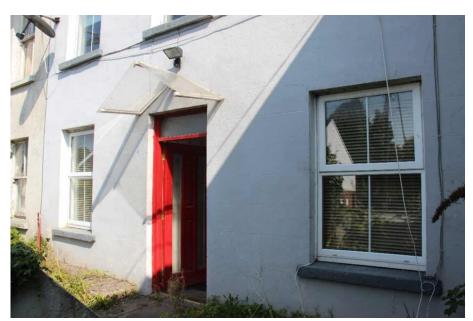
Photograph 29 - Front facade lower, cementitious render ruled and lined and painted.

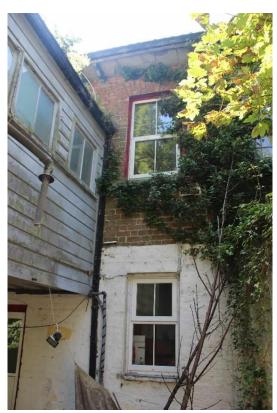
Photograph 30 - Main dwelling rear facade with painted brick and exposed brick.

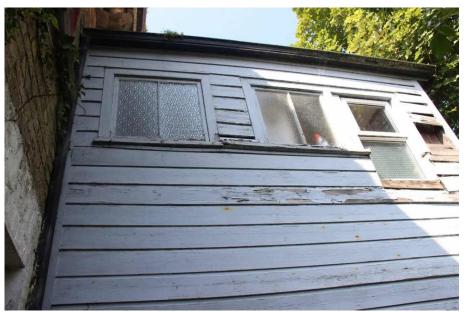
Photograph 31 - Return Annex timber cladded walls of site facade.

Windows are replacement double glazed uPVC top hung casement with some original timber casements remaining on the Annex Return. (See photograph 31 above).

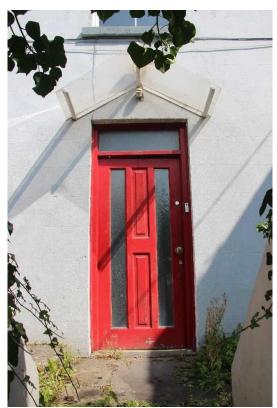
Photograph 32 - Modern replacement main entrance door.

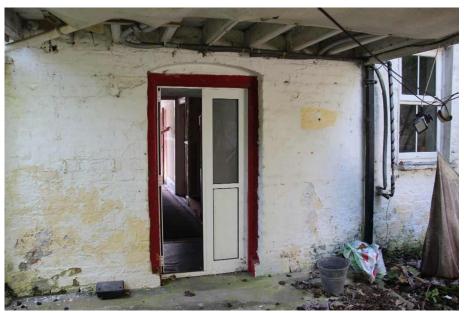
Photograph 33 - Modern replacement two leaf rear door.

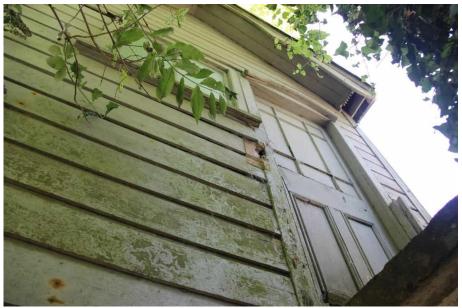
There is a door to the rear of the Annex Return, but this is hidden internally and therefore non-accessible. This door appears to give access onto a bridge to the upper garden, now no longer accessible from this property.

Photograph 34 - Blacked off Return Annex door with glazing painted out.

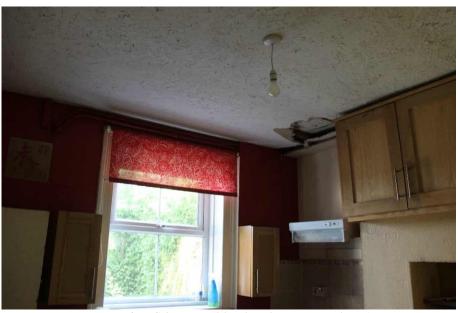
Photograph 35 - Stippled ceiling in Kitchen - possible Artex.

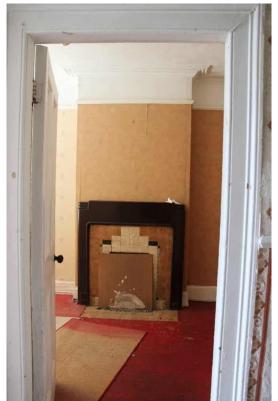
Photograph 36 - Replacement fireplace surround Room 1st LHS.

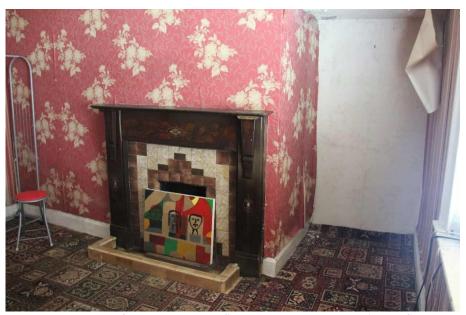
Photograph 37 - Replacement fireplace surround room 1st RHS.

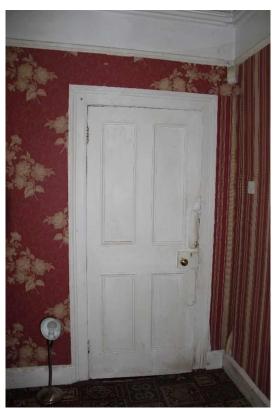
Photograph 38 - Front room, 4 panel solid timber door with brass doorknob.

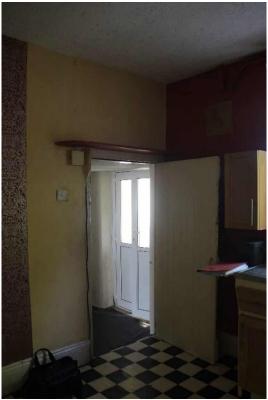
Photograph 39 - Rear room, vertical timber boarded door with curved silver-effect pull handle.

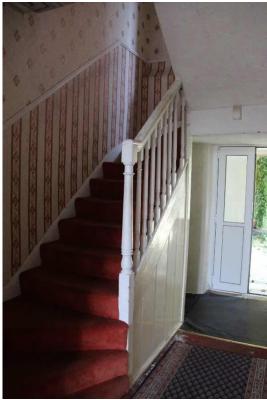
Photograph 40 - Timber closed string staircase with square headed newels and side panelling.

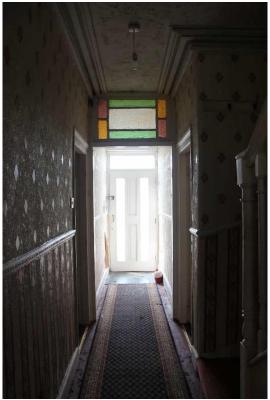
Photograph 41 - Stained glass vestibule screen to separate Hall.

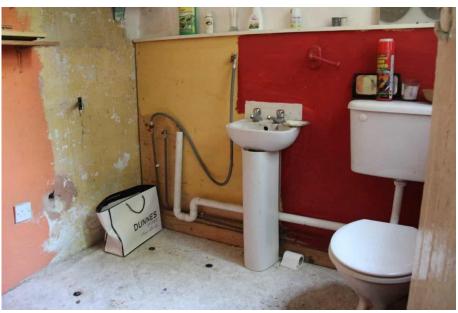
W.C., toilet and handbasin present but not tested.

Photograph 42 - Sanitary Facilities

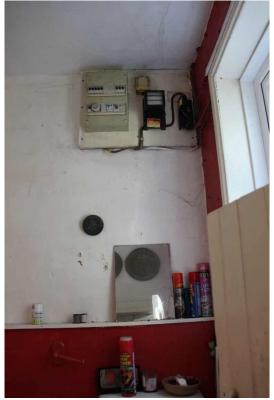
Electrical and mechanical installations are minimal. The fuse is located in the w.c. and is an out-of-date system. Fireplaces act as room heaters.

Photograph 43 - View of fuse box and meter

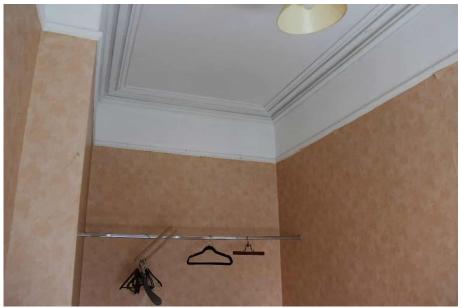
Photograph 44 - smooth plastered ceilings with coving.

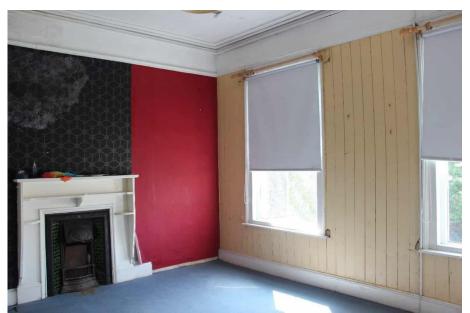
Photograph 45 - Vertical timber boarding to front roof and wall papered end wall.

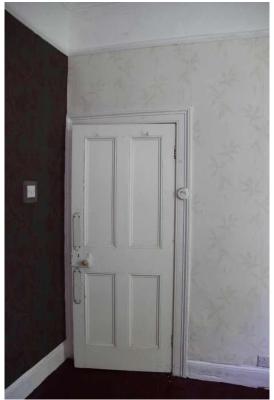
All door opes have architraves and these may have lead paint thereon. To be investigated.

Photograph 46 - Four panel door with brass doorknob.

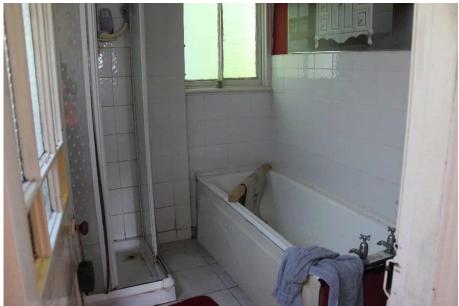
Photograph 47 - Shower and bathtub separate to toilet.

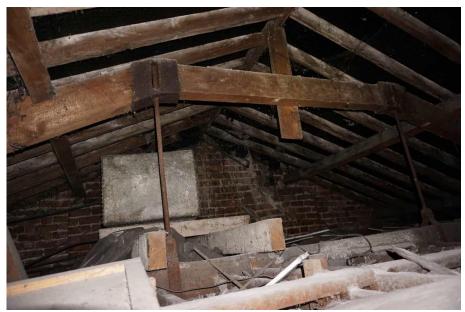
Attic has a cut timber roof consisting of cementitious replacement slates on bitumen underlay on original timber rafters on purlins with truss supports. Cast iron hangers are used to tie the truss members. The original lime parging is evident between the joists.

Photograph 48 - Truss with cast iron hanger.

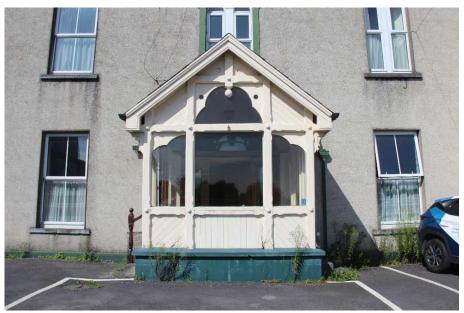
Photograph 1 - Fernbank House Front Entrance

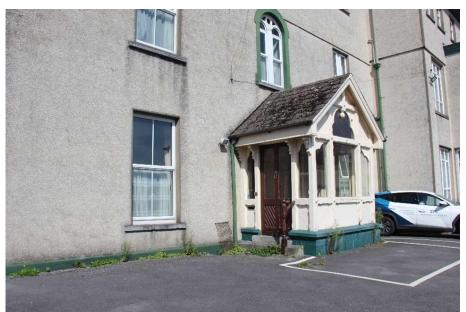
With the addition of the second floor to the original building, the main roof was lost. The current iteration is covered with a modern flat roof with the exception of the entrance porch roof. This is an 'A' pitched roof with cementitious tiles (possible Asbestos Containing Materials). Rainwater goods are mixture of cast iron, aluminium and PVC.

Photograph 4 - 'A' pitch with cementitious slates.

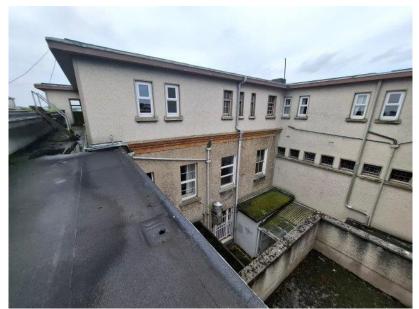
Photograph 5 - Earlier render remains on the original building at rear elevation.

Earlier cementitious render, and original brick cornice and string eaves course remain at the rear façade the latter indicating the original wall height. This may remain to the front façade under the render band. Original cills are limestone.

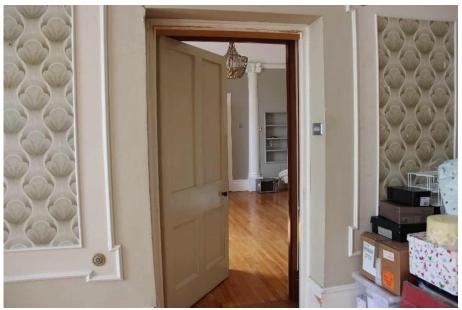
Photograph 26 - Structural opening to door between the two function rooms to the RHS of Hall appears to have been infilled to accommodate the door.

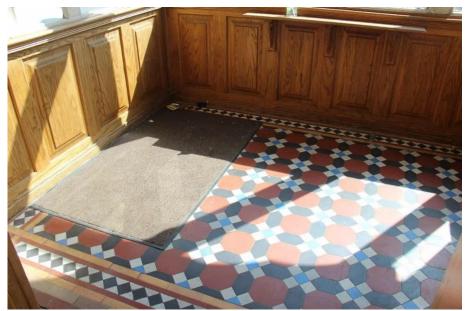
The internal floors are largely timber in the original sections of the building with solid floors elsewhere. These are covered in linoleum, tile and carpet. Due to dry rot floors off the back staircase have disintegrated and pose a danger. The porch floor is exposed and is decorated with tile from the early 20th century. Terrazzo was also noted in the later part of the building.

Photograph 34 - Porch floor tiles.

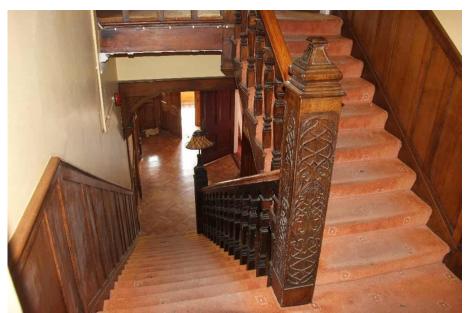
Photograph 44 - Decorative newels and timber wainscotting to Return level or main staircase.

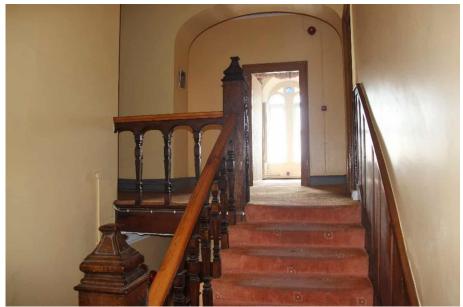
Photograph 45 - Decorative newels and timber wainscotting to first floor landing of original building.

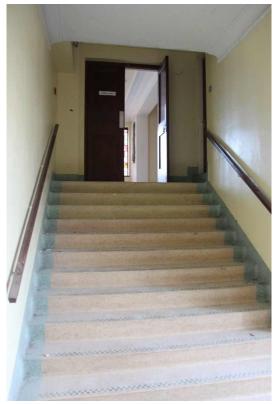
Photograph 47 - modern Terrazzo staircase from chapel to lower level.

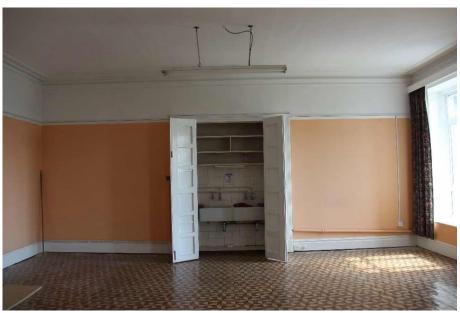
Photograph 48 - Ablution cupboard in eastern wall of southeast (front) room).

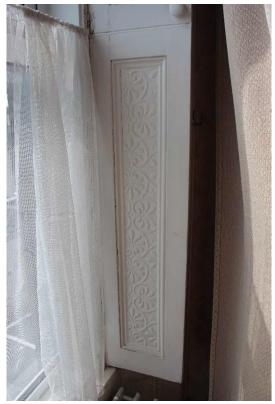
Photograph 49 - Shutter boxes are present in the original/earlier building. Decorative application.

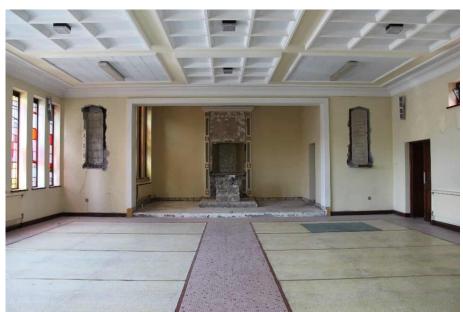
Photograph 50 - modern chapel floor with mosaic and linoleum floor covering. Alter removed.

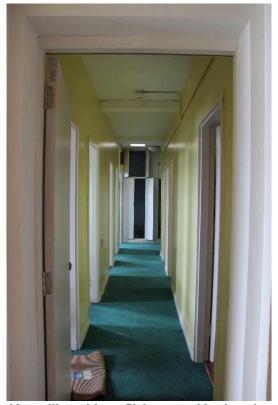
Photograph 51 - Corridor ceiling with rooflight at corridor junctions and support beams.

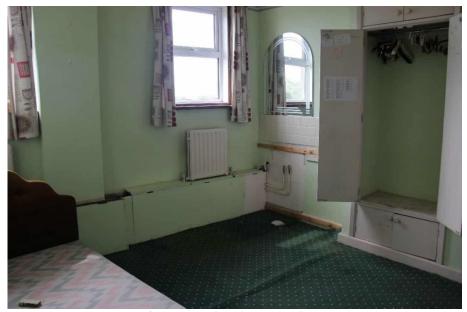
Photograph 53 - Modern inbuilt presses in selected rooms.

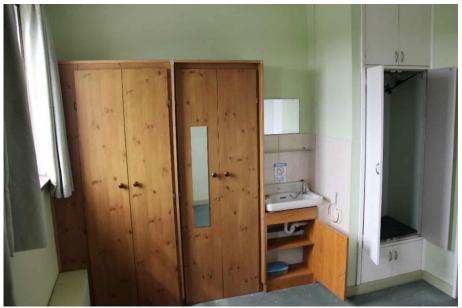
Photograph 54 - Built-in and free-standing furniture.

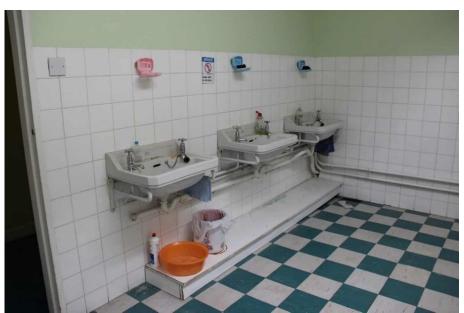
Photograph 55 - Sinks in central ablution block.

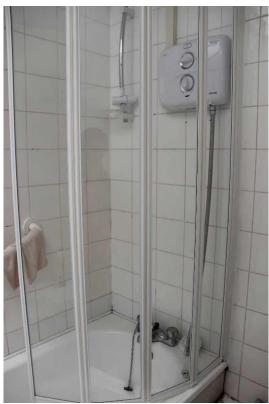
Photograph 56 - Modern shower facilities.

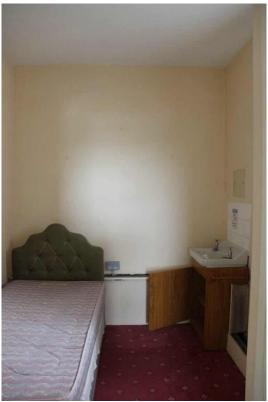
Photograph 57 - Typical cell with handbasin facilities.

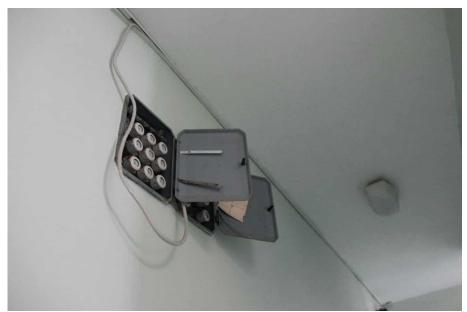
Photograph 58 - Fuse box on 2nd floor.

The services installations are noted to be mostly modern, with fluorescent tubed fittings throughout the buildings, modern electrical sockets and light switches mounted to the walls etc. It is recommended that prior to moving any plant, that an asbestos survey be conducted.
