Building Record Reports

Cleeves Former Condensed Milk Factory Cleeves Riverside Quarter

Client: Limerick 2030

Date: 15th of October 2025

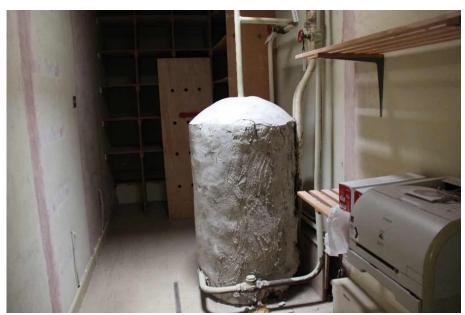
Photograph 59 - One of two walk-in Hot Presses on this level with cementitious layer to water cylinder.

May have ACMs.

The services installations are noted to be mostly modern, with fluorescent tubed fittings throughout the buildings, modern electrical sockets and light switches mounted to the walls etc. It is recommended that prior to moving any plant, that an asbestos survey be conducted.

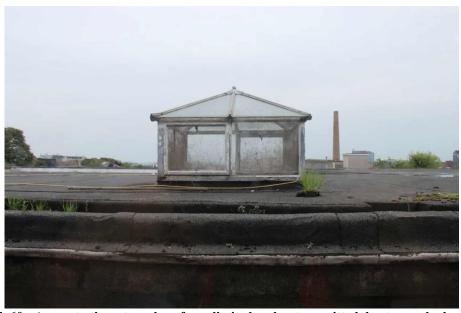
Photograph 60 - Access to the external roof was limited and not permitted due to overlook and privacy.

Modern rooflight cover.
