# **ENVIRONMENTAL IMPACT ASSESSMENT REPORT**

### Appendix 19-1 Asbestos Survey Report

## ASBESTOS SURVEY REPORT

**Location:** The Cleeves Site,  
North Circular Road, Limerick

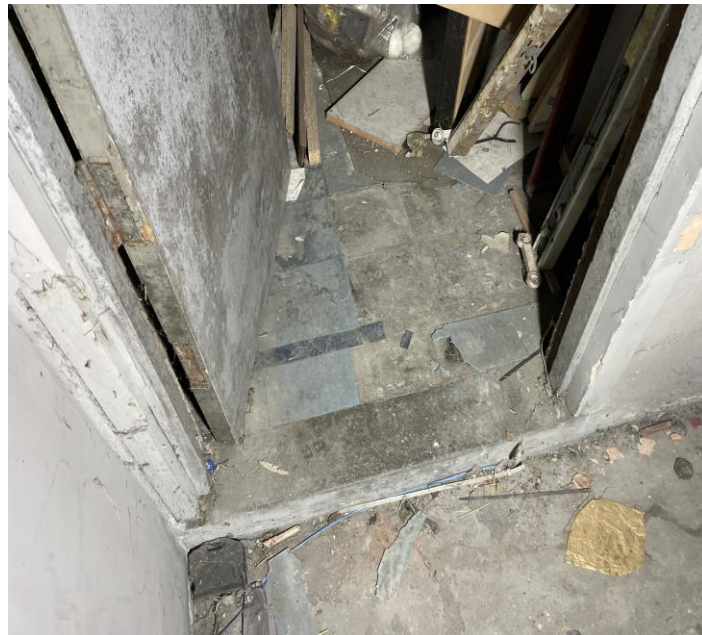
| Survey Date | 6.11.2024 | Sample No. | BS 222549 |

| Location | Storeroom |
| Extent/<br>Amount | 10 m <sup>2</sup> approx. |

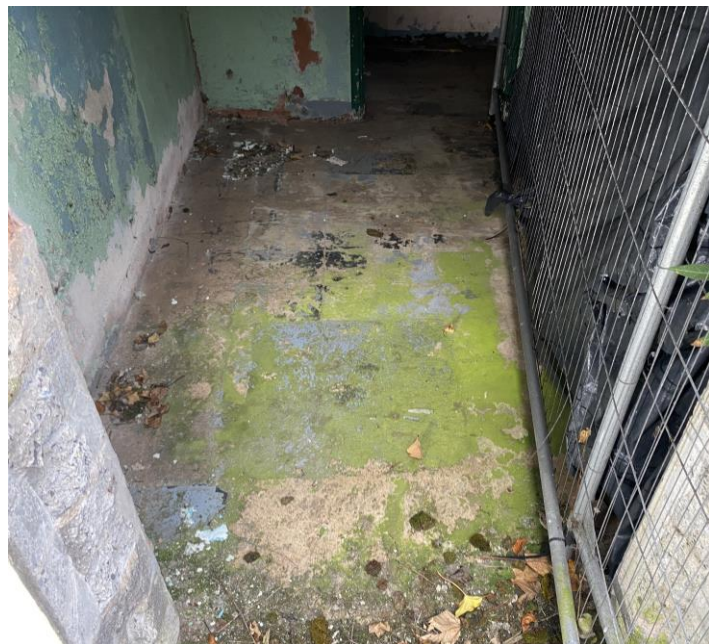
Extent/  
Amount

40 m<sup>2</sup> approx.

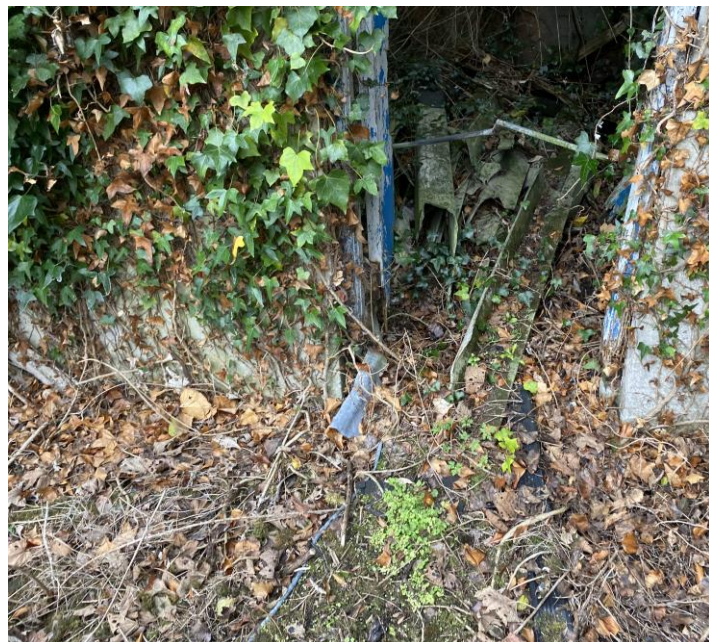
Extent/  
Amount

Not quantified

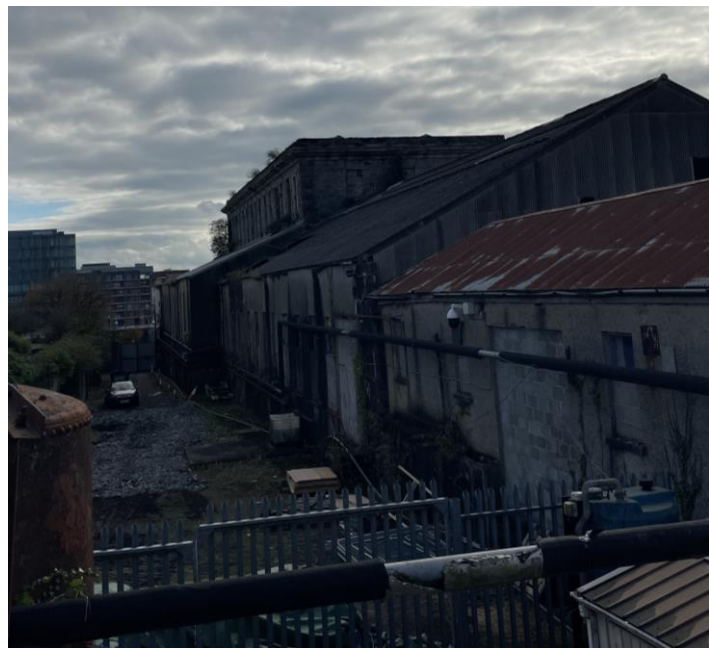
| Survey Date | 6.11.2024 | Sample No. | BS 222509 |

| Location | Roof areas |
| Extent/<br>Amount | Not quantified |

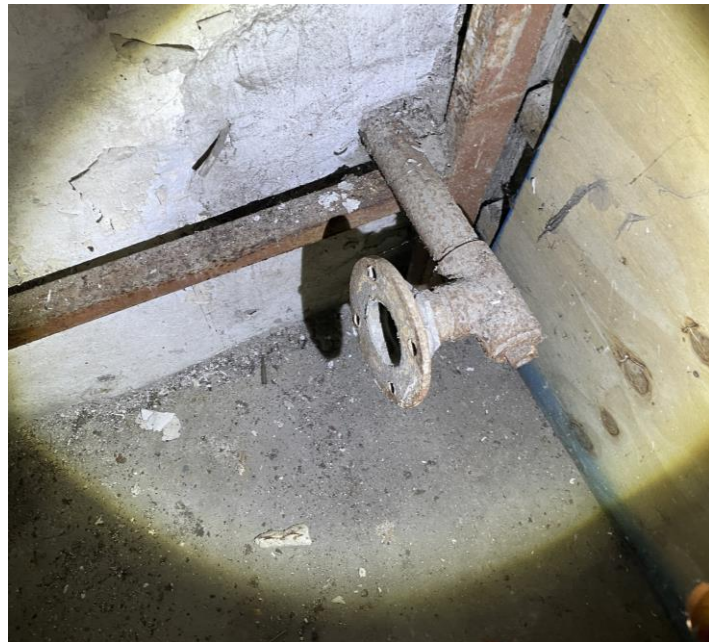
| Survey Date | 6.11.2024 | Sample No. | BS 222519 |

| Location | Pipework flanges |
| Extent/<br>Amount | 1 per flange |

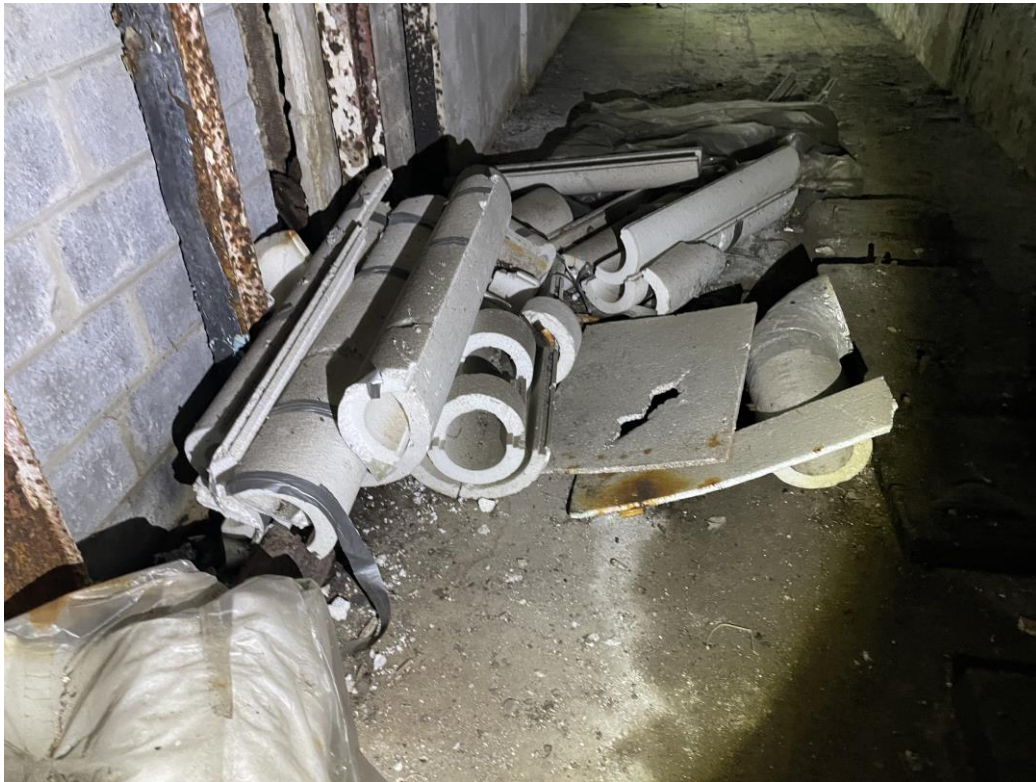
Pipework insulation in building 1

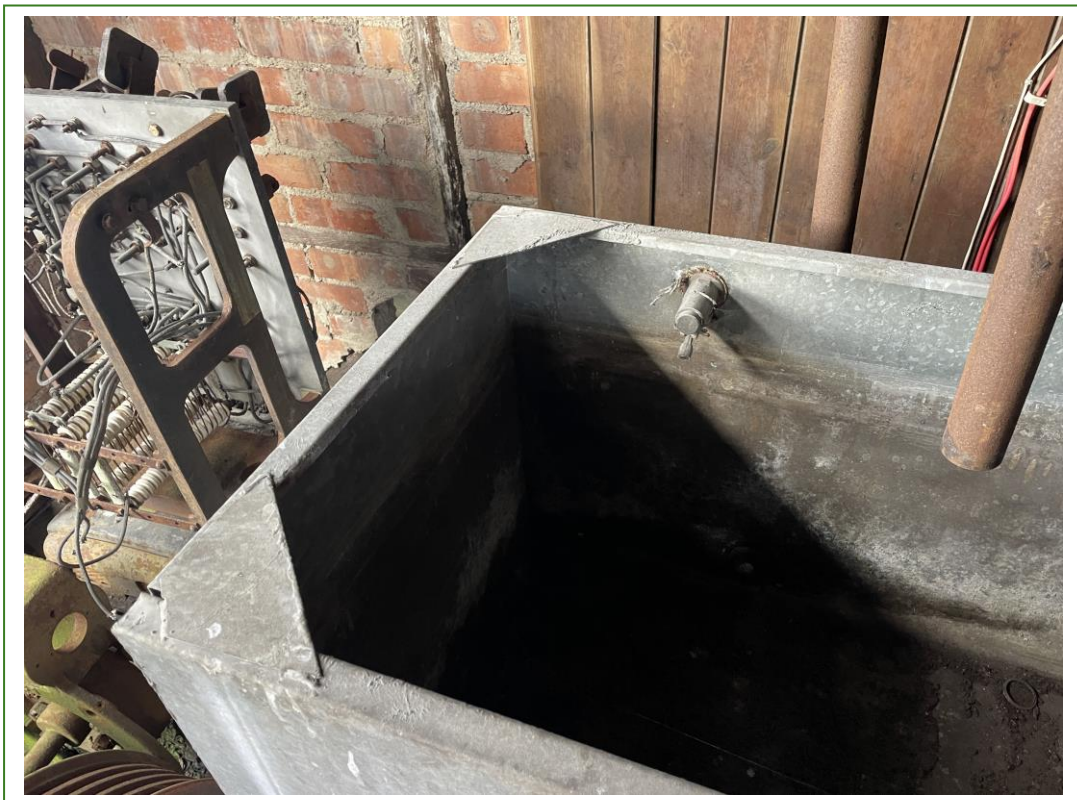
Rope on the tank in the attic in building 4

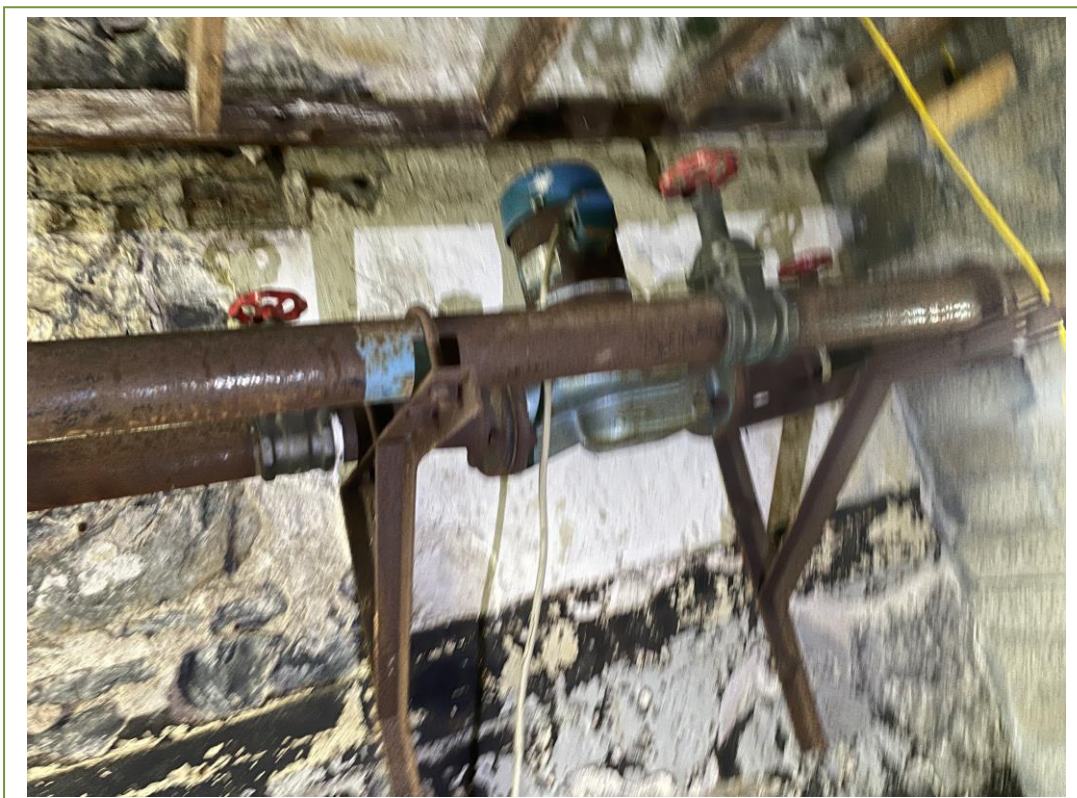
Rope on the pipework on the 3<sup>rd</sup> floor in building 4

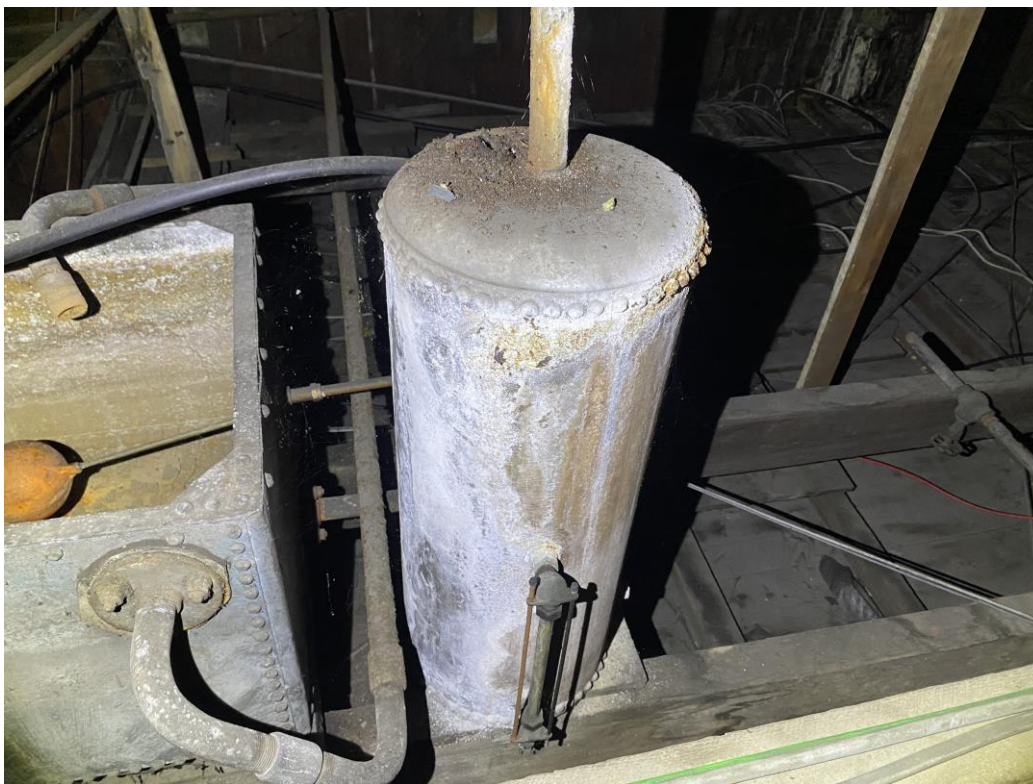
Coating sampled from the tank in the main attic of building 9

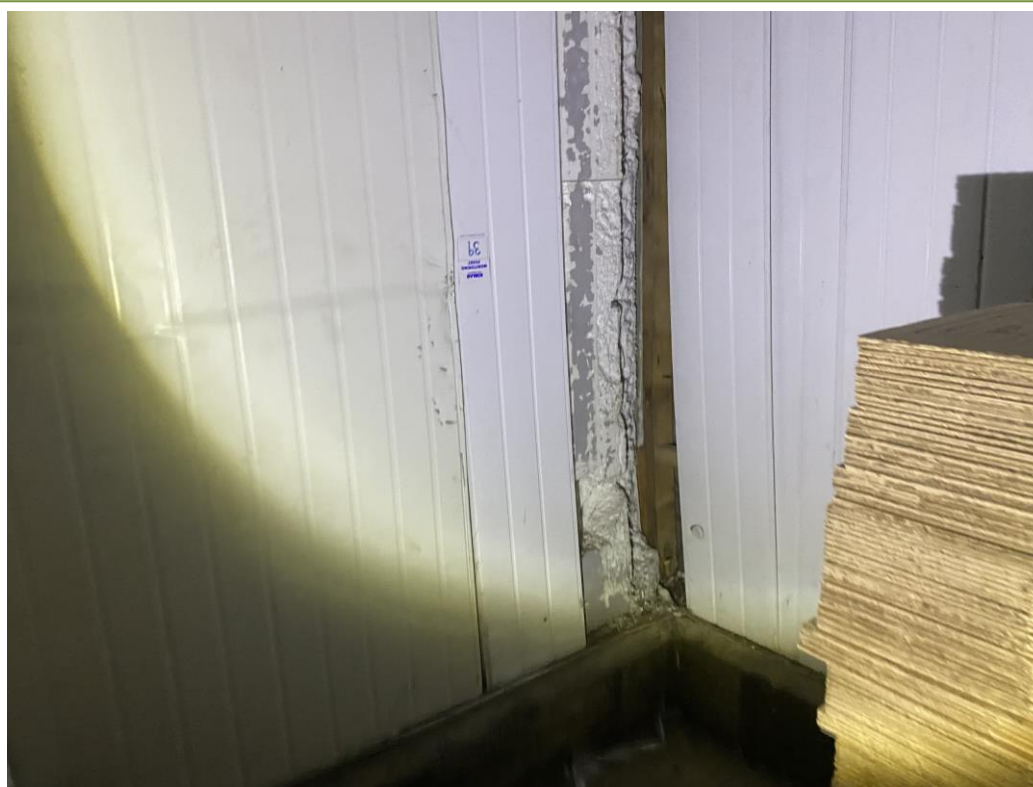
Polystyrene insulation in the wall panels of building 8

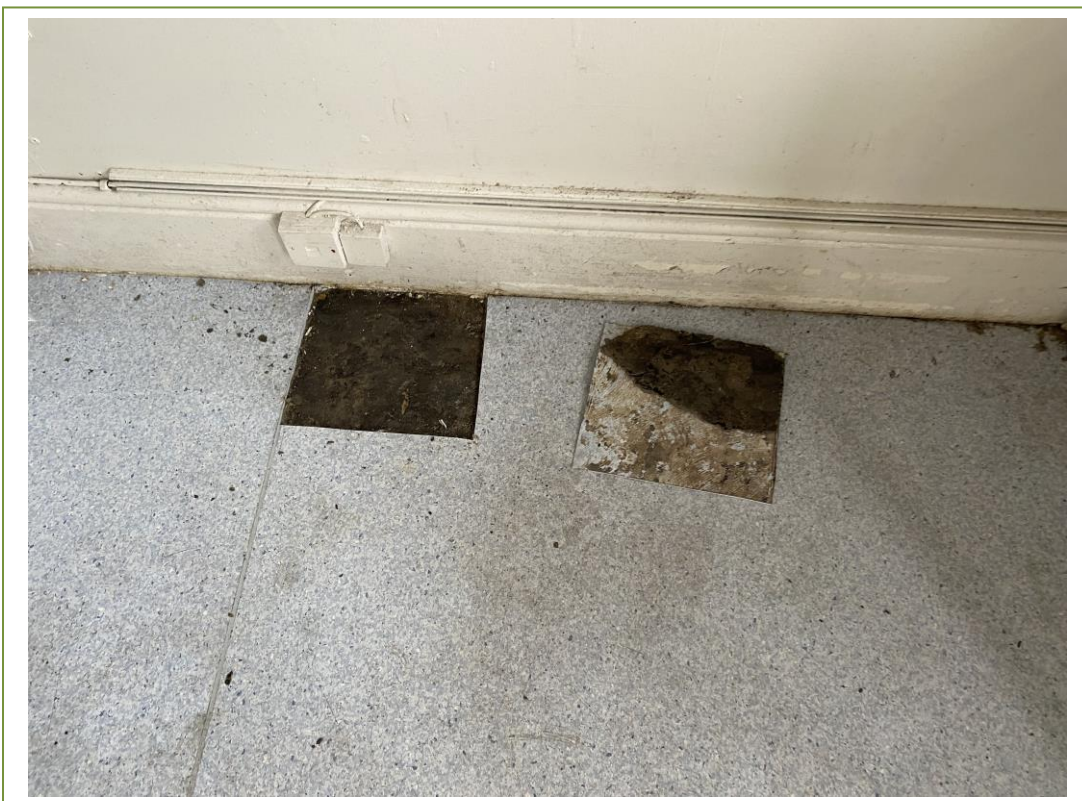
Black compound sampled in the security area of building 10
