ST. EDMUNDSBURY HOSPITAL, LUCAN, CO. DUBLIN

Volume 1 Part 1: Conservation Report -
Architectural Inventory, Condition Report & Appraisal

November 2023

Ref: 22037

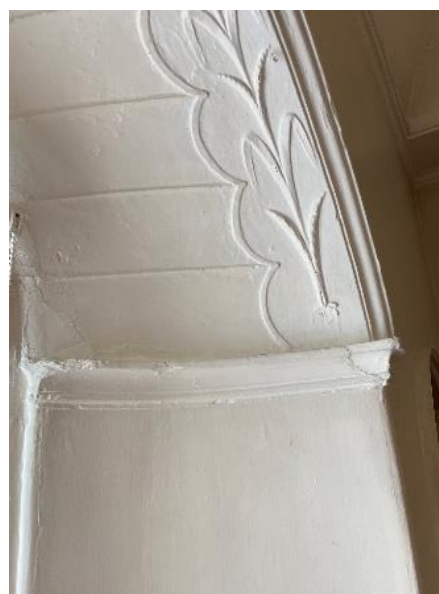
Fig.61: South wall, plasterwork detail to window head

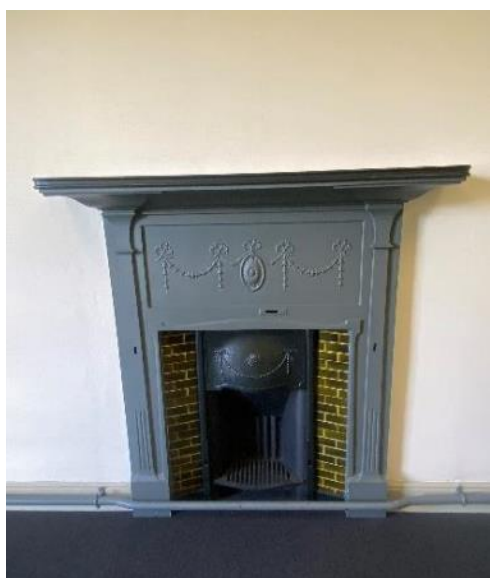
Fig.77: View facing east, fireplace
