ST. EDMUNDSBURY HOSPITAL, LUCAN, CO. DUBLIN

Volume 1 Part 2: Conservation Report -
Architectural Inventory, Condition Report & Appraisal

November 2023

Ref: 22037

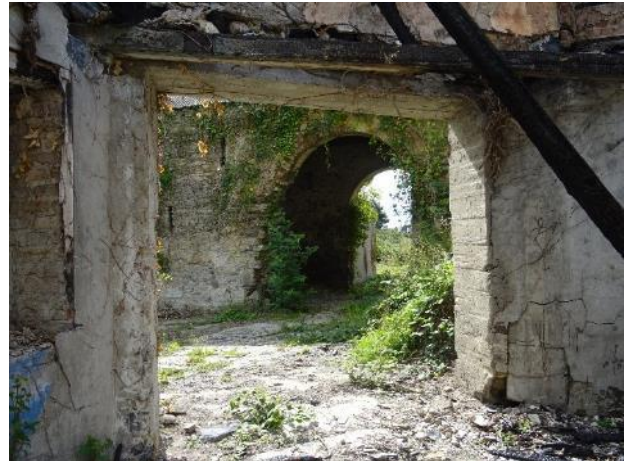
Description (materials, construction, location)	1 modern no. square-headed door opening on the south elevation with a concrete lintel and concrete reveal. 1 no. square-headed door opening on the east elevation with a timber lintel.
Condition	The door opening lintel on the east elevation is in poor condition.
Probable causes/consequences	Previous interventions.
Recommended measures	Rebuild top section and base of the round-headed archways. Lime mortar repointing. Repair timber door. Replace boarding-up.

Fig.12: Barn, internal south elevation, square-headed door opening with concrete lintel and reveal.

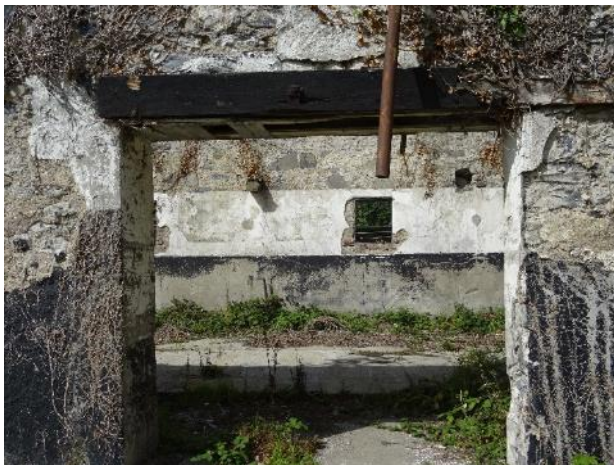
Fig.13: Barn, external east elevation, square-headed door opening with timber beam lintel.

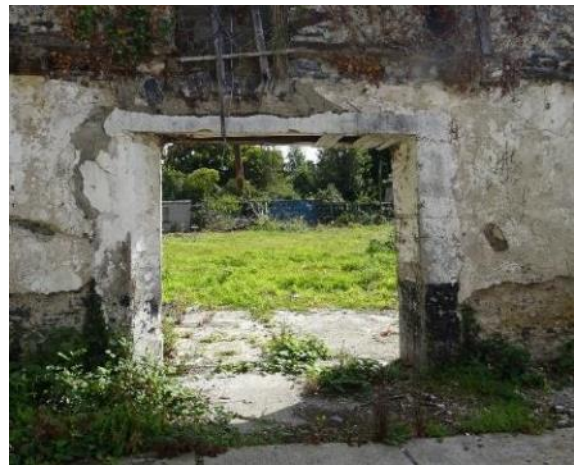
Fig.14: Barn, internal east elevation, square-headed door opening with stone lintel.

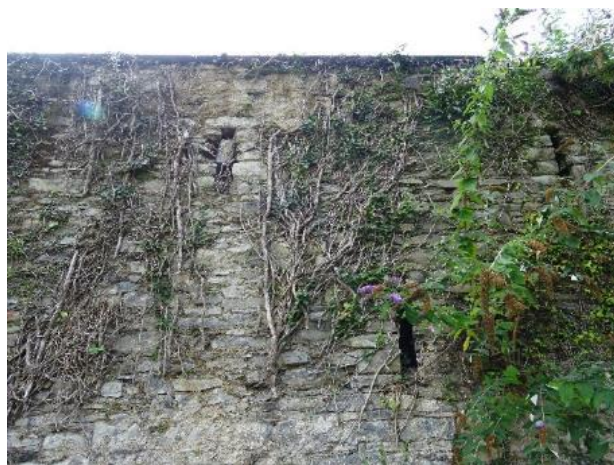
Fig.33: Coach House, west section, north elevation, stone have fallen at the window opening, vegetation overgrowth.

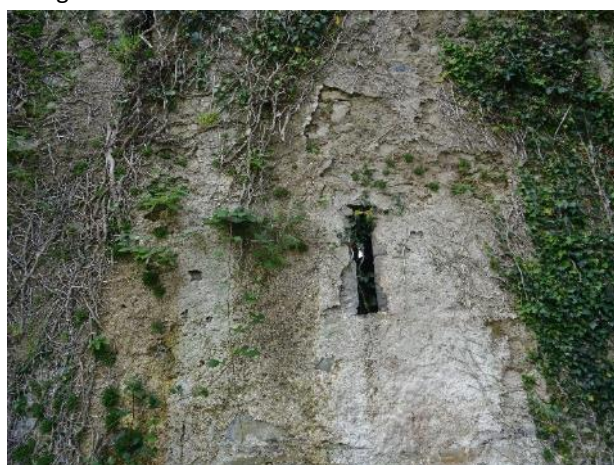
Fig.35: Coach House, west section, north elevation, earth-based lime mortar, vegetation overgrowth.

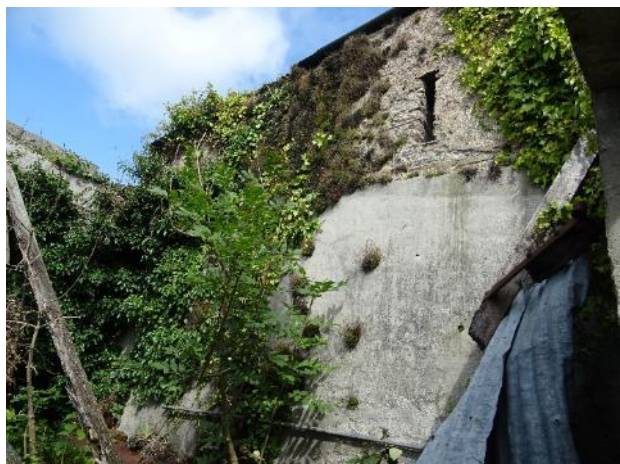
Fig.36: Coach House, west section, south elevation, section at the west has a concrete render, vegetation overgrowth.

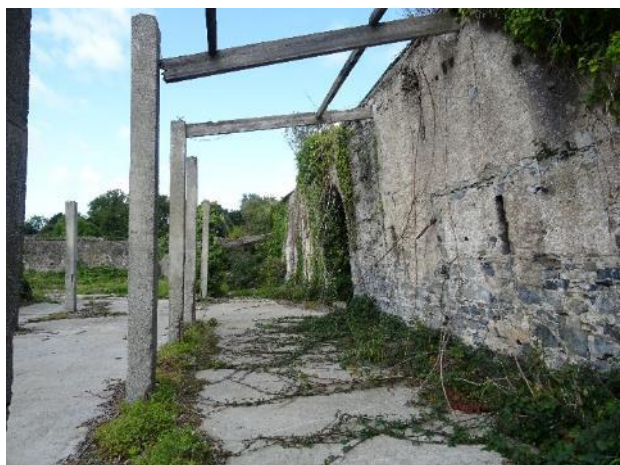
Fig.40: Coach House, west section, south elevation, the wall is leaning.

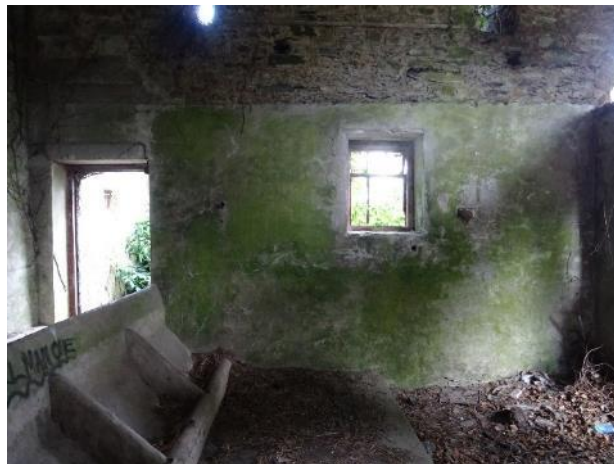
Fig.45: Coach House, west section, internal north elevation, non-historic square-headed window.

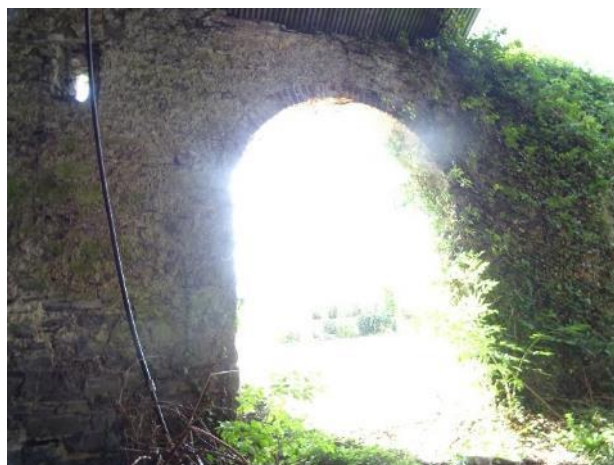
Fig.54: Coach House, West section, internal south elevation, central opening, arch is leaning.

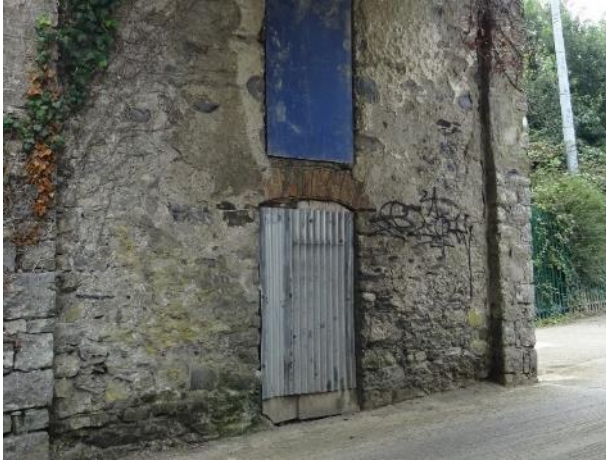
Fig.55: Coach House, east section, west elevation, low arch door opening was boarded up.

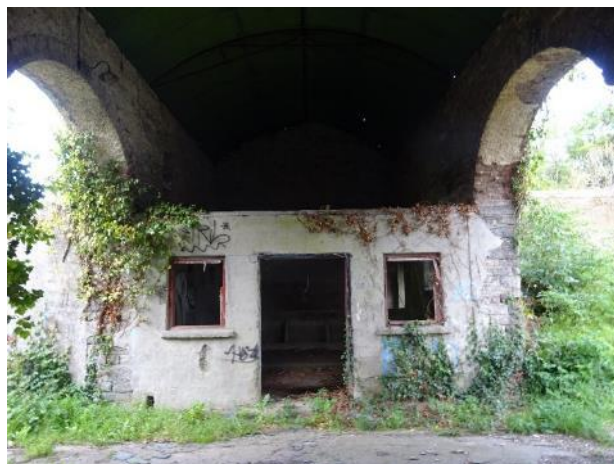
Fig.71: Coach House, west section, west internal elevation, late wall addition

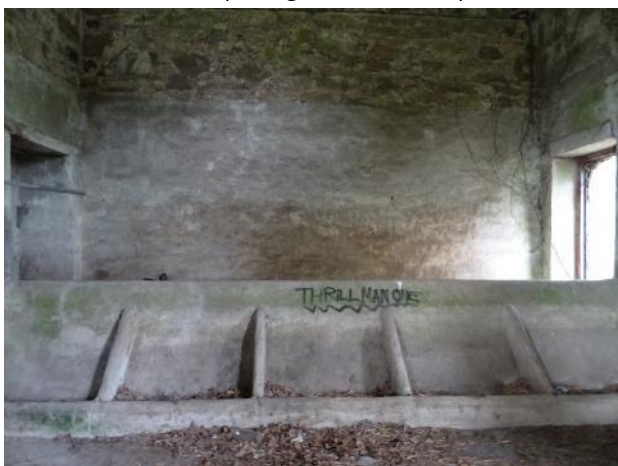
Fig.72: Coach House, west section, west internal elevation, cement render at the bottom part.

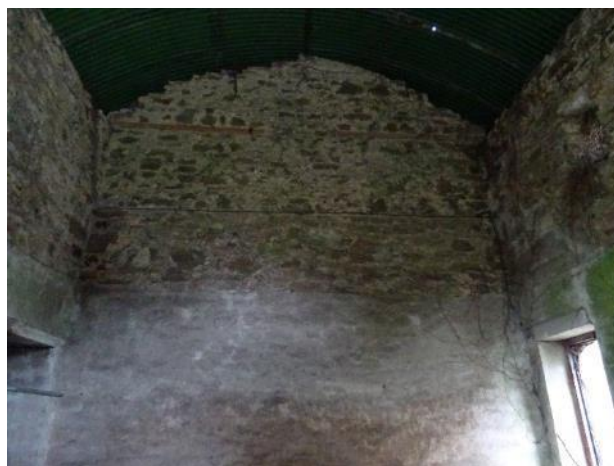
Fig.73: Coach House, west section, west internal elevation, timber piece at the top section.

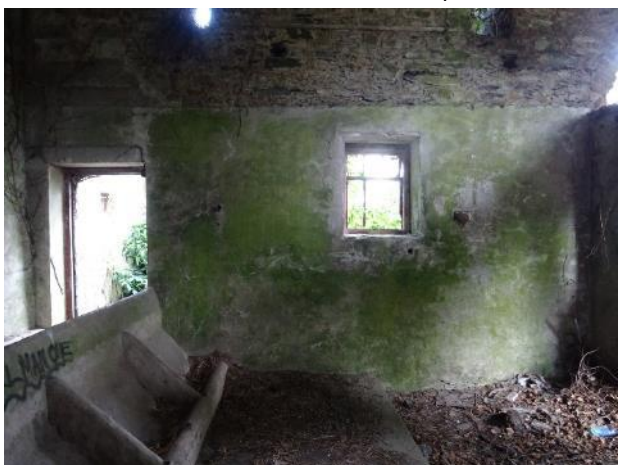
Fig.74: Coach House, west section, north internal elevation, cement render.

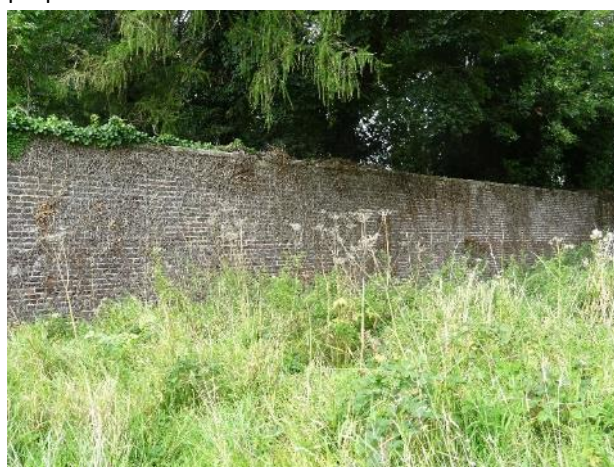
Fig.90: West wall of Walled Garden, east elevation

<p>Bricks are generally in fair condition. Some bricks are damaged.</p> <p>Brickwork have collapsed at the junction between walls and at the south section.</p> <p>Growing vegetation.</p> <p><u>South wall of Walled Garden:</u></p> <p>Failing lime mortar joint on the south elevation.</p> <p>Lime render is degraded to the bottom part.</p> <p>Growing vegetation.</p>
Probable causes/consequences	<p>Wear and tear.</p> <p>Previous alterations.</p>
Recommended measures	<p>East wall of Walled Garden to be salvaged.</p> <p>Replace damaged bricks with new matching bricks.</p> <p>Repoint with a lime-based mortar.</p> <p>Remove vegetation.</p> <p>Structural Engineer to inspect garden walls and make recommendations.</p>

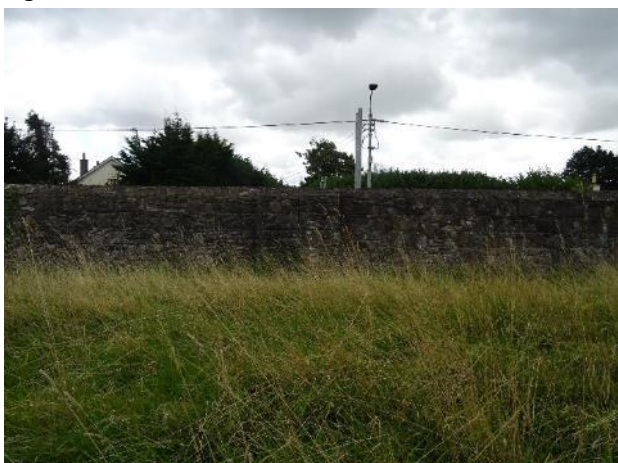
Fig.91: South wall of Walled garden, north elevation

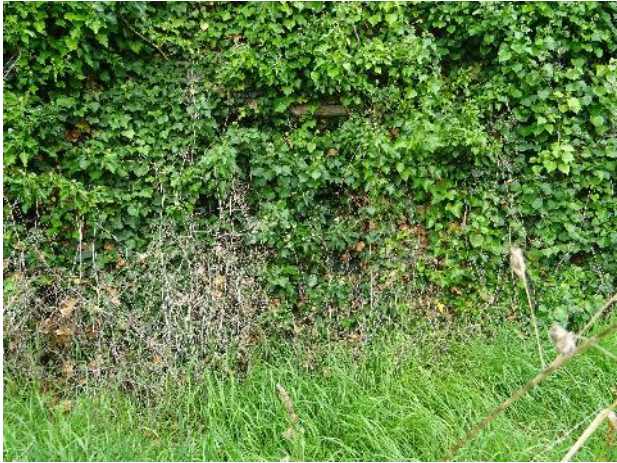
Fig.96: West wall of Walled Garden, square-headed door opening.

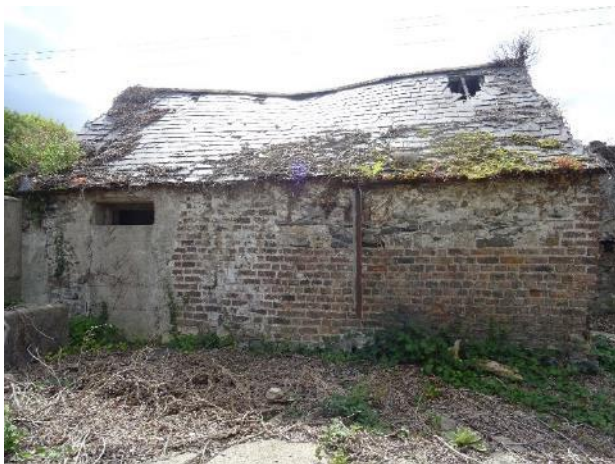
Fig.99: Farm building, external north elevation

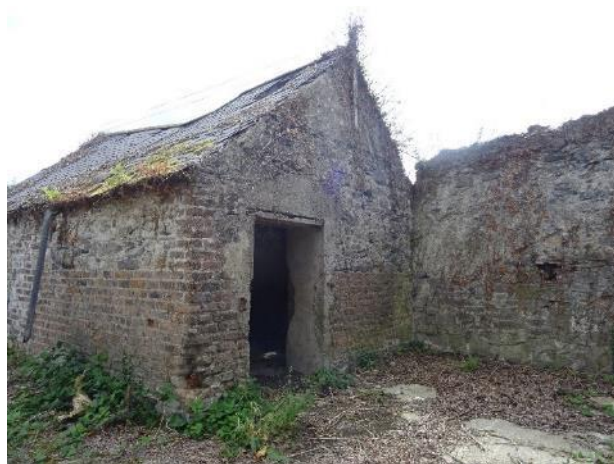
Fig.100: Farm building, external east elevation

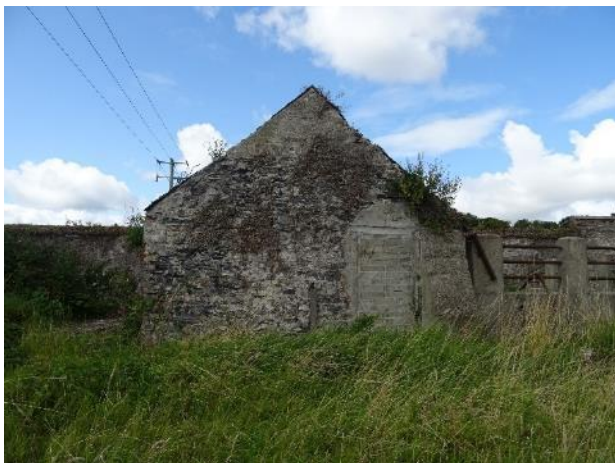
Fig.101: Farm building, external west elevation

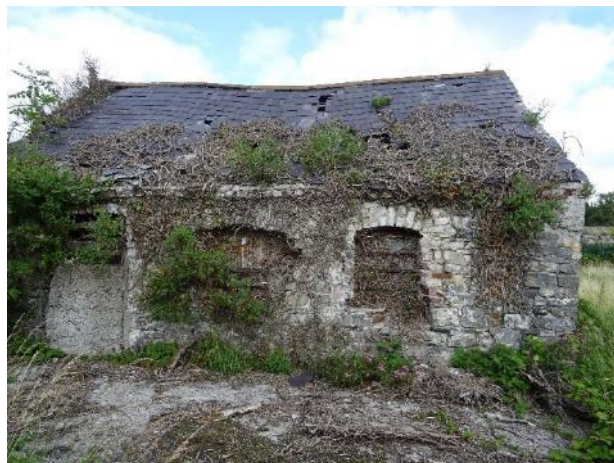
Fig.102: Farm building, external south elevation

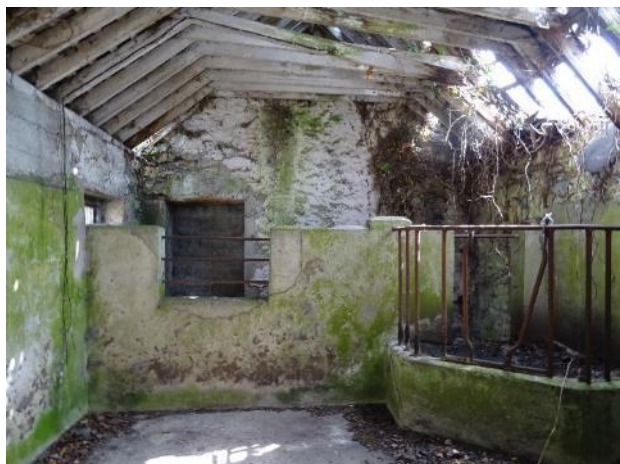
Fig.103: Farm building, internal east elevation

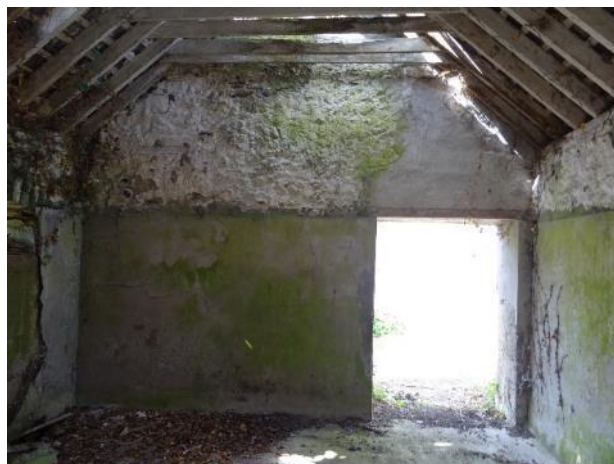
Fig.104: Farm building, internal west elevation

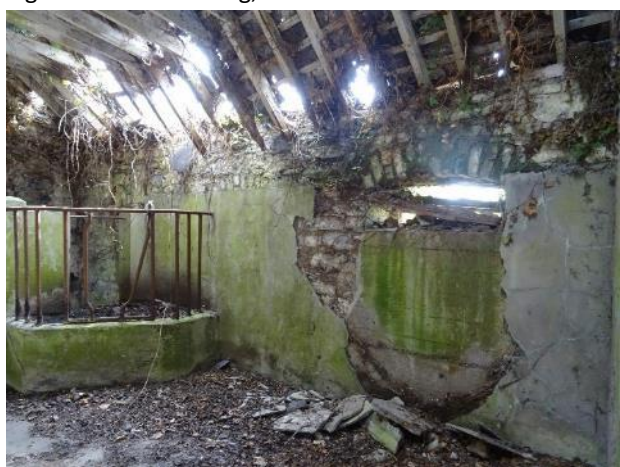
Fig.105: Farm building, internal south elevation

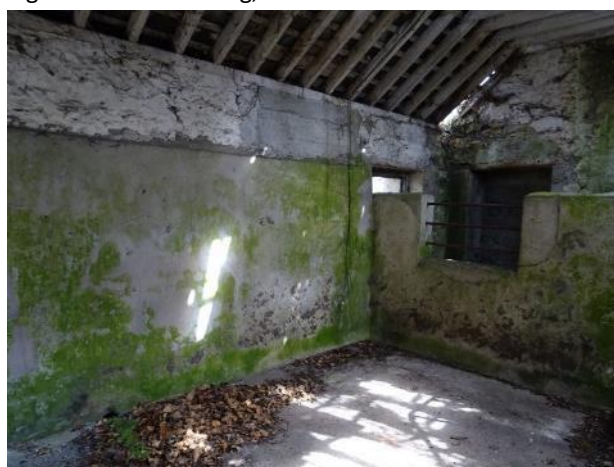
Fig.106: Farm building, internal north elevation
