Project Opera Limerick

Infrastructure Report

Project number: 60568520

8 March 2019

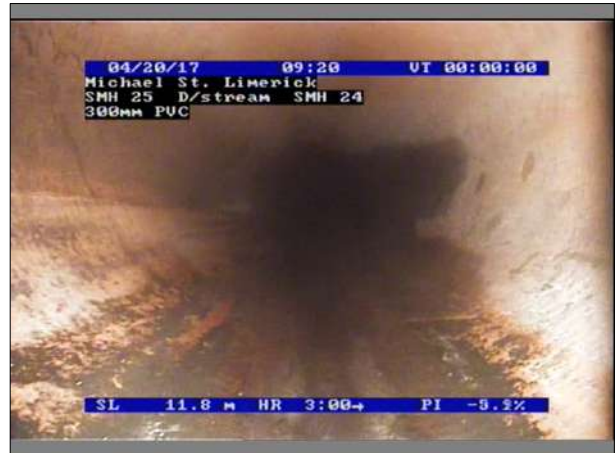
Photo: 1_1_18_A.jpg, 00:02:04
 11.8m, Water level, 5% of the vertical dimension

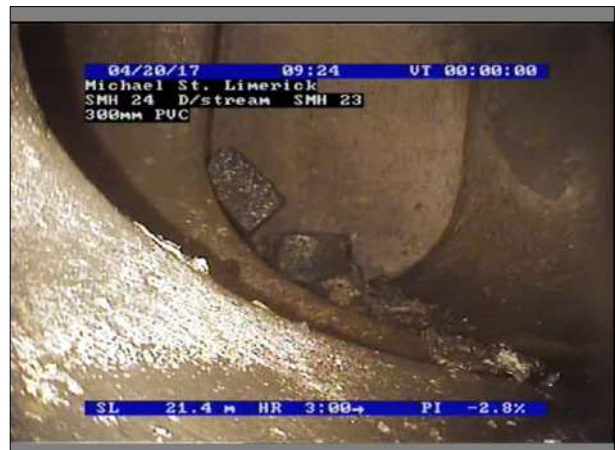
Photo: 3_3_23_A.jpg, 00:03:06
 21.4m, Water level, 5% of the vertical dimension

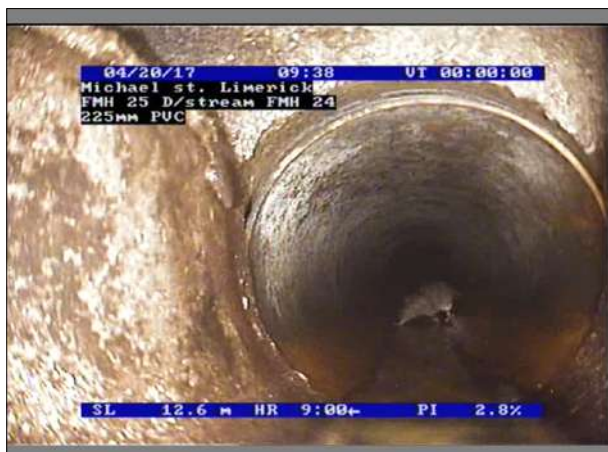
Photo: 4_4_27_A.jpg, 00:01:25
12.6m, Water level, 5% of the vertical dimension

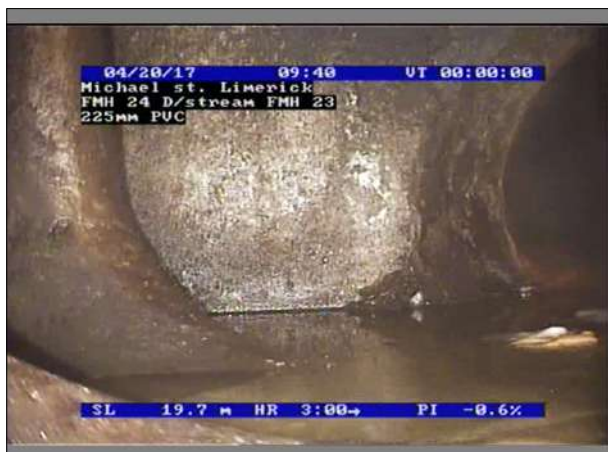
Photo: 5_5_31_A.jpg, 00:02:38
 19.7m, Water level, 5% of the vertical dimension

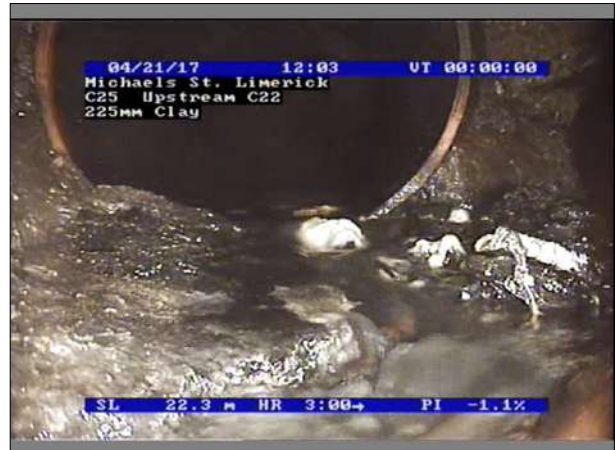
Photo: 12_12_54_A.jpg, 00:05:50
 22.3m, Water level, 5% of the vertical dimension

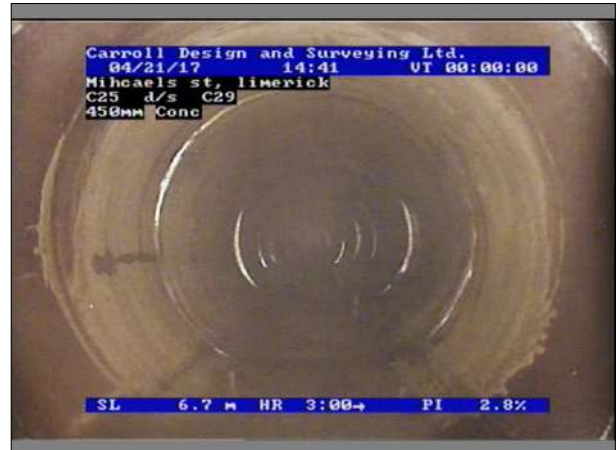
Photo: 14_14_318_A.jpg, 00:01:17
 6.7m, Water level, 5% of the vertical dimension

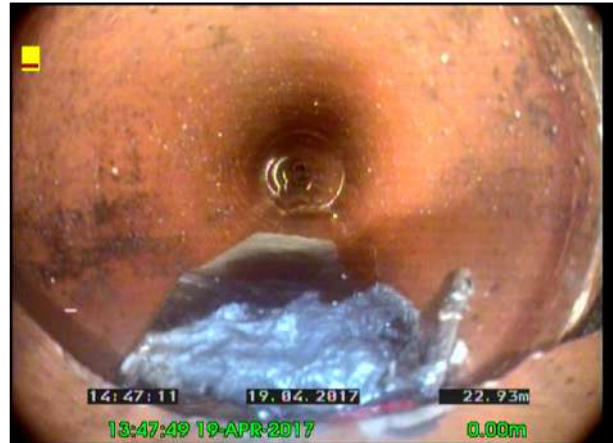
Photo: 16_16_81_A.jpg, 00:17:09
 22.93m, Survey abandoned Remarks: UNABLE TO TRAVEL

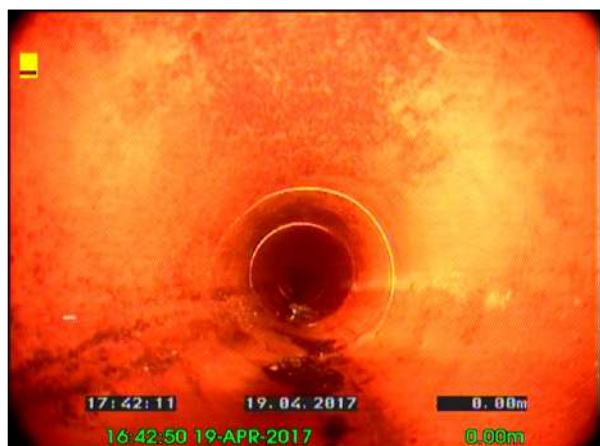
Photo: 20_20_111_A.jpg, 00:00:01
 0m, Water level, 5% of the vertical dimension

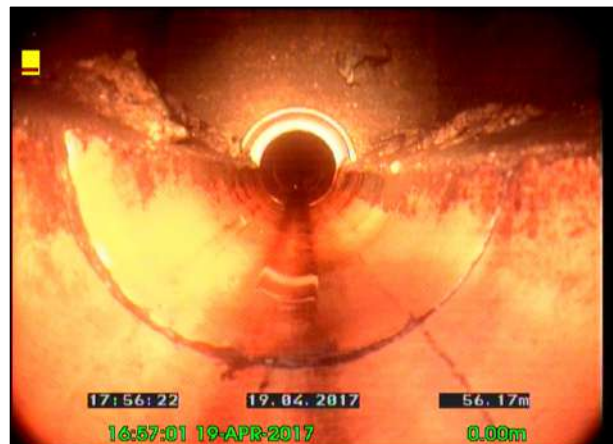
Photo: 20_20_126_A.jpg, 00:14:15
 56.16m, Water level, 5% of the vertical dimension

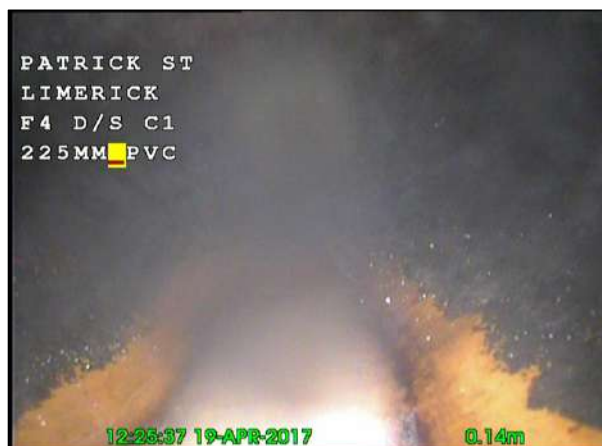
Photo: 23_23_143_A.jpg, 00:00:03
 0m, Water level, 5% of the vertical dimension

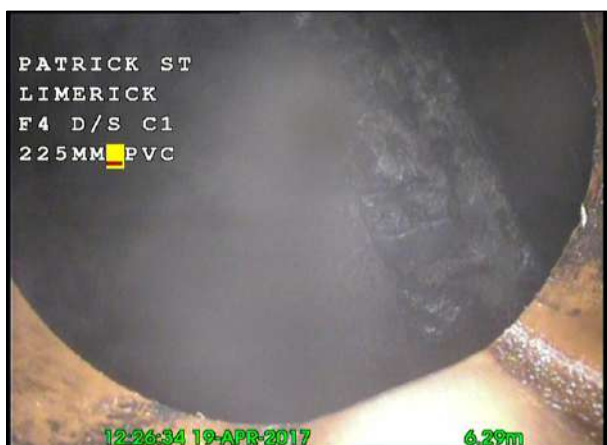
Photo: 23_23_144_A.jpg, 00:01:00
 6.29m, Water level, 5% of the vertical dimension

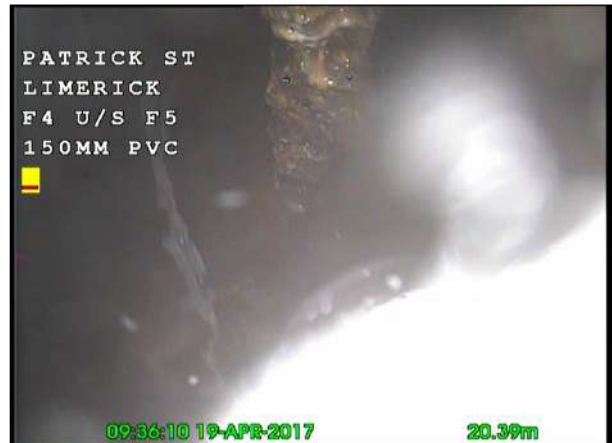
Photo: 24_24_148_A.jpg, 00:03:55
 20.39m, Water level, 10% of the vertical dimension

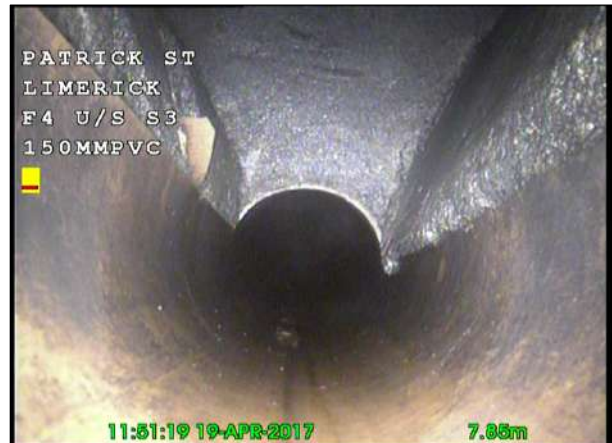
Photo: 25_25_153_A.jpg, 00:02:17
 7.83m, Water level, 5% of the vertical dimension

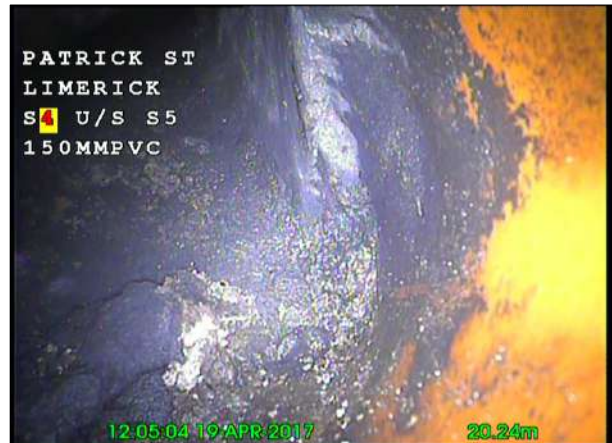
Photo: 27_27_160_A.jpg, 00:05:12
 20.24m, Water level, 0% of the vertical dimension

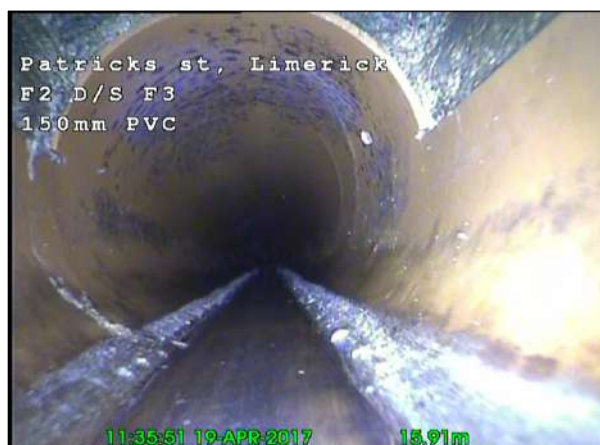
Photo: 29_29_173_A.jpg, 00:02:11
 15.92m, Water level, 5% of the vertical dimension

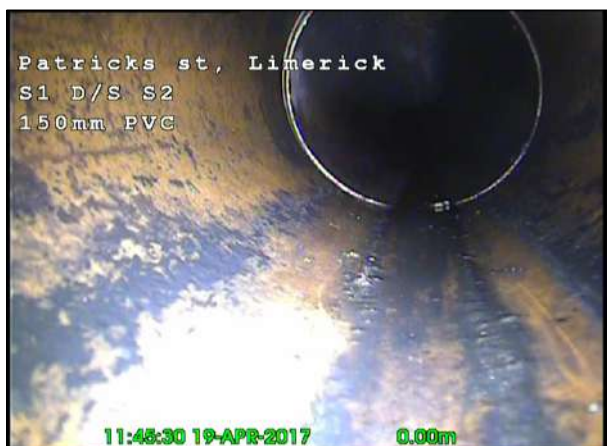
Photo: 31_31_179_A.jpg, 00:00:01
 0m, Start node type, manhole, reference number : SMH 1

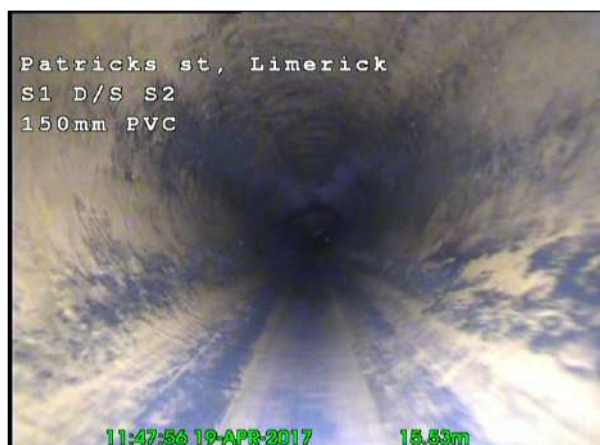
Photo: 31_31_183_A.jpg, 00:02:27
 15.32m, Water level, 5% of the vertical dimension

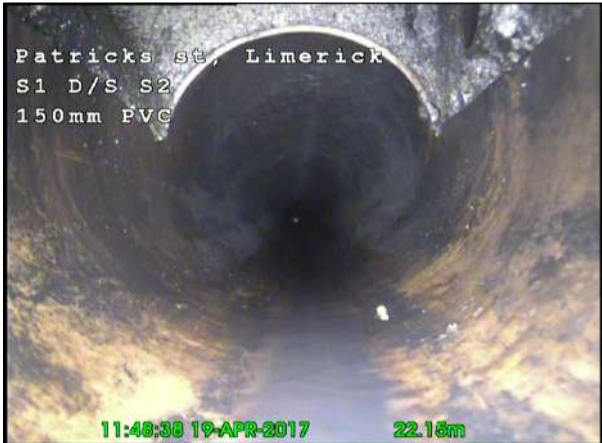
Photo: 31_31_184_A.jpg, 00:03:09
22.15m, Water level, 5% of the vertical dimension

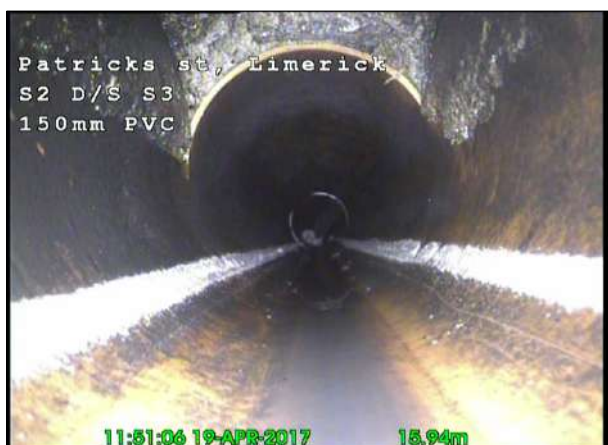
Photo: 32_32_189_A.jpg, 00:02:11
 15.94m, Water level, 5% of the vertical dimension

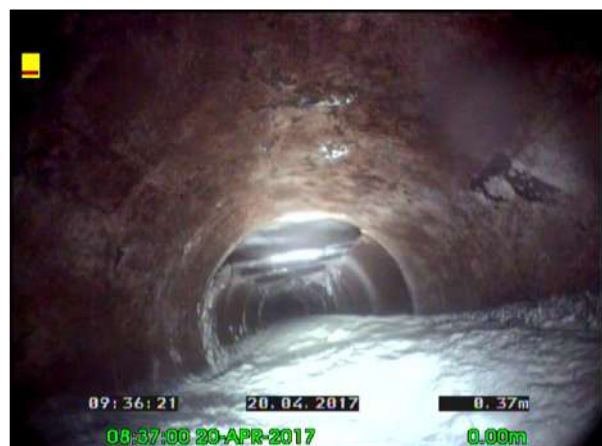
Photo: 33_33_194_A.jpg, 00:00:30
 0.37m, Water level, 40% of the vertical dimension

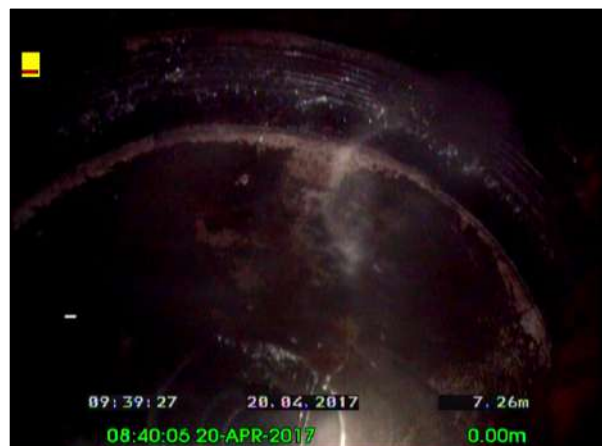
Photo: 33_33_195_A.jpg, 00:03:36
 7.26m, General photograph taken at this point

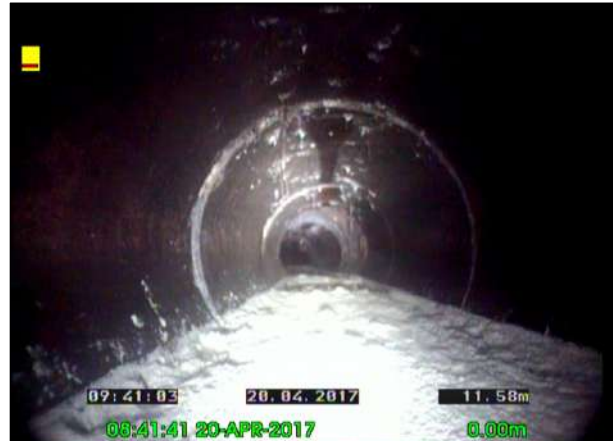
Photo: 33_33_197_A.jpg, 00:05:12
 11.57m, Water level, 15% of the vertical dimension

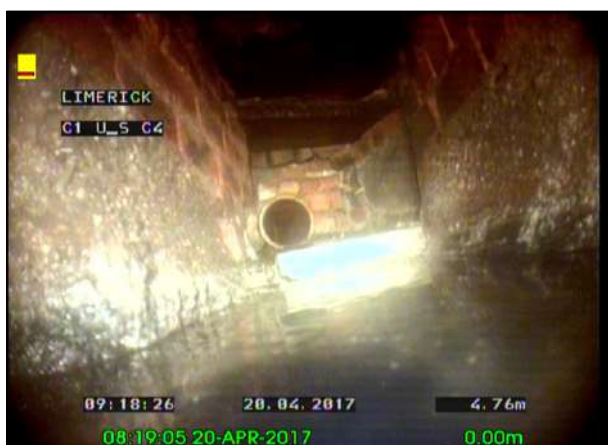
Photo: 34_34_212_A.jpg, 00:02:58
 4.76m, Water level, 5% of the vertical dimension

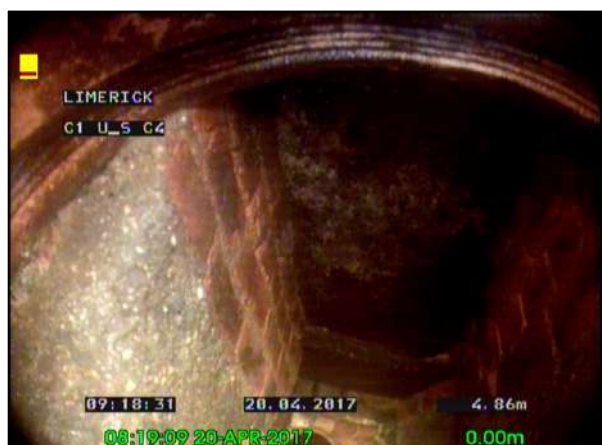
Photo: 34_34_213_A.jpg, 00:03:03
 4.86m, Finish node type, manhole reference number: C 4

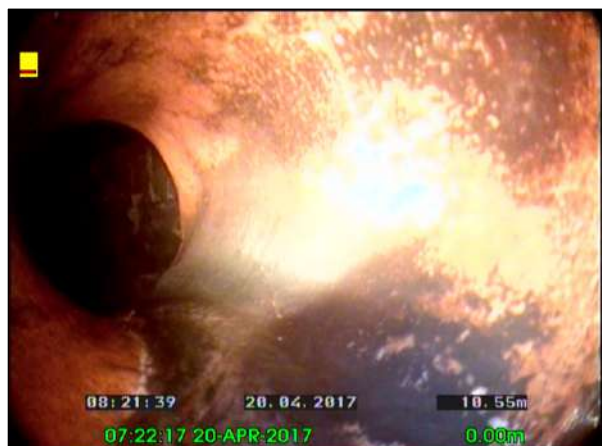
Photo: 35_35_222_A.jpg, 00:04:42
 10.55m, Line deviates left

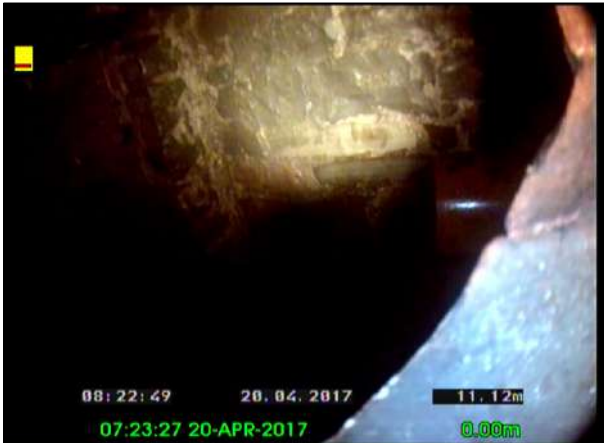
Photo: 35_35_224_A.jpg, 00:05:53
11.12m, Finish node type, manhole reference number: C 1

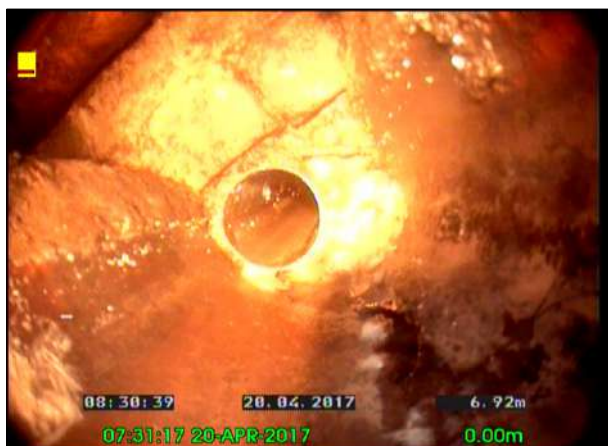
Photo: 36_36_228_A.jpg, 00:01:38
 6.92m, Water level, 5% of the vertical dimension

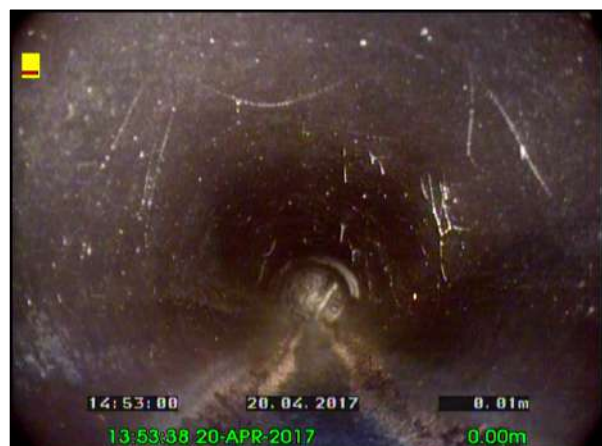
Photo: 37_37_231_A.jpg, 00:00:00
 0m, Water level, 5% of the vertical dimension

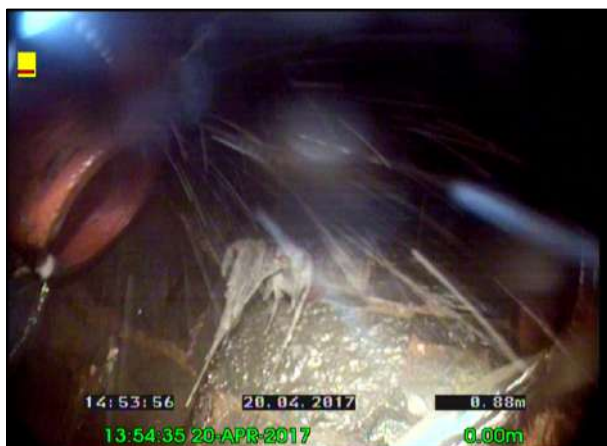
Photo: 37_37_233_A.jpg, 00:00:59
 0.88m, Finish node type, manhole reference number: C 25

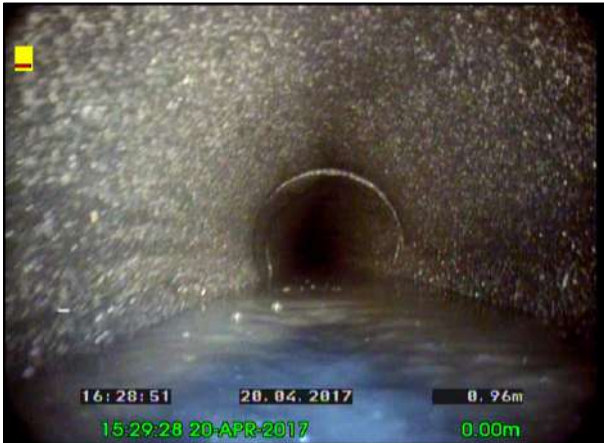
Photo: 38_38_237_A.jpg, 00:00:22
 0.95m, Water level, 15% of the vertical dimension

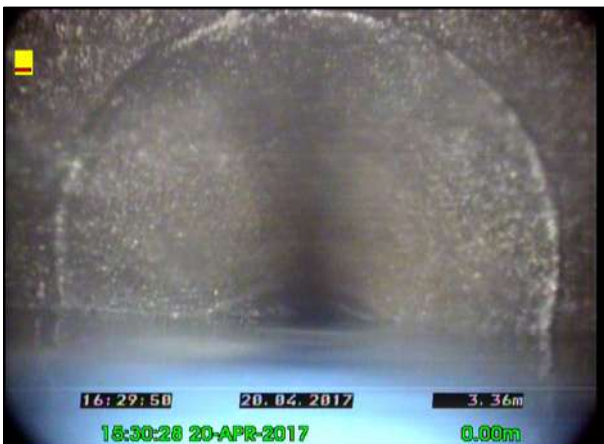
Photo: 38_38_239_A.jpg, 00:01:21
 3.35m, Water level, 30% of the vertical dimension

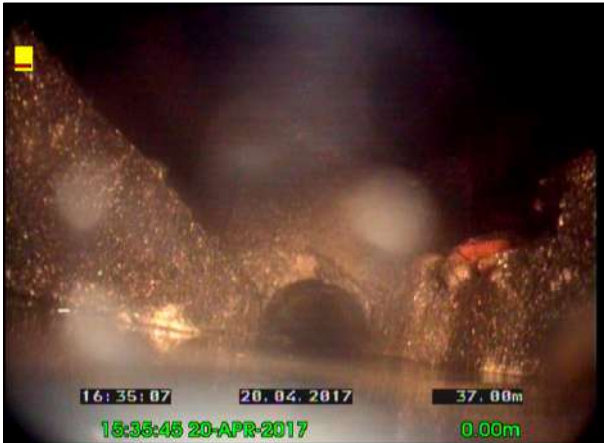
Photo: 38_38_241_A.jpg, 00:05:01
37m, Water level, 15% of the vertical dimension

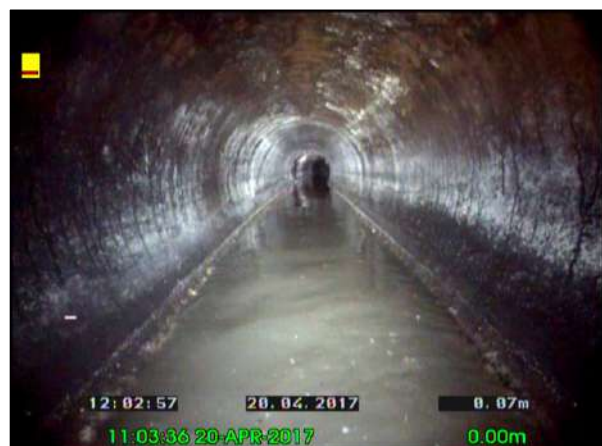
Photo: 39_39_244_A.jpg, 00:00:04
 0.07m, Water level, 10% of the vertical dimension

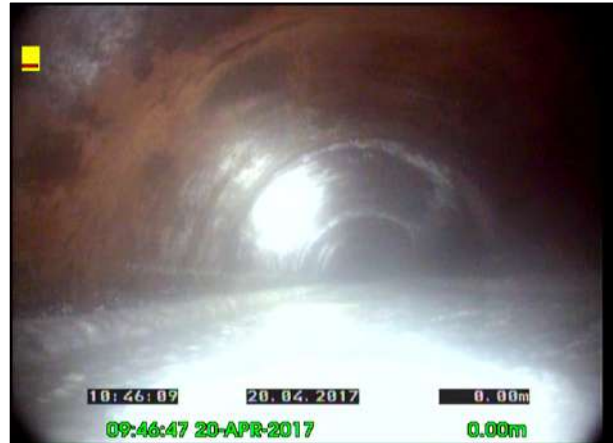
Photo: 40_40_258_A.jpg, 00:00:01
 0m, Water level, 40% of the vertical dimension

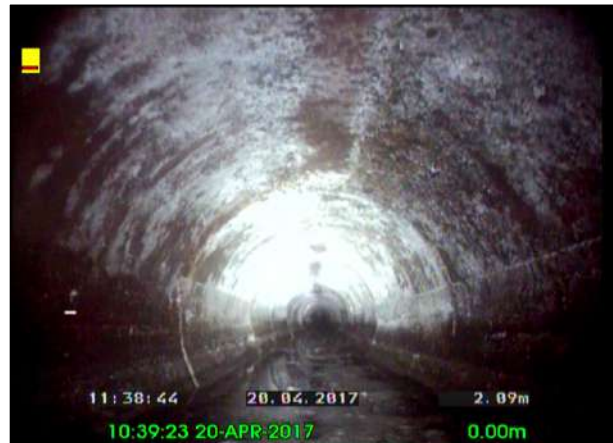
Photo: 41_41_260_A.jpg, 00:00:52
 2.08m, Water level, 10% of the vertical dimension

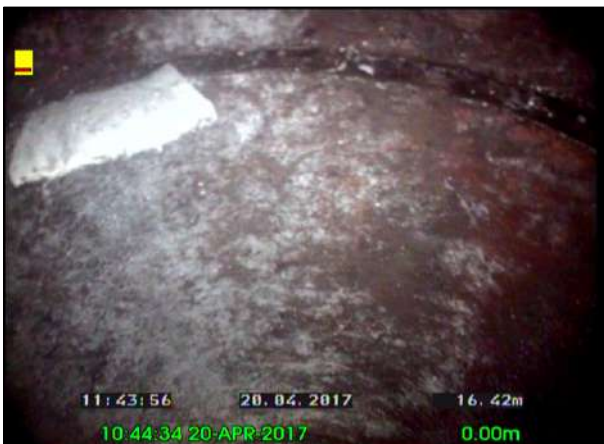
Photo: 41_41_269_A.jpg, 00:06:03
 16.42m, General photograph taken at this point

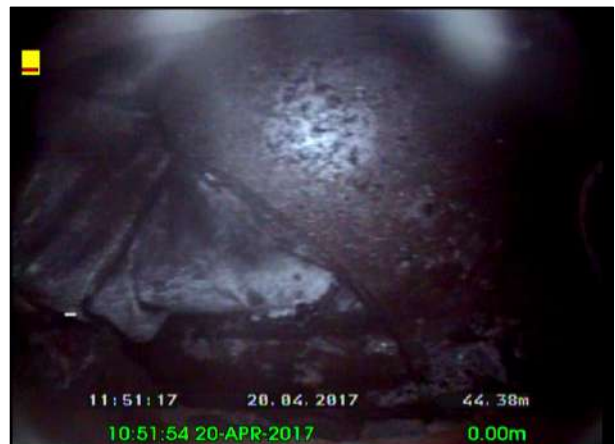
Photo: 41_41_280_A.jpg, 00:13:24
 44.38m, Finish node type, manhole reference number: C 43

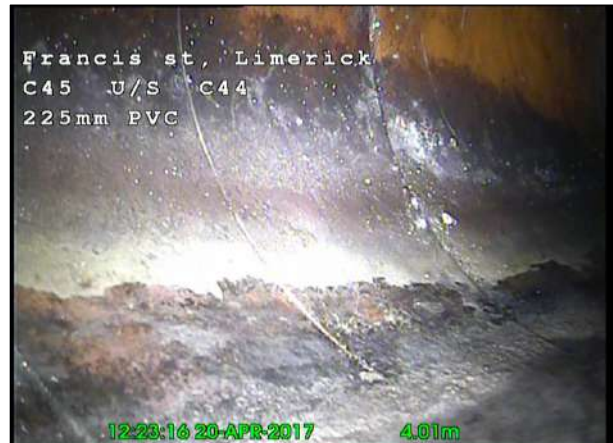
Photo: 42_42_283_A.jpg, 00:00:33
 4.01m, Line deviates right

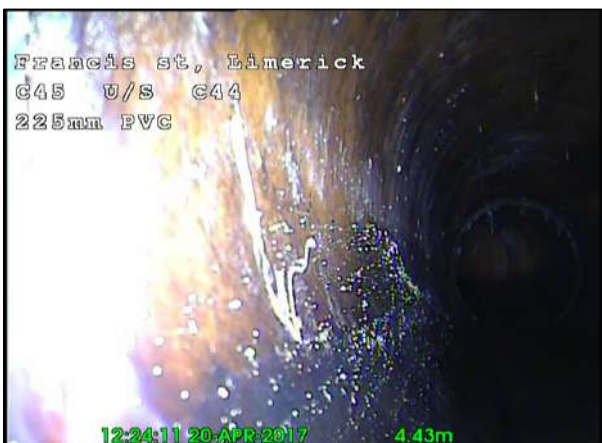
Photo: 42_42_284_A.jpg, 00:01:28
 4.43m, Survey abandoned Remarks: UNABLE TO TRAVEL
 BENDS

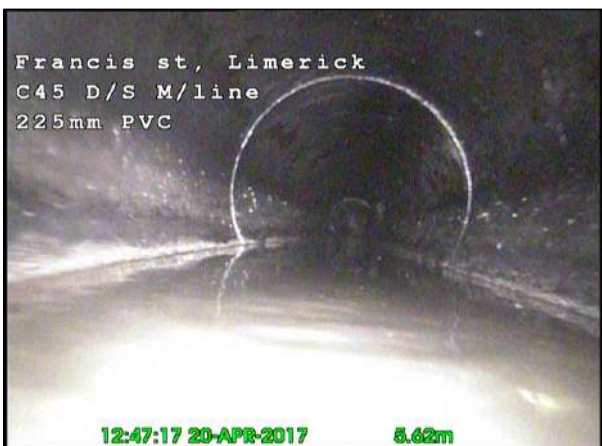
Photo: 43_43_287_A.jpg, 00:00:39
 5.62m, Water level, 10% of the vertical dimension

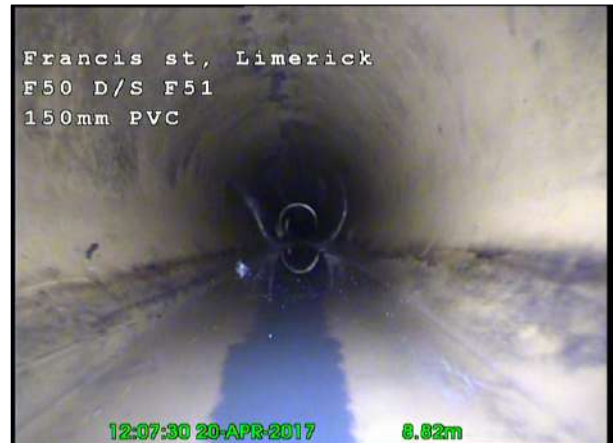
Photo: 44_44_292_A.jpg, 00:01:04
 8.76m, Water level, 5% of the vertical dimension

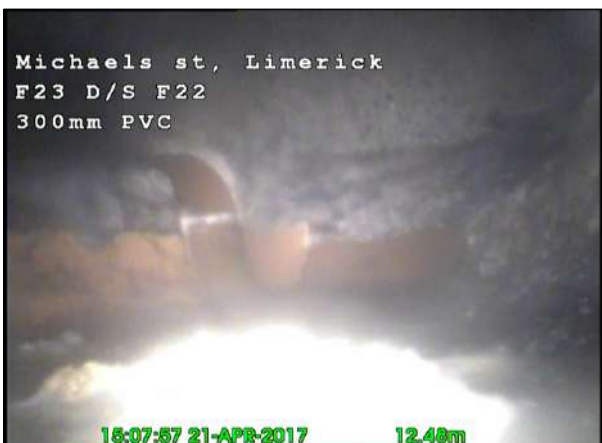
Photo: 47_47_307_A.jpg, 00:00:58
 12.46m, Finish node type, manhole reference number: C 22
