Proposed Strategic Housing Development on the
Former Player Wills Site and Undeveloped Land
Owned by Dublin City Council at South Circular
Road, Dublin 8.

Structural Assessment Report for Planning

DOCUMENT NO: 19.117 – PWFR – 01

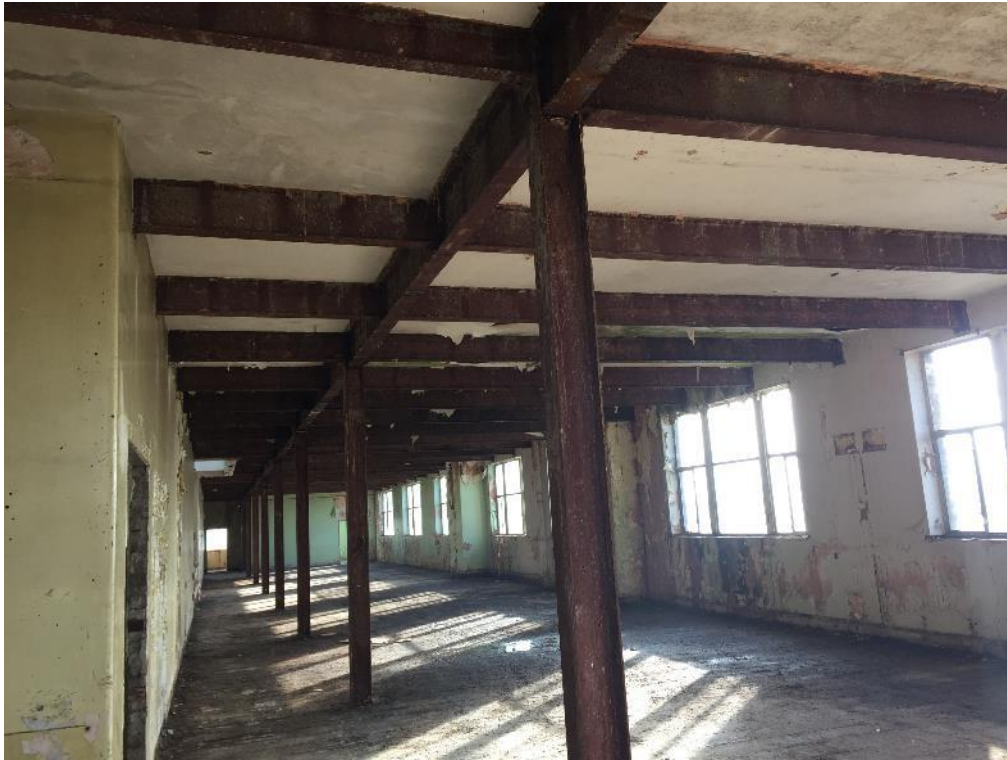
Photo 15: Level 2 in 1930's section

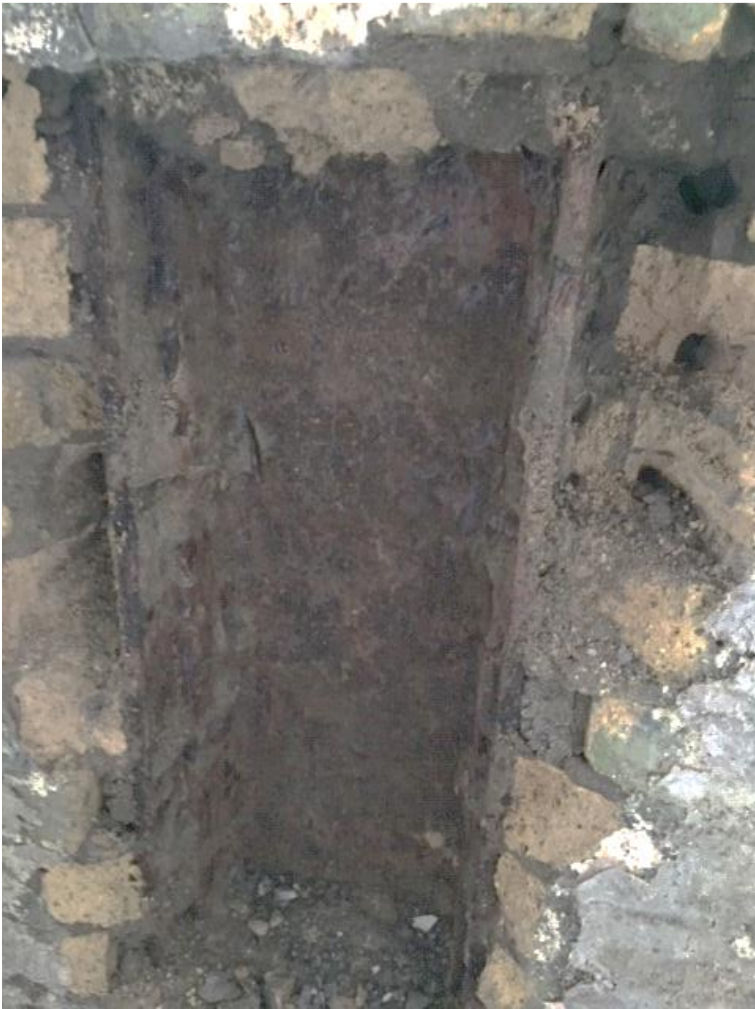
During the investigations, it was discovered that the external brick façade piers encase structural steel columns, and that the concrete lintels are an encasement to structural steel beams (refer to Photos 16-20 in Appendix A). Corrosion of the steelwork was noted in the initial opening up works and the results of this initial opening up can be seen in Appendix E. As a result, specialist cathodic protection testing has been commissioned so as to investigate its effectiveness of protecting the steel within the facade. This is to establish if this method of corrosion protection will be successful in preventing further corrosion of the structural steelwork, which would affect its loadbearing capacity, and also result in expansive corrosion having deleterious effects on the encasing brick façade. This cathodic protection testing has commenced and a report outlining the findings and long term corrosion protection for the encased steel elements will be produced upon completion of the testing.

Photo 19: Embedded Steel

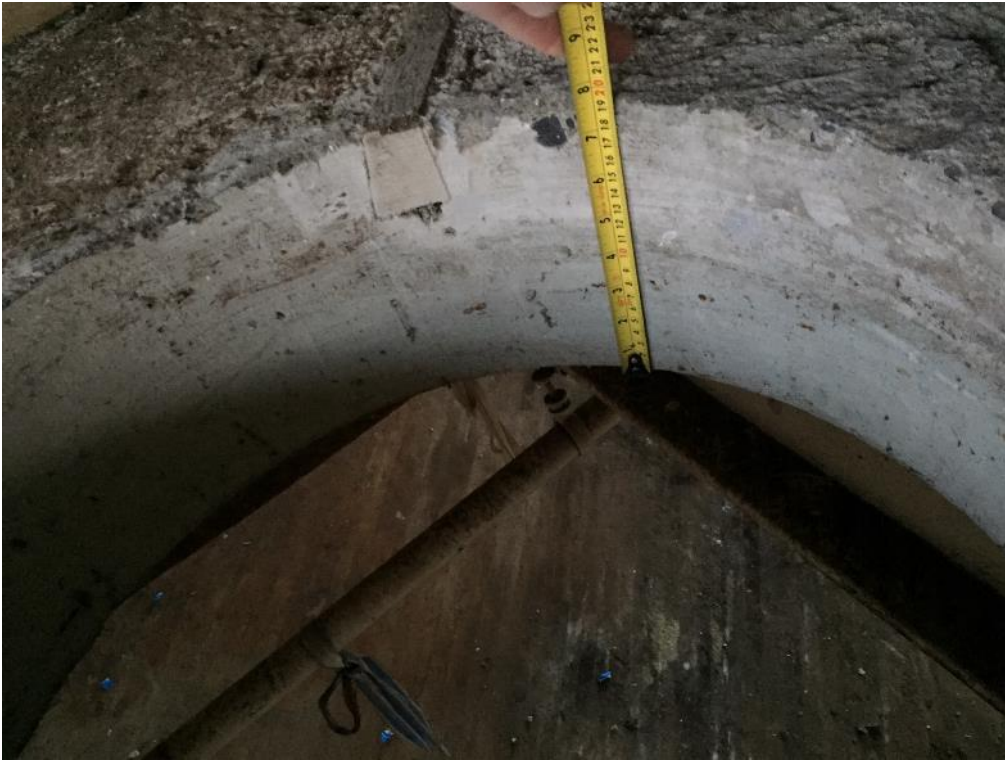
Photo 24: Core Sample

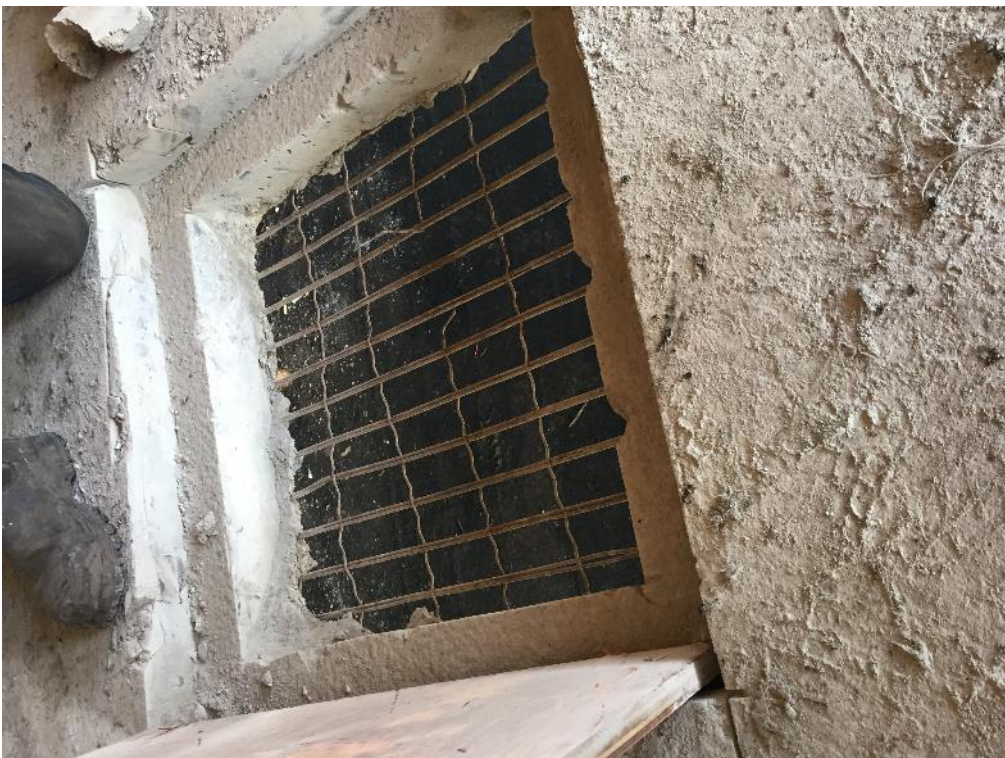
Local opening of the existing slabs (approximately 500mm*500mm) was carried out at each area related to a different construction period. The concrete around the reinforcement was broken away to identify the type, spacing and size of the reinforcement, along with concrete cover for determination of exposure and fire rating capacity (refer to Photos 23-27 in Appendix A). Concrete core samples were taken for compressive testing. Several samples of the reinforcement were also taken for tensile testing.

Photo 25: Level 1 Reinforcement

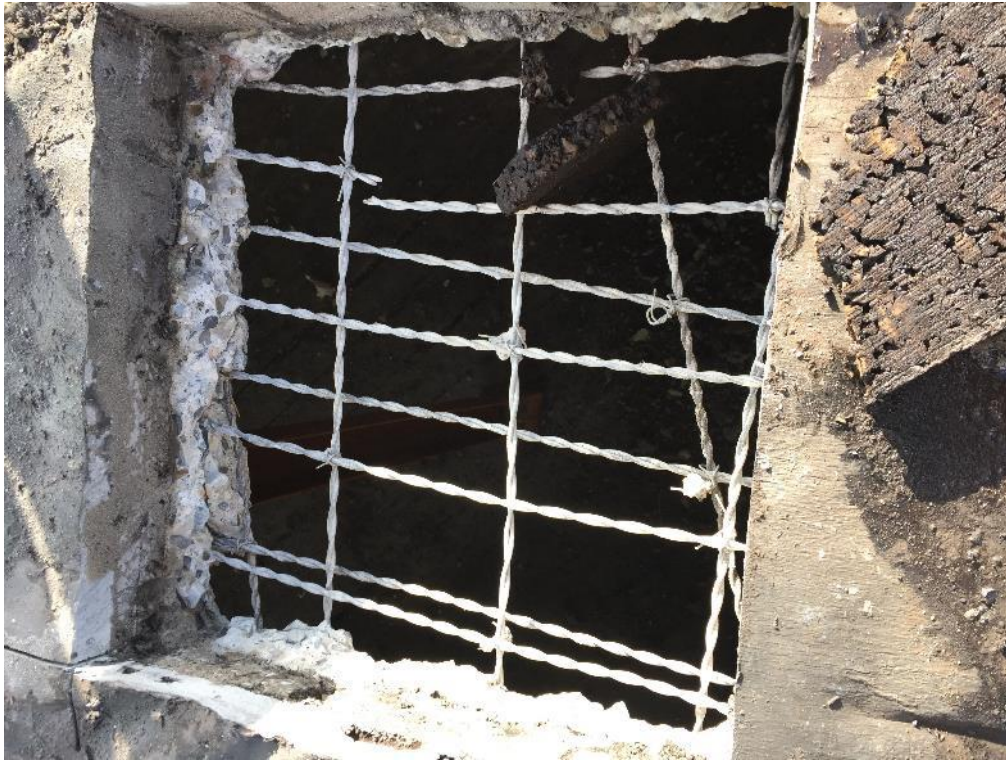
Photo 26: Level 2 reinforcement

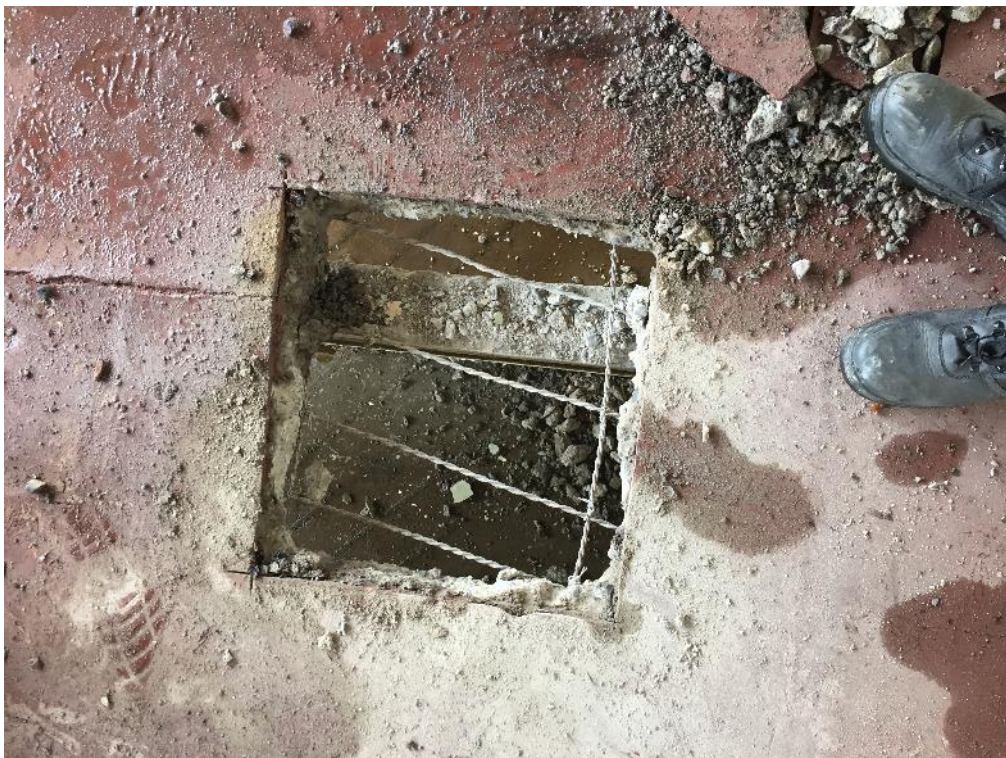
Photo 27: Level 3 reinforcement

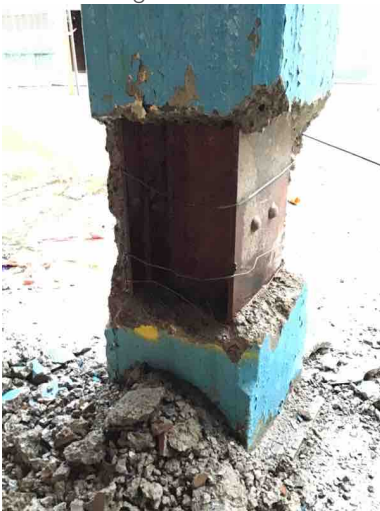
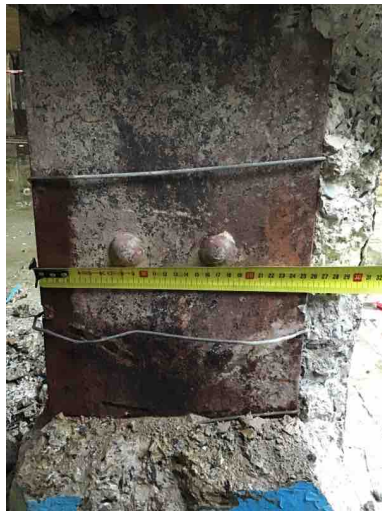
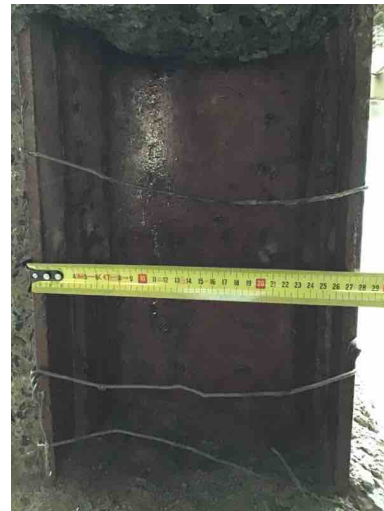
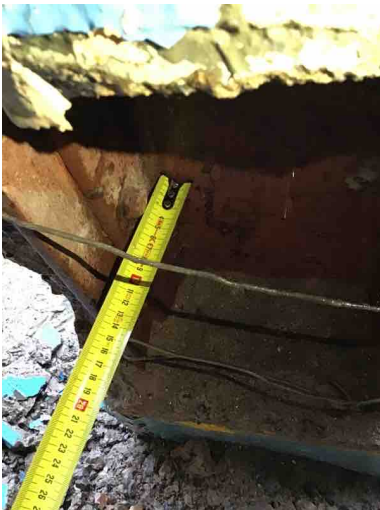
8 + 24/09/2019

Steel Investigation

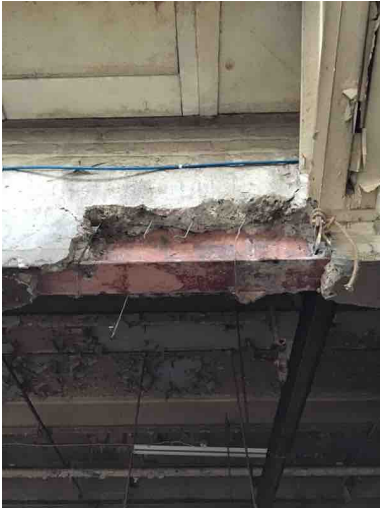
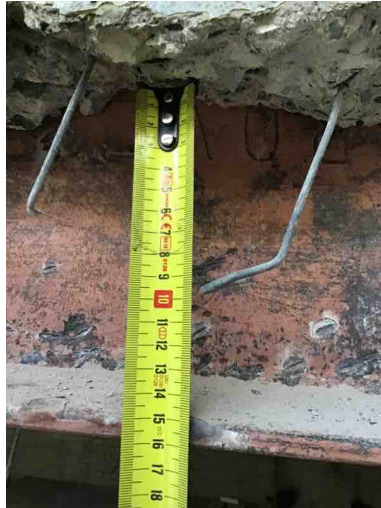
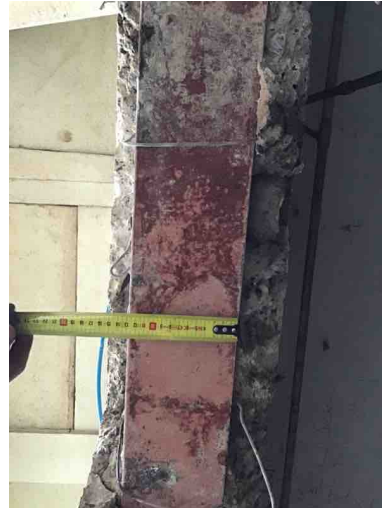
11 + 24/09/2019

Steel Investigation

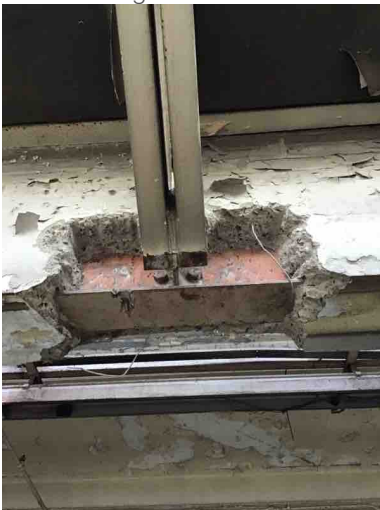
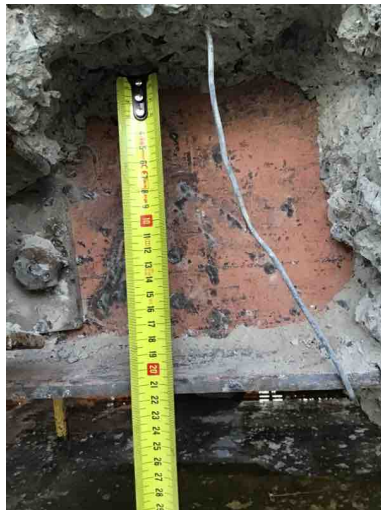
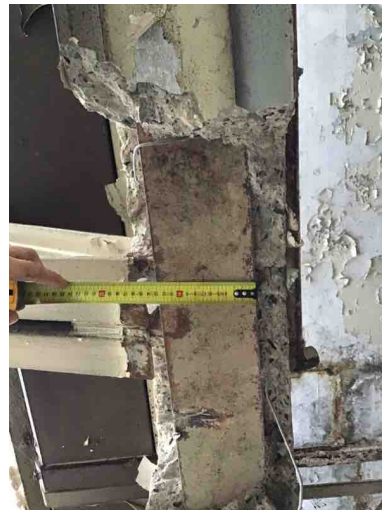
12 + 24/09/2019

Steel Investigation

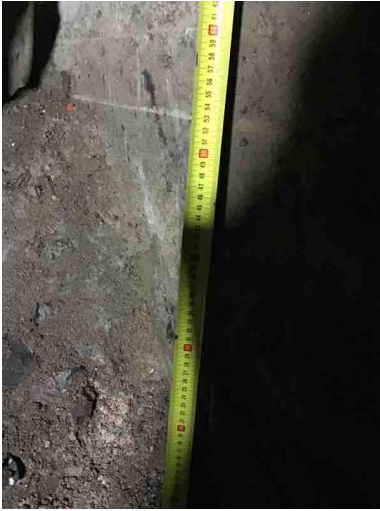
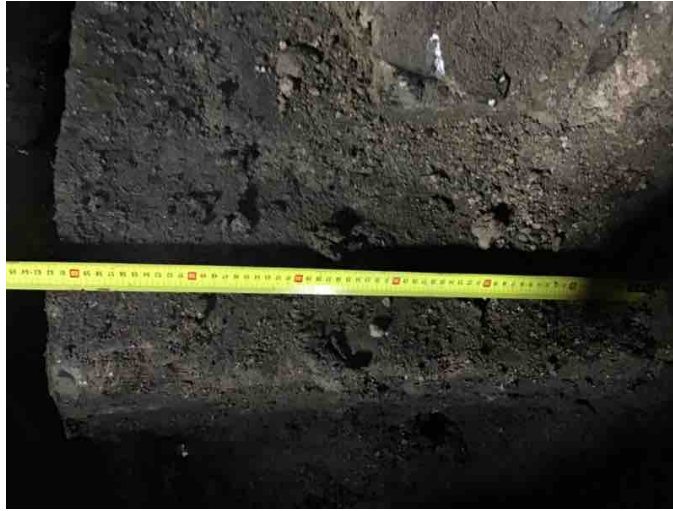
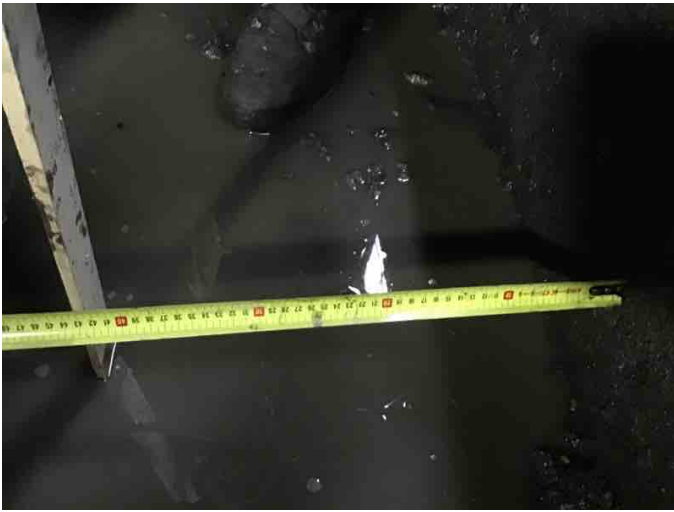
15 + 24/09/2019

Inside Wall Investigation

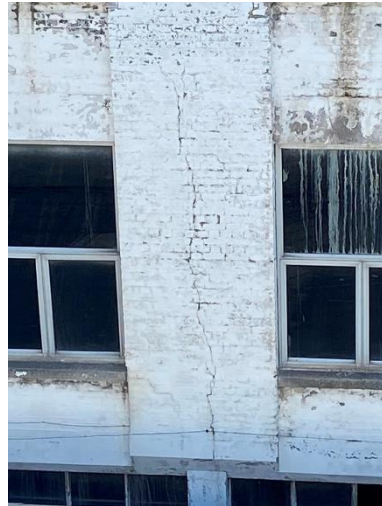
Plate 2

- Numerous instances of cracking were observed on the brickwork encasement at column locations. The severity of cracking ranged from hairline cracking to heavy cracking. The orientation of the observed cracking tended to be vertical, following the alignment of the embedded steel column (Plates 1 to 3). In the most severe of cases, 2no. parallel vertical cracks, coinciding with alignment of the column flanges, were present over the full height (storey height) of the affected columns (Plates 4 to 6).

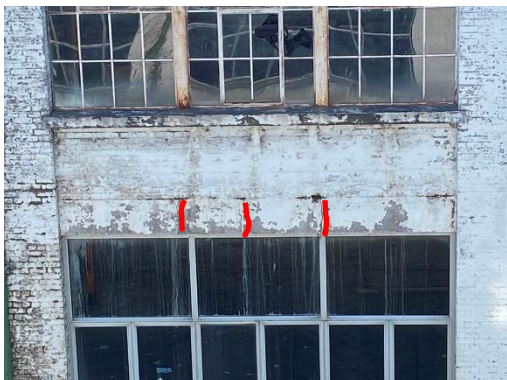
Plate 12

- Numerous instances of cracking were observed on concrete encased lintels. The cracking was predominantly vertical in orientation, likely coinciding with the position of supplementary stirrups (Plates 12 and 13) – this type of bar reinforcement was observed surrounding the steel lintel sections at locations where opening up works had been undertaken (by others). At a limited number of locations, horizontal cracking was also observed, likely coinciding with the bottom flange of the encased lintel (Plates 14 to 16). Localised cracking of the concrete encasement was also observed at the point of connection between encased lintels and secondary beams (Plate 17).

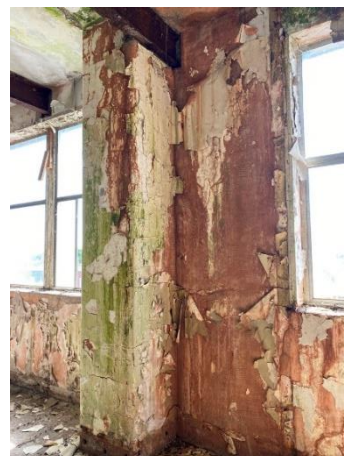
**Plate 20**

- Within the interior of the building, surface finishes (paint coatings, tiling, plasterwork, panelling etc.) may have inhibited the identification of defects (plate 20). Additionally, along the southern building elevation (gridline N) the existence of inbuilt chimney flues, thickened brick piers and exterior stone cladding may have concealed defects (Plates 21 to 23).

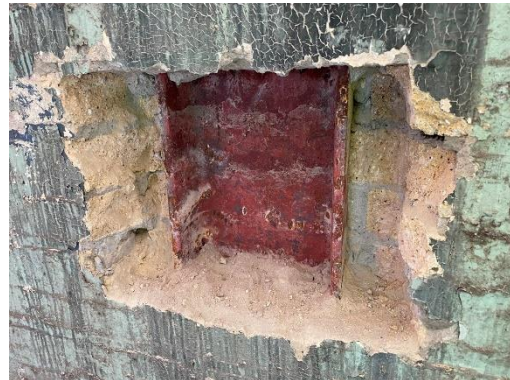
Plate 24

- Localised areas of brick/concrete encasement have been removed (by others) to expose the embedded steel sections or steel reinforcement. The condition of the steel present at these locations varied, from exhibiting little or no corrosion (Plates 24 and 25) to exhibiting moderate surface corrosion (Plates 26 and 27). From the limited number of elements exposed, it appears that the embedded columns located along the eastern elevation are worst affected.

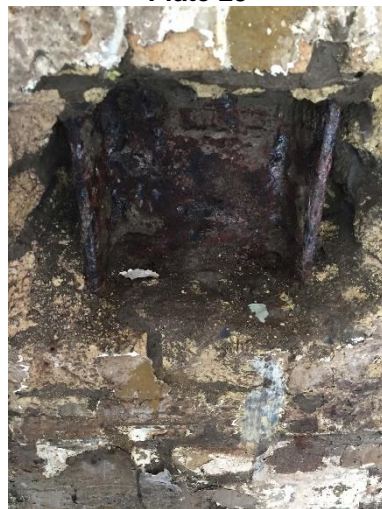
Plate 26

The nature of the observed cracking, in conjunction with the condition of the embedded steel exposed in localised areas, would suggest that steel corrosion is a likely cause of the observed defects. The lack of cavity space provided between the embedded steel columns and the surrounding brick encasement is likely contributing to the cracking observed at these locations. In the absence of a cavity space, the build-up of expansive corrosion products on the surface of the steel columns imposes increased stress directly onto the surrounding brickwork, subsequently causing it to crack. However, cracking arising from structural deficiencies or structural movement cannot be ruled out; these considerations should be checked by a suitably qualified structural engineer.

Nonetheless, it is recommended that further investigations are undertaken to determine whether the embedded steel is likely to be actively corroding, and the extent over which this may be occurring. It is also recommended that investigations are undertaken to determine the presence of deleterious contaminants or the action of deterioration processes which may be contributing to the corrosion of the embedded steel.
