ARKLOW BANK WIND PARK  
PHASE 2

**ONSHORE GRID  
INFRASTRUCTURE**

**Appendix 9.2** Site Walkover Summary

# Arklow Bank Cable Route Arup Site Walkover

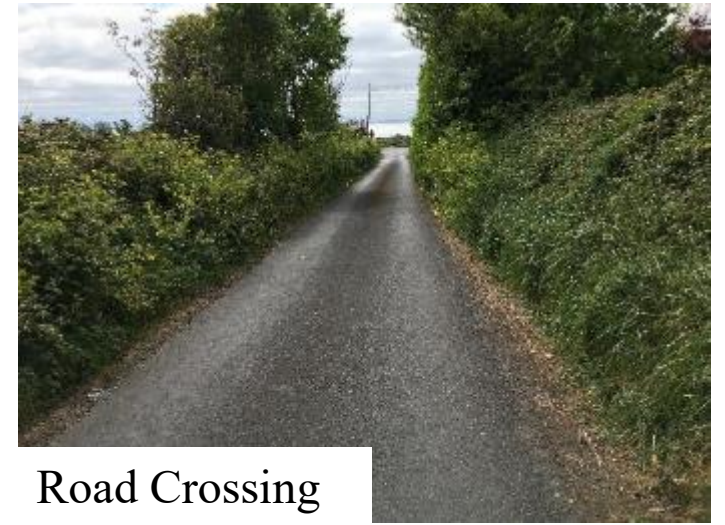
Road Crossing

Dumped Metal

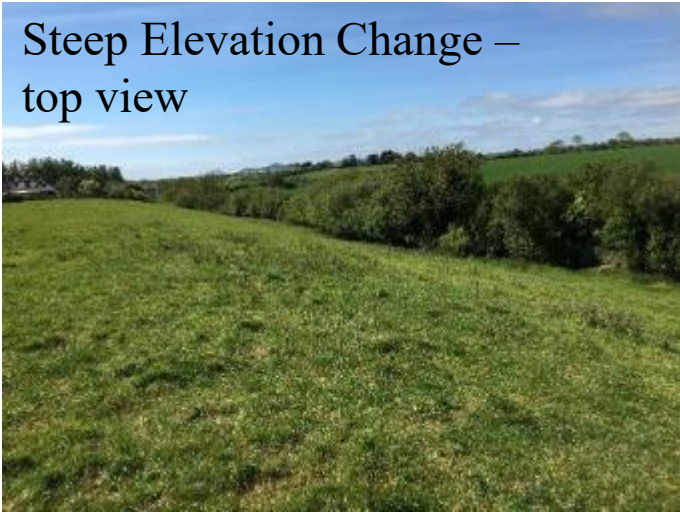
Steep Elevation Change –  
top view

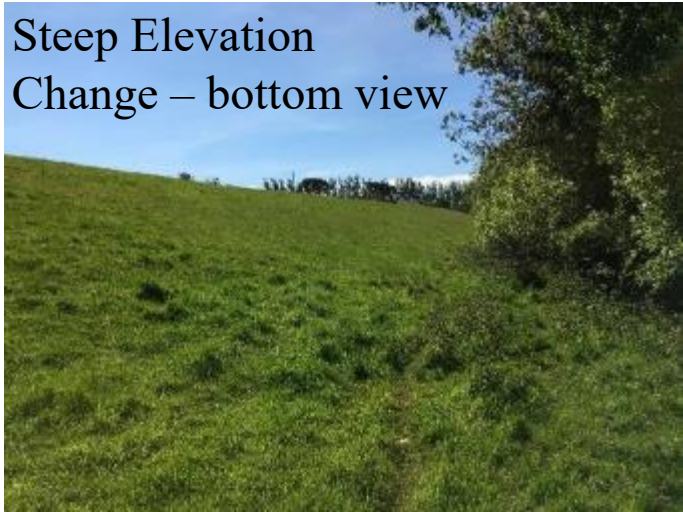
Steep Elevation  
Change – bottom view

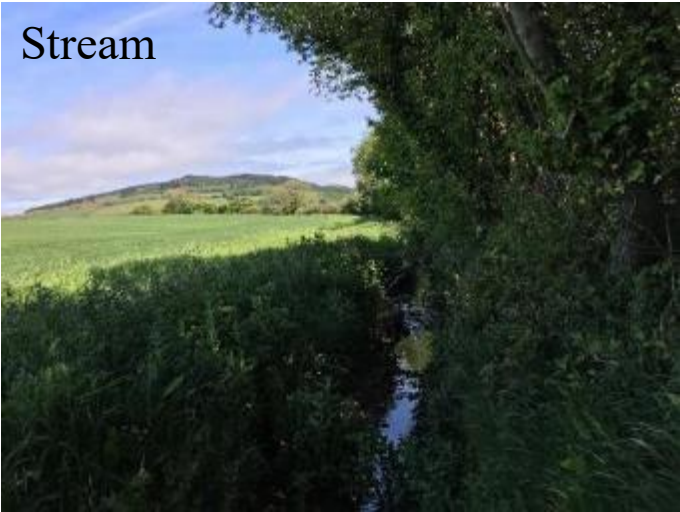
Stream

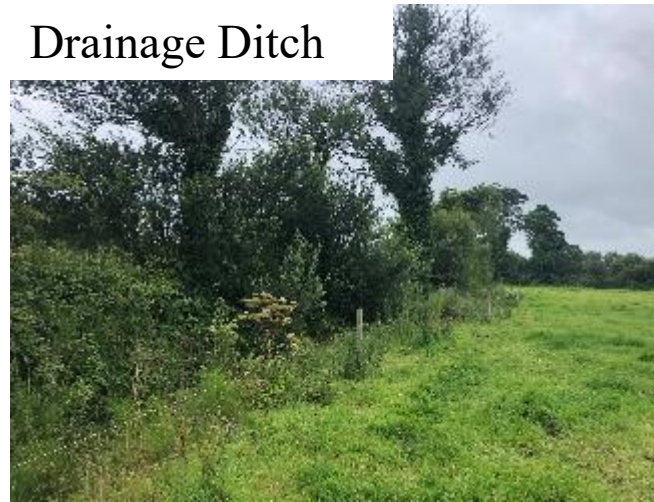
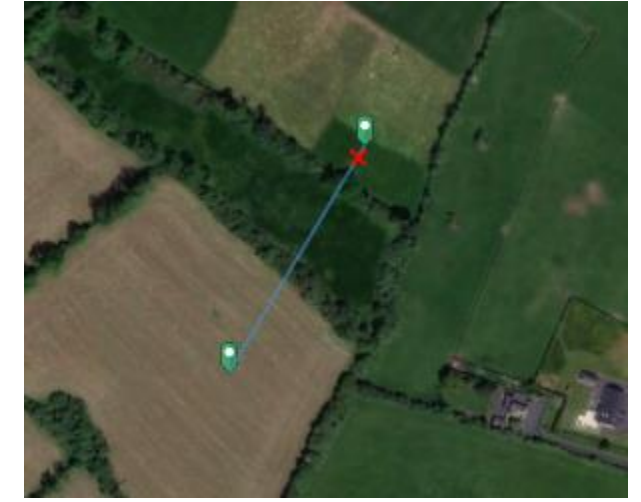
Generally limited soft spots apart from areas around the drainage ditches – low lying soggy wet ground which has been artificially drained;

Drainage Ditch

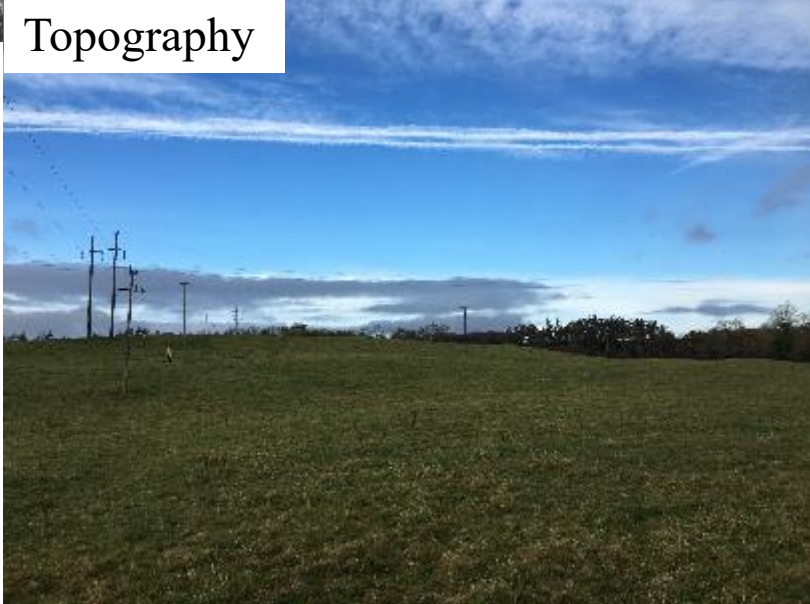
Topography

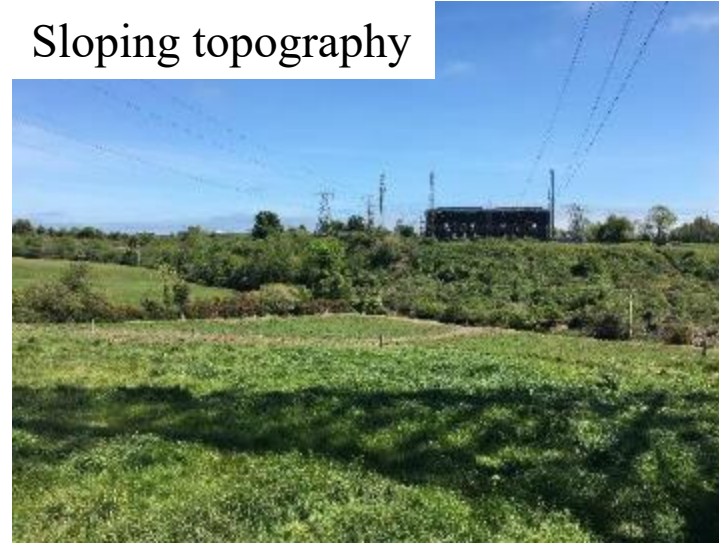
Sloping topography

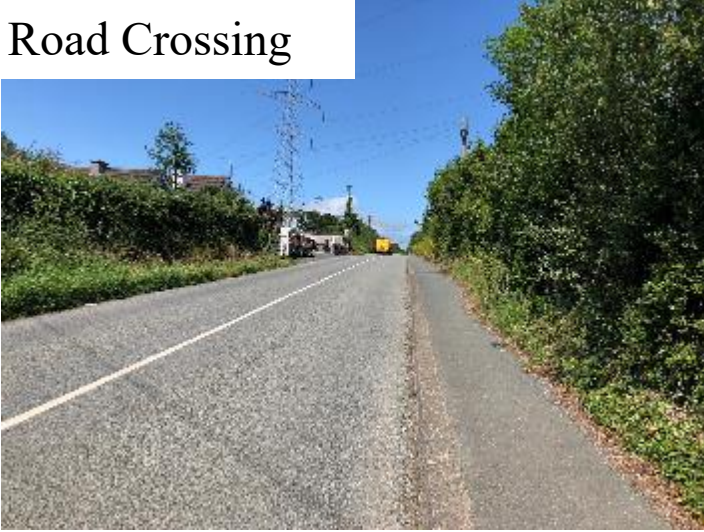
Road Crossing

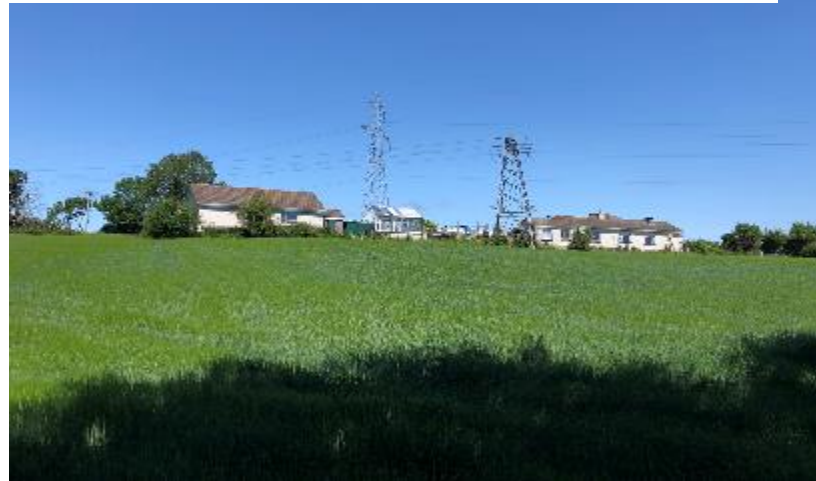
Agricultural Land with gently sloping topography

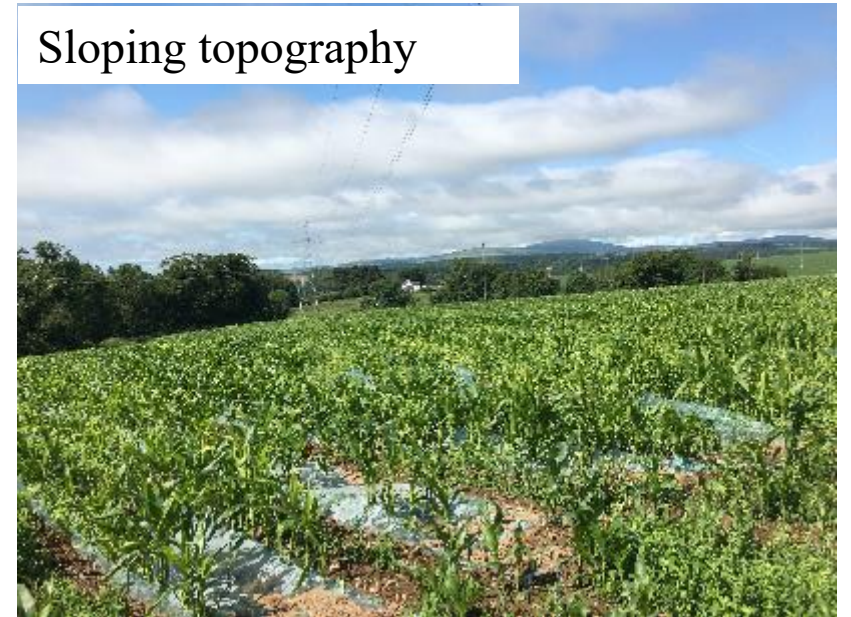
Sloping topography

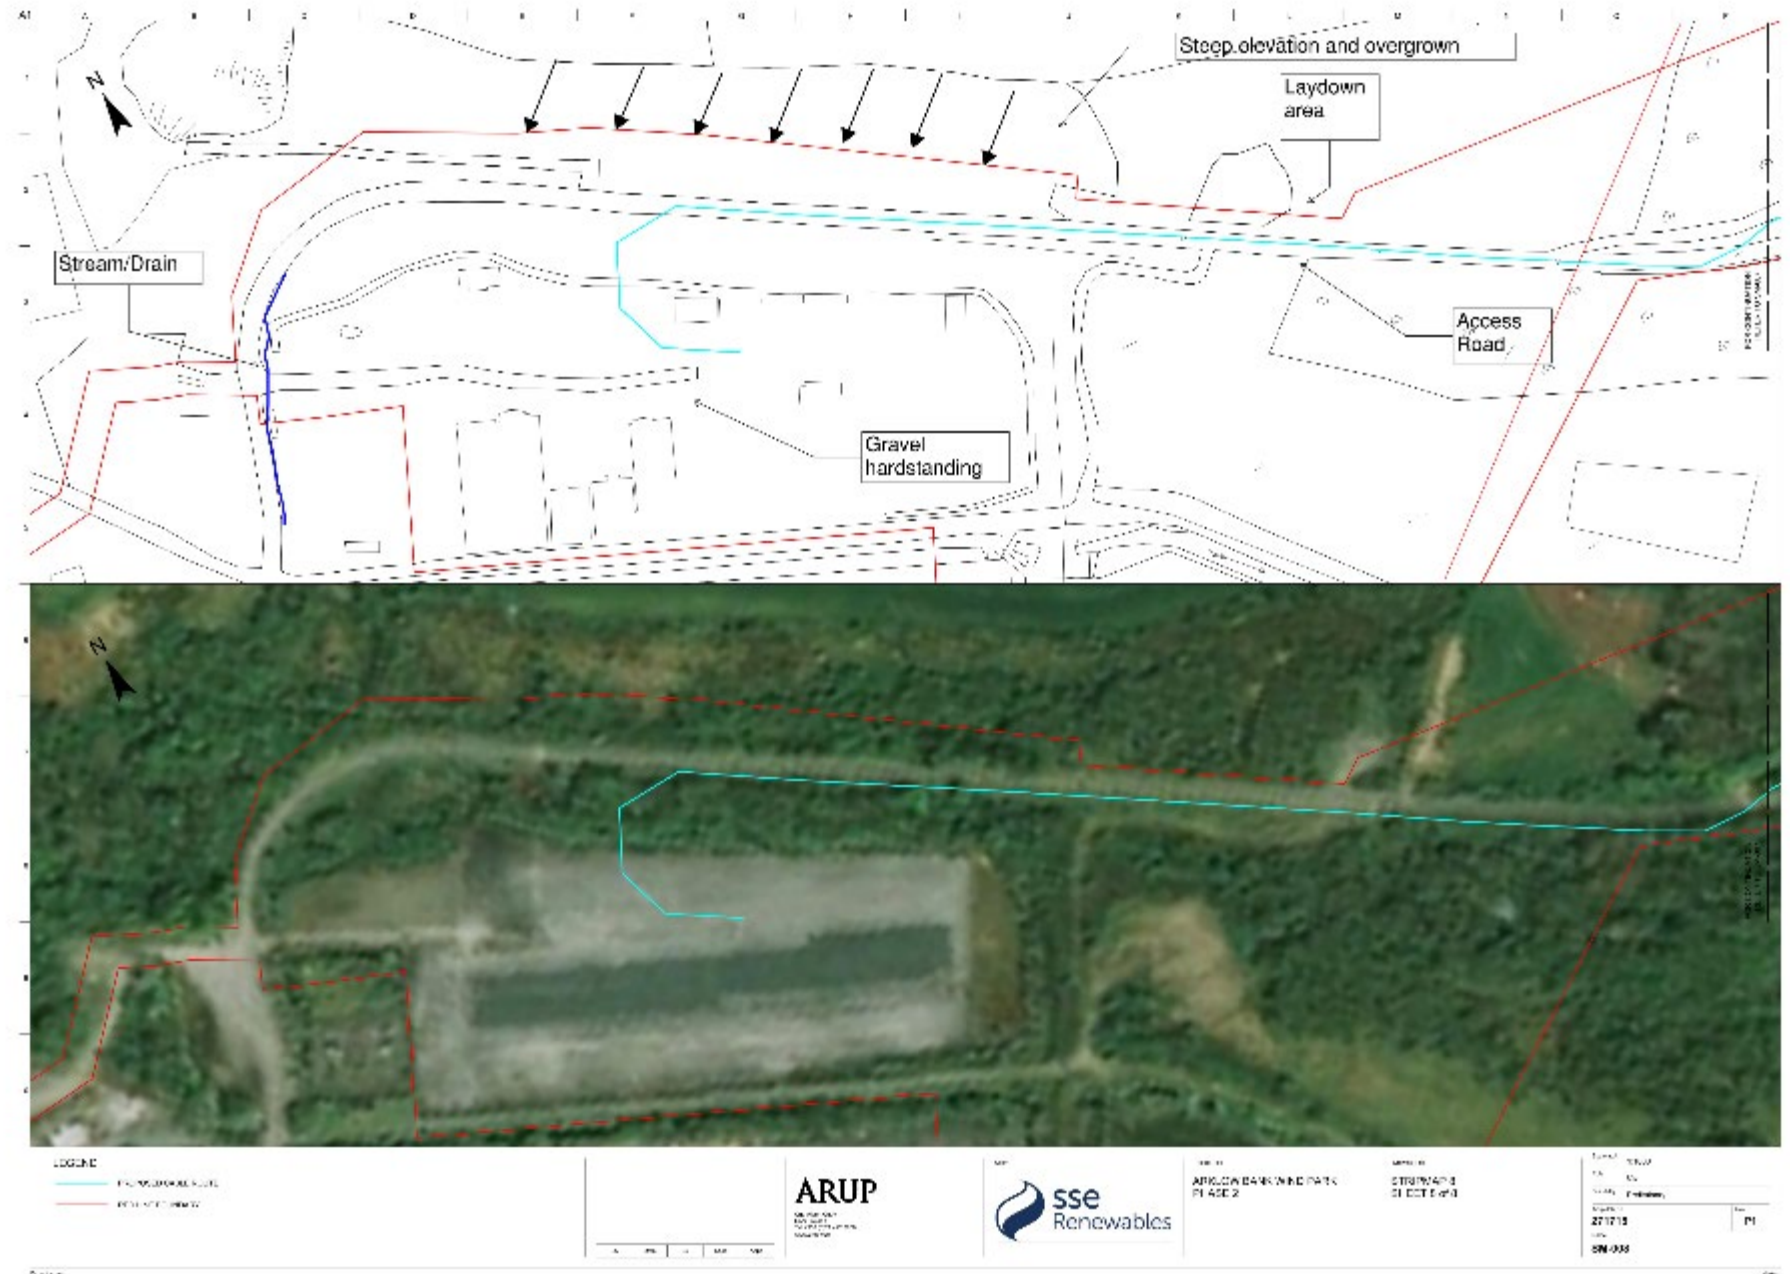
# Sheet 8 – Proposed Substation

- Former industrial site
- Steep elevation change and dense vegetation 1 no. overhead cables
- 1 borrow pit and outcropping bedrock
- 1 no. stream drain at compound site entrance
- Possible services

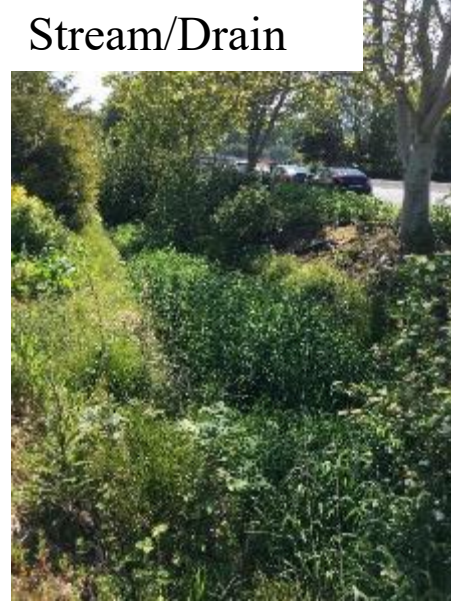
Stream/Drain

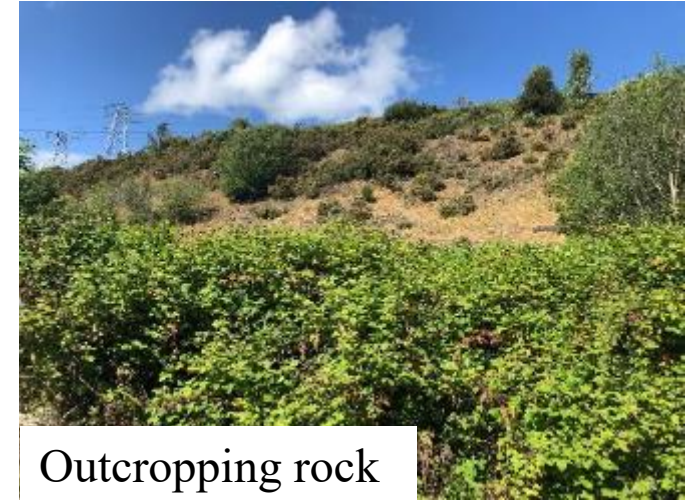
Outcropping rock

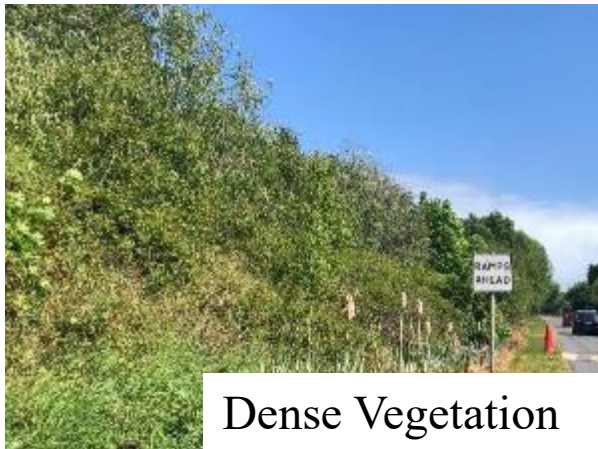
Dense Vegetation

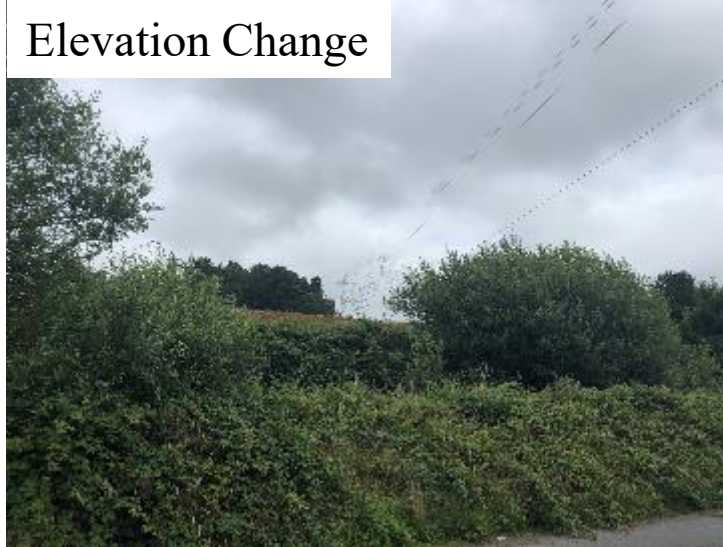
Elevation Change
