Historic Building Record
The Farm, Bessboro, Ballinure, Blackrock, Cork City

Prepared by
John Cronin BA MRUP MUBC
John Cronin & Associates
3a Westpoint Trade Centre
Ballincollig
County Cork

February 2022

1. Introduction

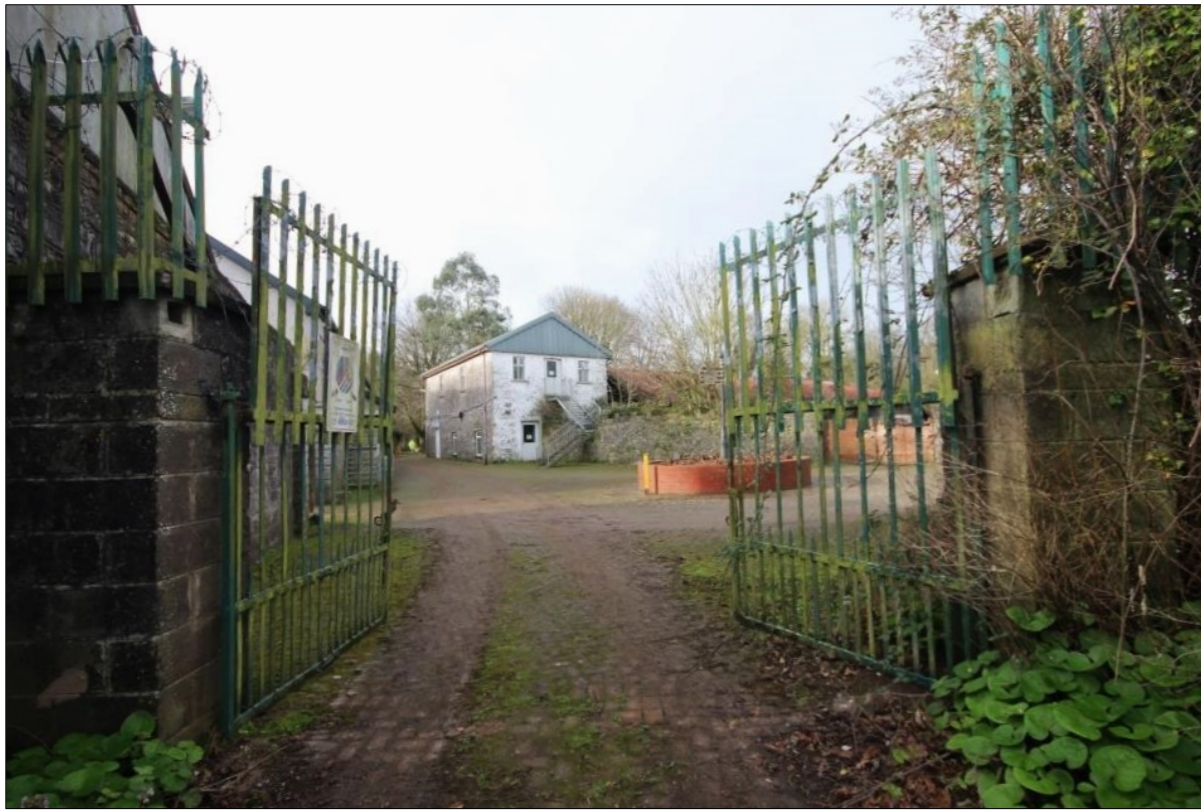
Plate 1: View to subject site from gateway to east

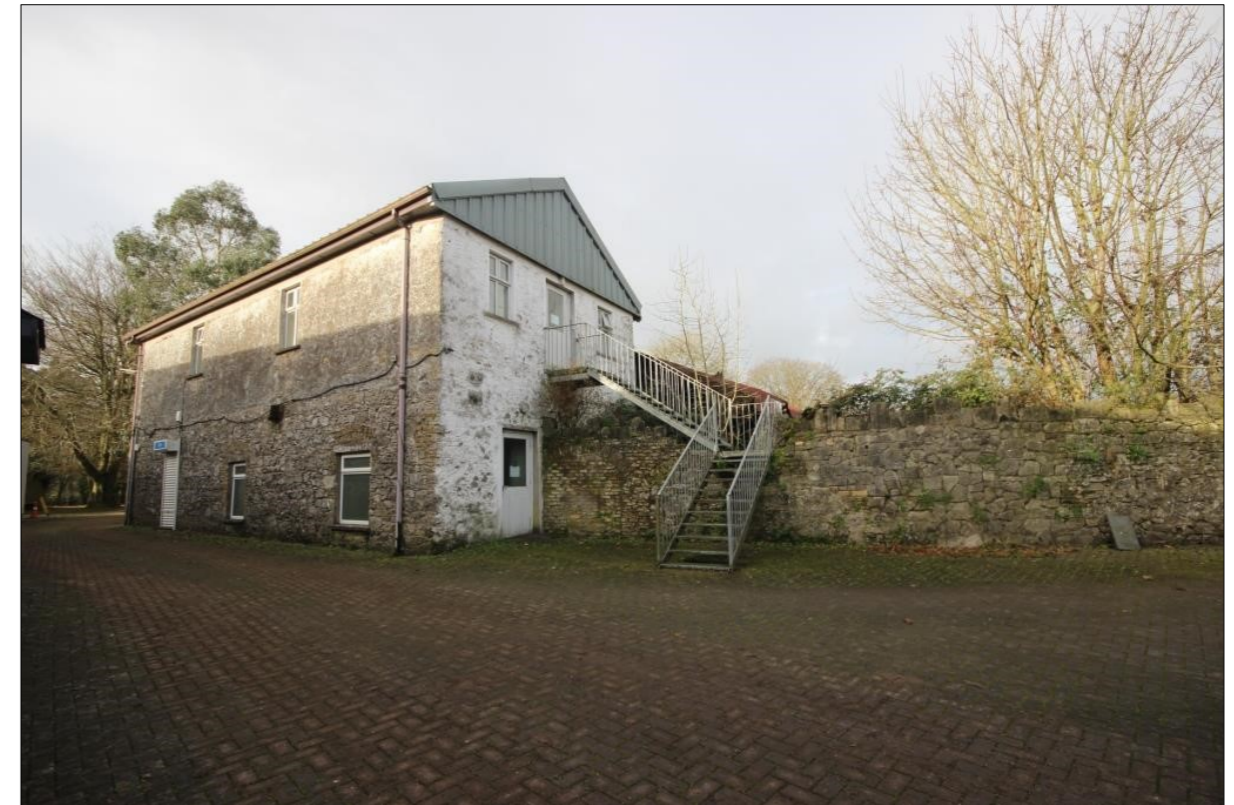
Plate 3: South-eastern and north-eastern elevation of Building A

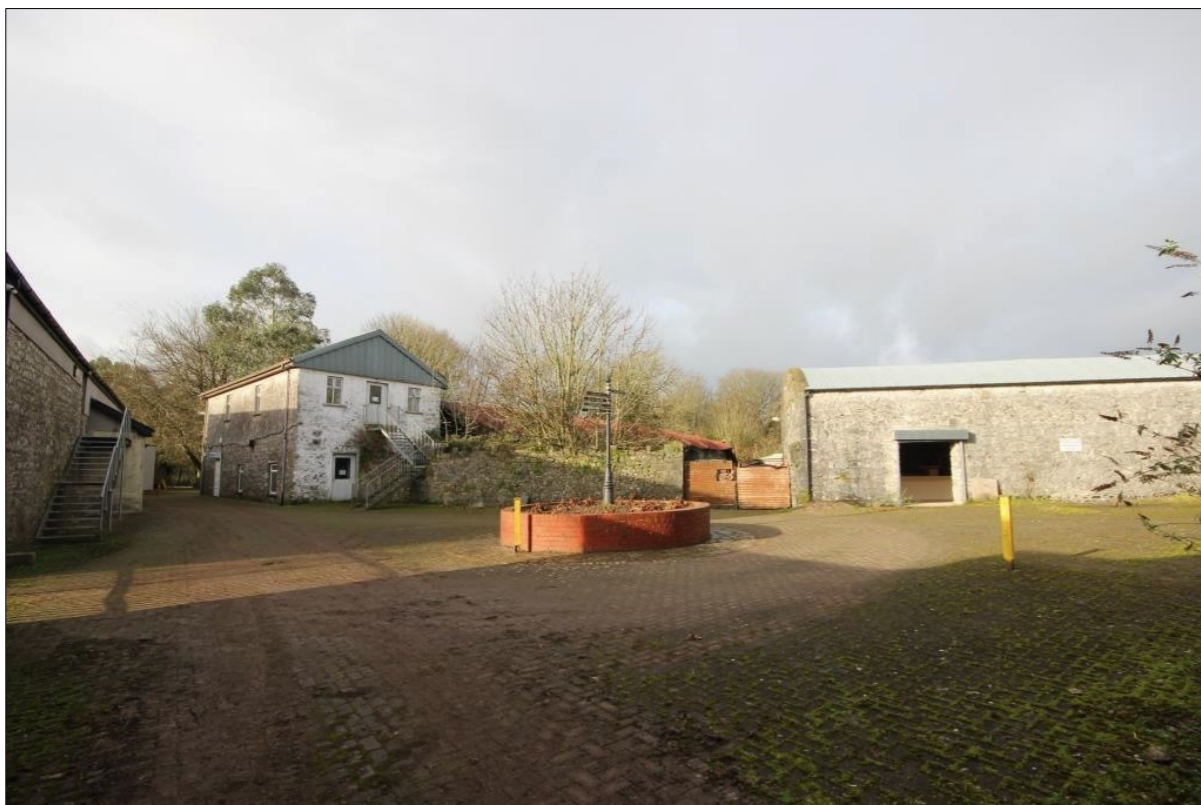
Plate 2: General view to northern range with Building A on left and Building B on right

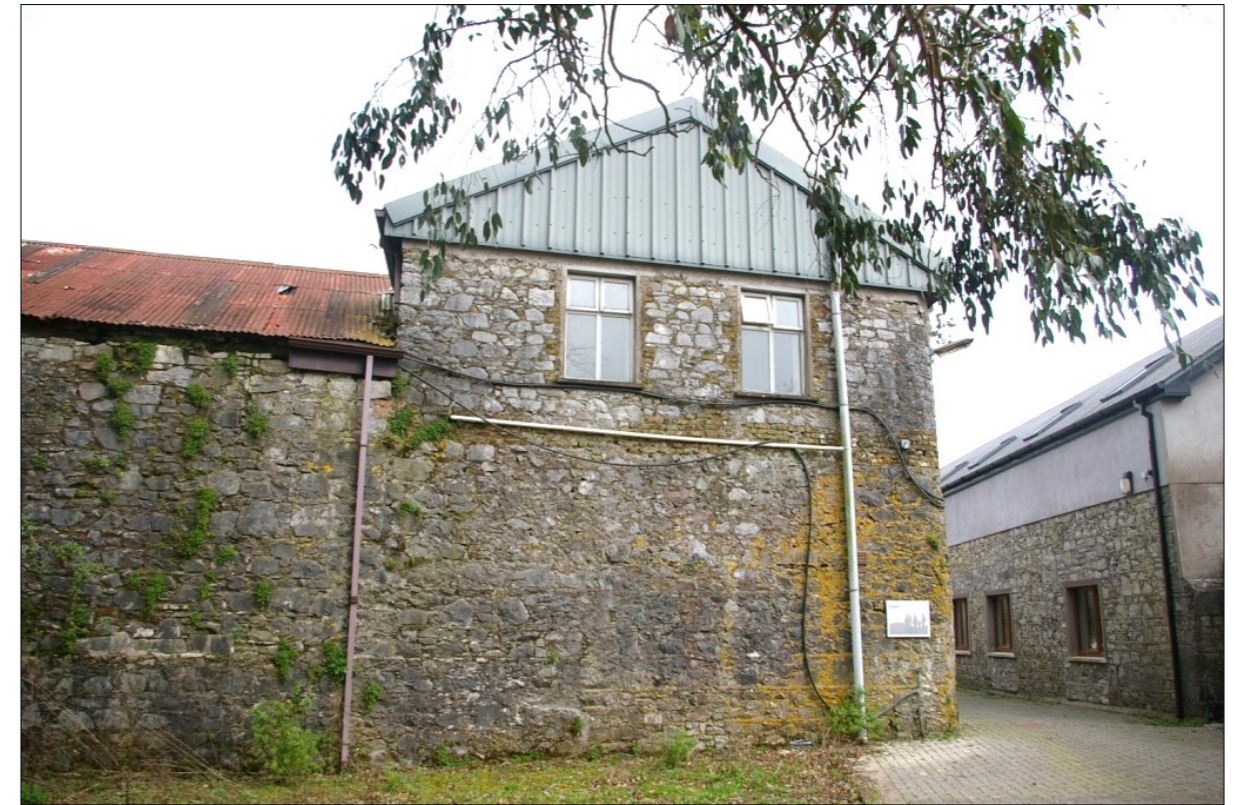
Plate 4: South-western elevation of Building A

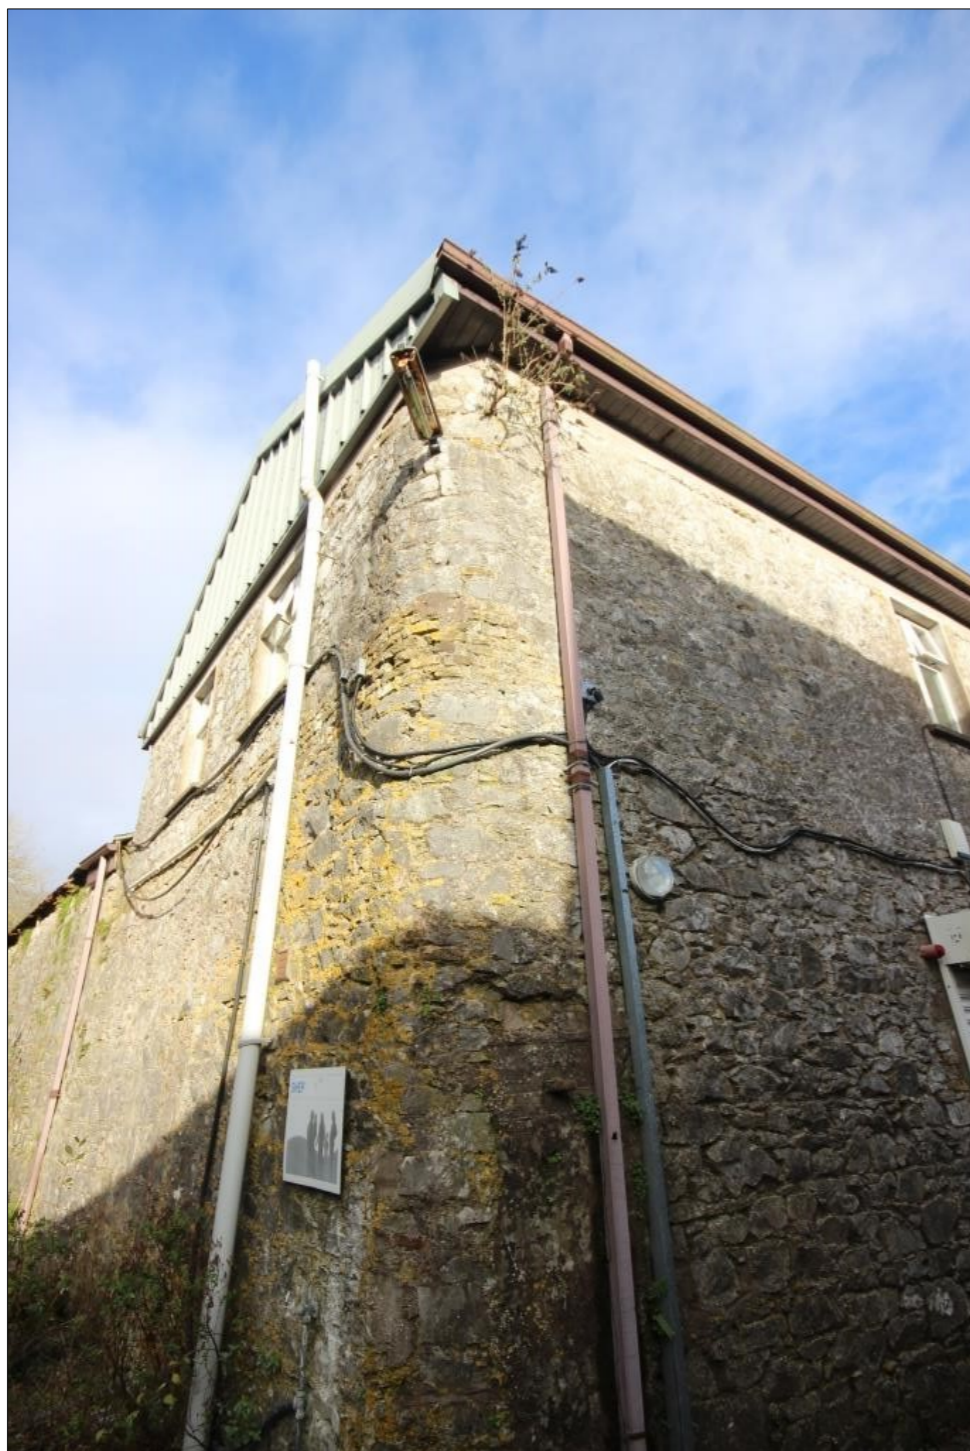
Plate 5: South-eastern corner of Building A

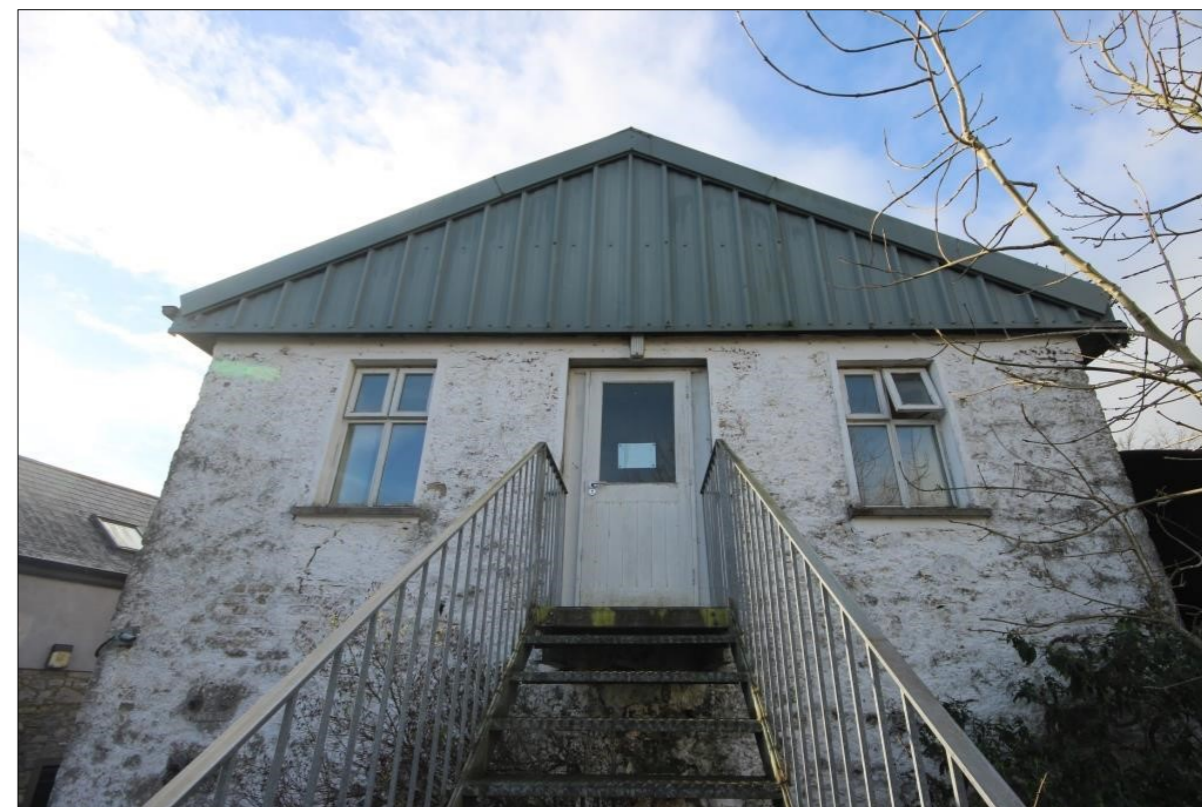
Plate 6: Modern steps to first floor on northeast elevation of Building A

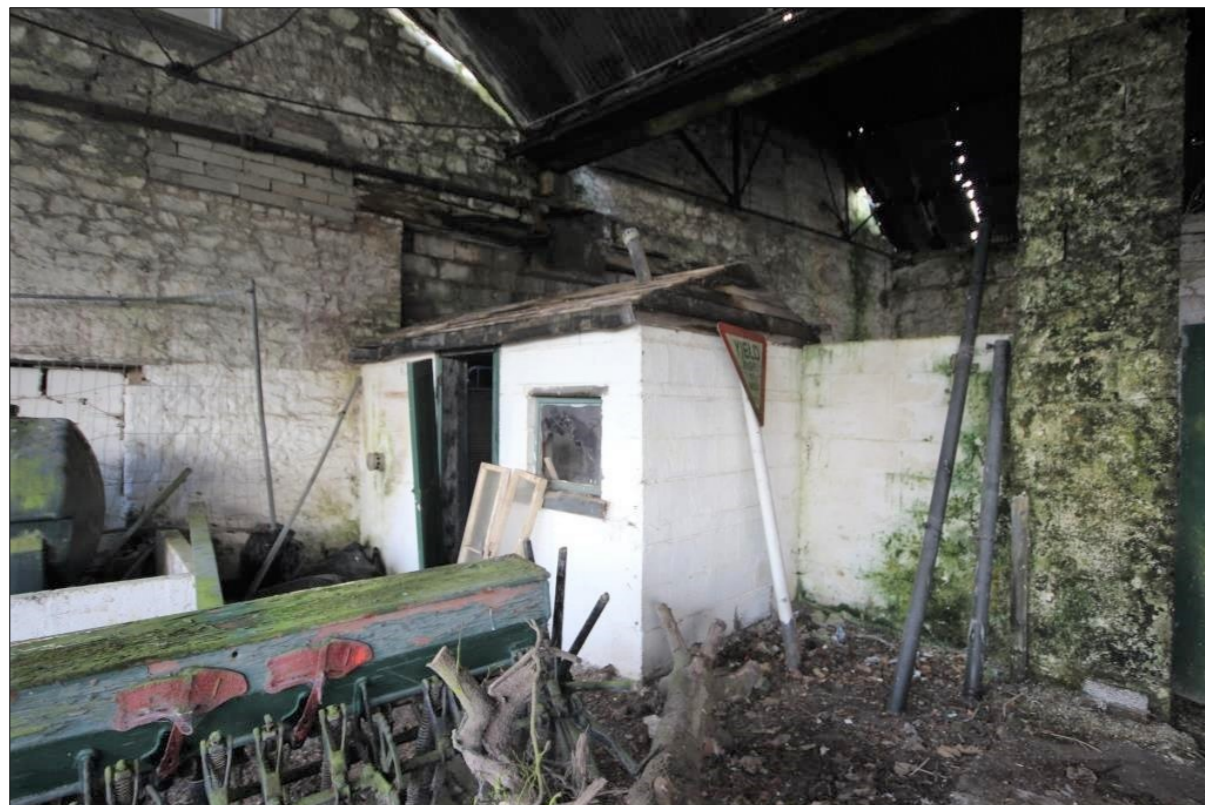
Plate 8: Modern boiler house and north-western elevation of Building A

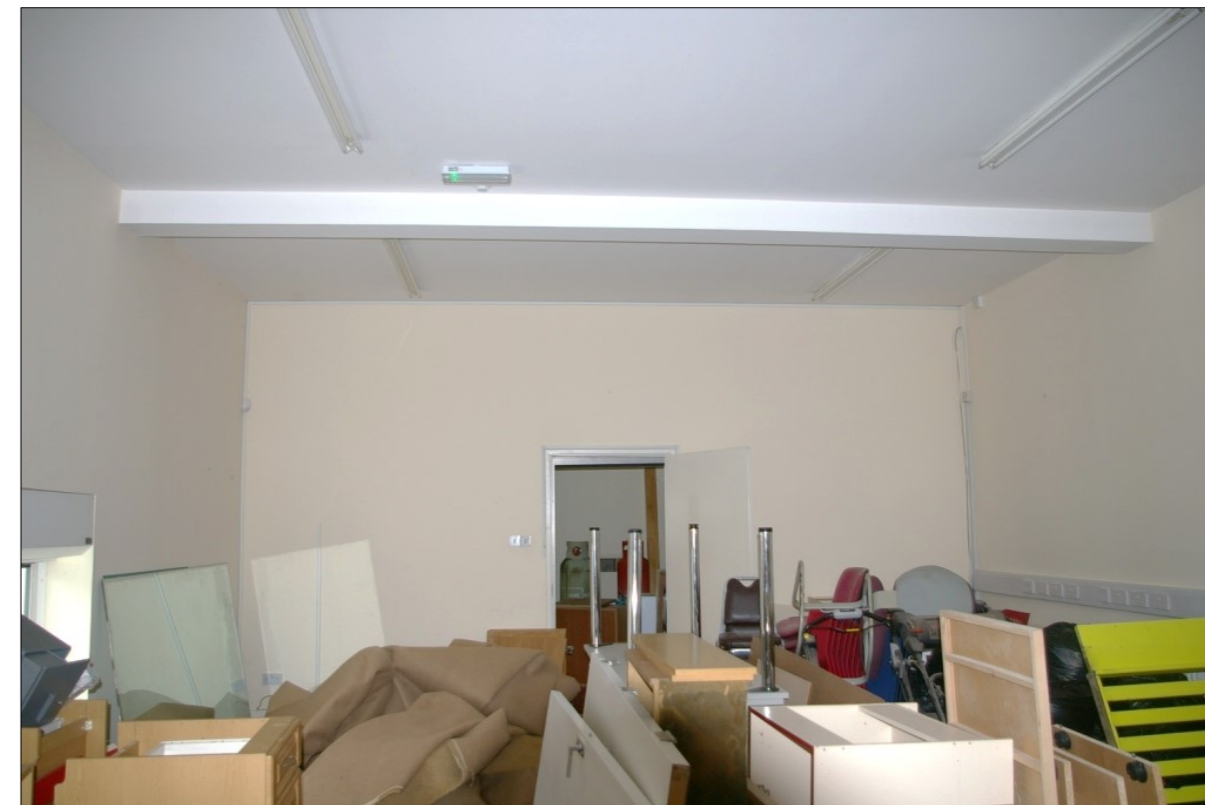
Plate 10: Ground floor room A-GF02 Building A

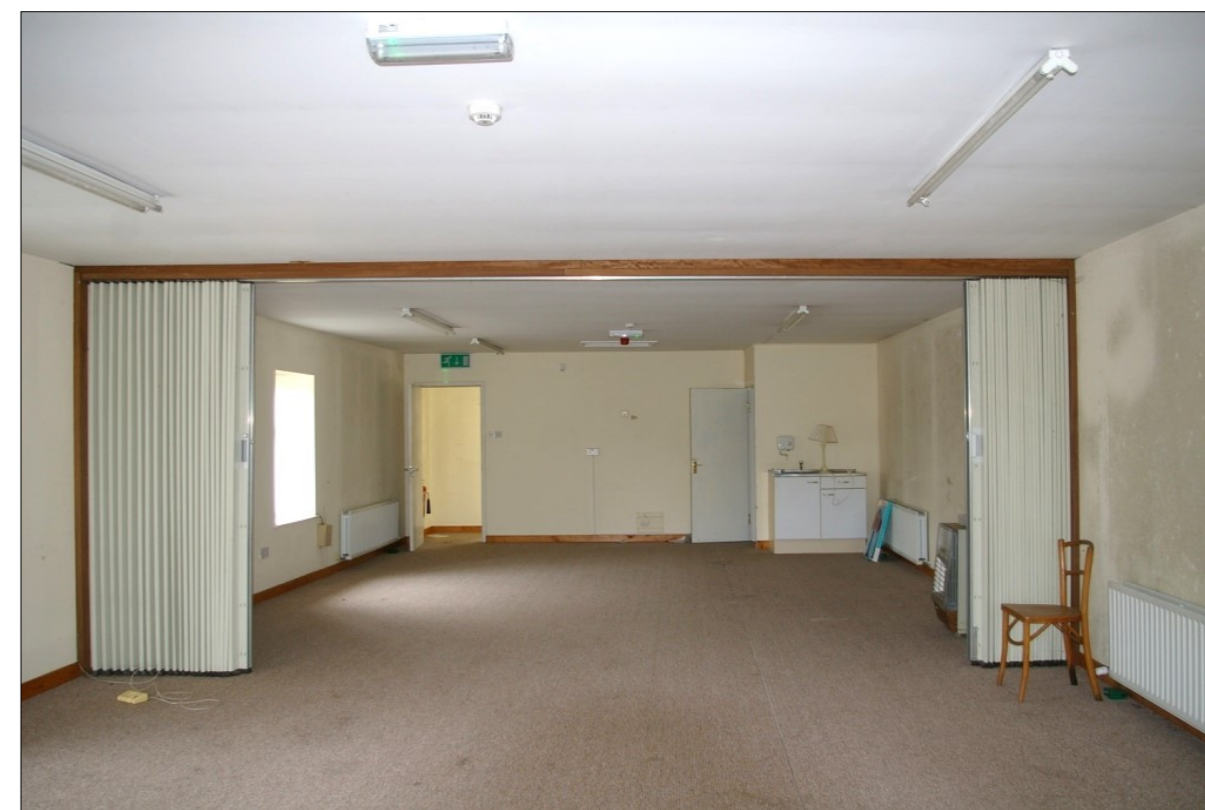
Plate 11: First floor room A-FF01 Building A

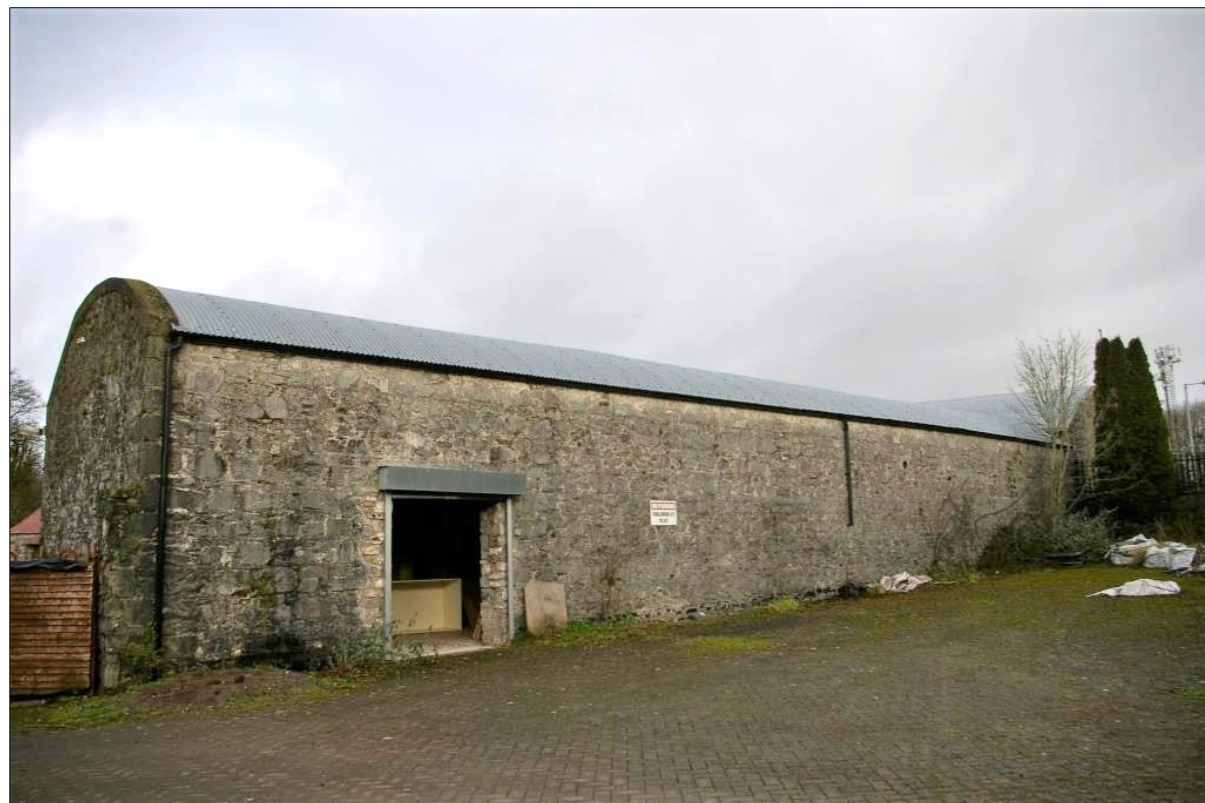
Plate 12: Eastern elevation of Building B

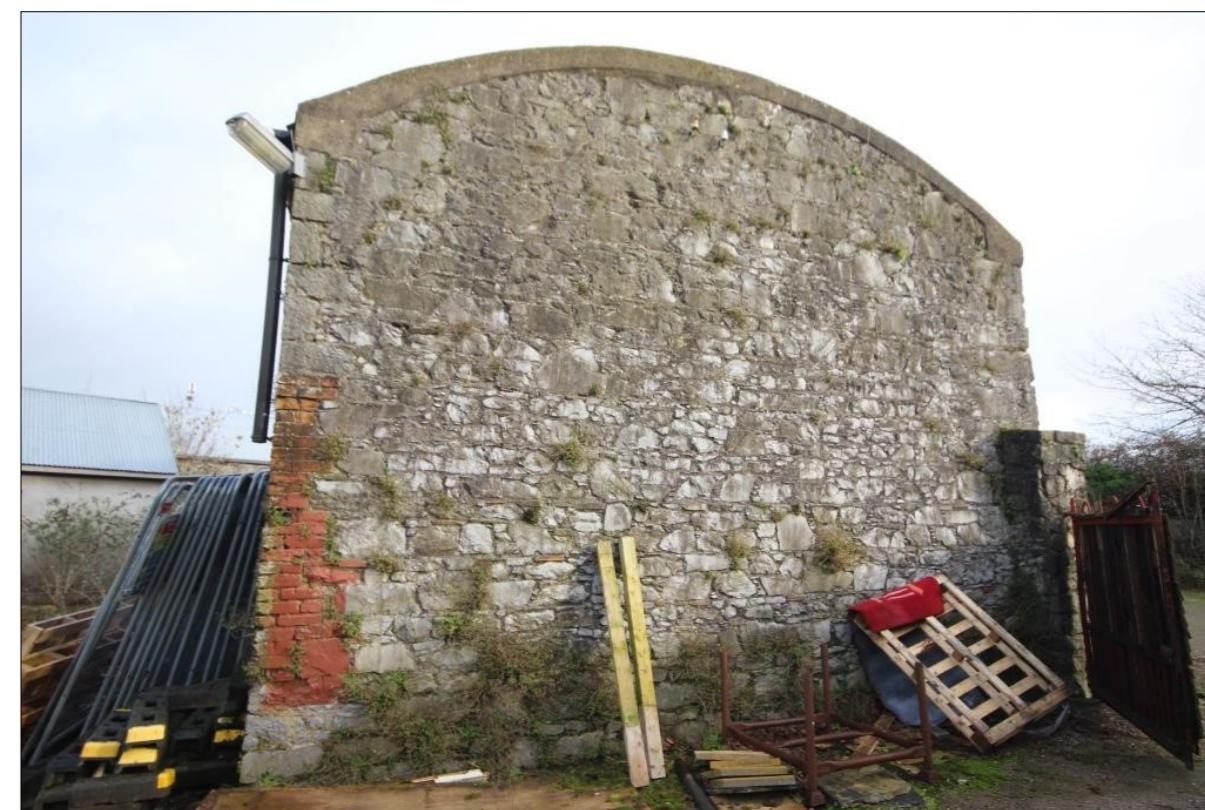
Plate 15: Southern elevation of Building B

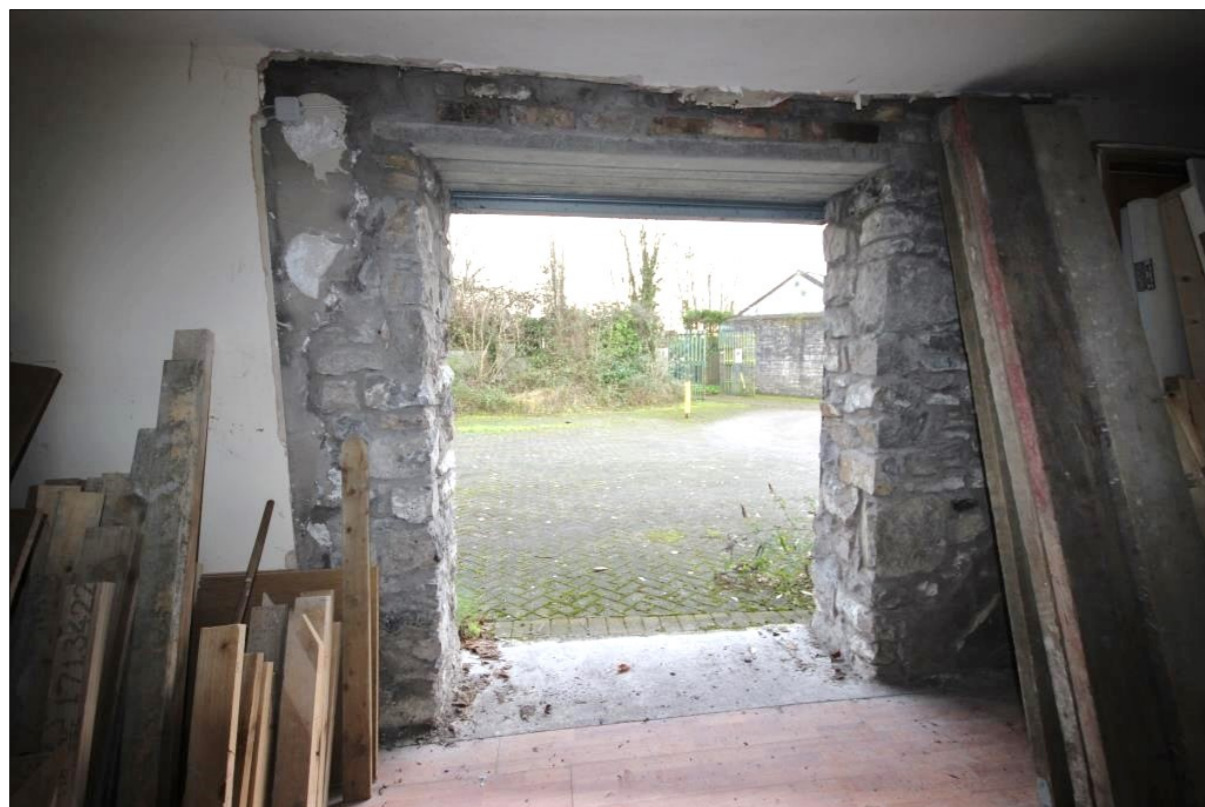
Plate 16: Entrance on eastern elevation of Building B

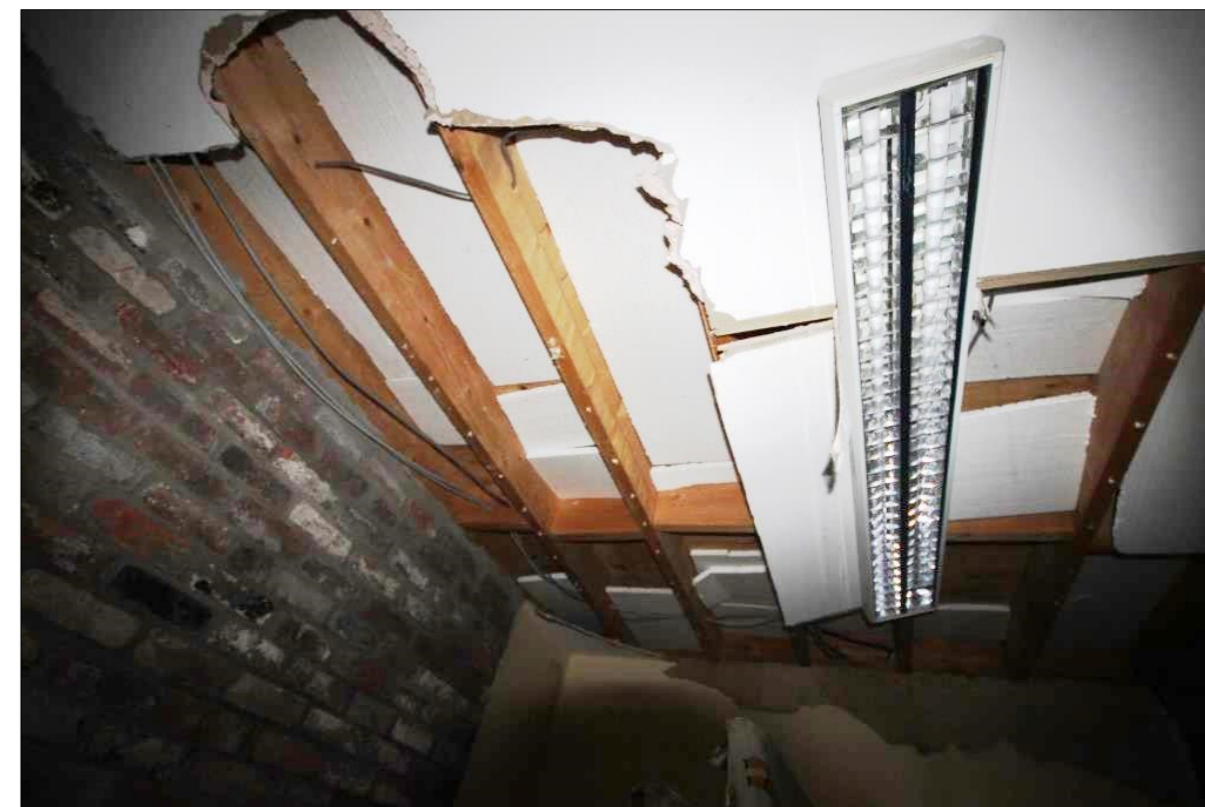
Plate 18: Modern floor joists in Building B

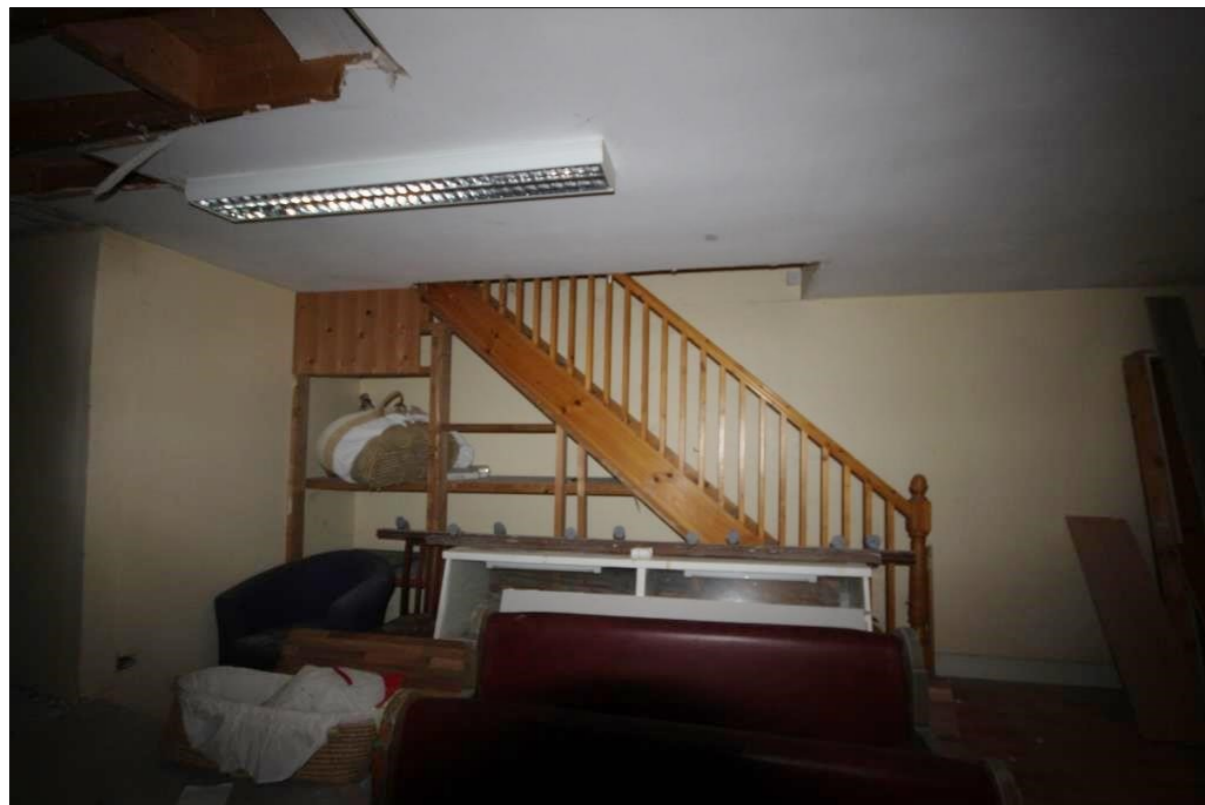
Plate 20: Modern staircase in ground floor room B-GF Building B

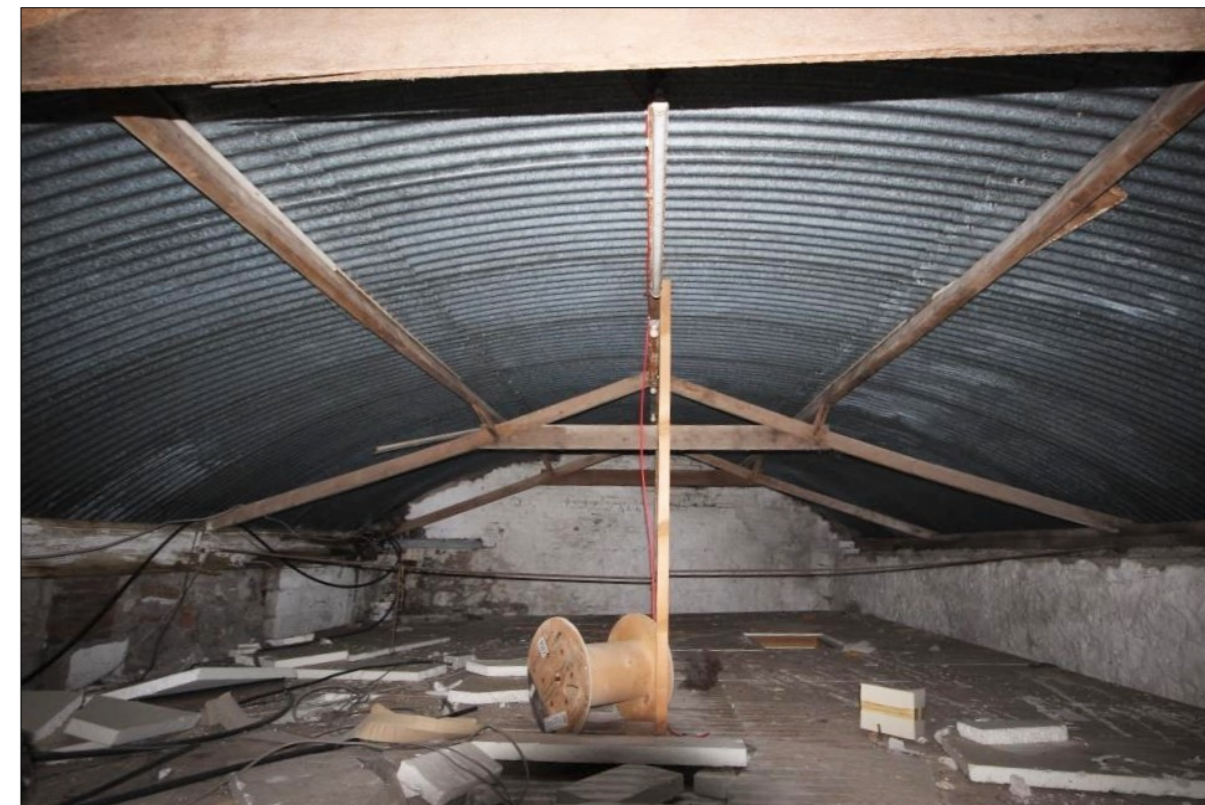
Plate 22: First floor room B-GF Building B

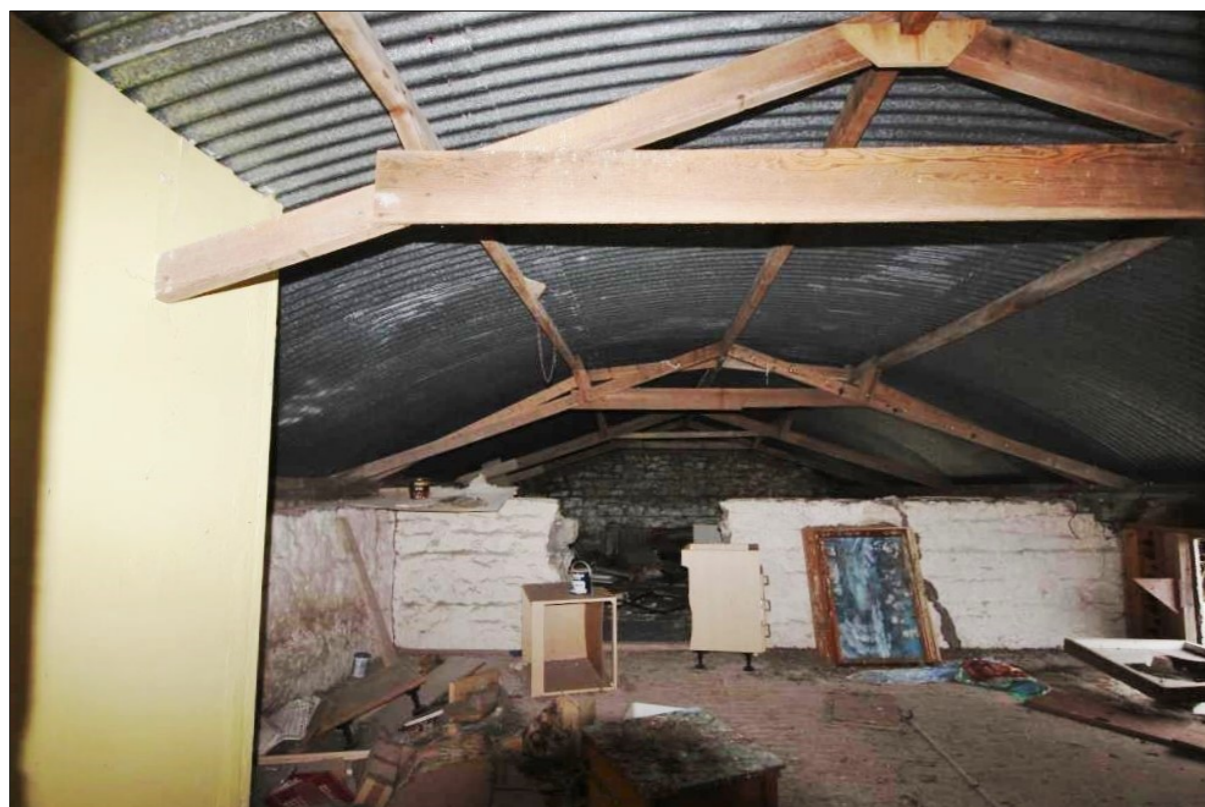
Plate 21: First floor room B-BF Building B

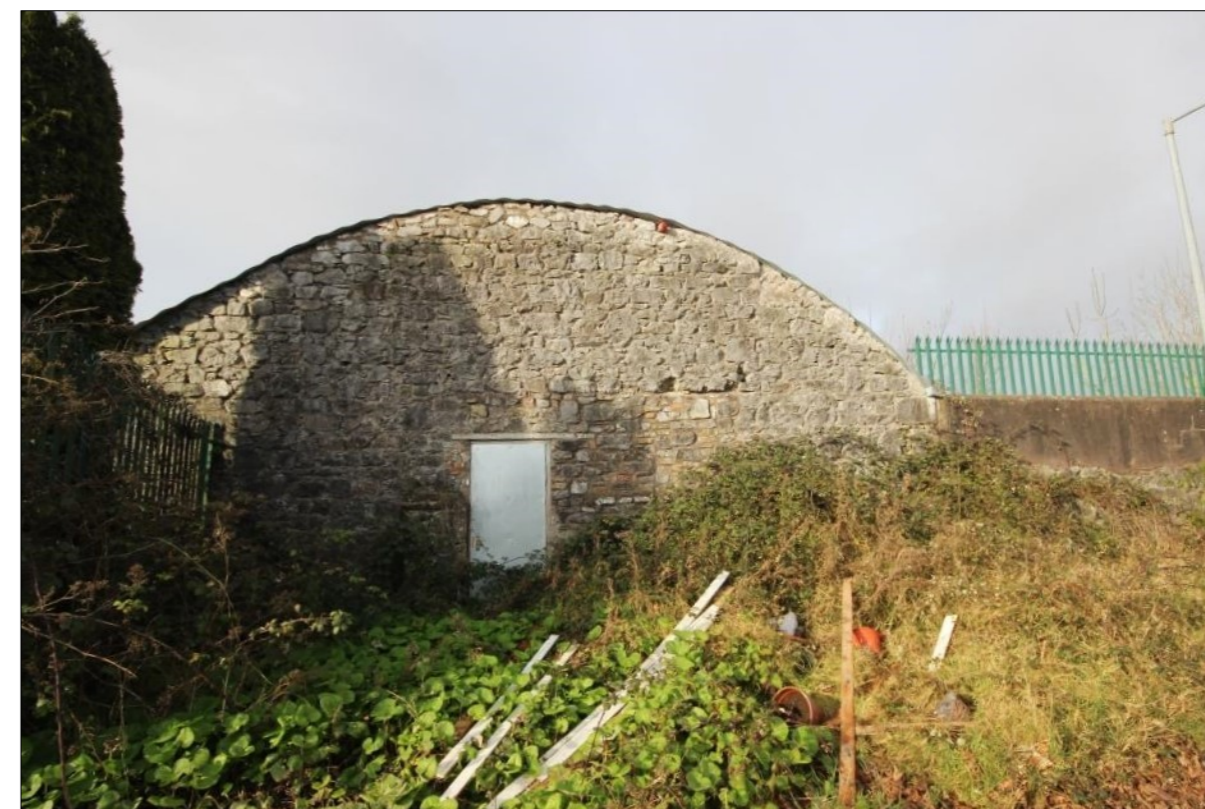
Plate 23: Eastern elevation of Building C

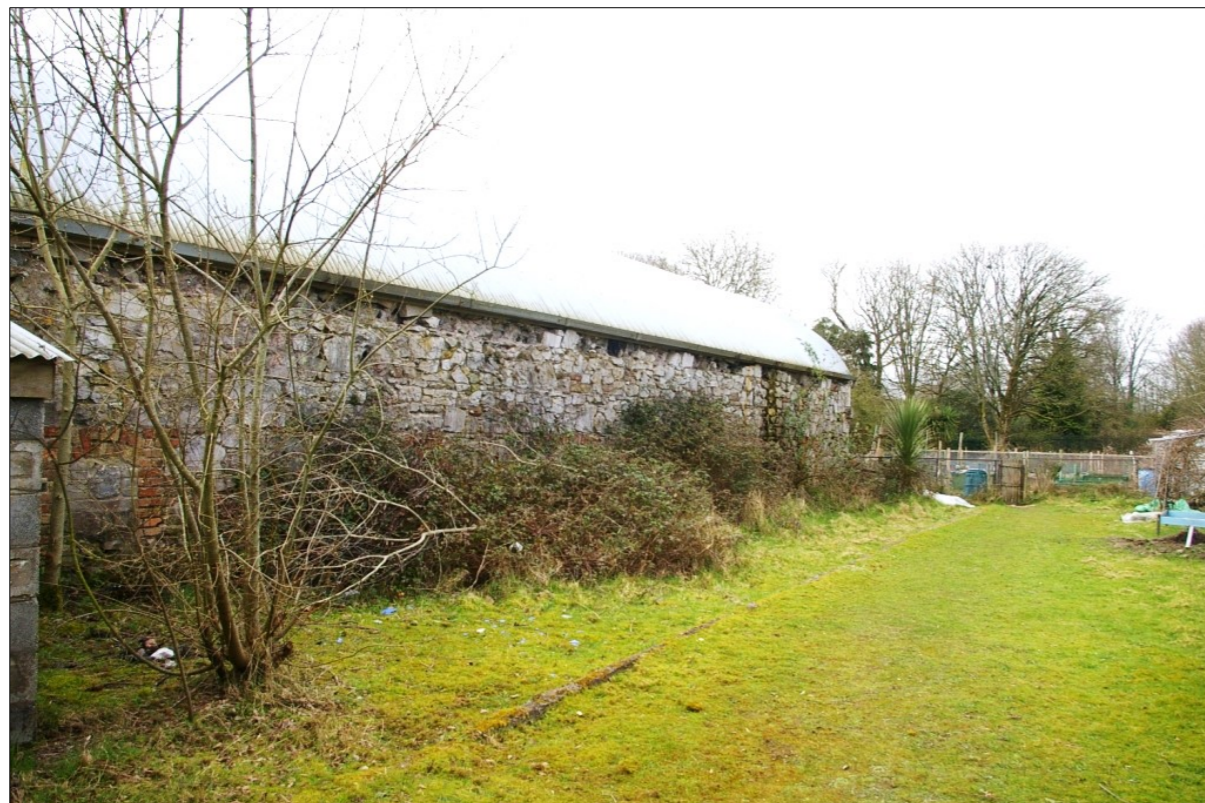
Plate 24: Northern elevation of Building C

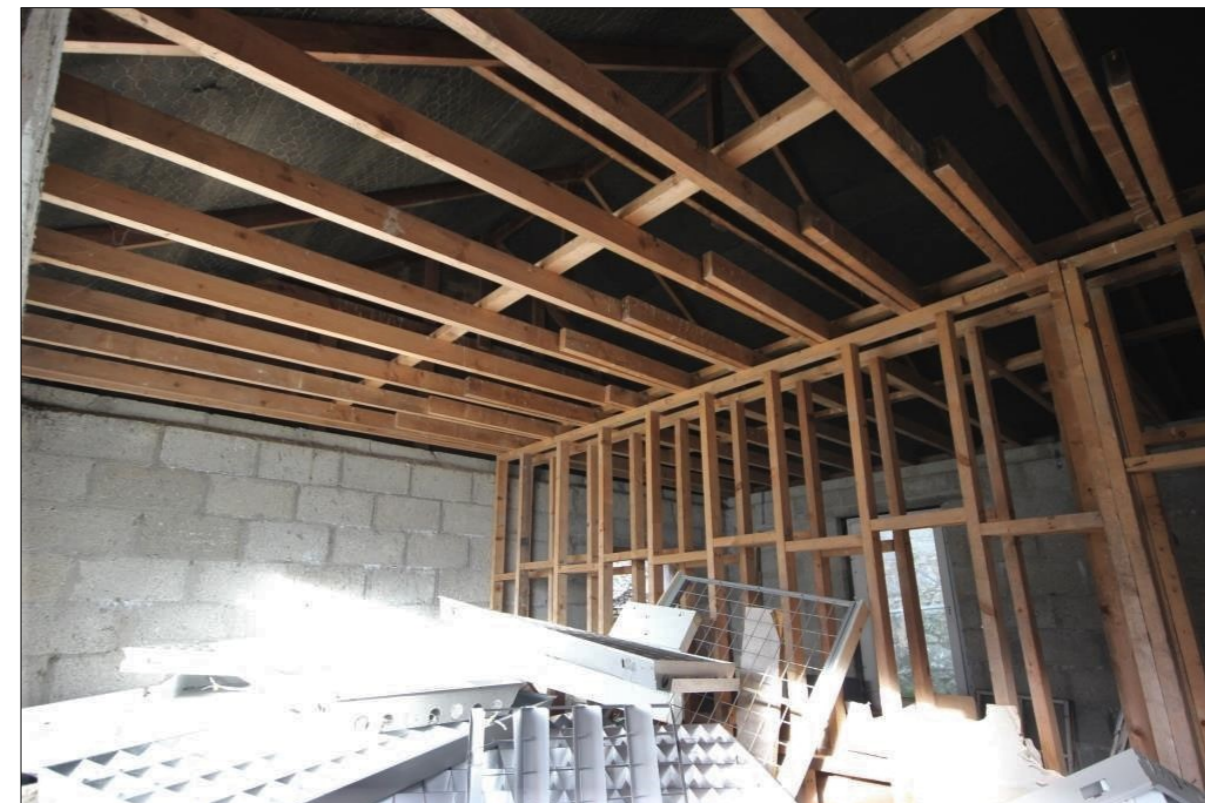
Plate 26: Interior of Building D with modern blockwork and joinery

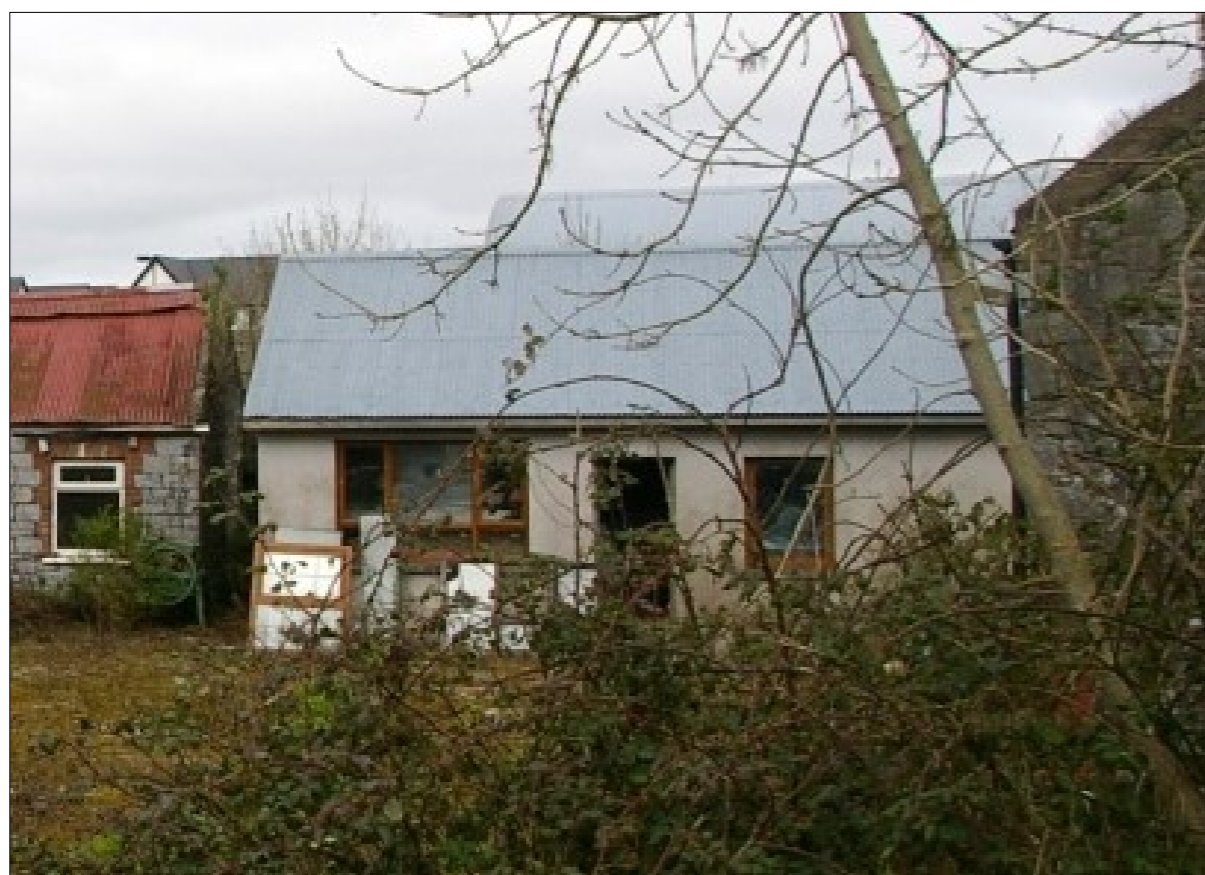
Plate 25: Southern elevation of modern structure Building D

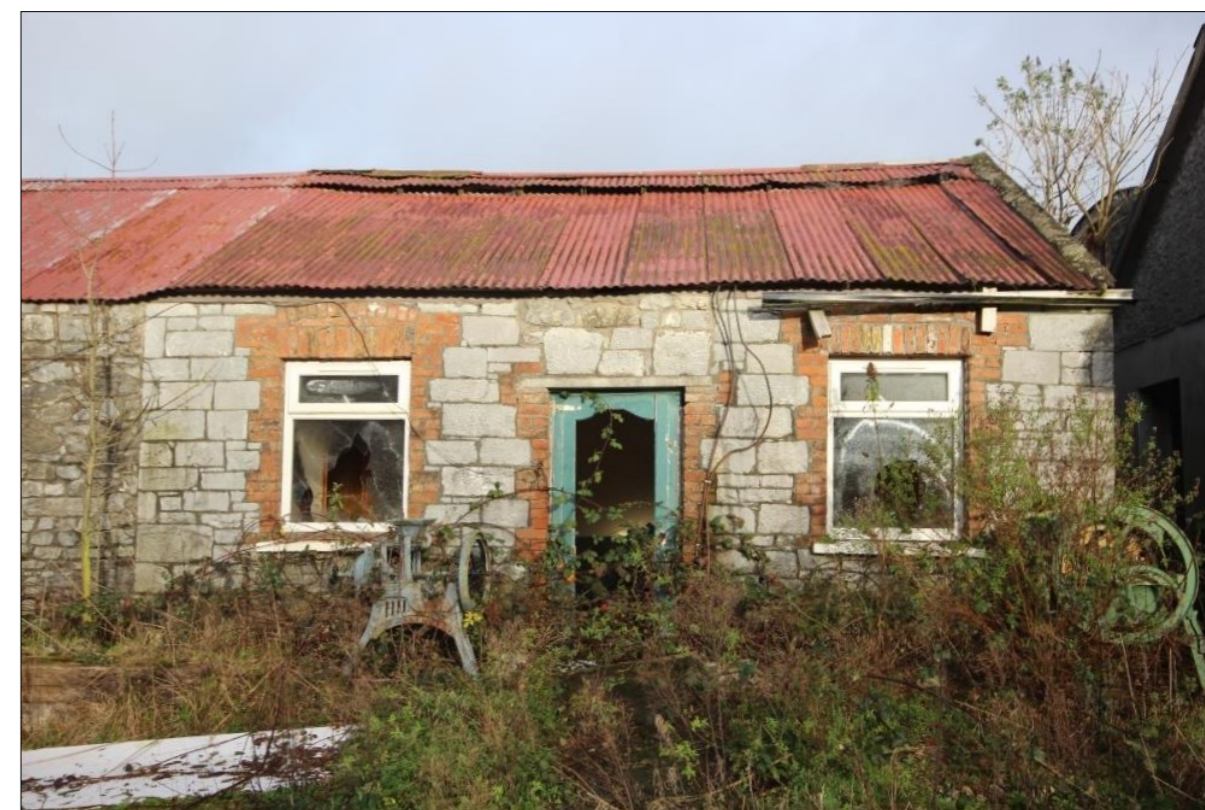
Plate 27: Southern elevation of Building E

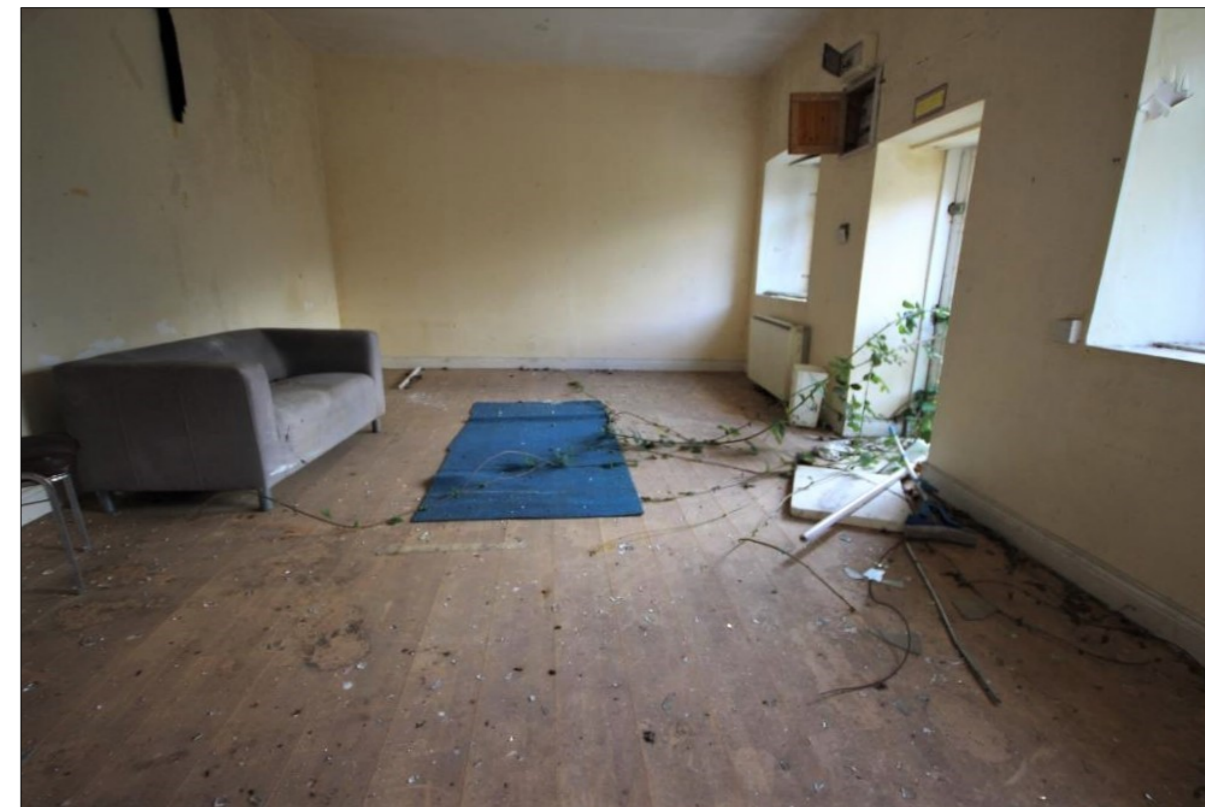
Plate 30: Interior view of Building E with modern floor, ceiling and wall finishes

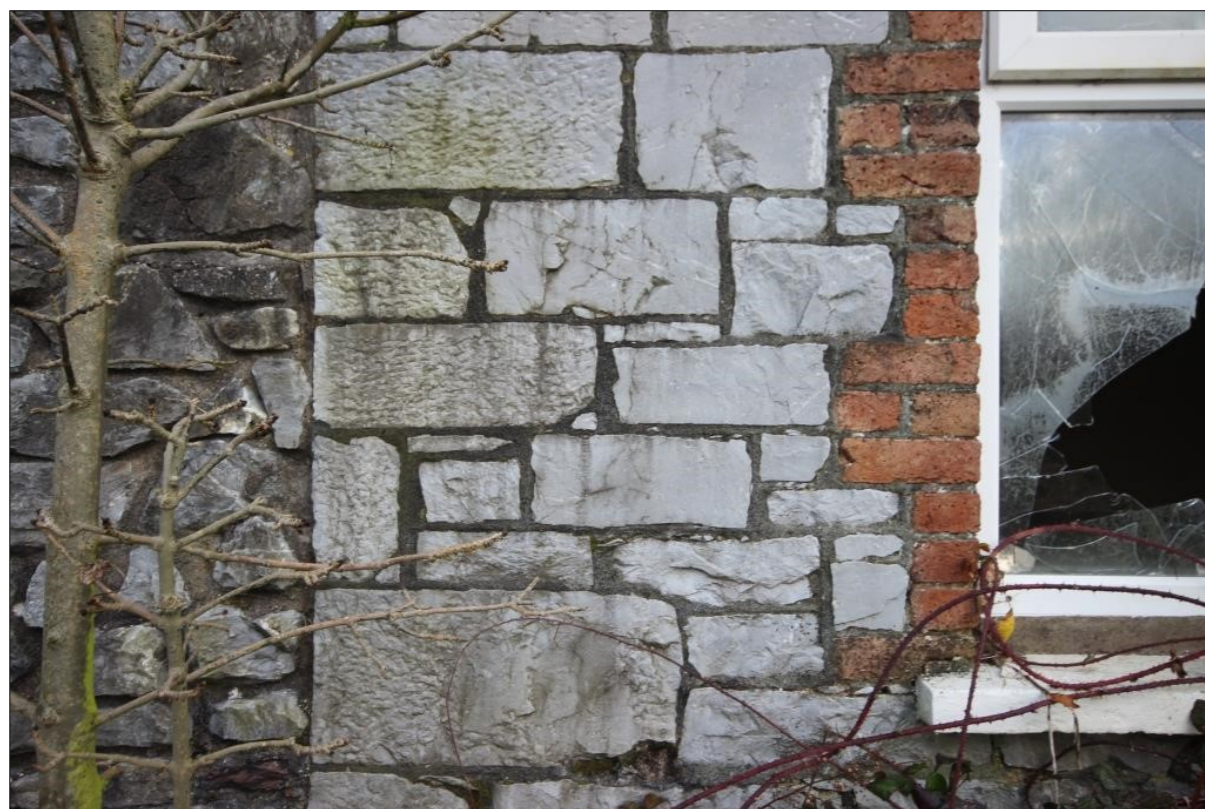
Plate 29: Cut stone detail to wall on southern elevation of Building E
