Historic Building Record
The Farm, Bessboro, Ballinure, Blackrock, Cork City

Prepared by
John Cronin BA MRUP MUBC
John Cronin & Associates
3a Westpoint Trade Centre
Ballincollig
County Cork

February 2022

1. Introduction

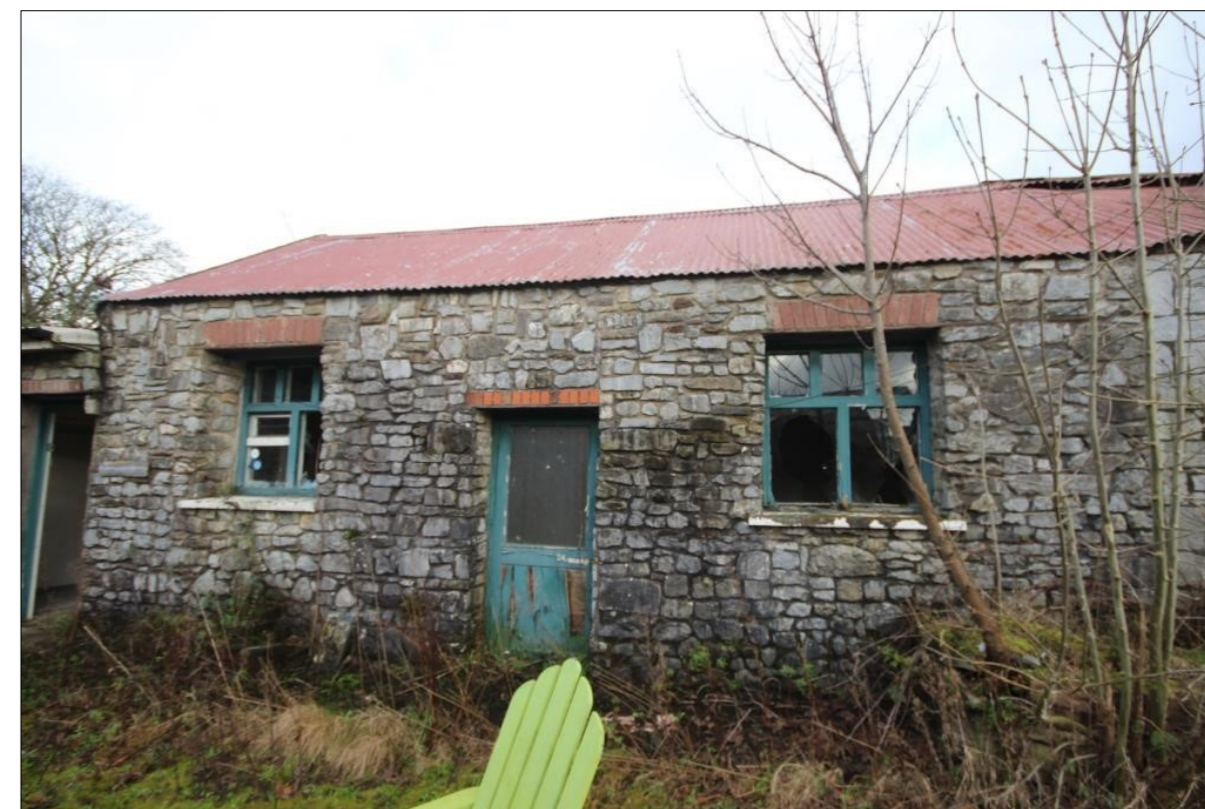
Plate 31: Southern elevation of Building F

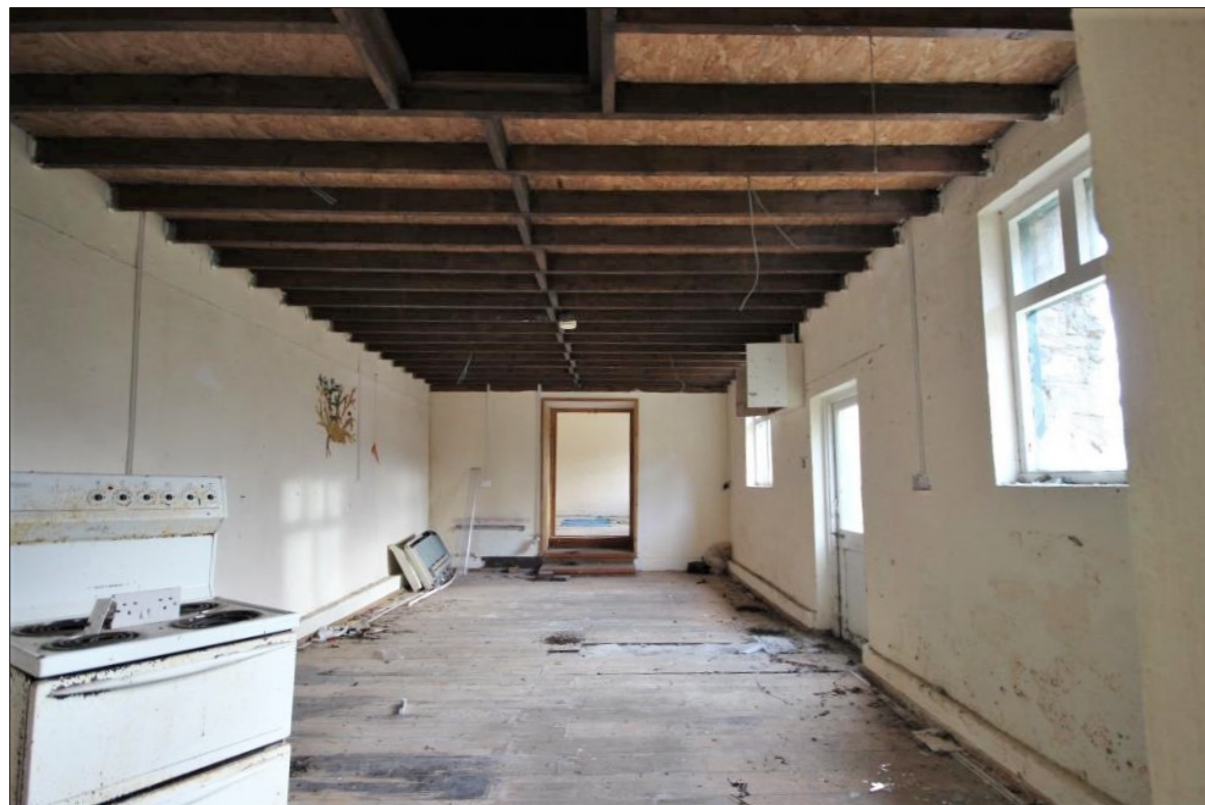
Plate 32: Interior of Building F with modern floor, ceiling and wall finishes

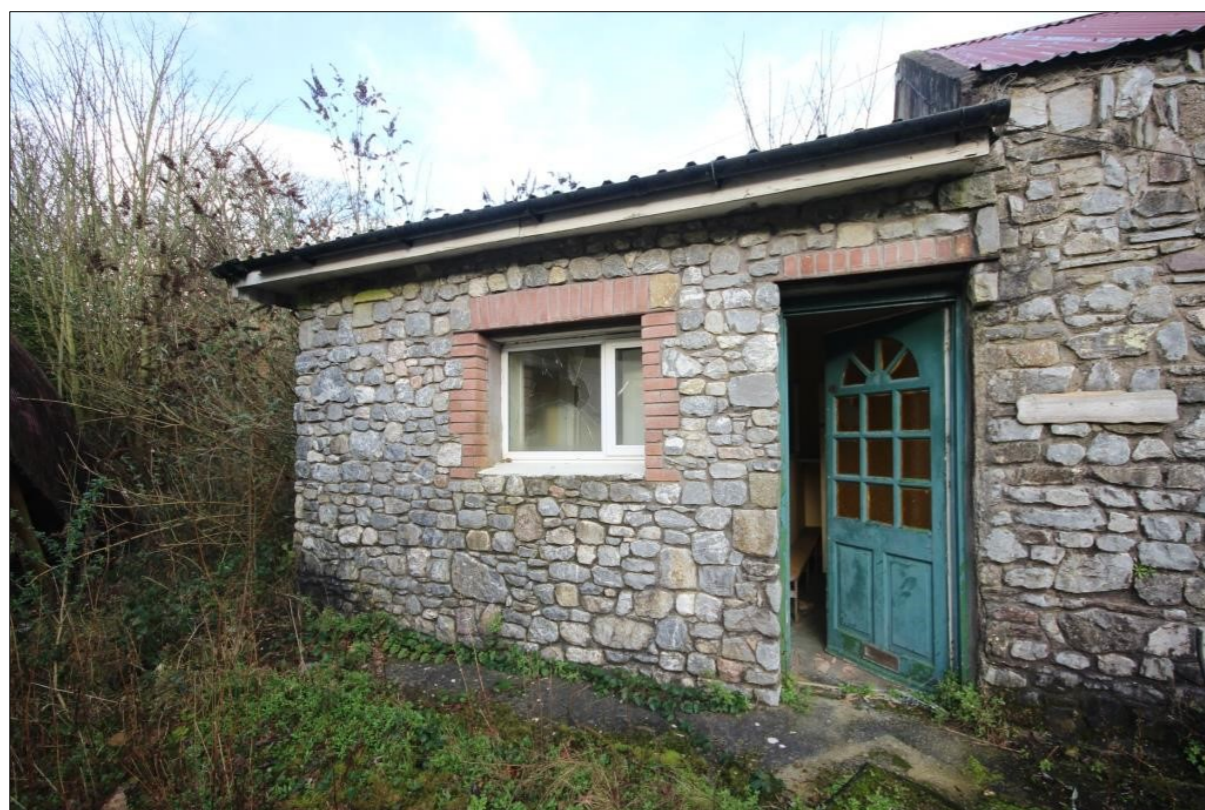
Plate 33: Southern elevation of Building G

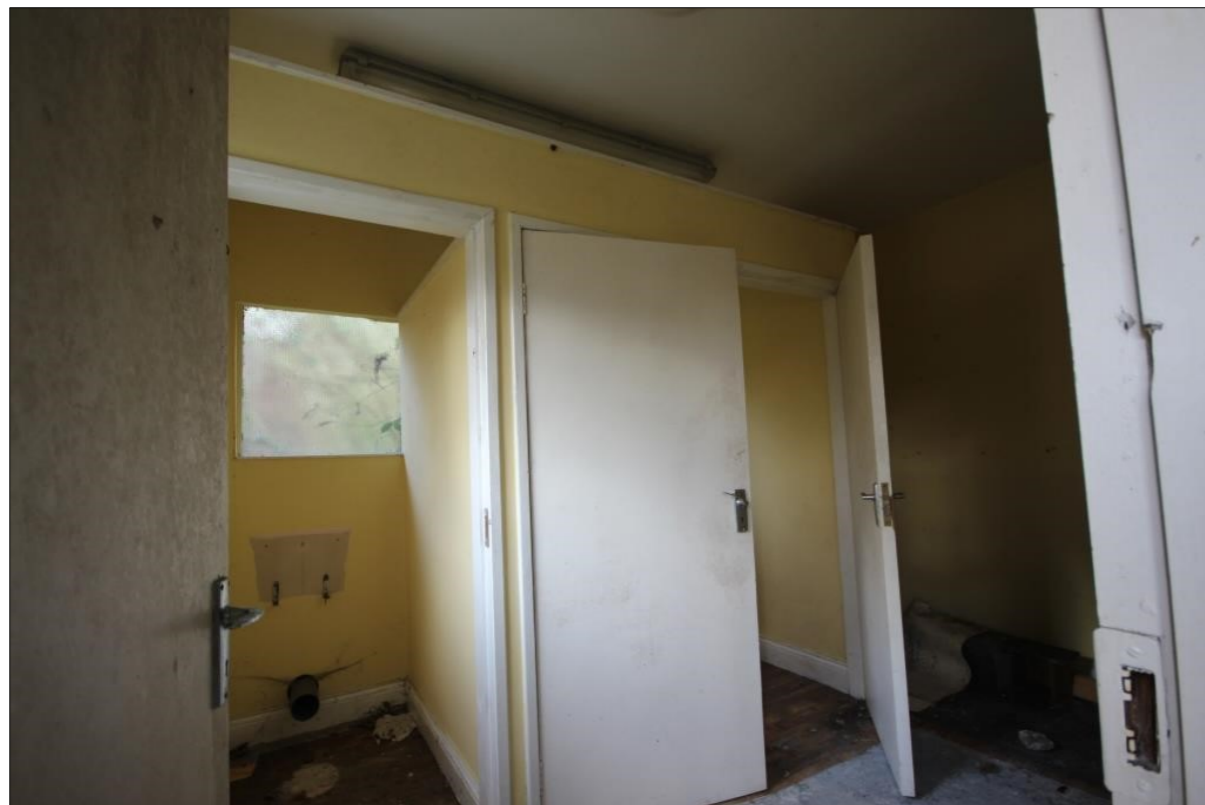
Plate 35: Interior of Building G with modern finishes

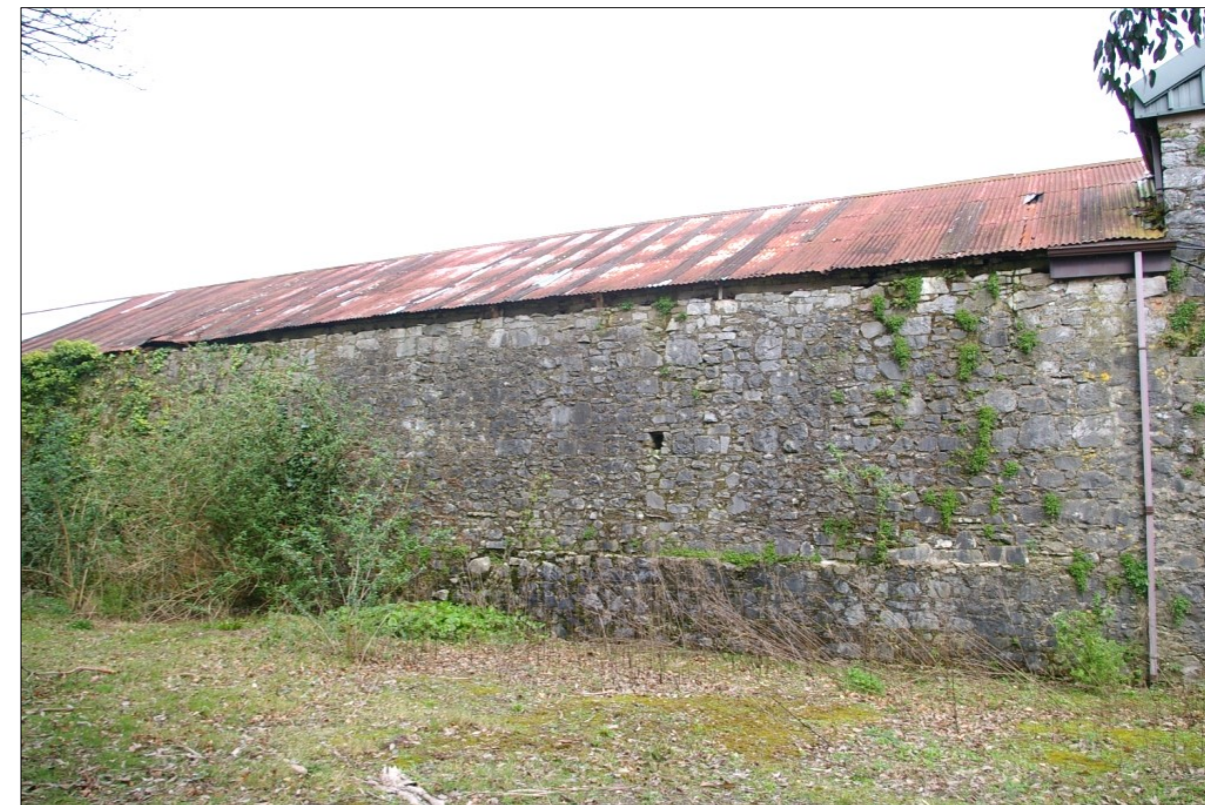
A late nineteenth-century, double height stone-built former barn, open to eastern elevation. It is sub-divided into two sections with a replacement pitched metal profile roof to western section and a badly damaged barrel corrugated roof to eastern section. The western wall is of exposed rubble stone and extends to the north forming part of the western boundary wall. Some sections have two courses of brickwork at the eaves level.

Plate 37: Western elevation of Building H

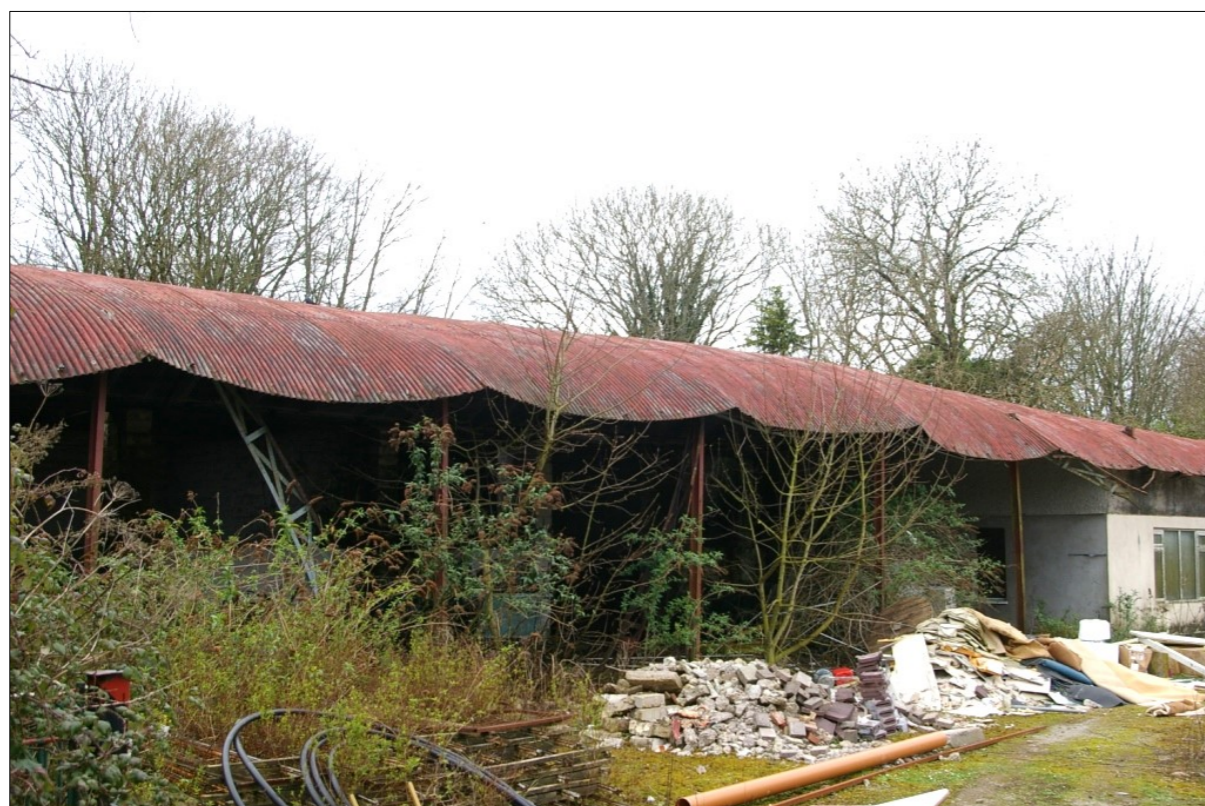
Plate 36: Eastern elevation of Building H

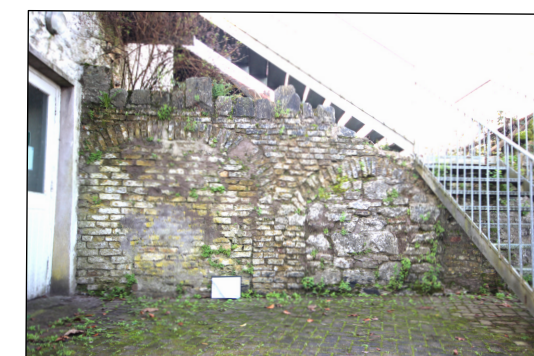
South-eastern elevation of three original blocked-up arched openings under stairs

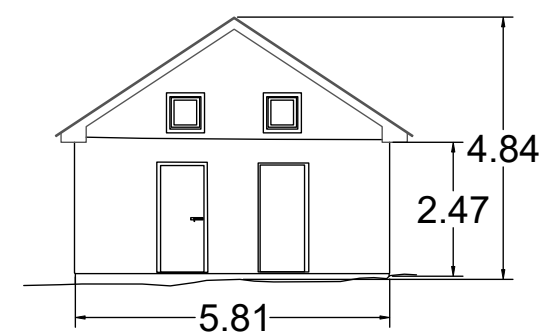
Corrugated pitched
metal roof

uPVC windows and door

Concrete blockwork walls
with cement render
