**Gortyrahilly, Inchamore and
Cummeennabuddoge (CMBG) Wind Farms**

Civil & Structural Due Diligence Report

October 2020

Document Number: Project No. 201164-R0

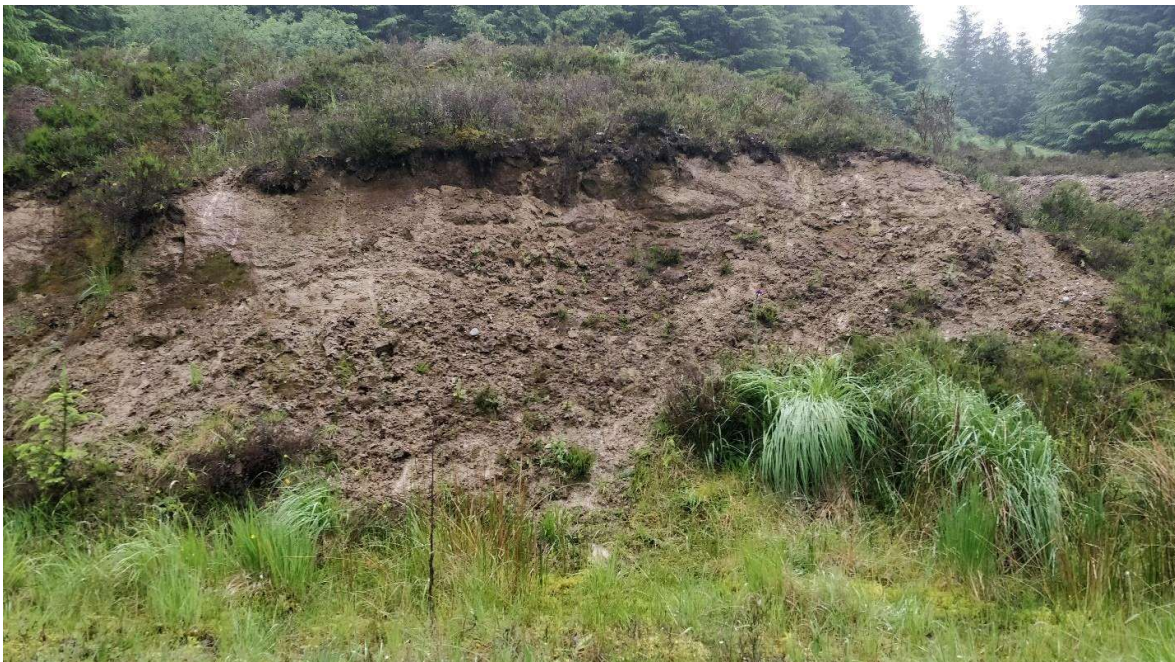
Between waypoints J and K, the existing track levels out vertically with the cross slope falling south to north as observed, with the track typically being cut with near-vertical edges into the southern side of the track, and occasionally on both sides of the track. Some deeper sections of cut were observed to have exposed peat overlying till consisting of a cohesive material with sand and gravel content. Several locations were observed to have been subjected to erosion with shallow slips evident as shown in Figure 6-4 to Figure 6-7 inclusive with approximate ITM coordinates provided for each location. As described in Section 5.2, historic landslide events were also identified on the GSI online mapping portal in the River Clydagh valley. As such, there is a risk associated with potential landslides along route C should this option be progressed to construction. This risk could be managed by felling trees where necessary and cutting the adjacent slopes to a suitable gradient of 1V:2H or shallower. Some alternative routes are proposed along route C between waypoints G and K which typically pass through steeper areas which would require tree felling to permit the installation of the cables.

Figure 6-5: Exposed overburden cut with evidence of erosion/shallow slips (ITM 516203E,582876N)

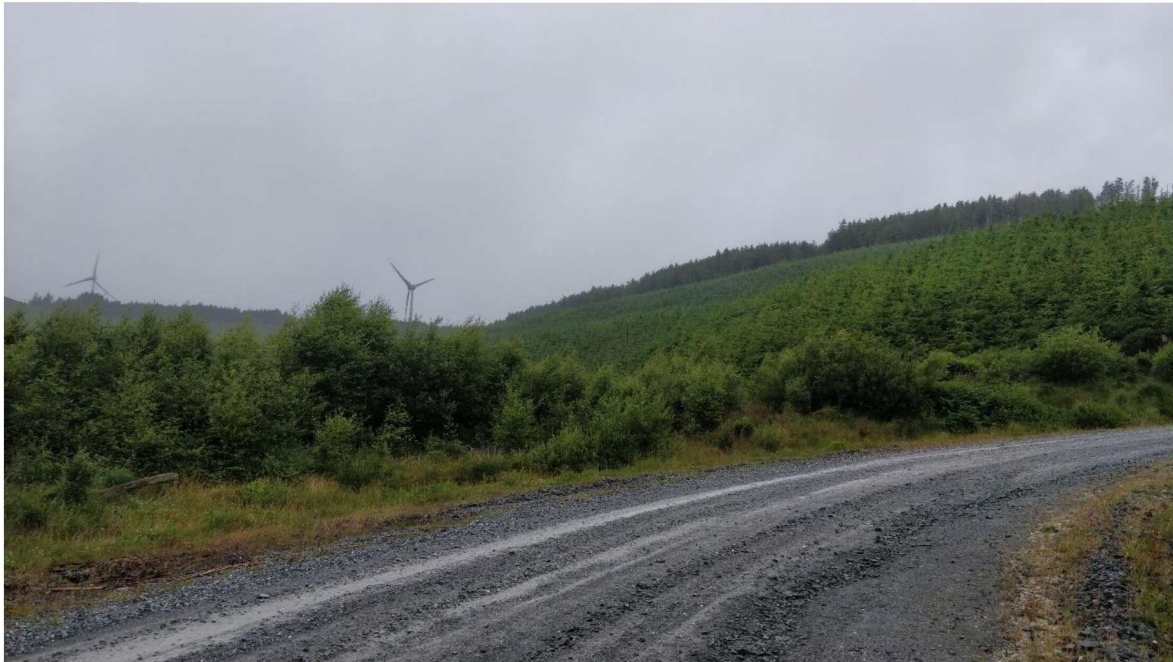
Figure 6-8: The view of waypoints L-K from the east

The alternative route between waypoints K and L passes to the south of the existing Caherdowney and Curragh wind farms through an area of forestry on a relatively steep slope. A view of the slope is shown in Figure 6-8. Beyond this steep forested slope, the route traverses open grassland down to Ballyvouskill Substation (waypoints L-M-substation). This final stretch of the proposed route is located along a cross slope falling from north to south. Another alternative route to waypoints L-M-substation is proposed along an existing access track to the existing windfarms before traversing southwest to the local road before connecting to the Ballyvouskill substation.

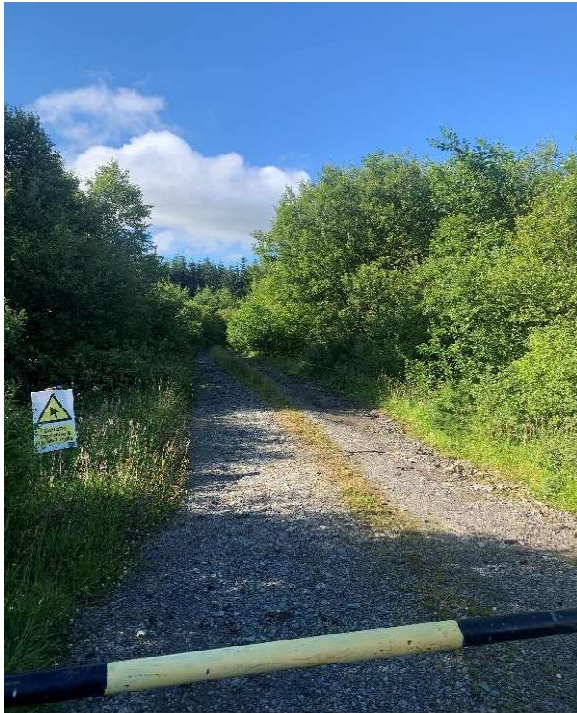
Image : 1
Coillte forestry Track

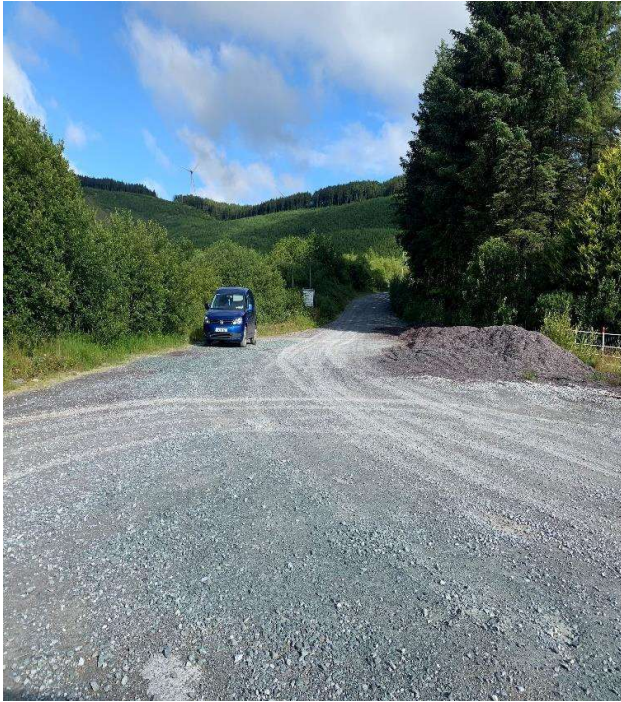
Image : 5
Entrance to existing windfarms

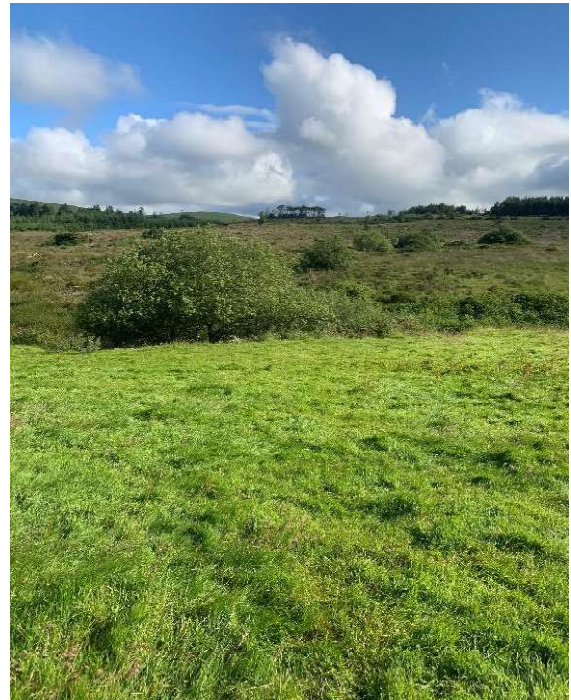
Image : 10
Private land crossing river into Coillte owned property

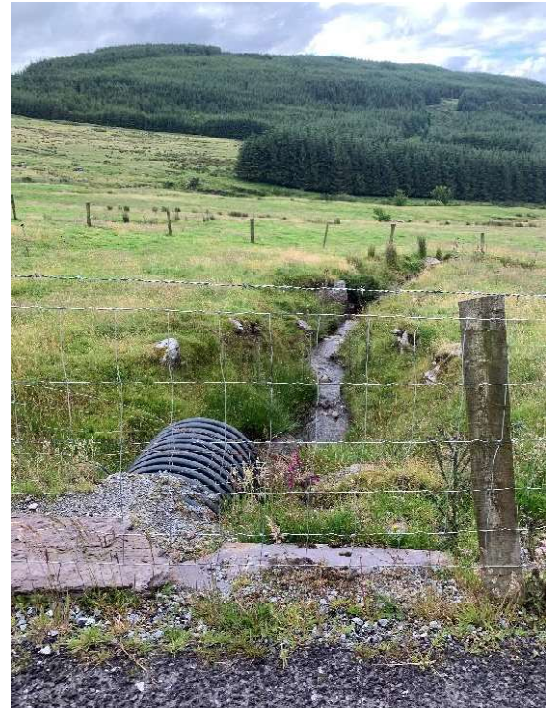
Image : 20
Storm water pipe crossing under road at this location

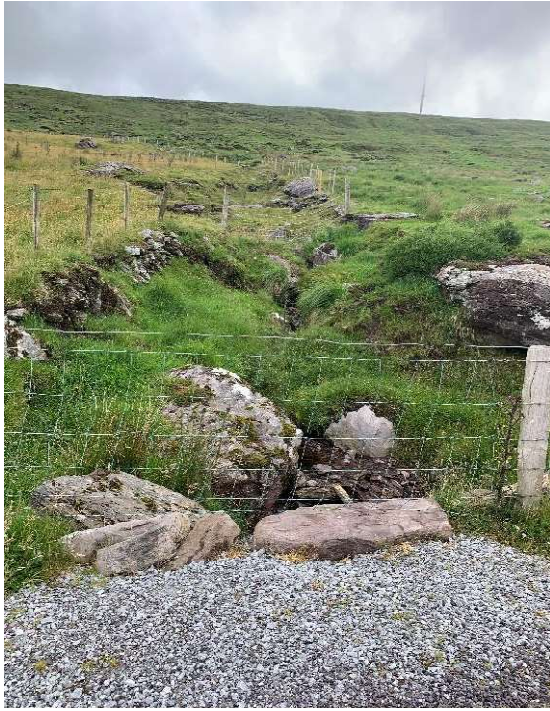
Image : 21
Storm water pipe crossing under road at this location

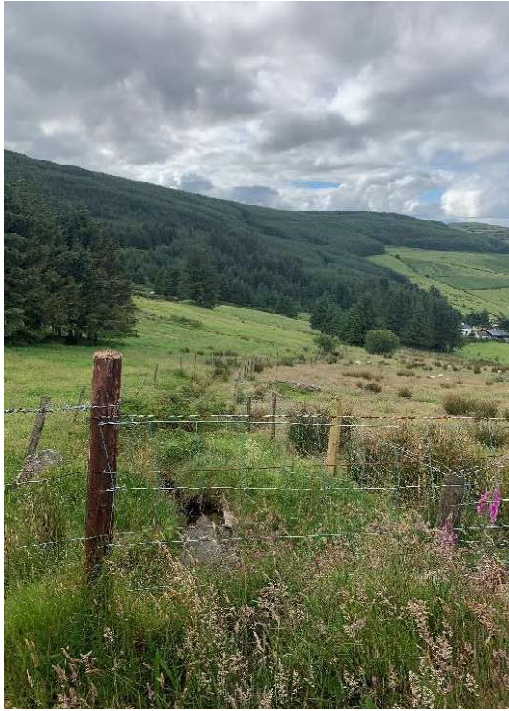
Image : 23
Storm water pipe crossing under road at this location

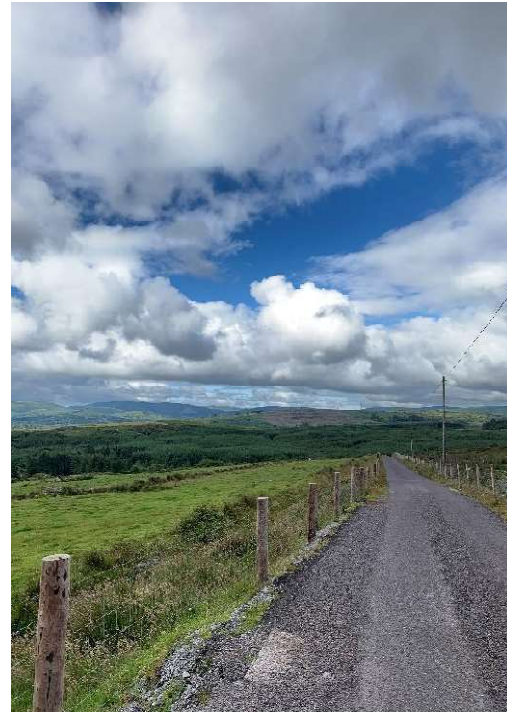
Image : 28
Joint bay on the road here with a links box and communications chambers visible.

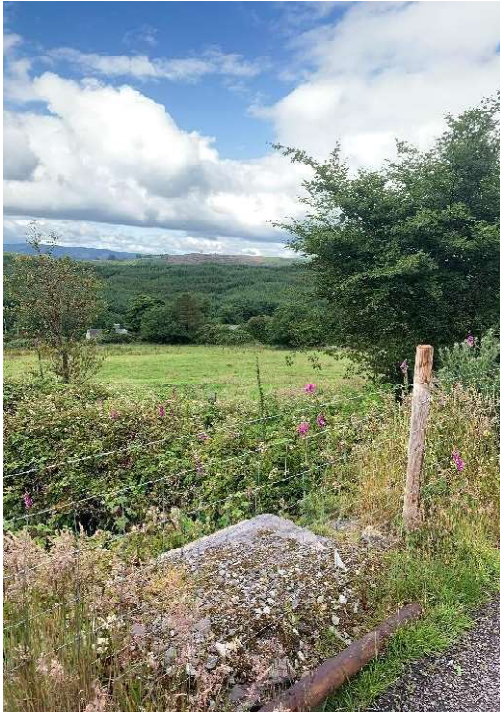
Image : 29
Storm water pipe crossing under road at this location

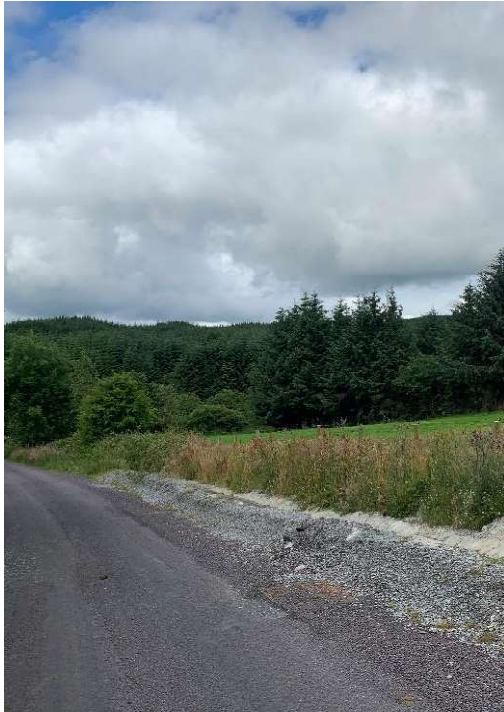
Image : 31
Joint bay on the road here with a links box and communications chambers visible

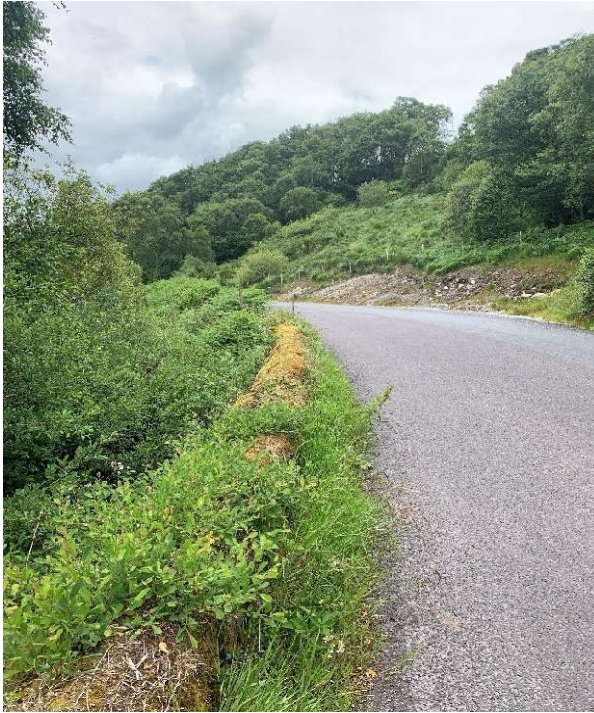
Main risks are the existing cables in the road as highlighted in images 52 to 54 and will only work if there is a substation built in Inchamore to take the cable before eventually going to Ballyvouskill substation through the Coillte lands.

Image : 52
Joint bay on the RHS of the road at this location
with a links box and communications chambers
visible.

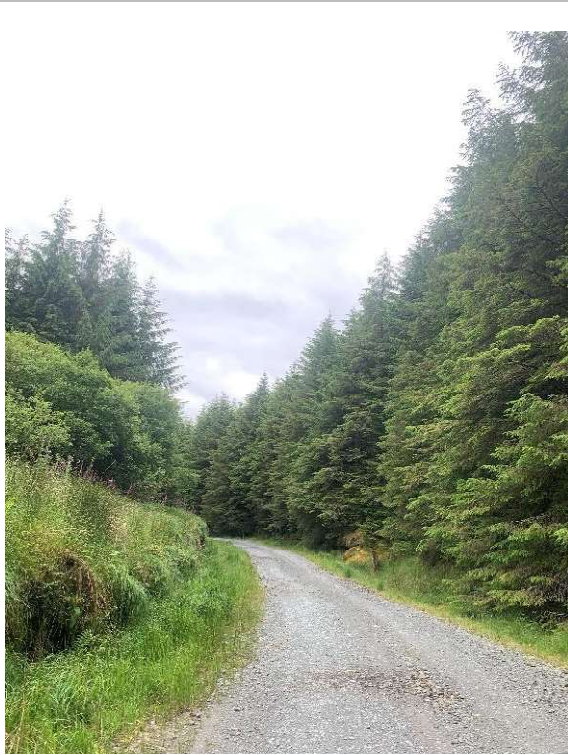
Image : 73
Forestry track on Coillte lands very step and heavily rutted

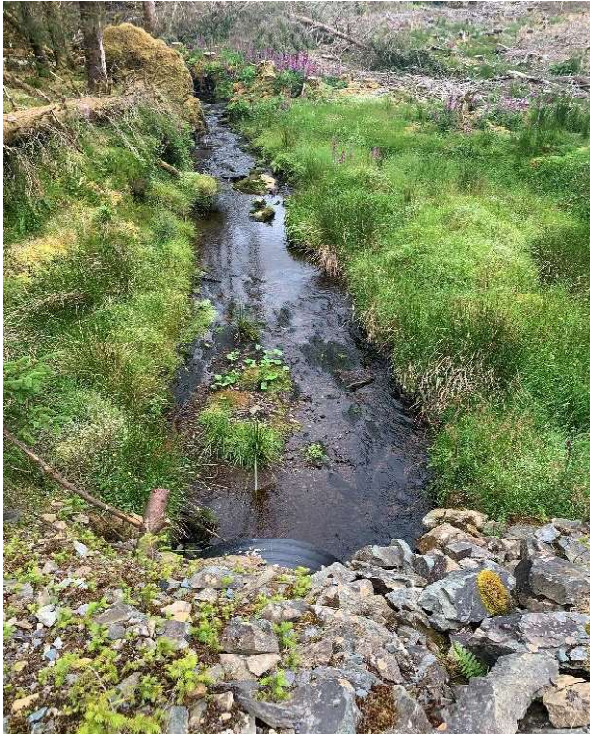
Image : 81
Twin wall UPVC storm pipe crossing under road

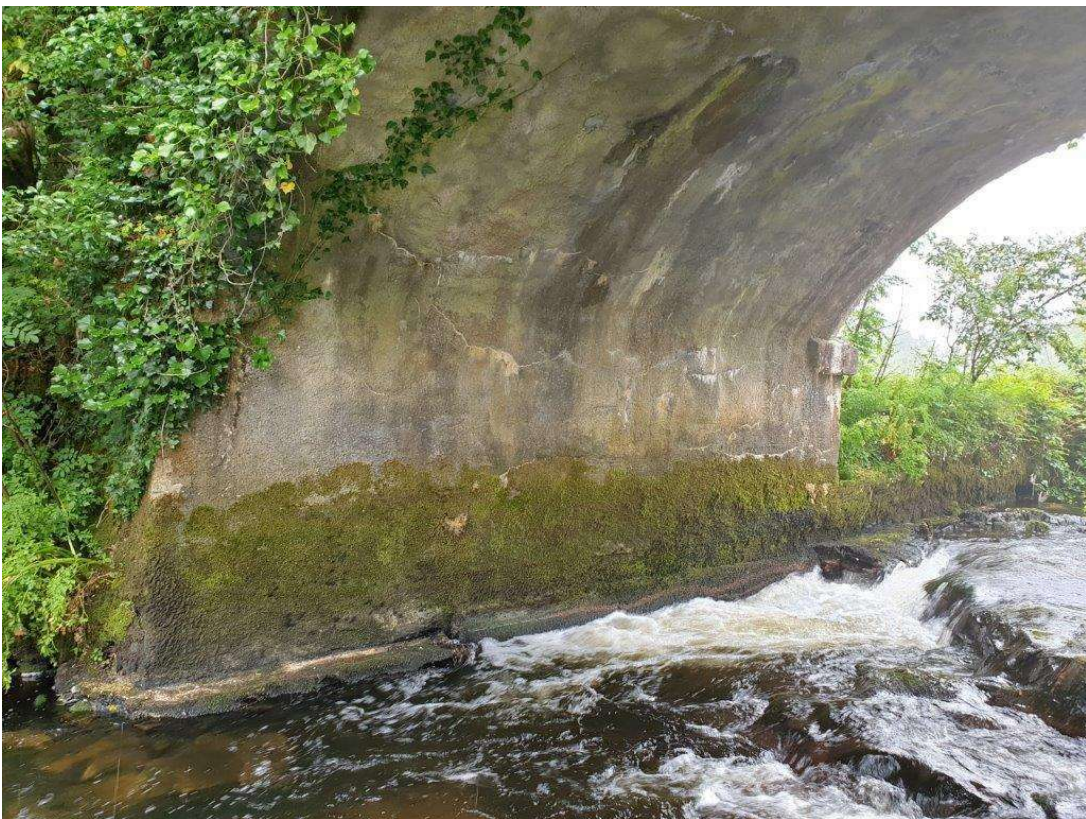
The abutments are founded on bedrock. The face of both abutments has been repaired with gunite. Some minor vegetation growth is present. Minor cracks are noted in the gunite, however, no bulging or movement of the abutments is evident. The abutment footings have been protected with grout bags.

Western abutment

Overall the structure is in good condition with few defects found. Maintenance repairs to the masonry elements and historical protection works to the pier and abutment footings are required. Debris should be removed from the riverbed.

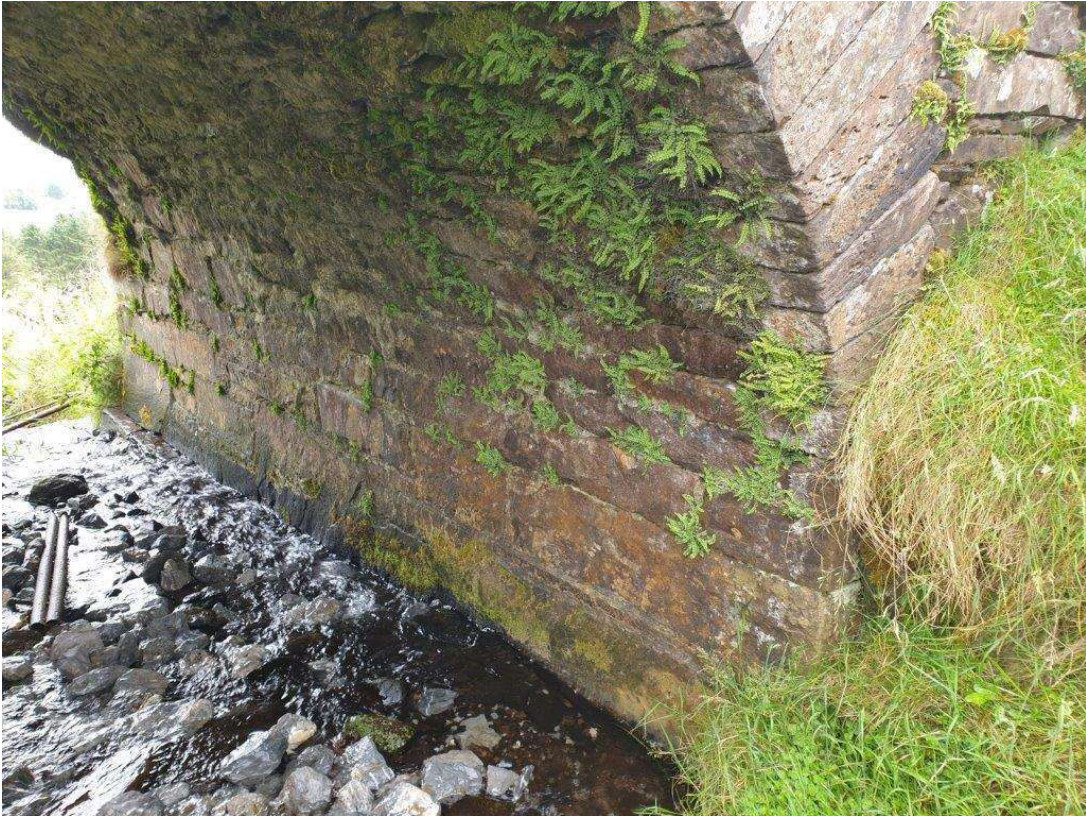
General view of the west abutment and arch barrel

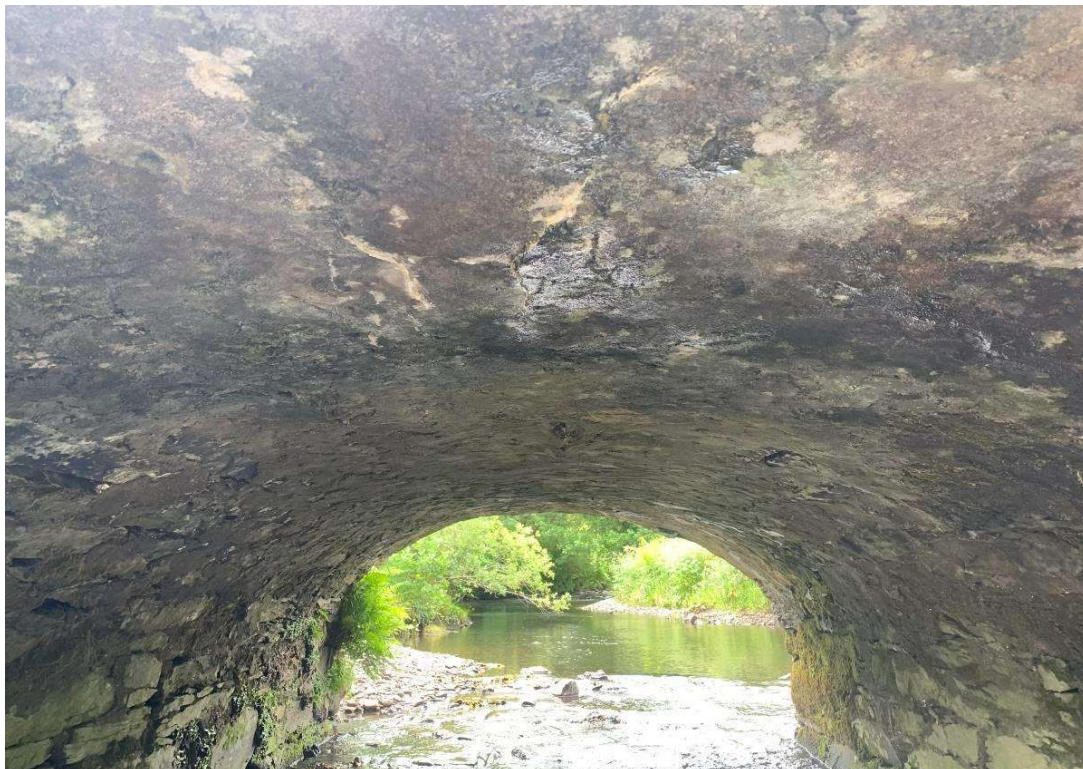
General view through arch barrel

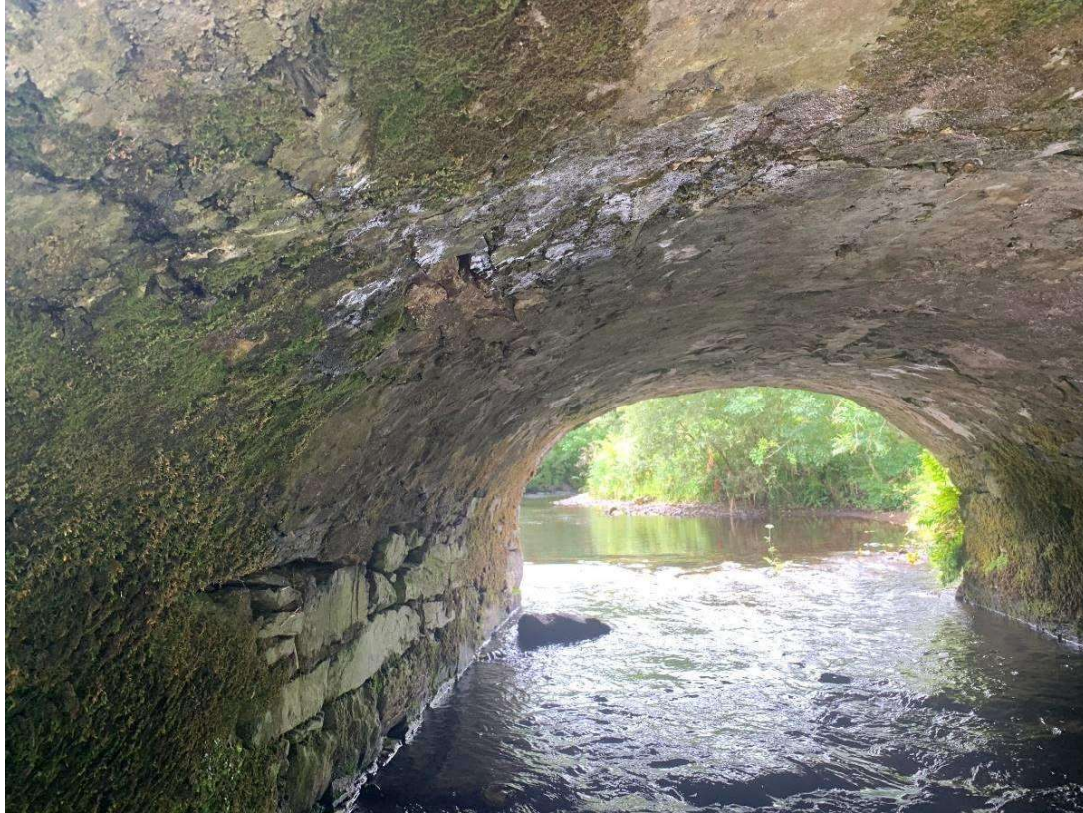
General view through arch barrel

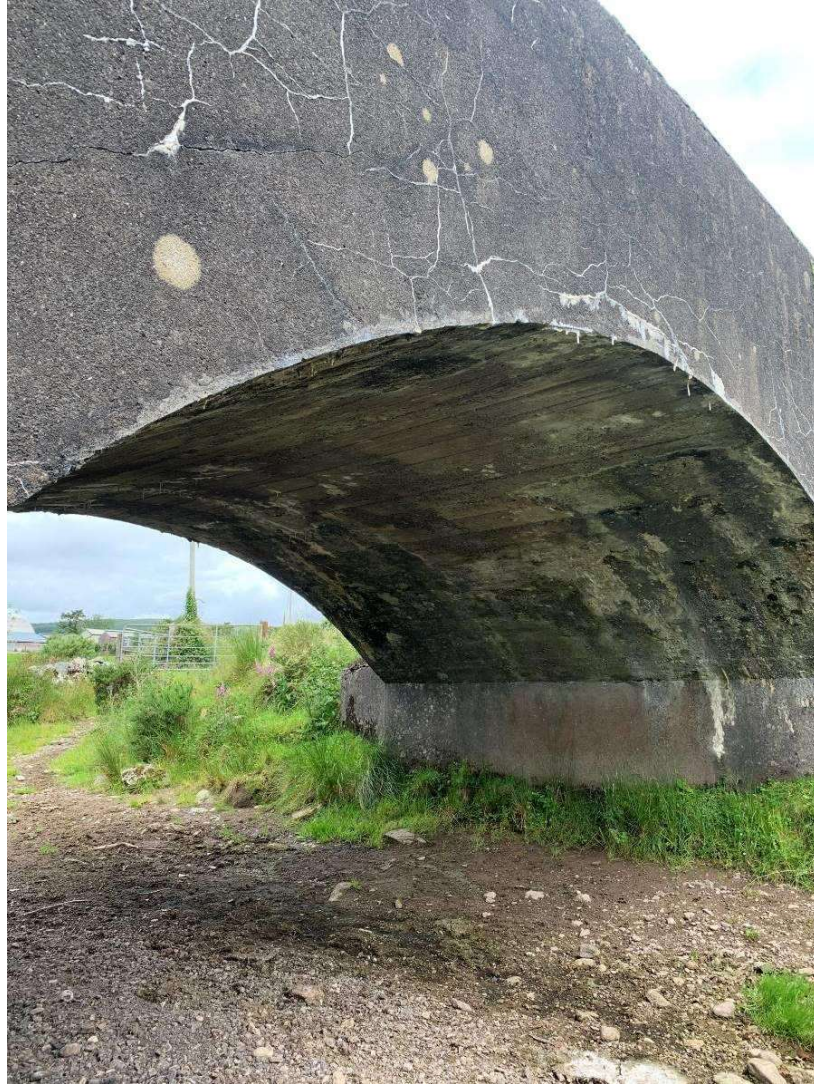
The abutments are generally in good condition. Some minor washout of the concrete is evident towards the abutment footings; however, no undermining or significant loss of material has occurred.

Both arches are constructed in concrete. No significant structural defects were noted.

General view of bridge span showing typical condition of arch barrel and abutment

Overall the structure is in good condition with few defects found. General maintenance works are required, including concrete repairs to the abutments, piers and parapets.
