**APPENDIX 3: GKCE EXISTING BUILDING STRUCTURAL CONDITION SURVEY**

## 1-6 City Quay, Dublin Existing Building Structural Condition Survey

Address : 1-6 City Quay Dublin

Survey type Condition survey

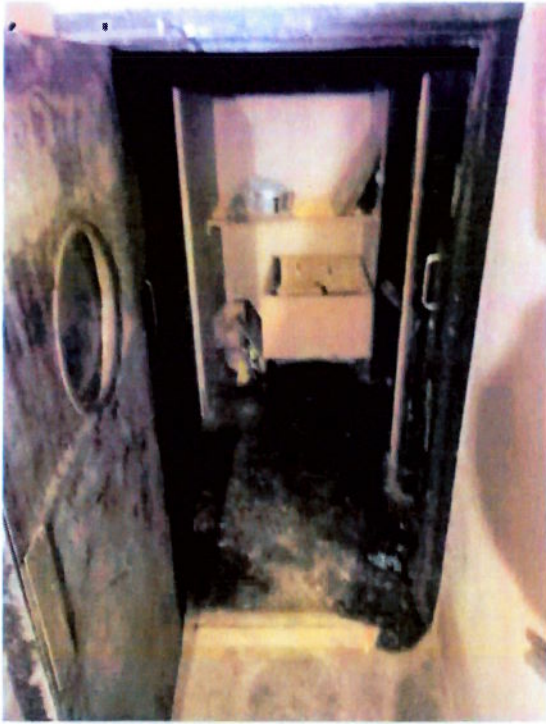
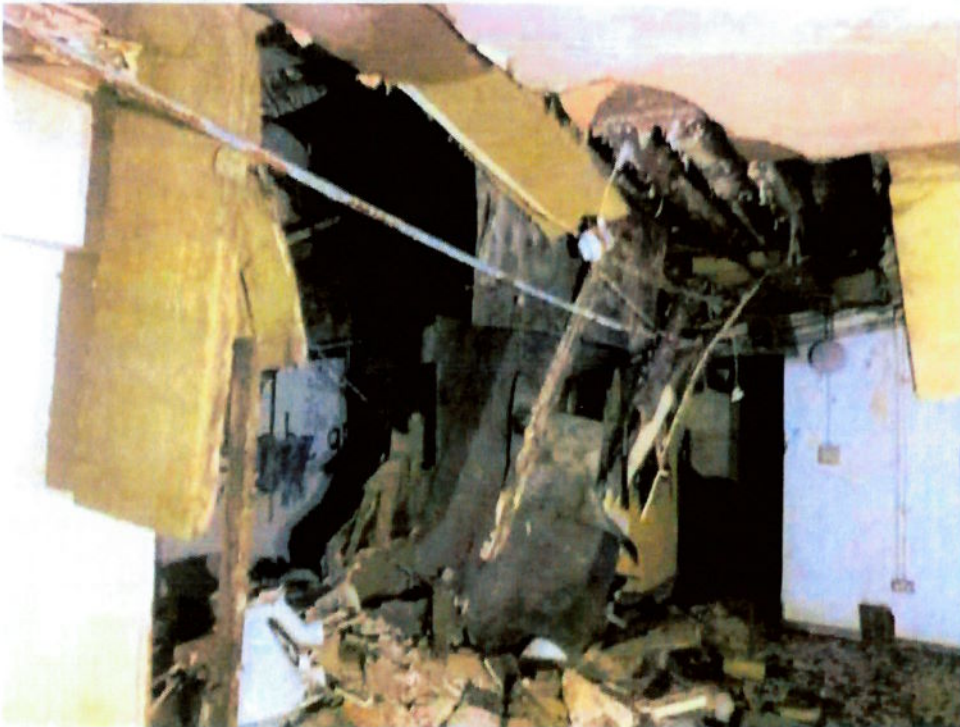
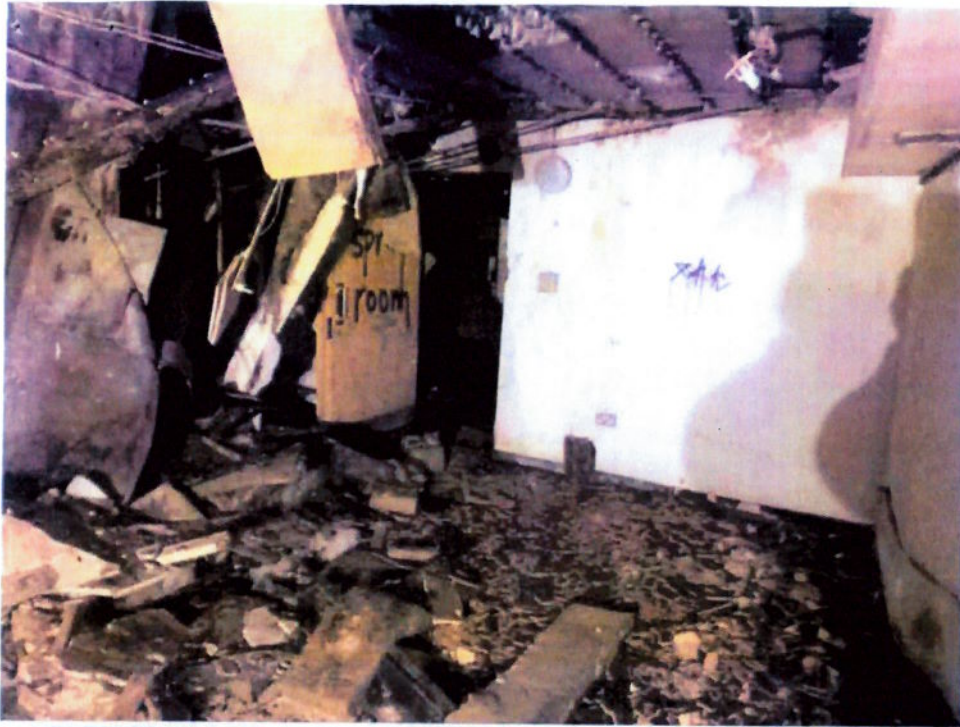
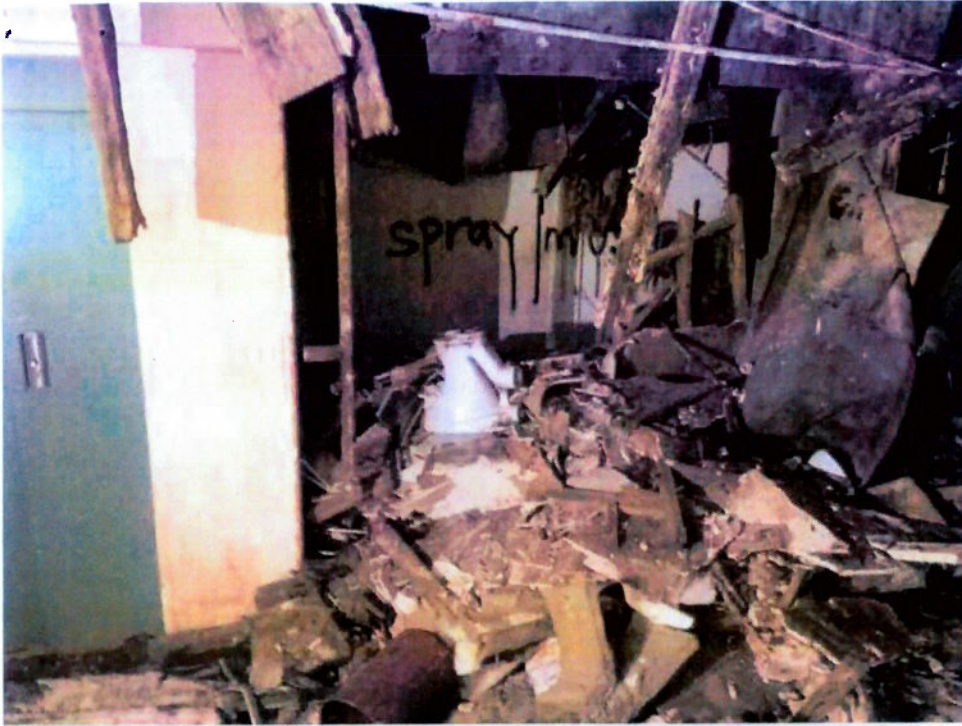
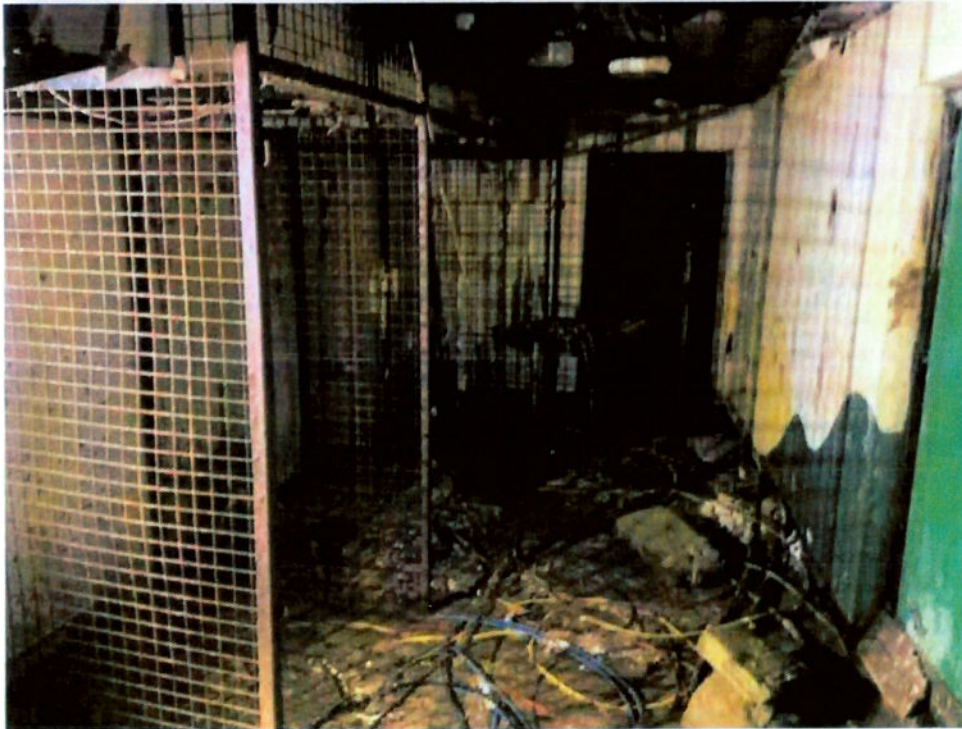
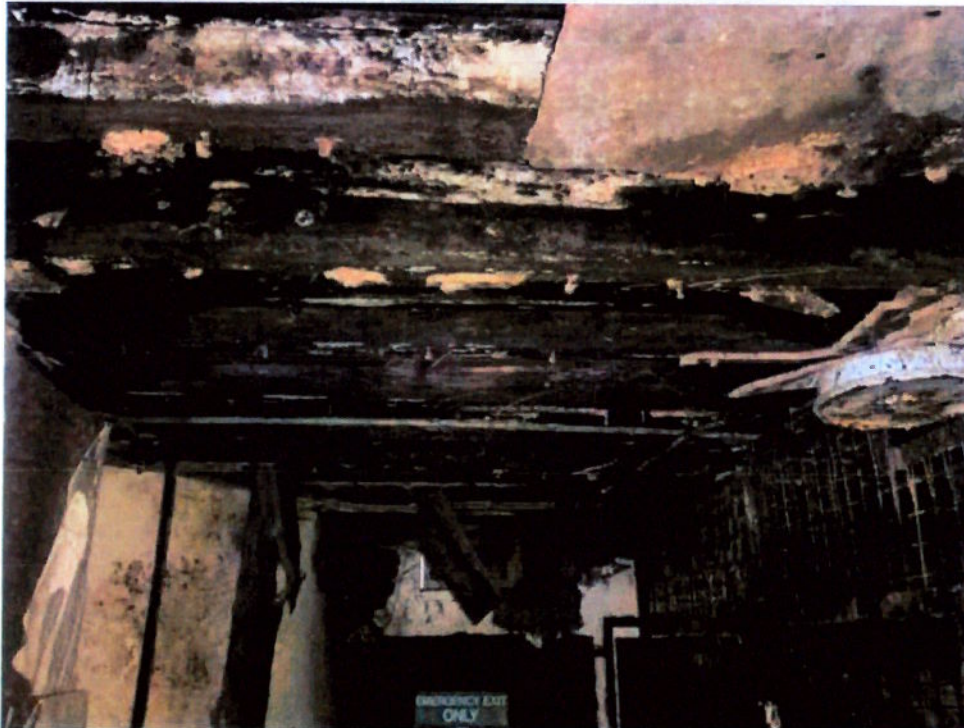
The basement access is limited. Areas of the ground floor have collapsed into the basement & doors are sealed shut on some rooms

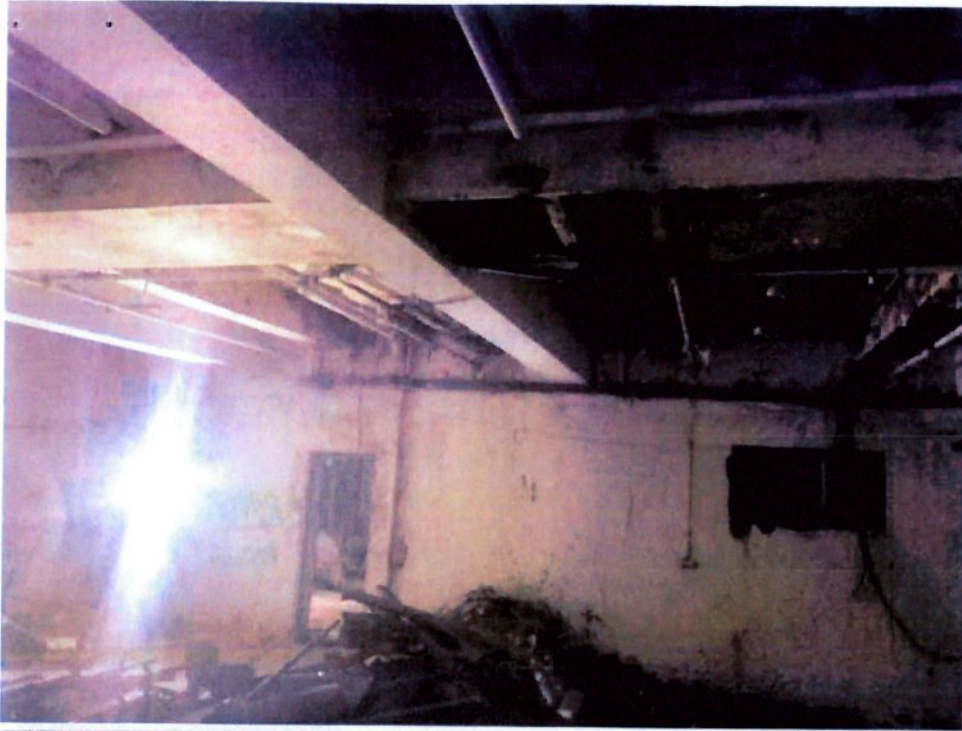
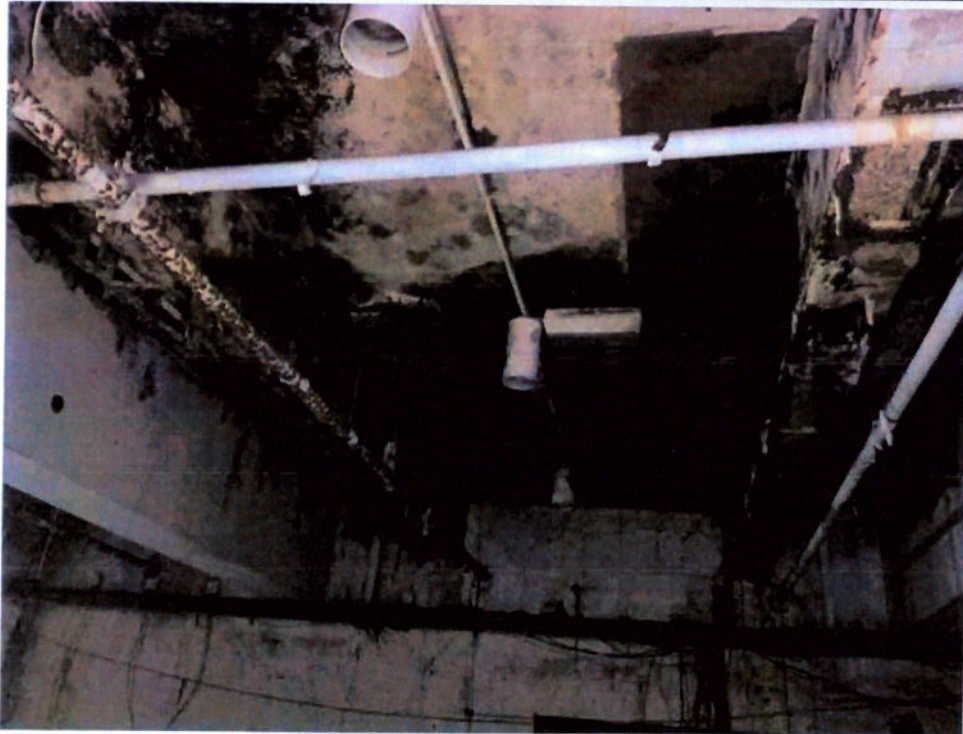
1 Comments

We note evidence of structural alterations to this room. The columns overhead do not transfer to ground level. Concrete beams transfer the column loads. The ground floor slab is concrete. The first-floor ceiling overhead is perished from water damage.

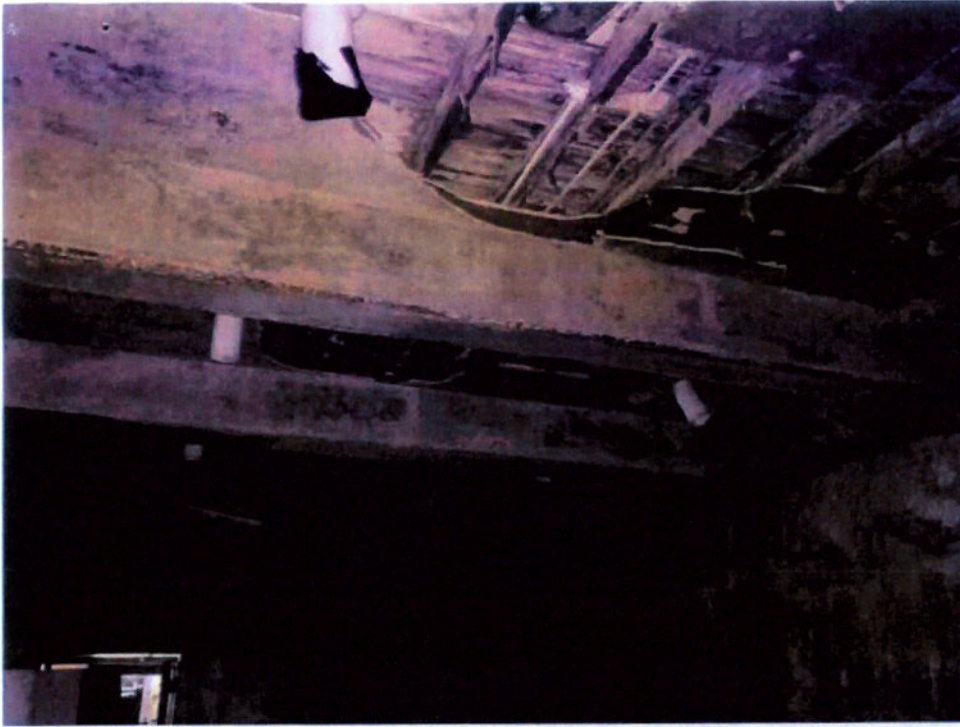
3 Comments

The timber ceiling & floor overhead has perished & is at risk of collapse

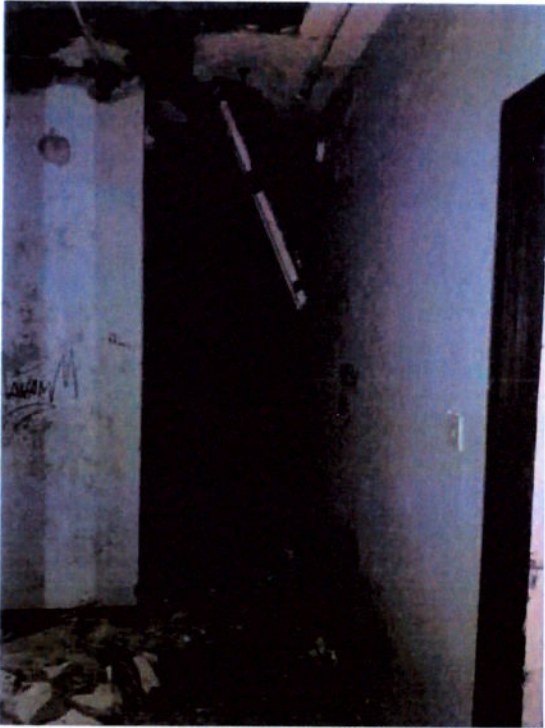
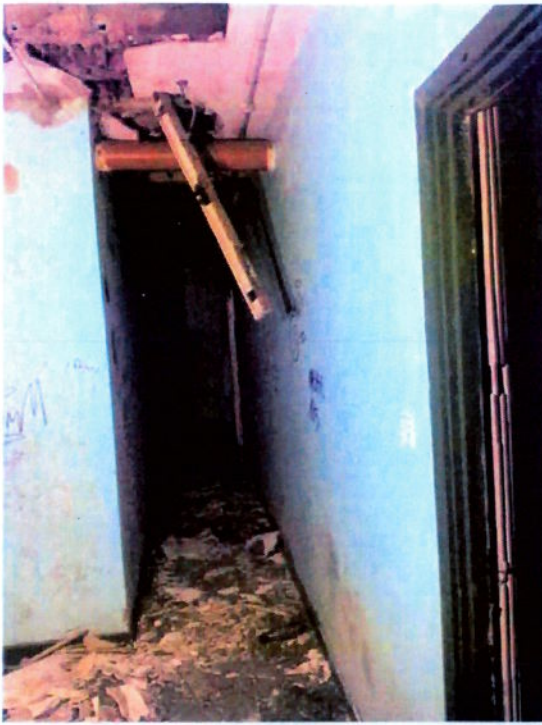
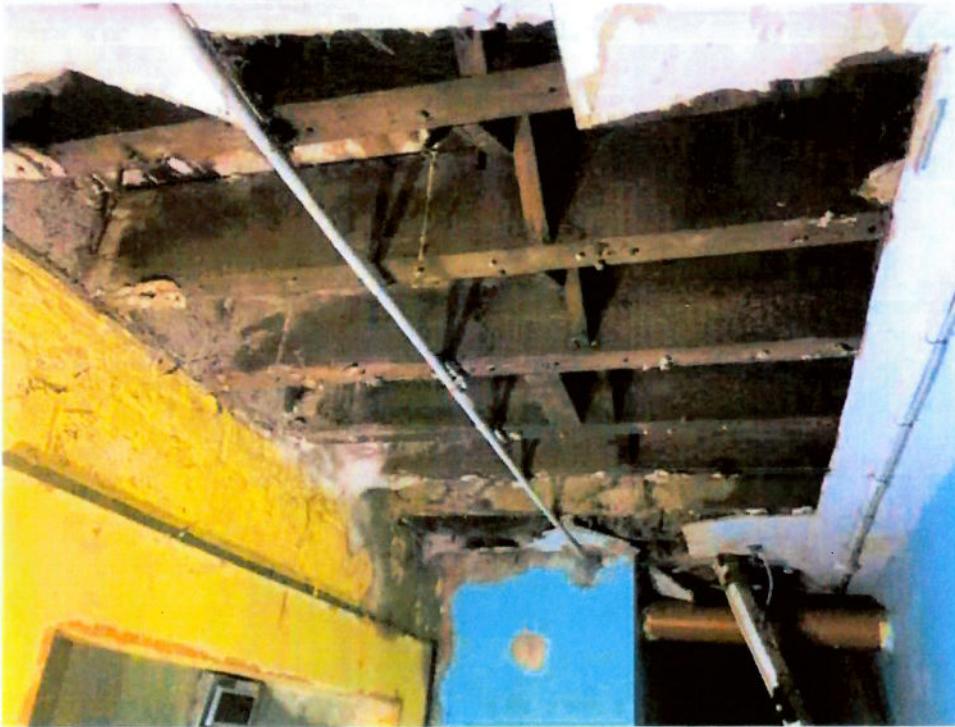
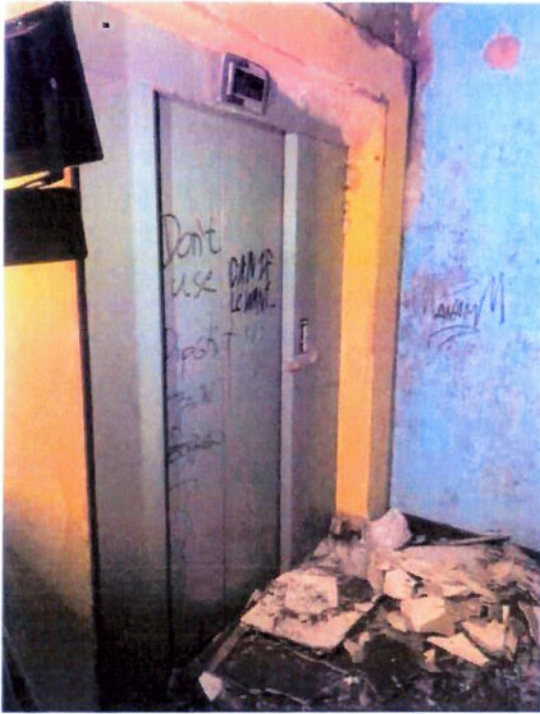
8 Comments

The timber floor overhead is perished & at risk of collapse

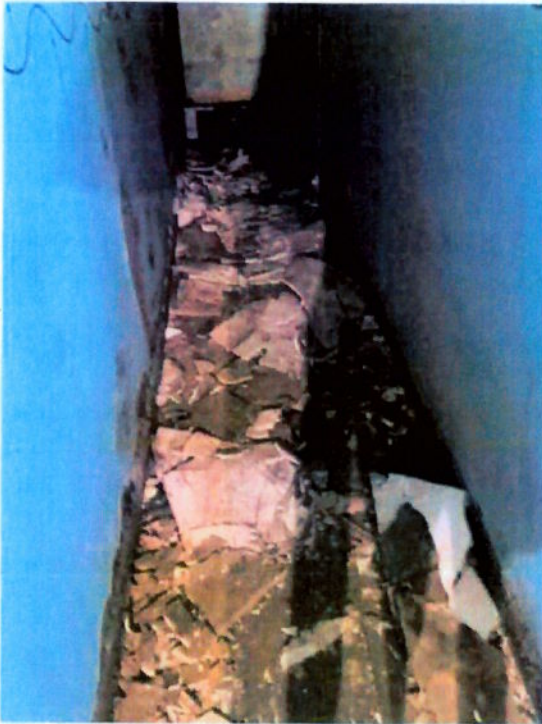
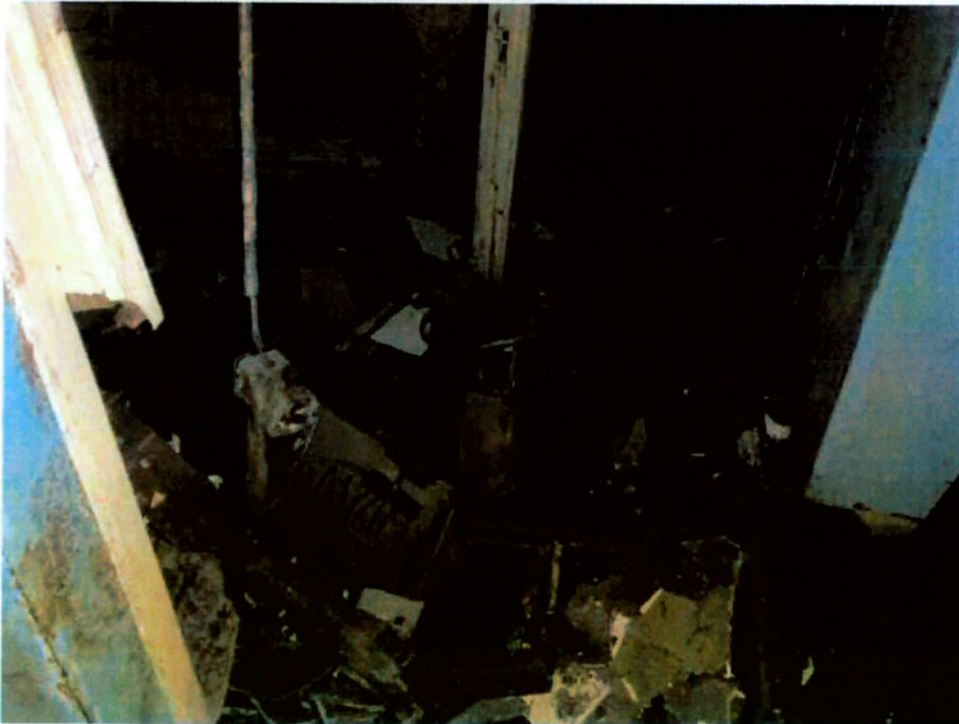
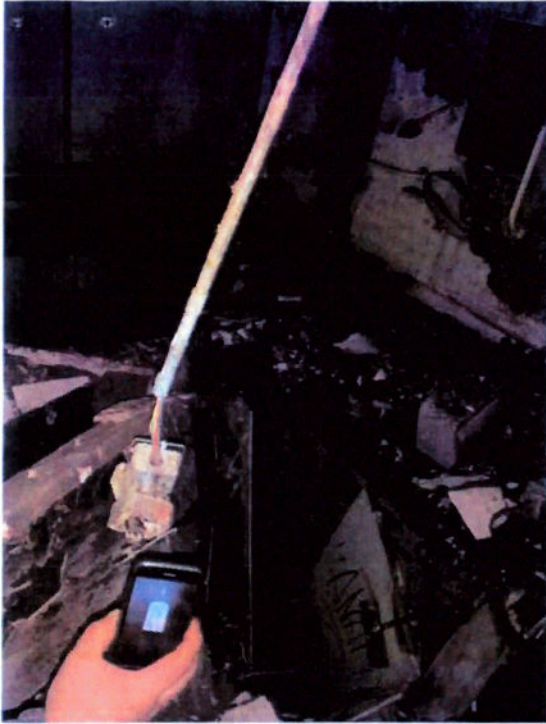
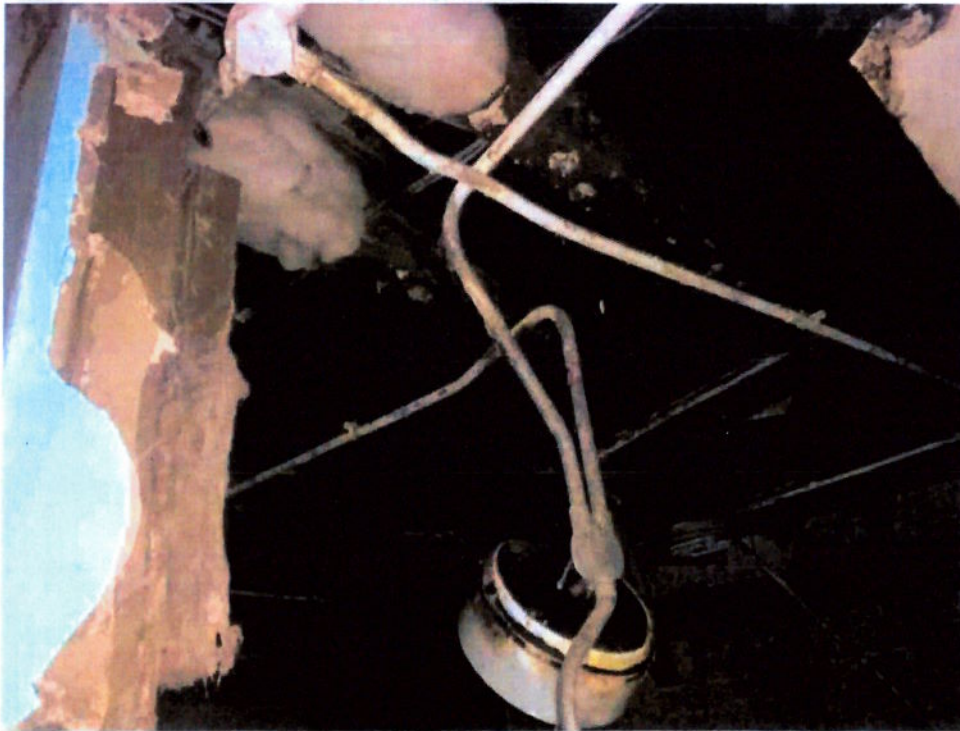
9 Comments

The suspended ground floor & ceiling overhead has fully collapsed. Access is limited

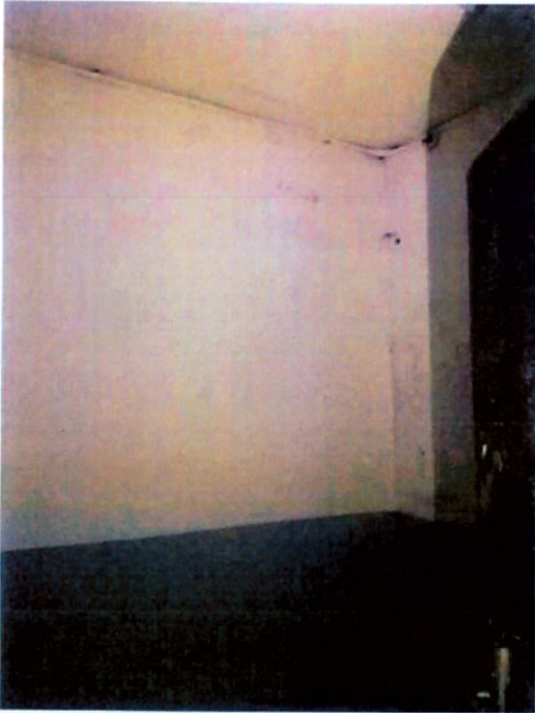
12 Comments

The timber floor overhead has collapsed. The remaining floor is unsafe. The existing floor under has also partially collapsed & is unsafe for access

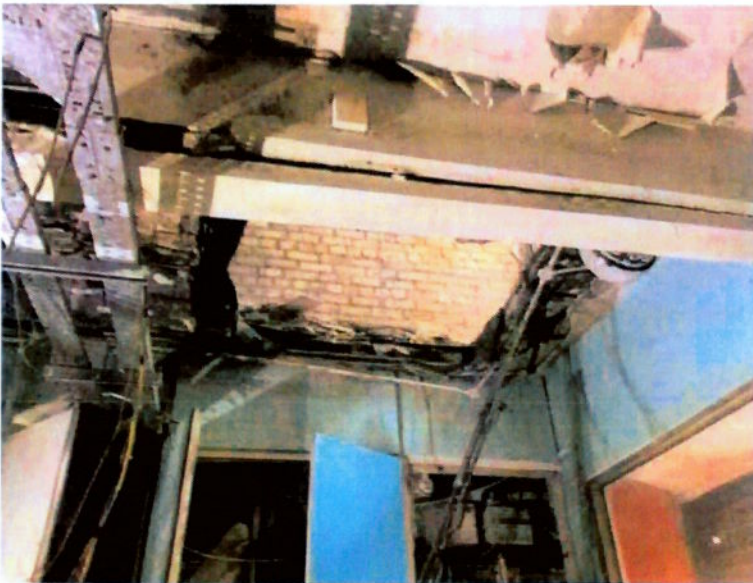
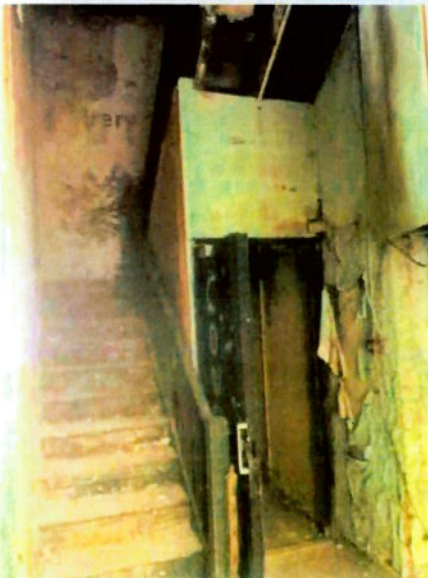
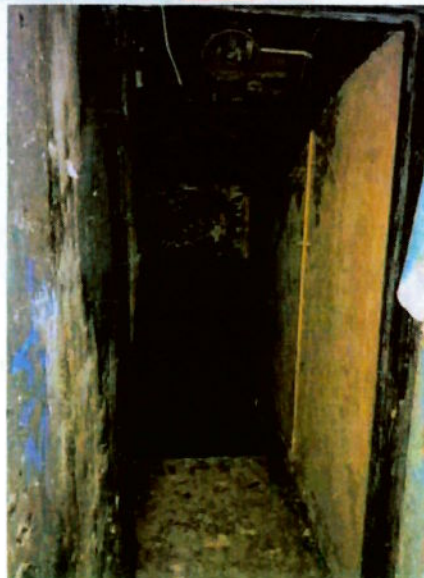
13 Comments

The floor overhead has perished & at risk of collapse

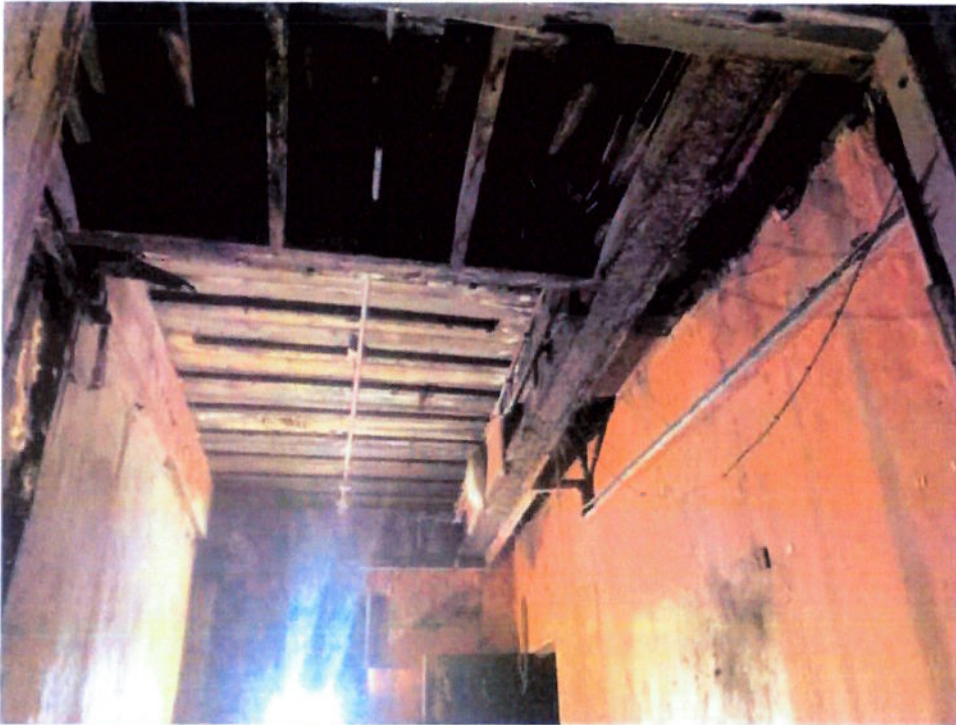
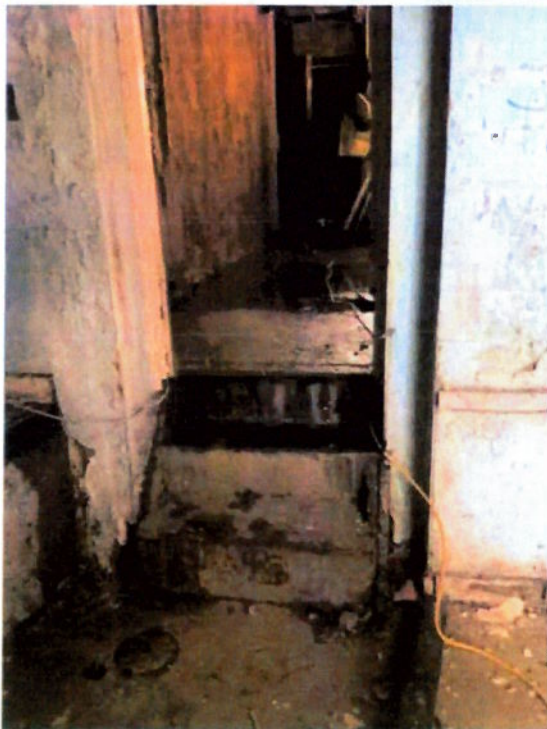
14 Comments

Access to this area is limited. The floors are unsafe & ceiling overhead has collapsed. Floors perished and not safe to walk on

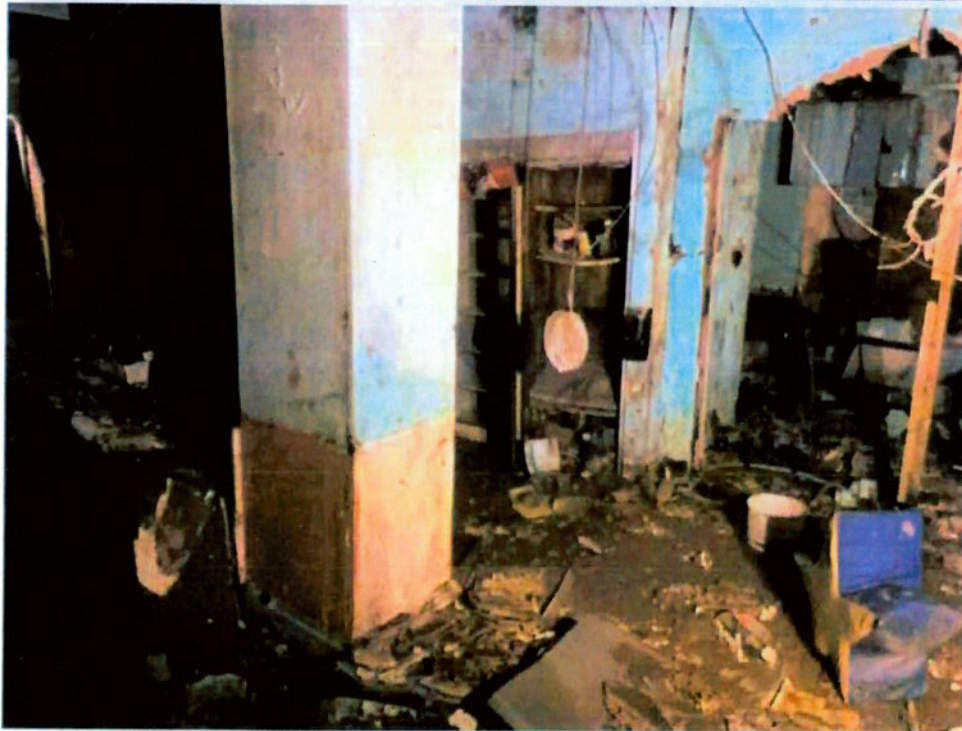
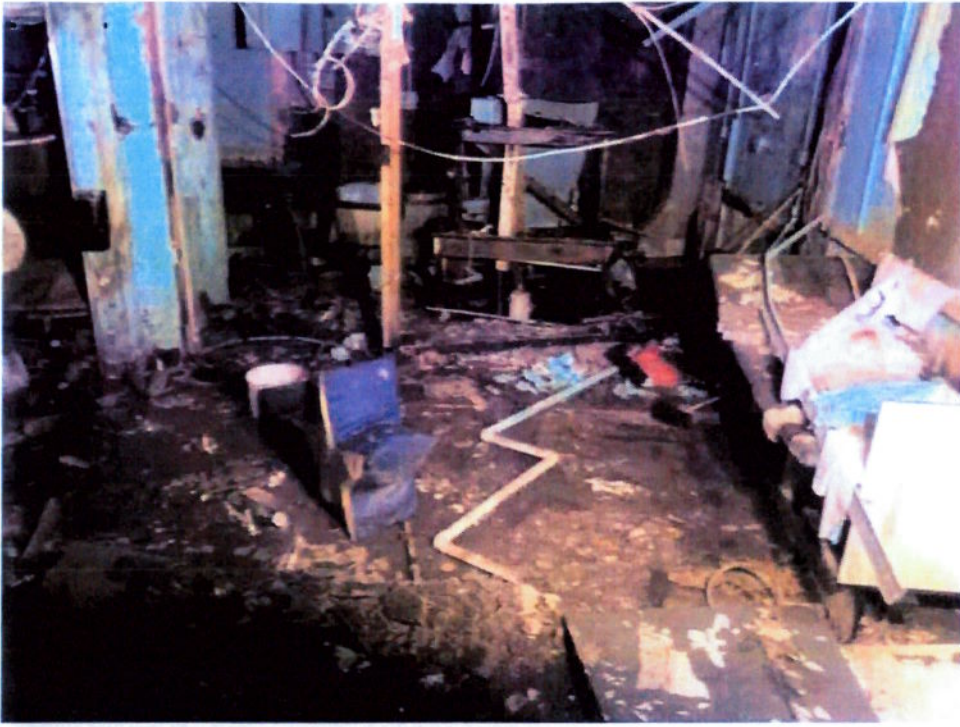
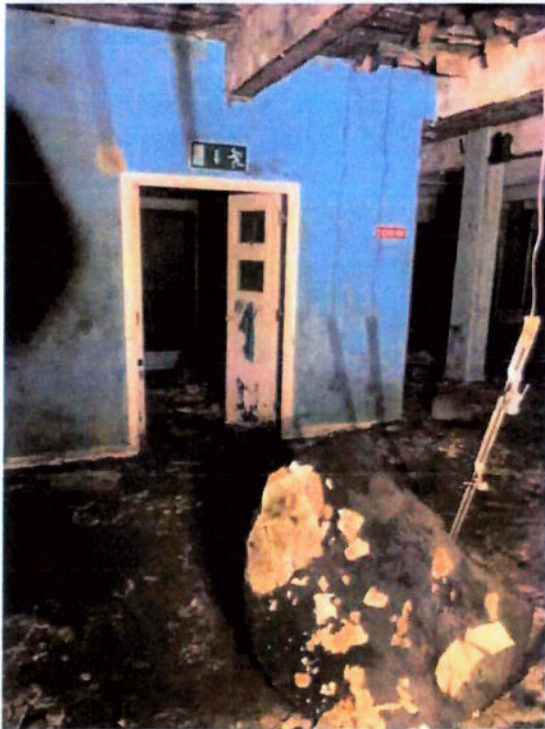
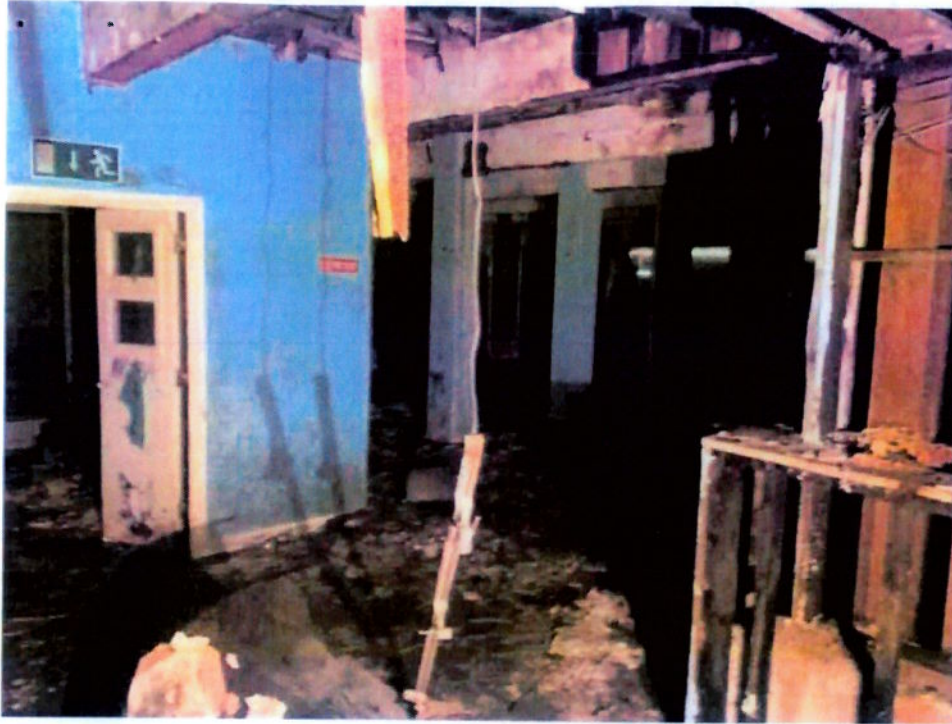
#### 15 Comments

No access floors are perished & unsafe for access

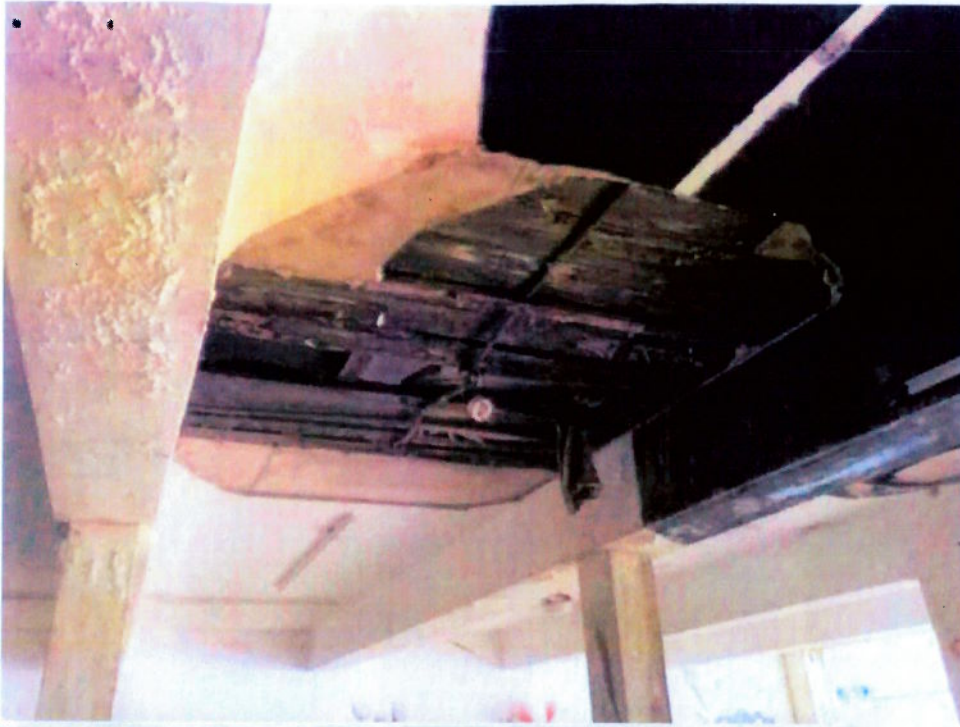
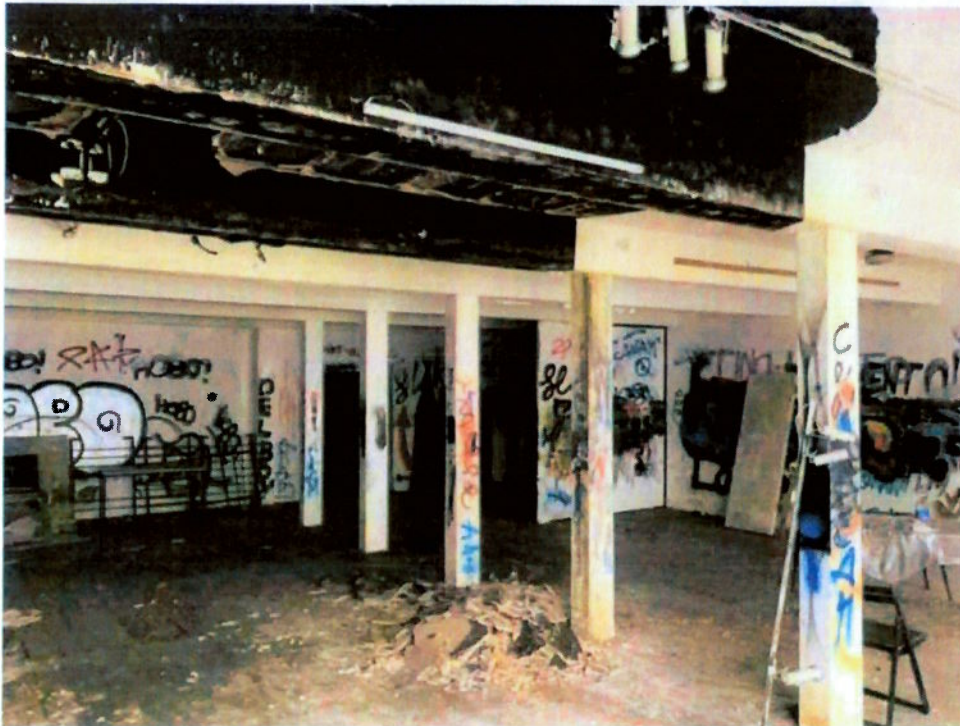
17 Comments

Floors are unsafe to walk on

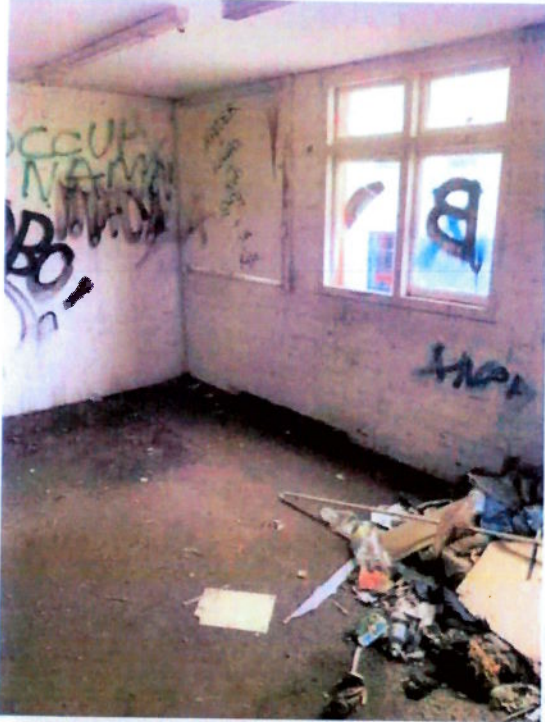
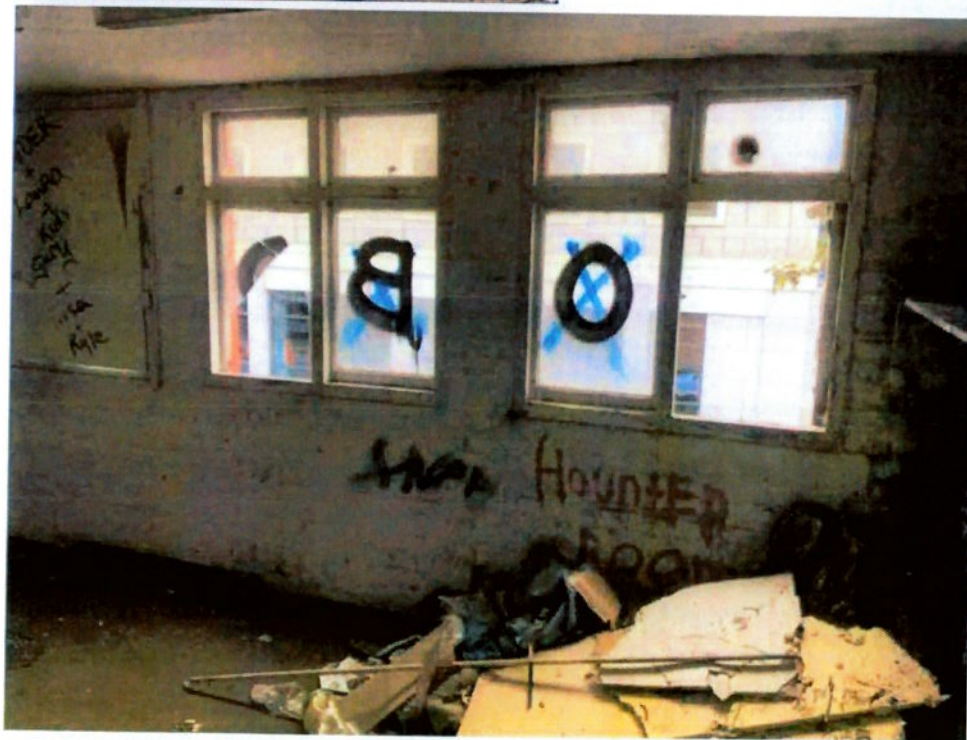
19 Comments

Access to this area is restricted, the floor is not safe to walk on

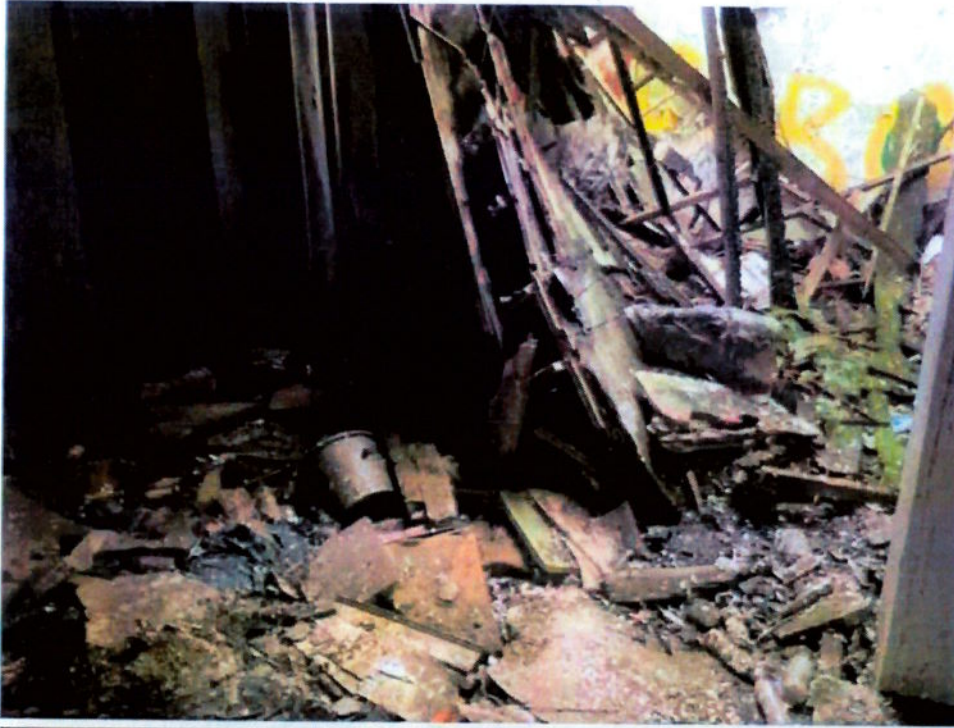
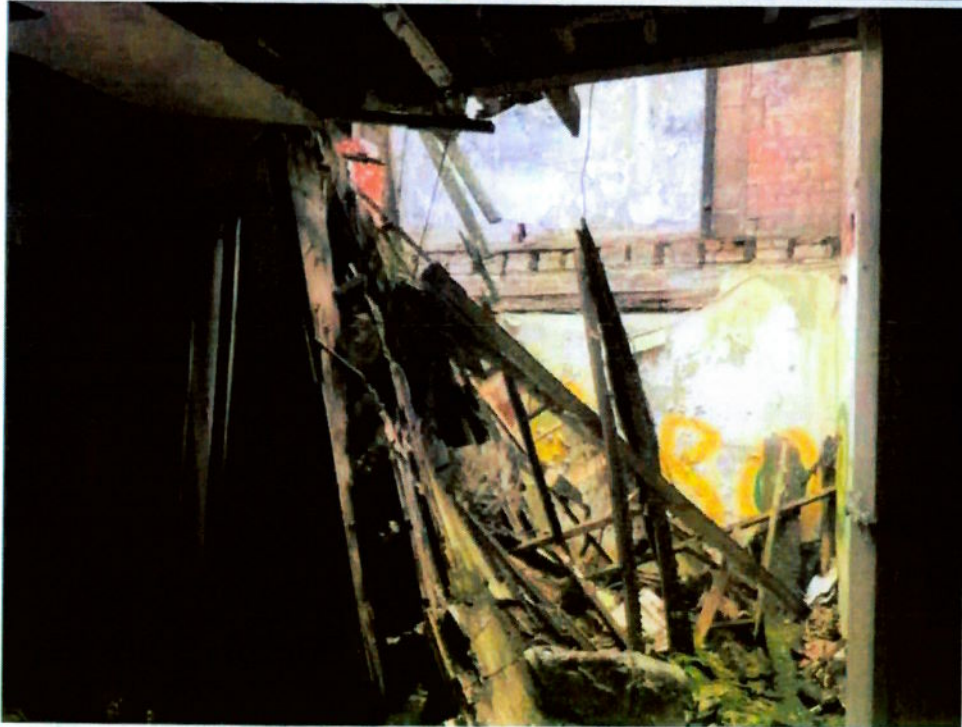
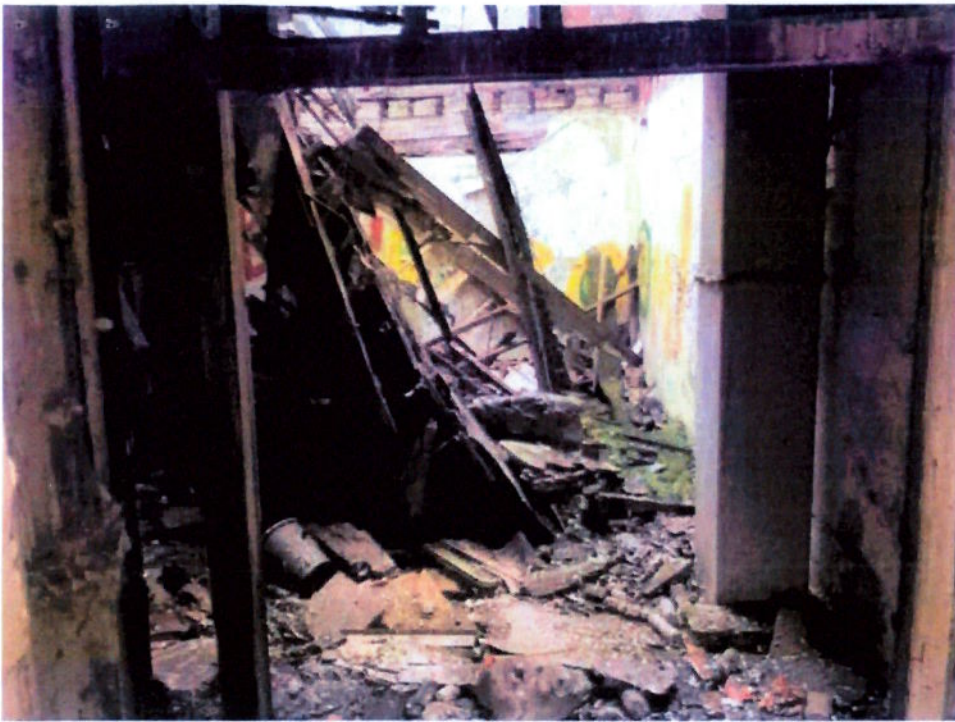
25 Comments

Floor is extremely wet & soft to walk on not safe to access

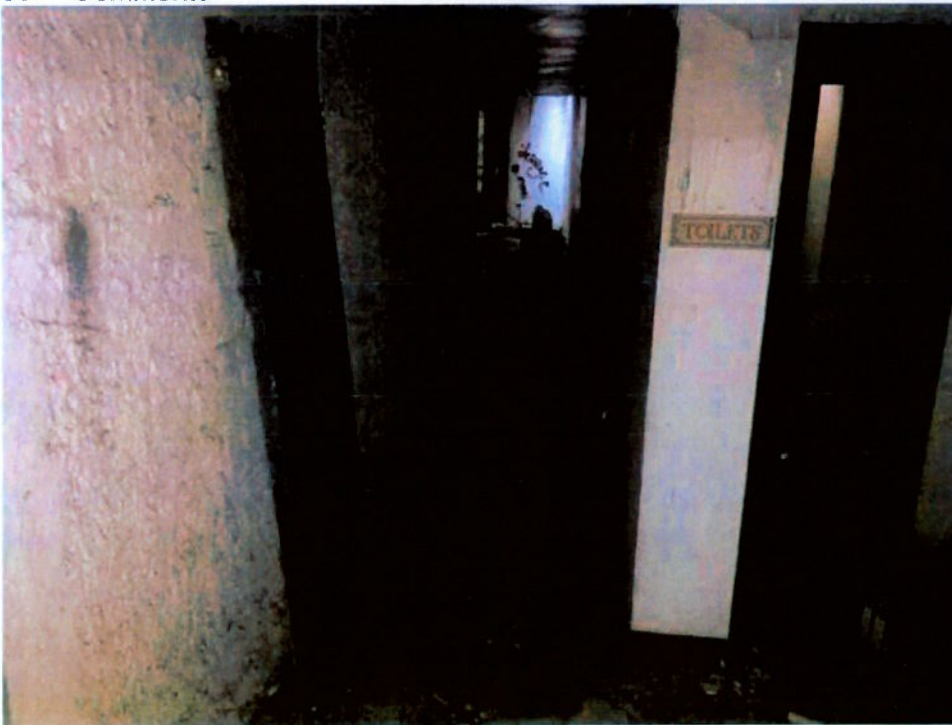
31 Comments

Floor has holes & is dangerous. Access is limited

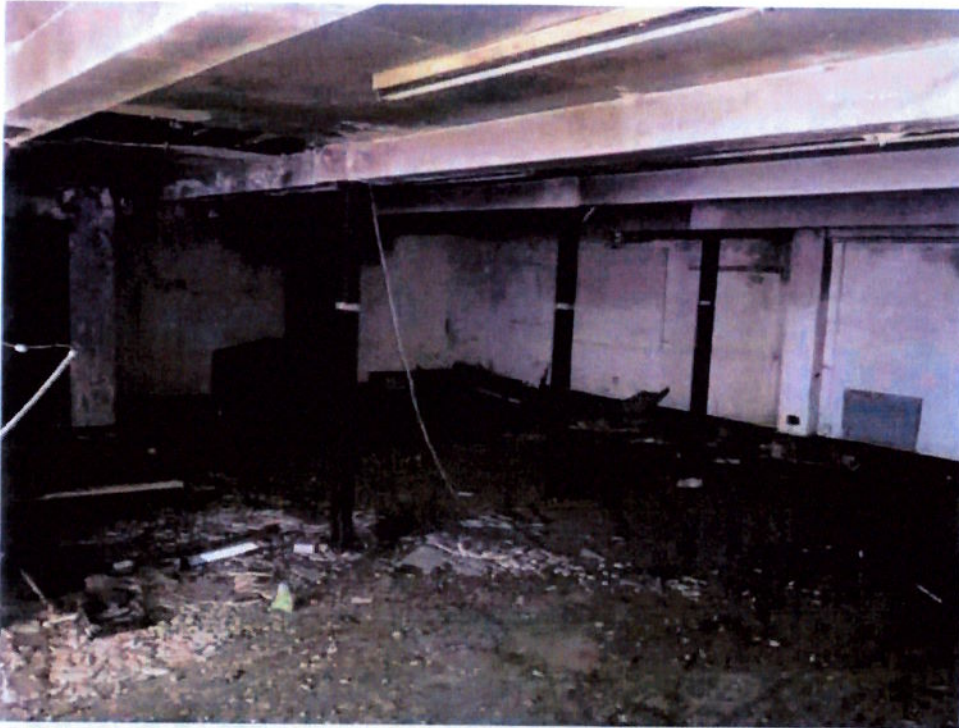
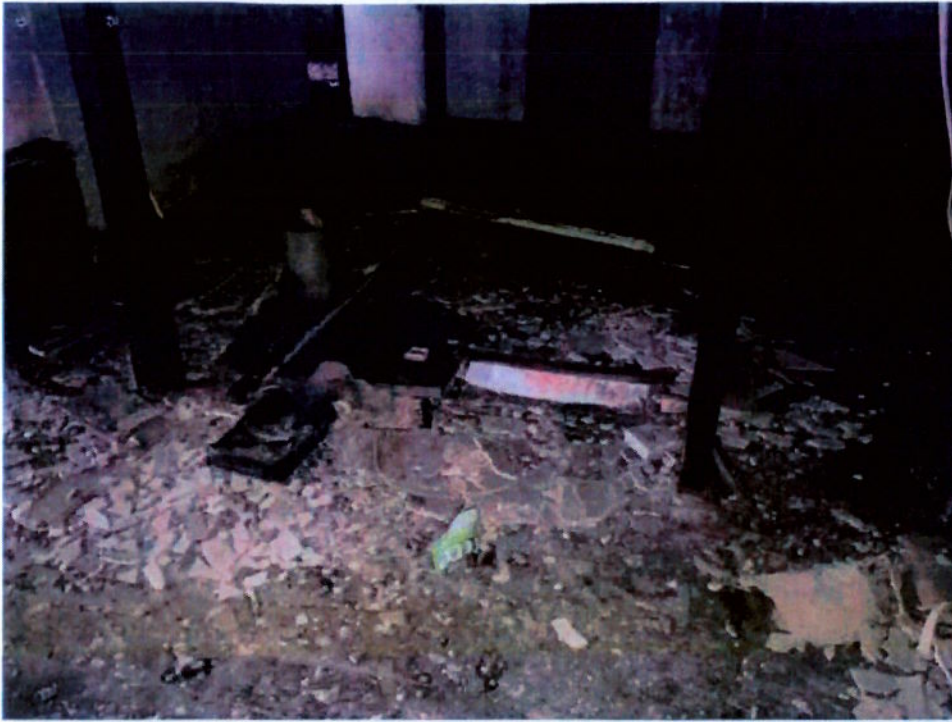
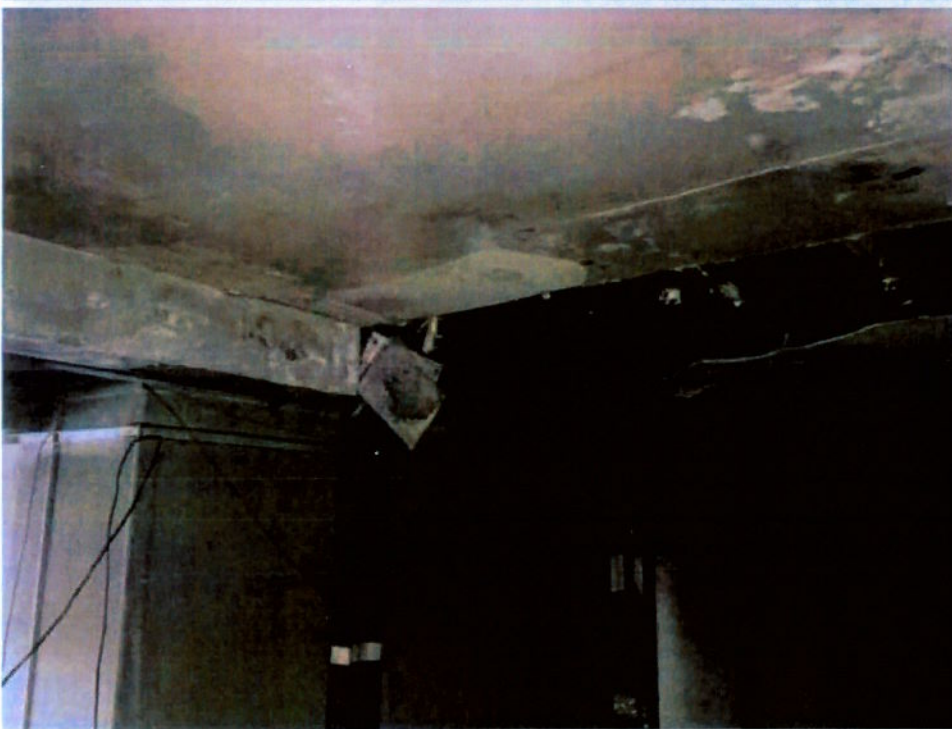
32 Comments

Extensive structural damaged by fire. Evidence of timber charring & smoke damage throughout
