**APPENDIX 3: GKCE EXISTING BUILDING STRUCTURAL CONDITION SURVEY**

## 1-6 City Quay, Dublin Existing Building Structural Condition Survey

Address : 1-6 City Quay Dublin

Survey type Condition survey

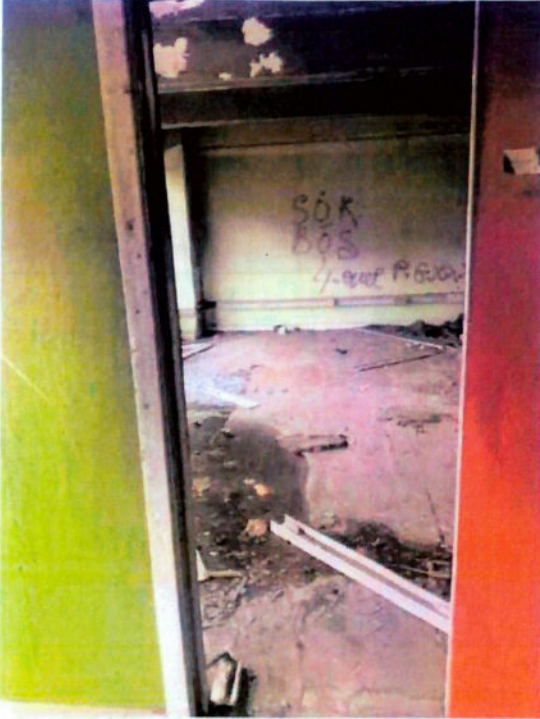
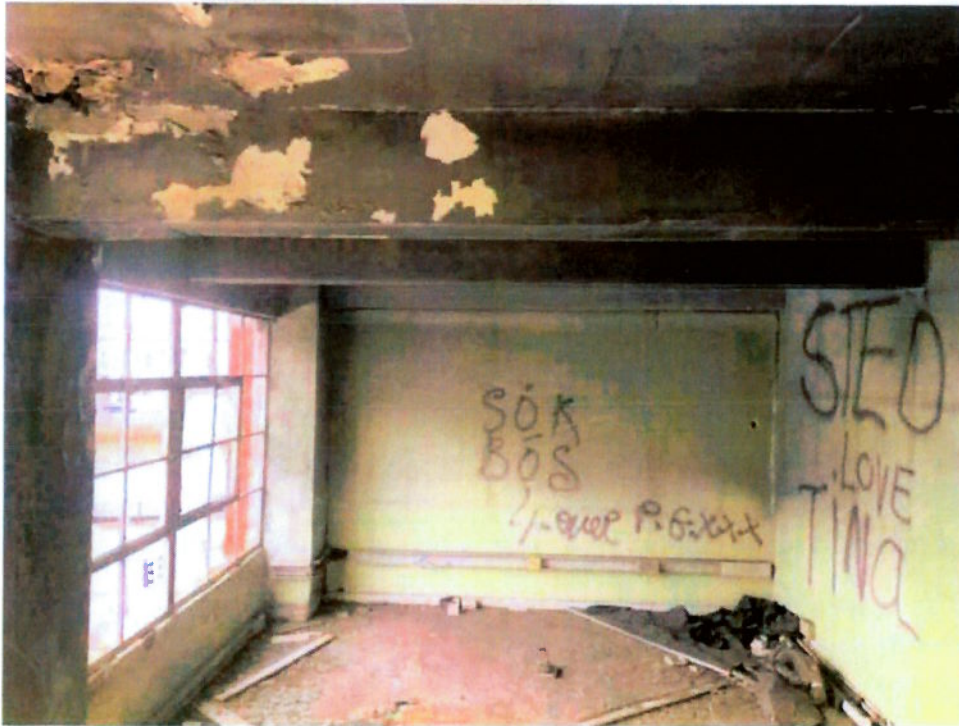
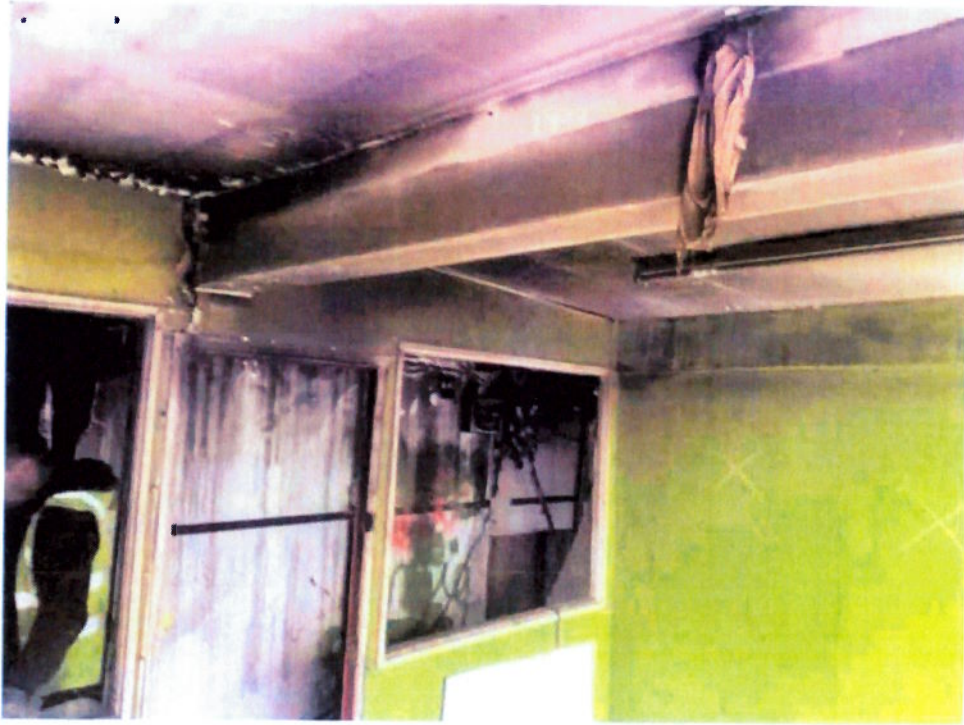
Extensive structural fire damaged & risk of collapse

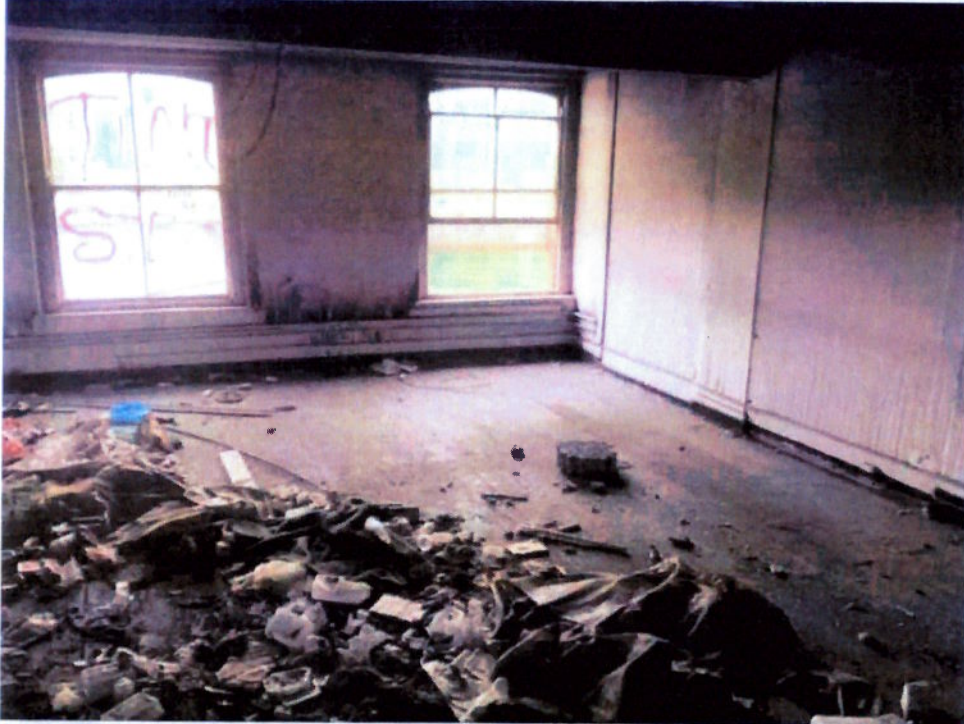
37 Comments

Evidence of illegal occupation or squatting in the building. We have concerns the building is not safe & there is potential for a severe injury or fatality to individuals who are walking on these floors

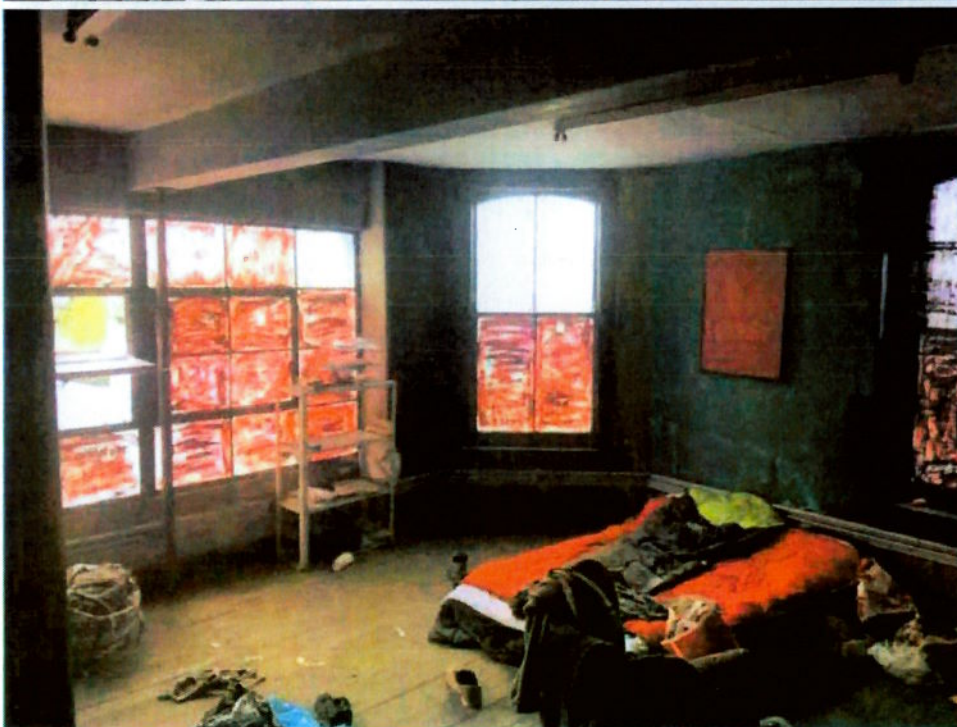
39 Comments

Ceiling and roof overhead has completely perished & at risk of collapse

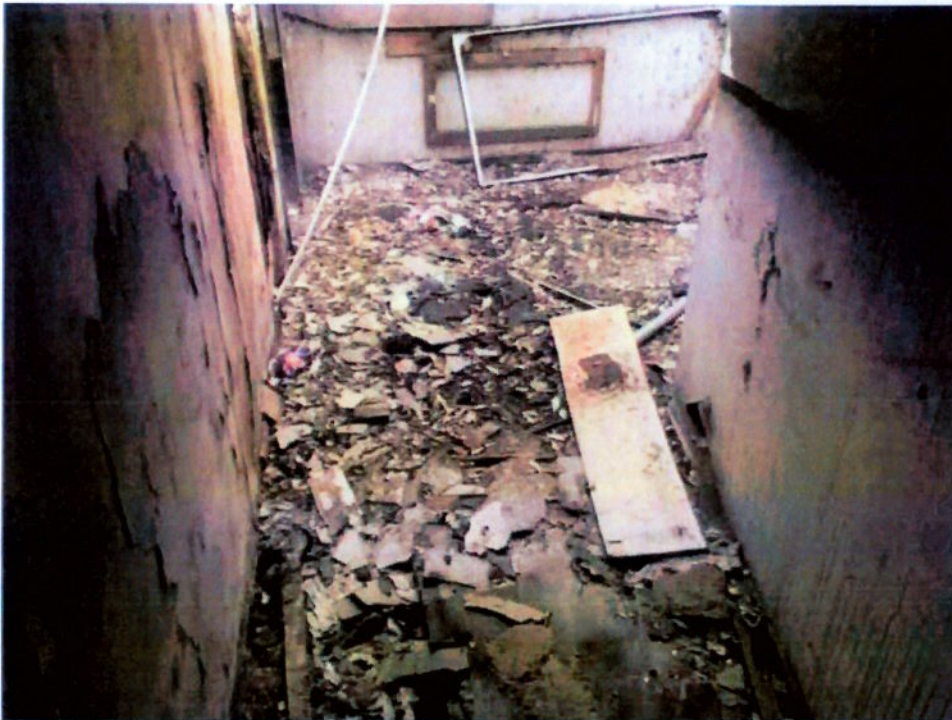
41 Comments

No access collapsed floor

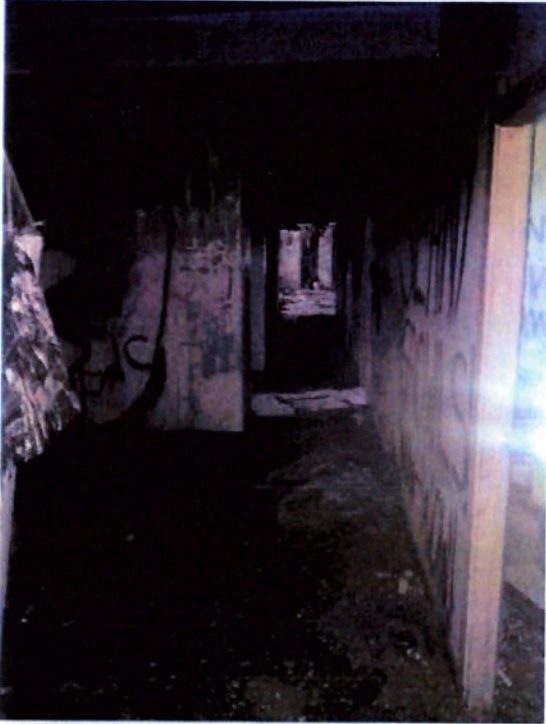
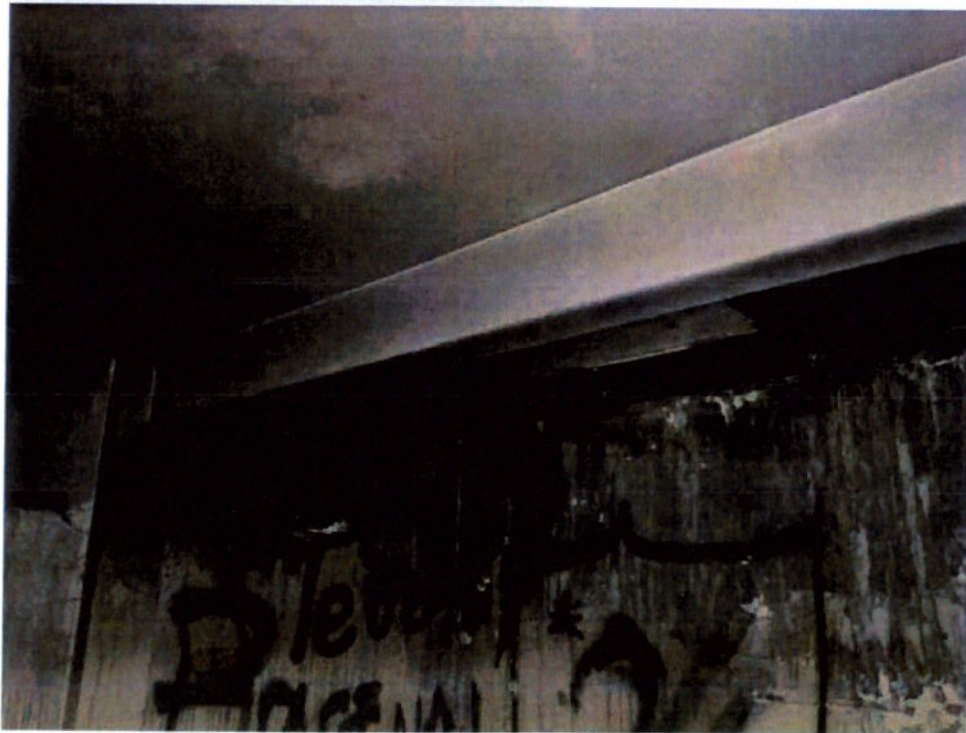
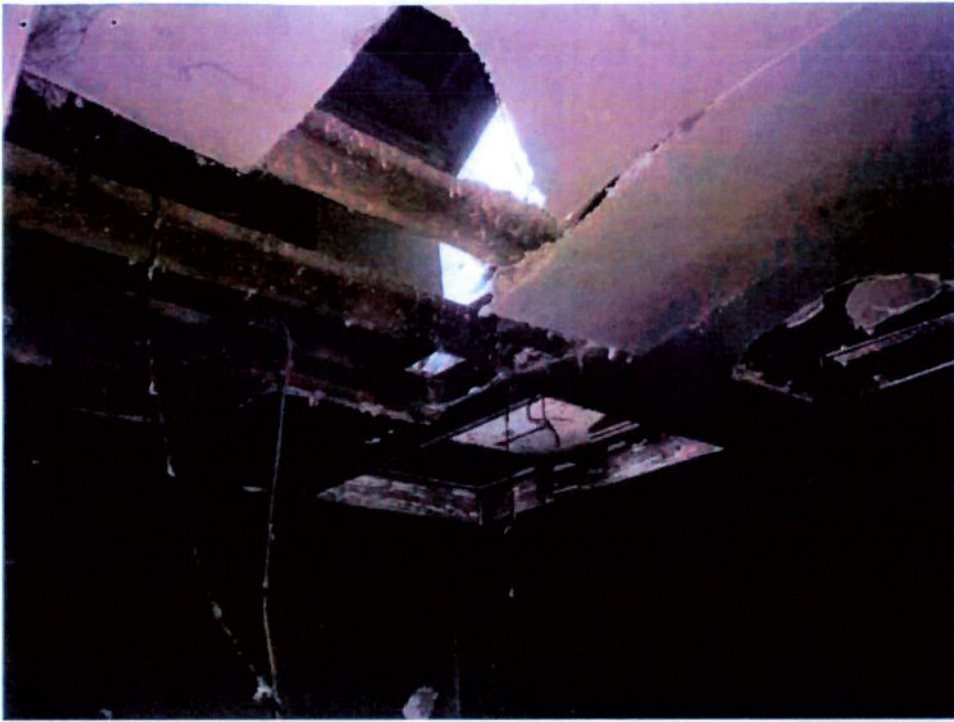
43 Comments

Collapsed floors & ceilings

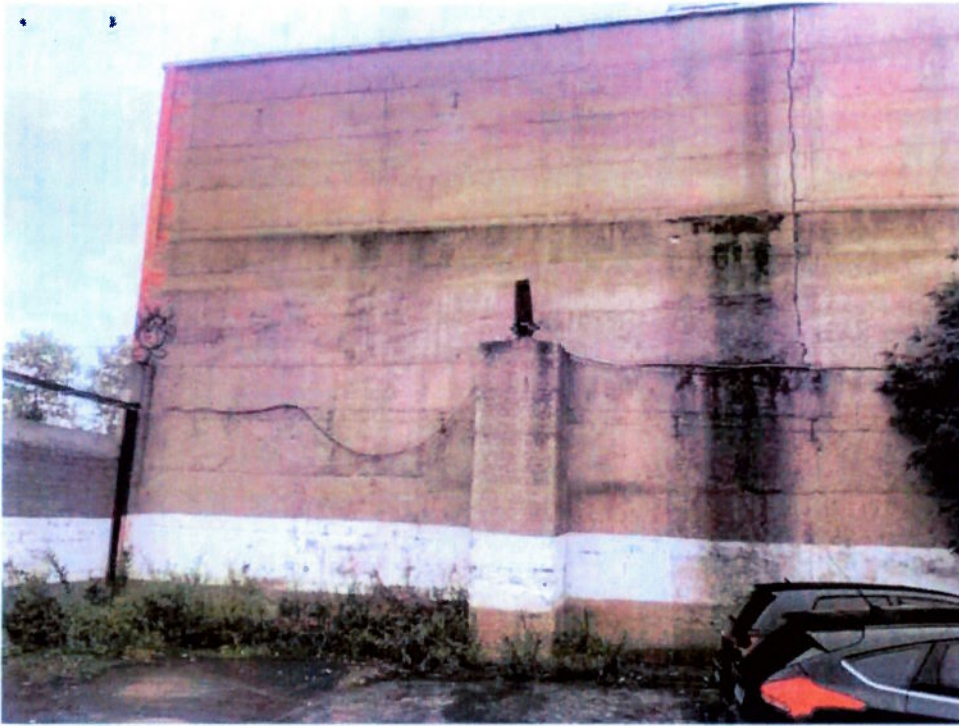
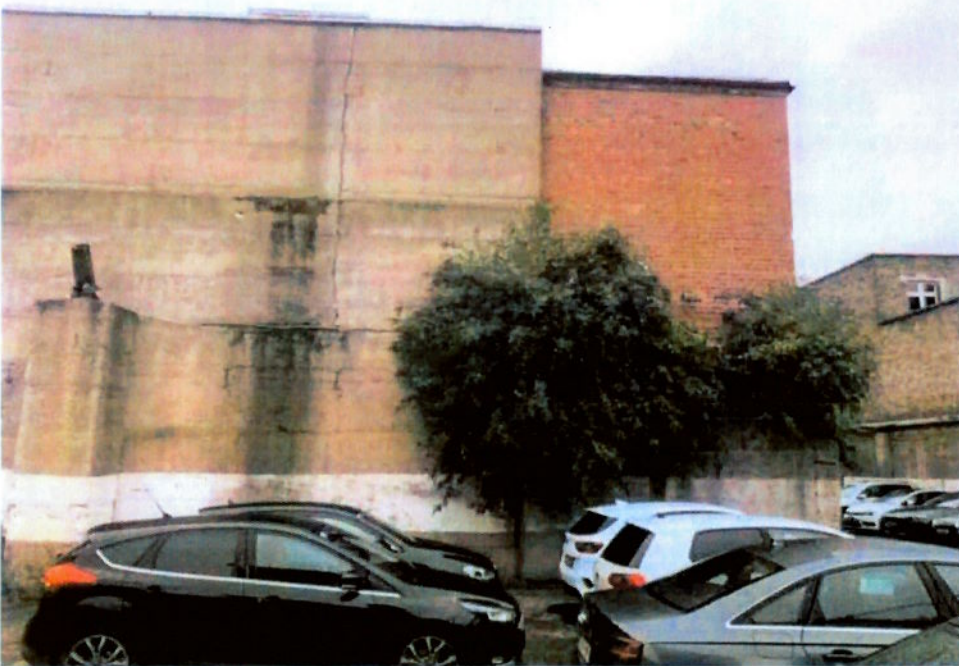
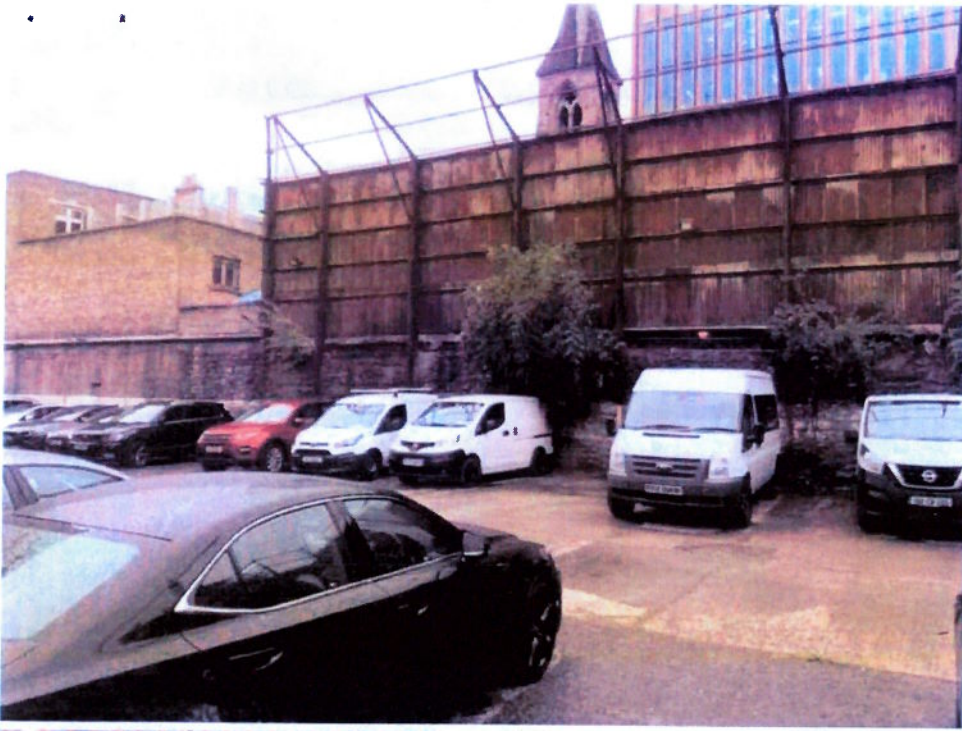
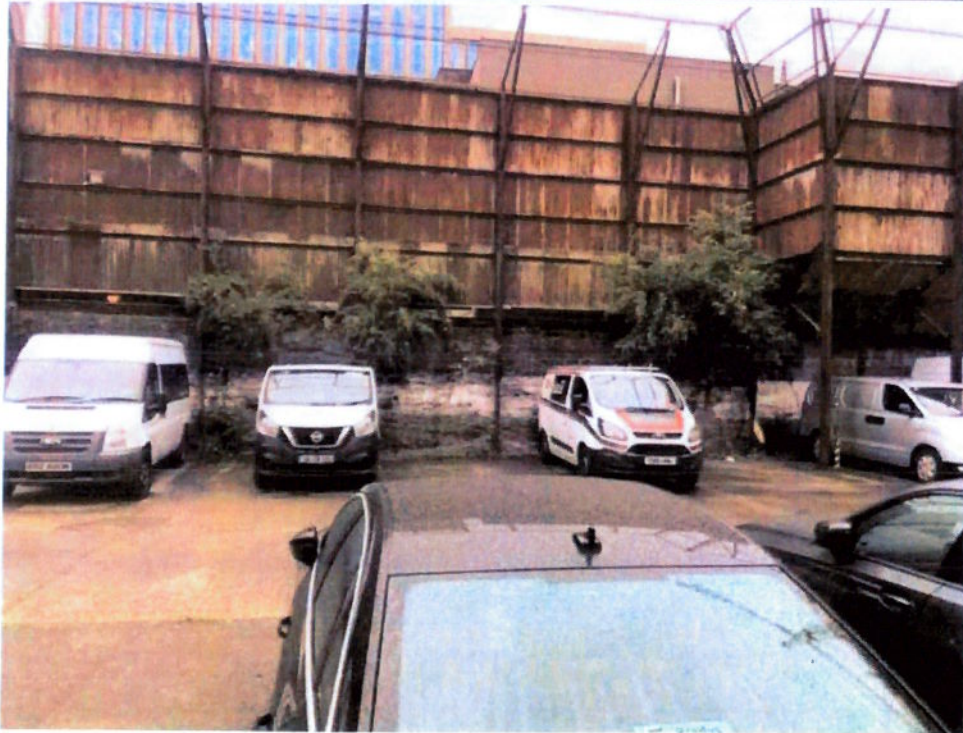
47 Comments

There is a significant structural crack over the full height of the wall. We have concerns the wall has debonded from the building structure & will potentially fall away into the car park. This is a risk to the general public.

We recommend this building is condemned & demolished.

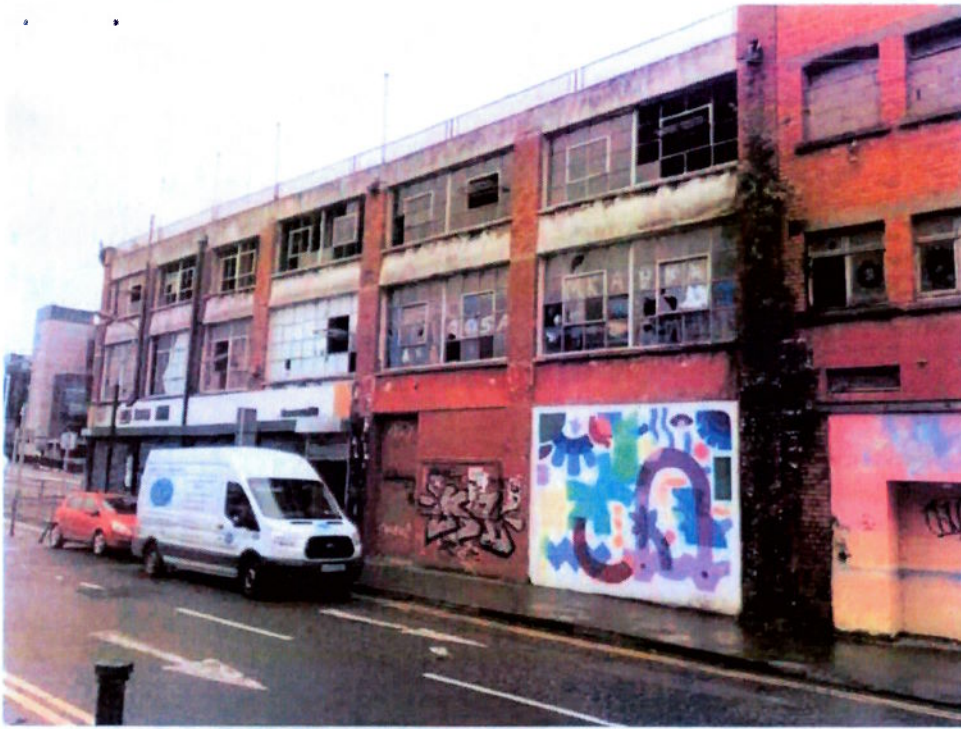
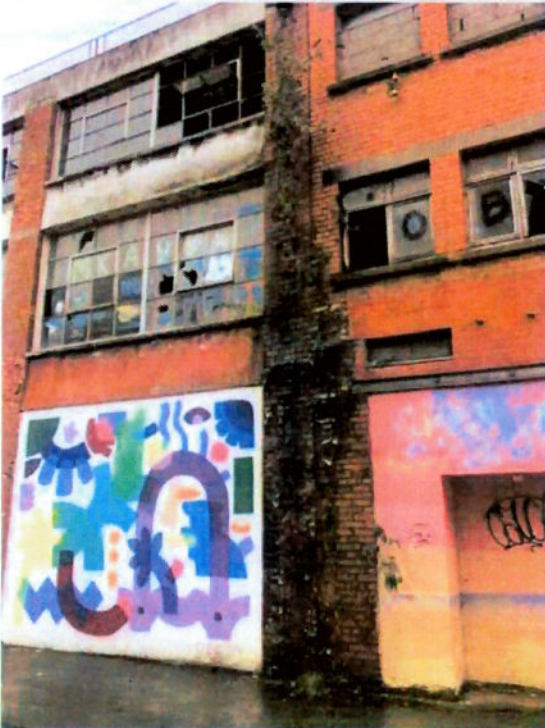
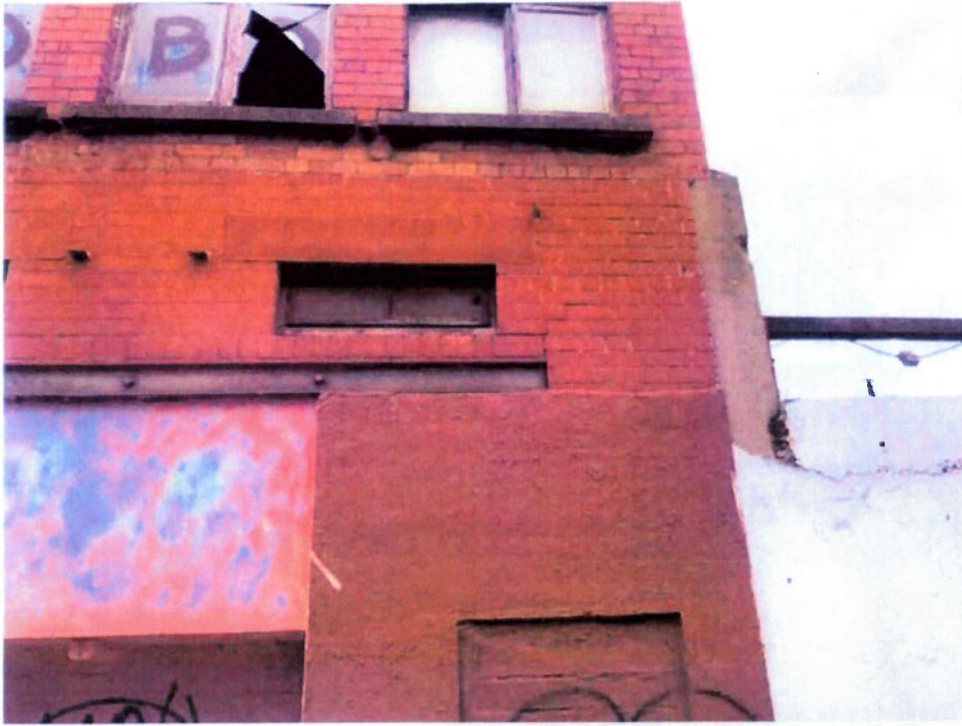
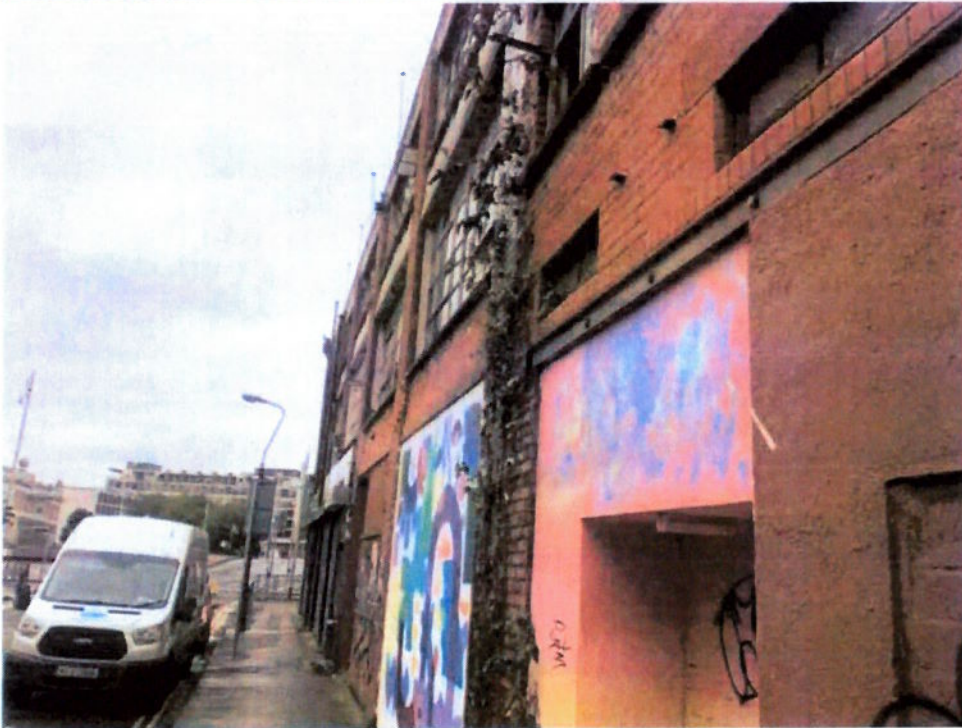
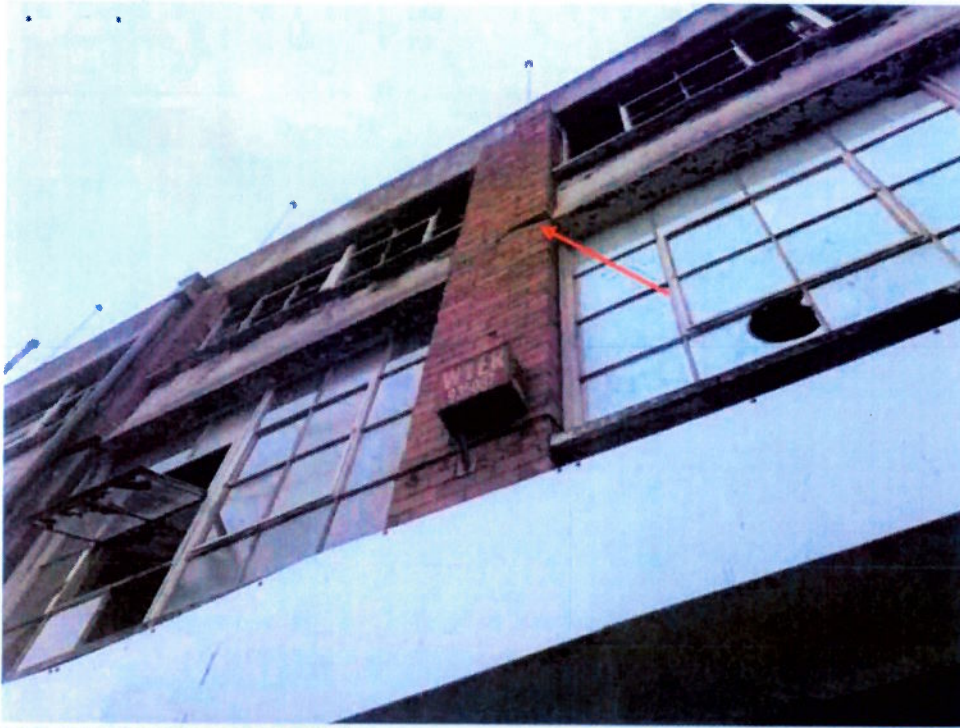
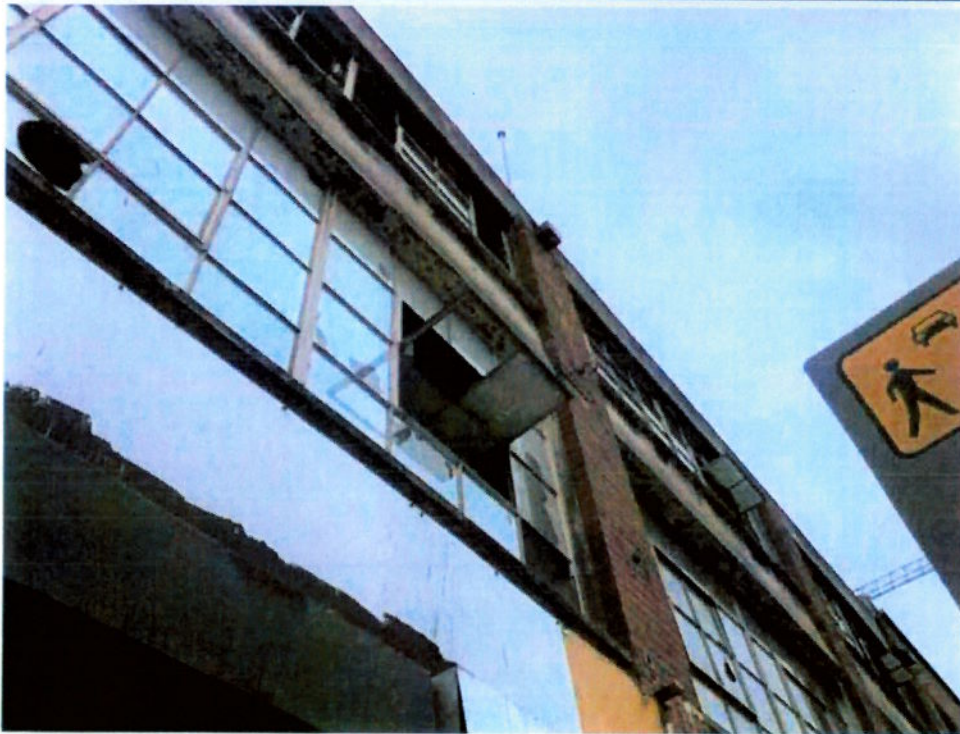
44 Comments

The vertical masonry piers have slipped at second floor level. Masonry has loosened and fallen away in some instances. This is an immediate concern for the building. There is a high risk of collapse of the vertical load bearing piers & danger to the public footpath below.

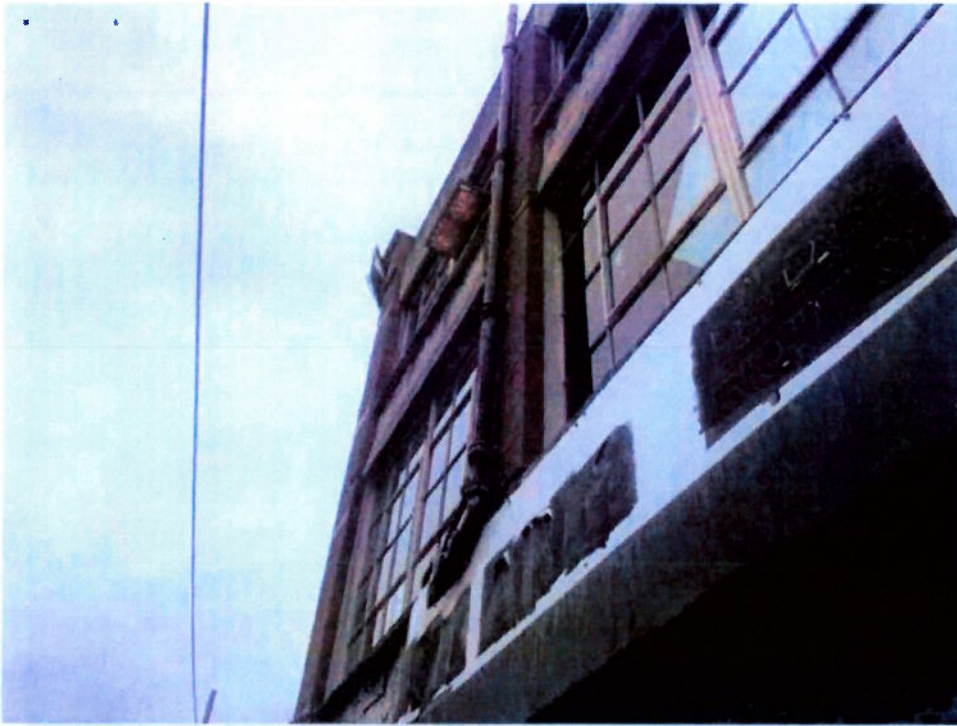
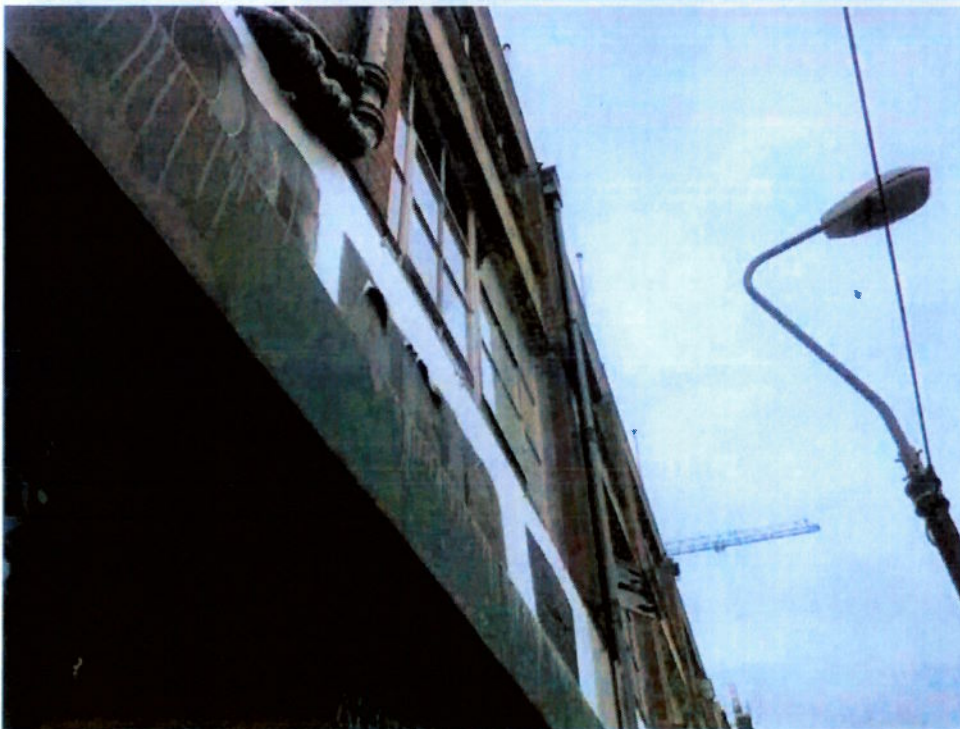
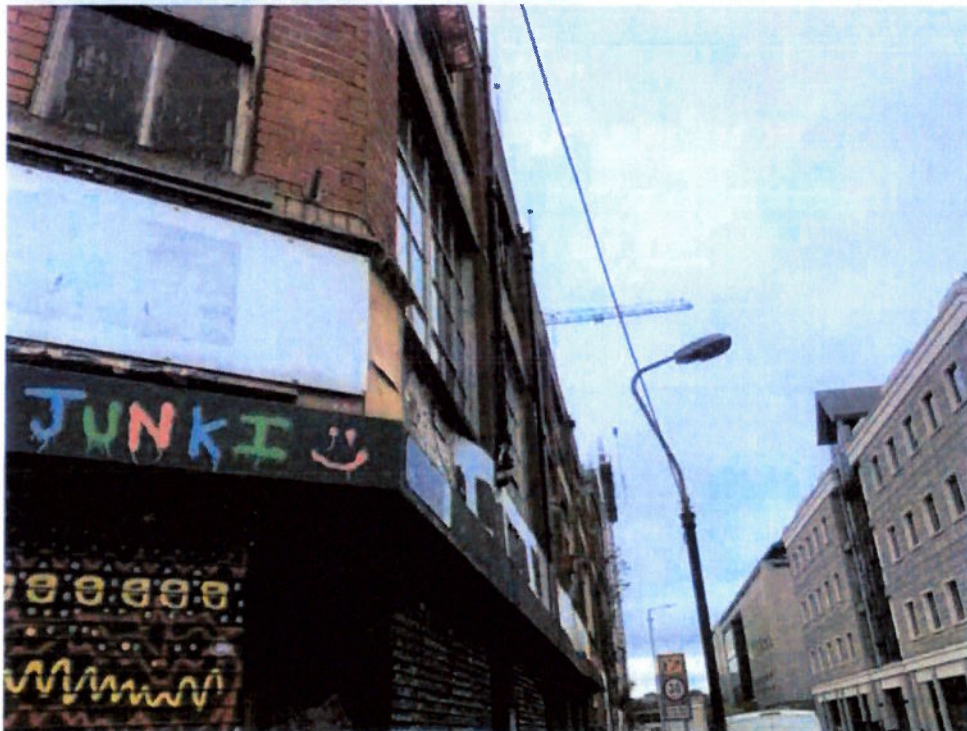
46 Comments

There is evidence of vertical structural cracking on this elevation

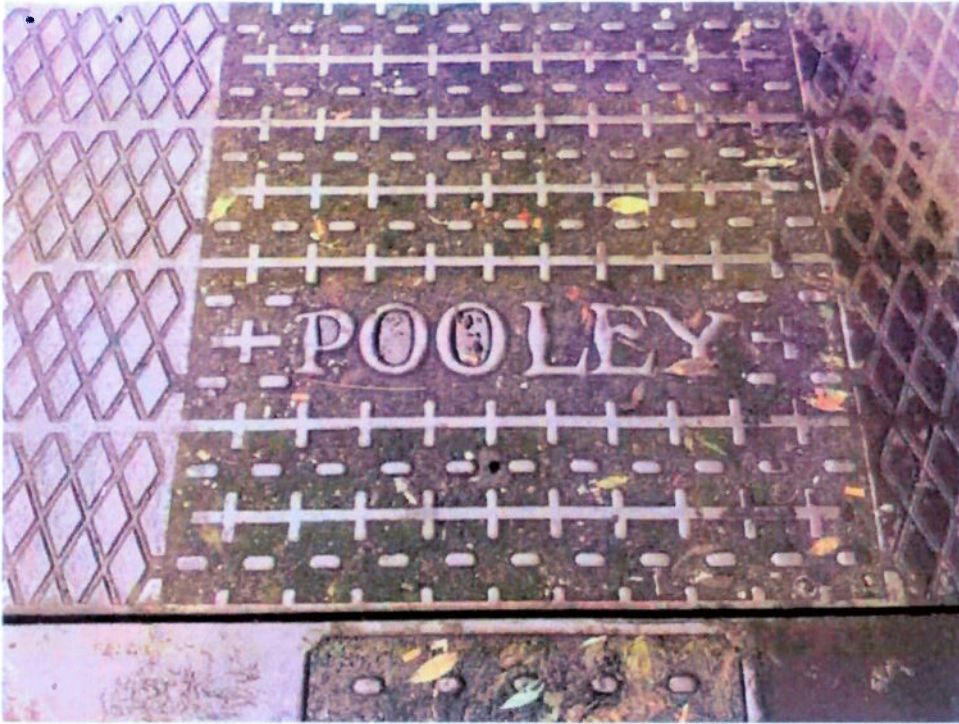
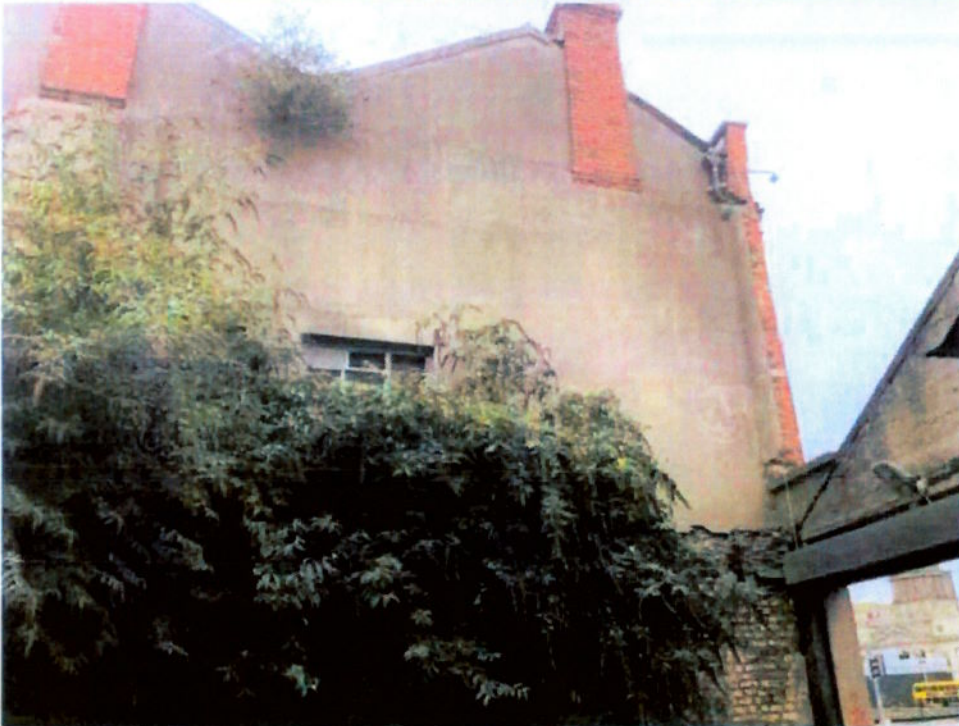
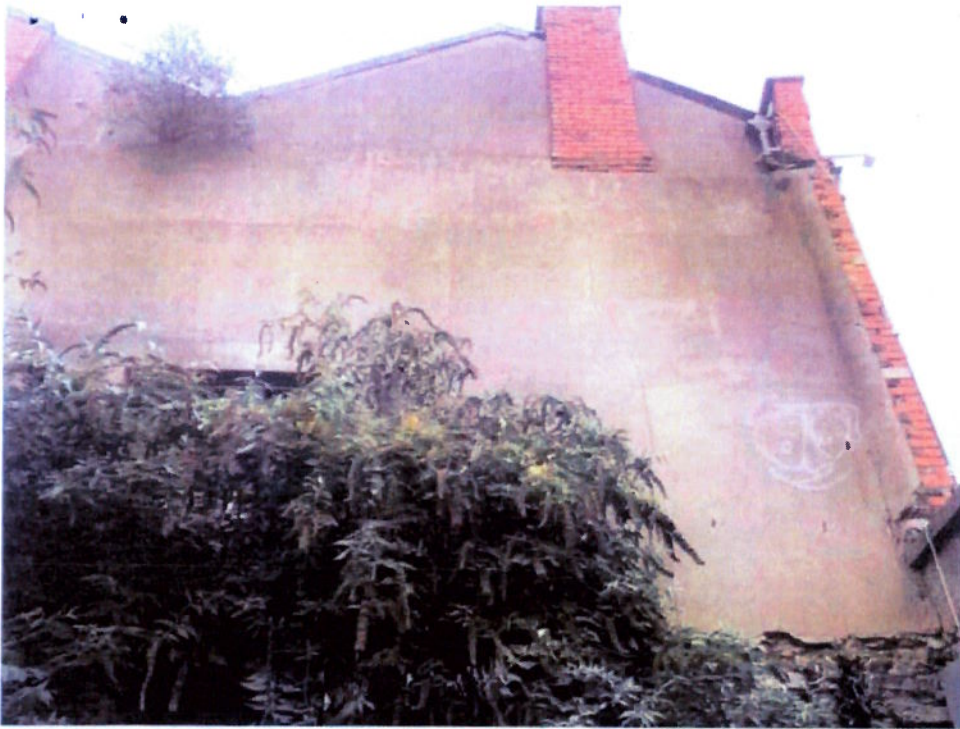
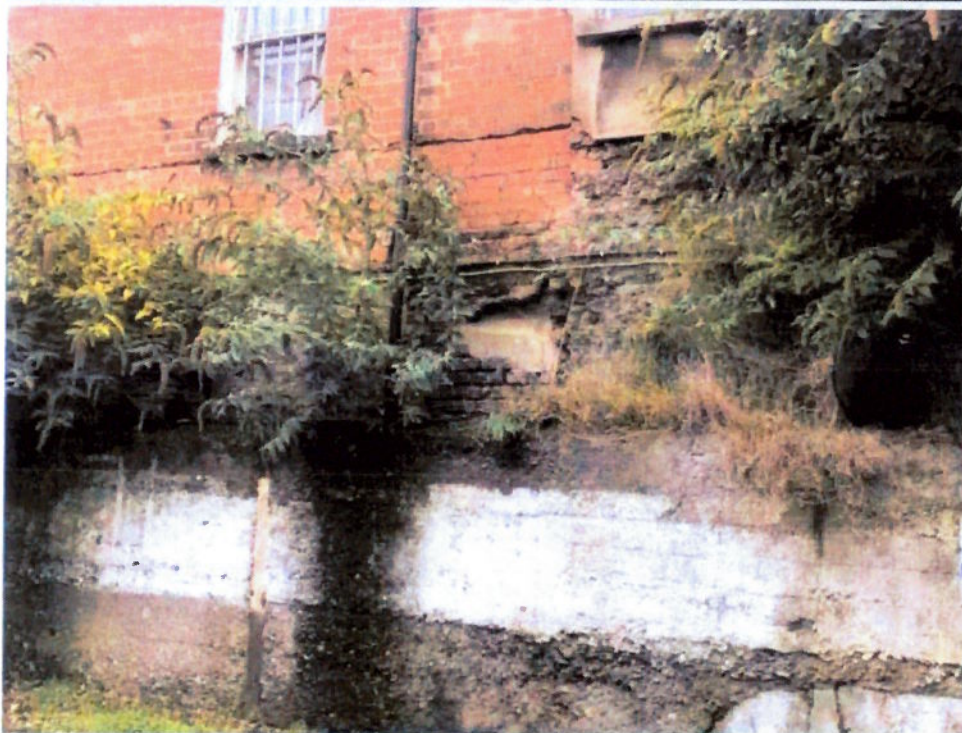
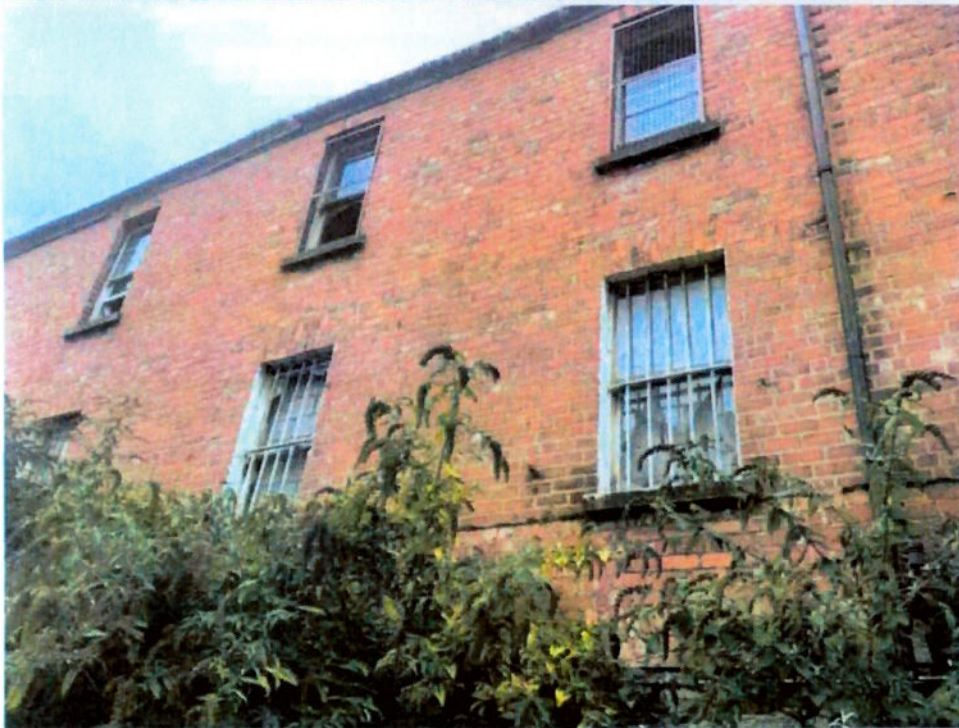
We regard the condition of this building to be dangerous. A considerable area of the building floor plates have perished & are not capable of loadbearing. In some areas the floors have collapsed under their own self weight. The masonry walls on the external elevations have cracked. On the Moss Street elevation the brick piers have already slipped laterally. We have concerns these piers are not capable of loadbearing. There is a risk to anyone using the public footpath below, of falling debris.
