APPENDIX A7.2.9

BUILDING A

MILLTOWN PARK HOUSE – INTERNAL IMAGES

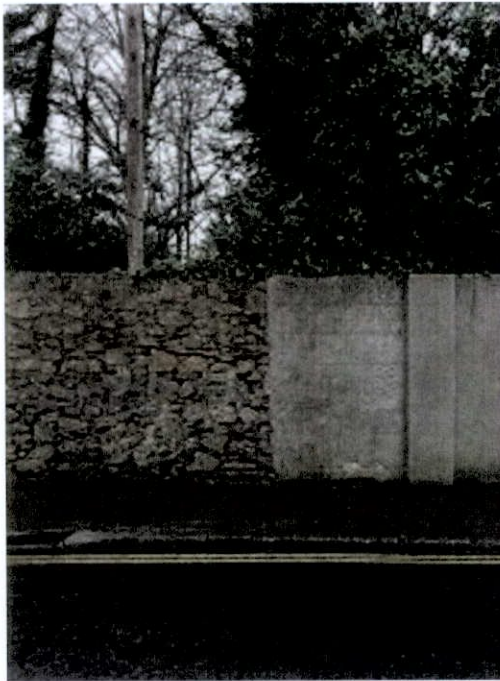
Plate 78: Change in wall composition on Milltown Road near junction with Sandford Road. Rubble wall is rendered and meets later pier

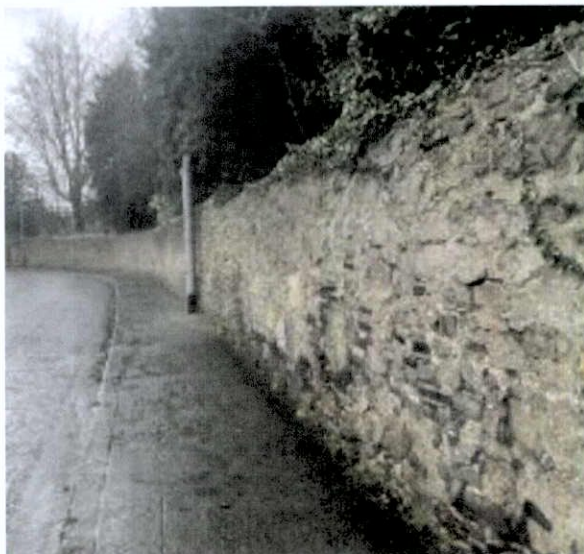
Plate 80: Curve of wall looking up Milltown Road towards new entrance, note multiple pointing types cement repairs to rubble wall

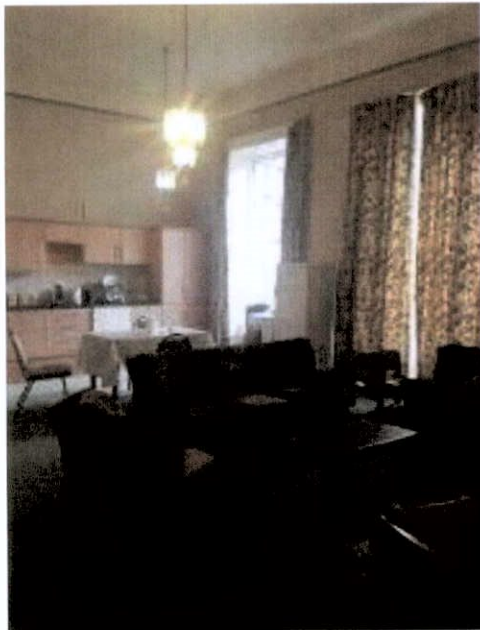
Plate 98: Large room within the former Orangery to the south with full height ceiling, missing fireplace, and more recently in use as kitchen/diner

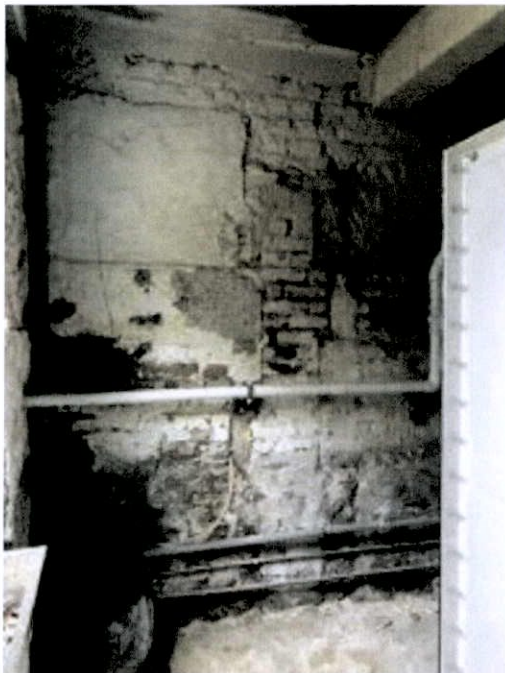
Plate 102: Note multiple layers of intervention; infilled masonry and brick arch-headed opening, later concrete structure

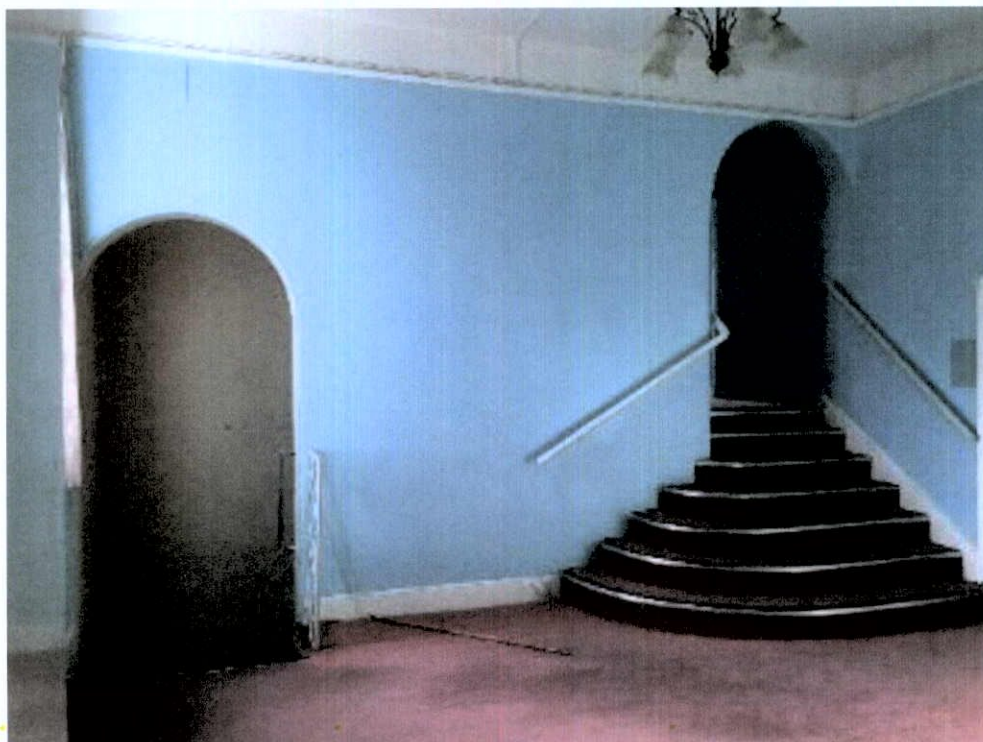
Plate 105: First floor level infilled entrance hall with later stairs leading to vertical extension.

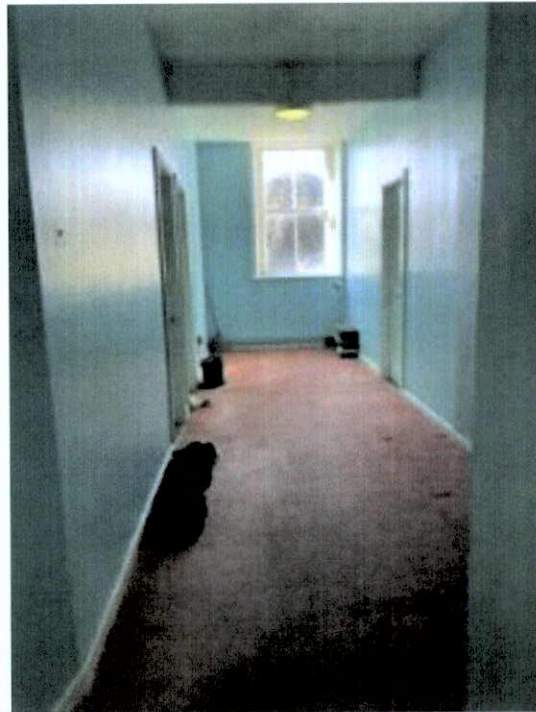
Plate 111: Modified upper level. Dropdown beam supporting vertical extension over. View facing south-west. Contemporary linings and loss of original layout evident.

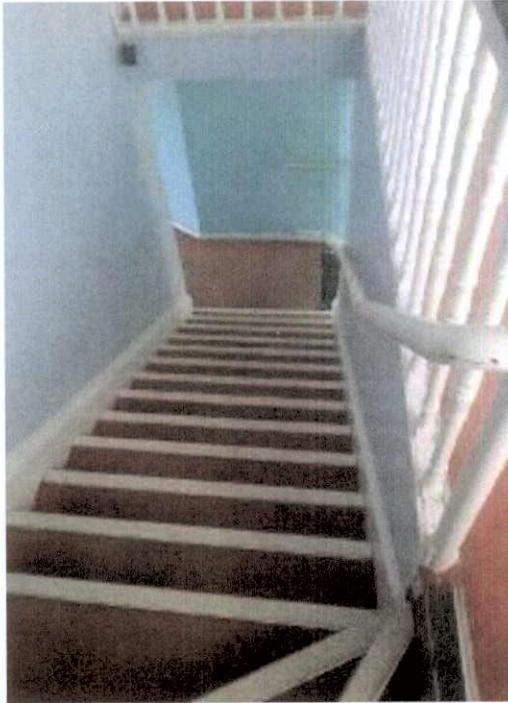
Plate 117:: Stairs from first floor viewing up

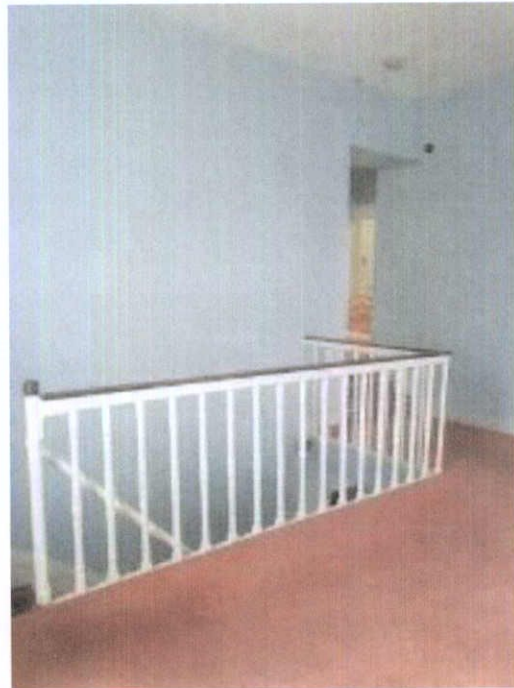
Plate 118: Level 2 Landing within MPH with mahogany painted stair rail. No decorative plasterwork.

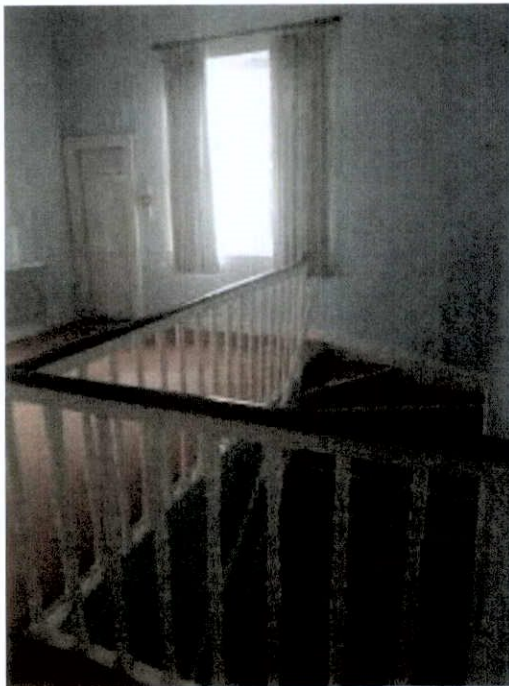
Plate 119: Level 2 landing facing south-east towards front elevation.

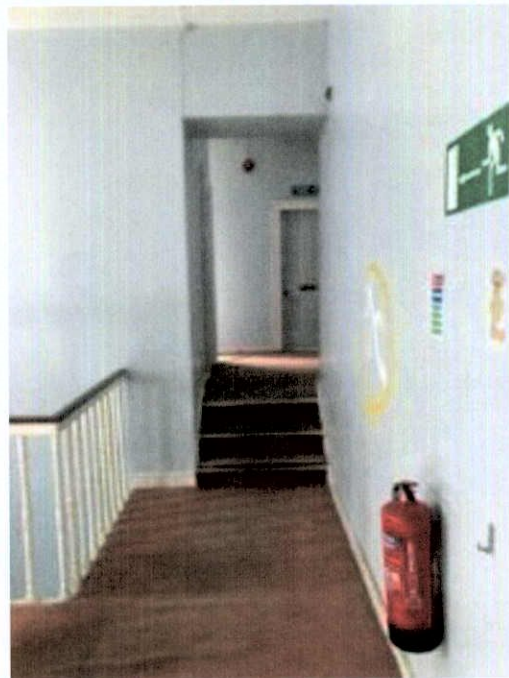
Plate 120: Level 2 landing facing south.

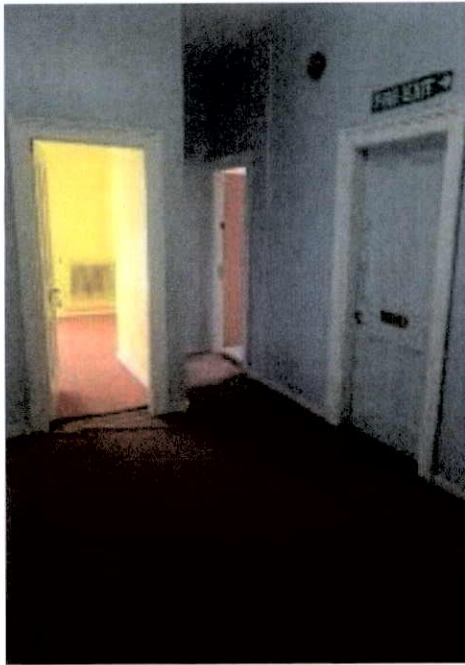
Plate 121: Internal circulation within the uppermost level of Milltown Park House

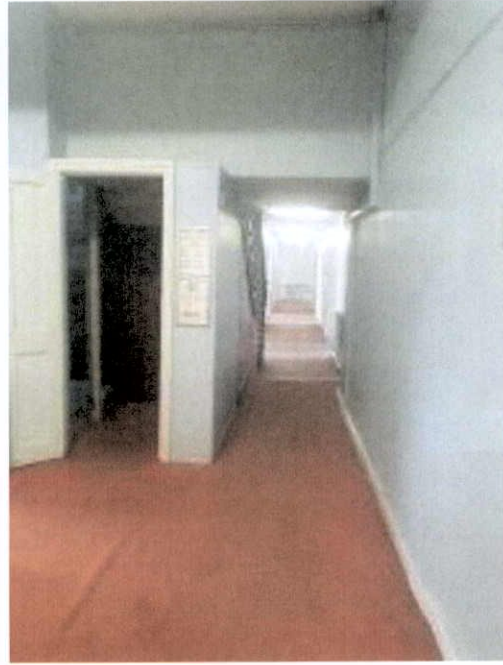
Plate 122: Central hall at 2nd floor level linking to rear extension block. Note water tank room to lhs of image which extends up into roof void

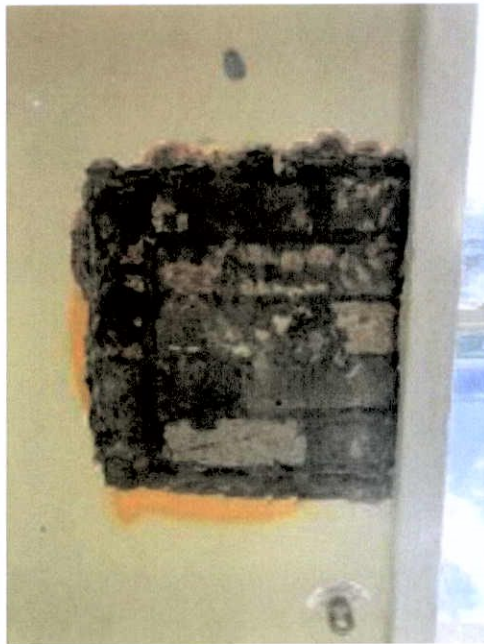
Plate 123: Opening up investigations to uncover brick substrate.

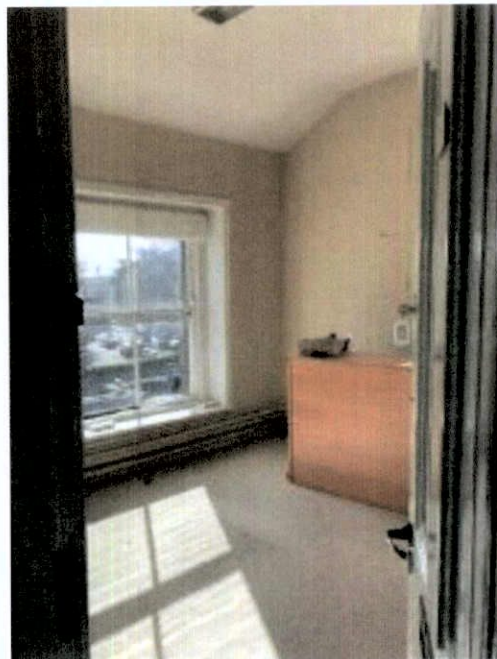
Plate 128: Two-over-two sash windows to the south of MPH.

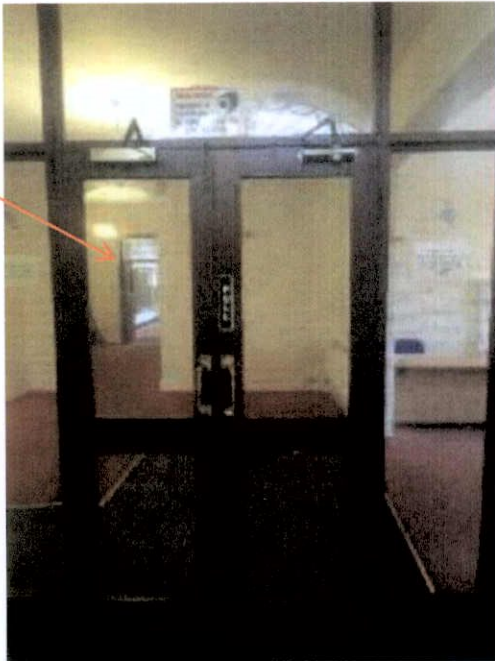
Plate 129: View towards rear extension block from entrance of main house

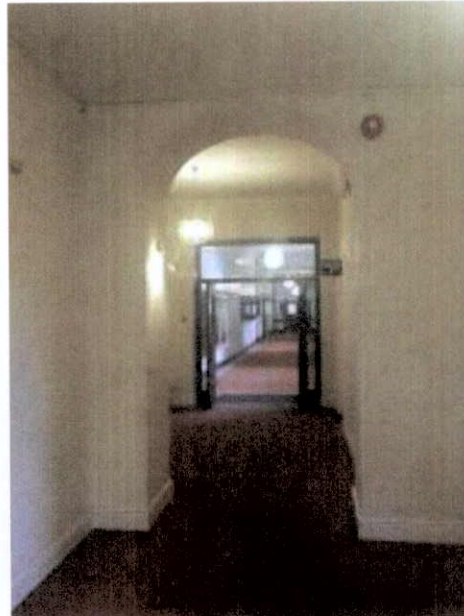
Plate 130: Connection with rear extension block, from rear of entrance hall

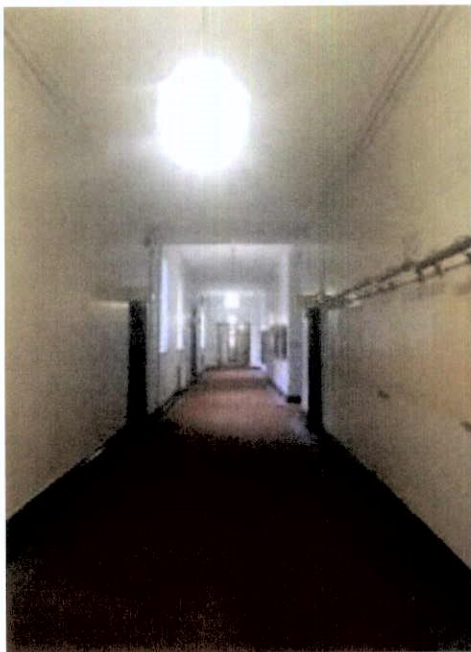
Plate 131: Wide corridor within rear extension block, with dormitories/meeting rooms on either side

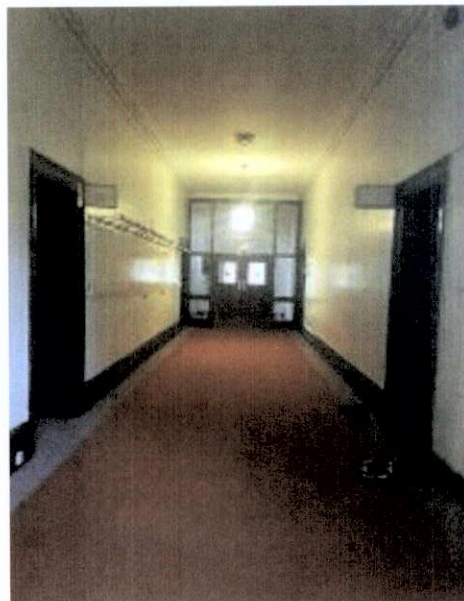
Plate 132: As above, opposing view

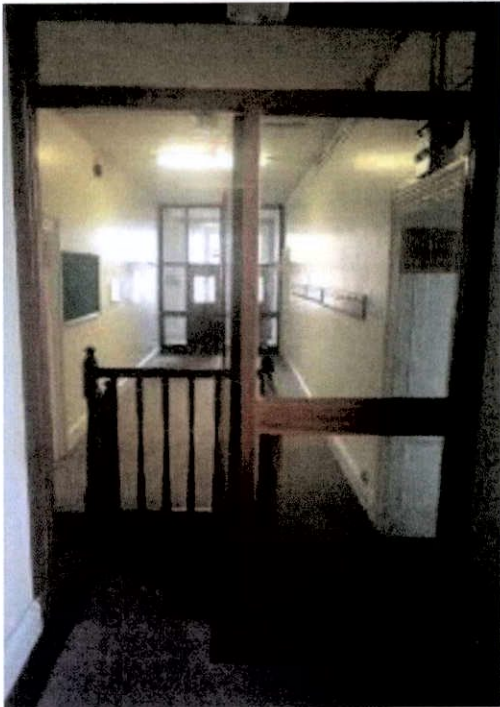
Plate 133: View from entrance link, from main house to central corridor of rear extension block

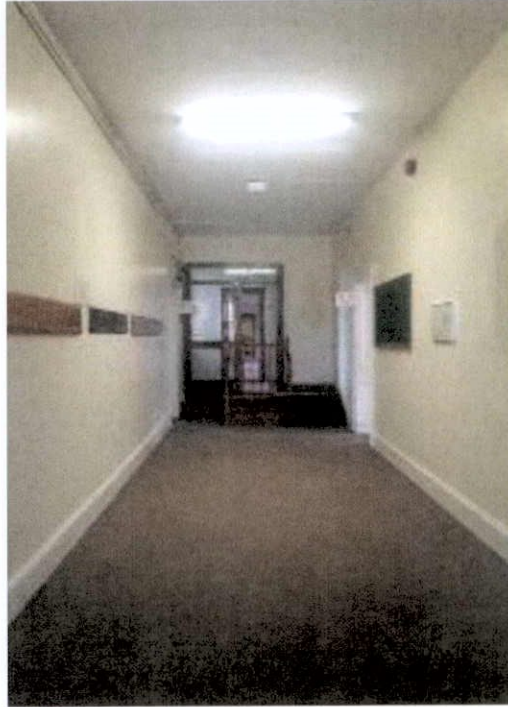
Plate 134: Corridor at same level viewing west to east

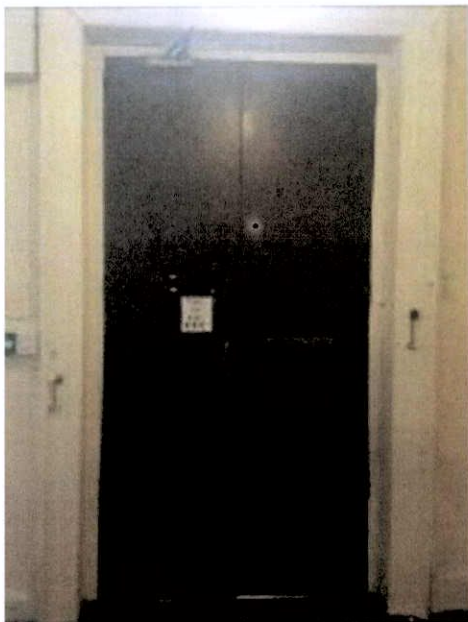
Plate 135: Security door off main block corridor

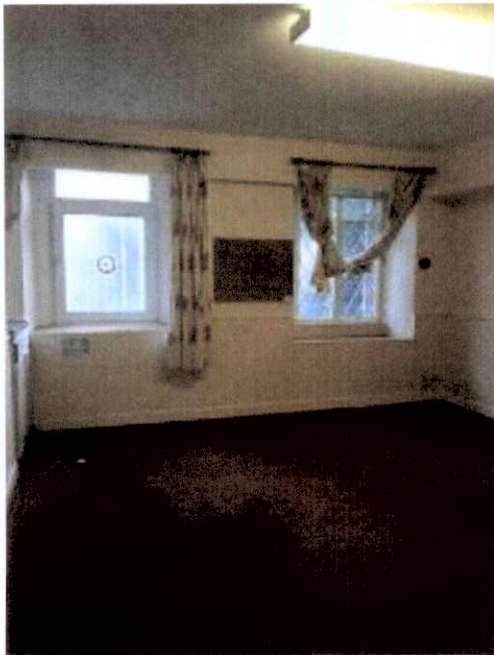
*Plate 136: Dormitory at lower ground floor level.
Note water ingress*

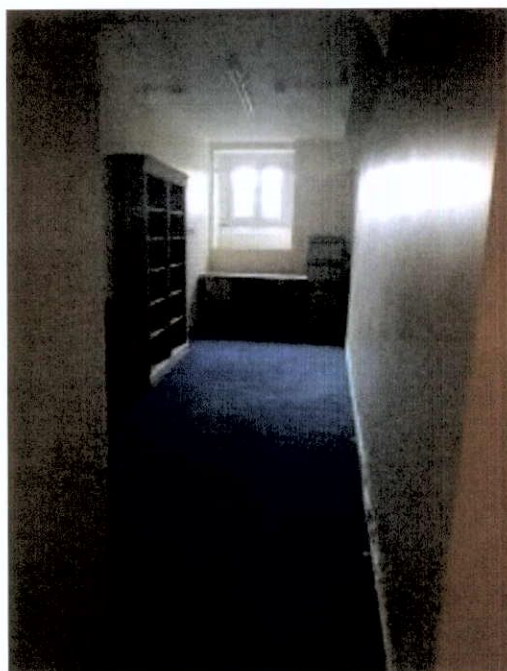
*Plate 138: Narrow office space with partition wall, to
the southwest corner of main house*

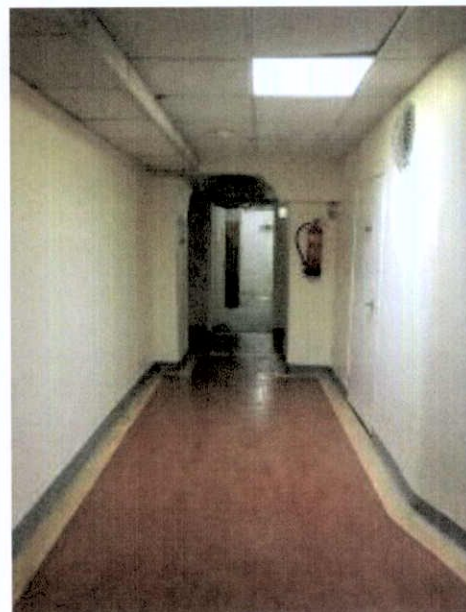
*Plate 139: Corridor viewing back to main house,
from west to east*

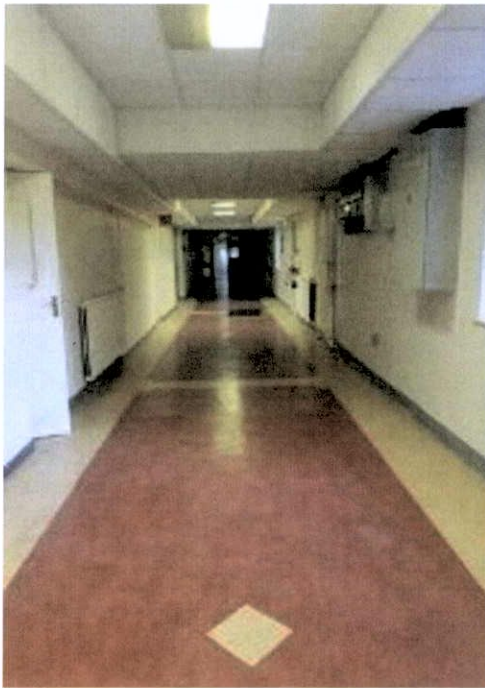
Plate 140: Same corridor, viewing from east to west

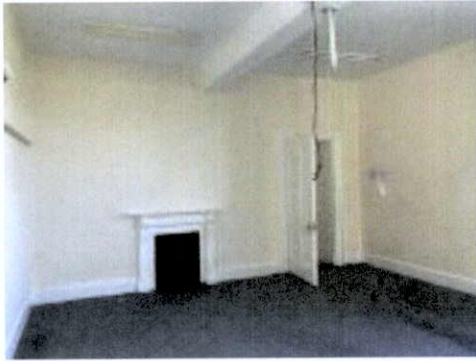
Plate 142: Lecture room within rear extension block at 1st floor level

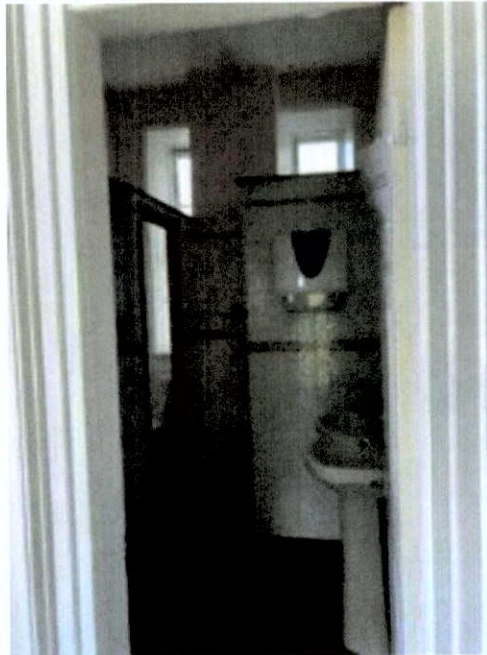
Plate 143: Toilet block within 1st floor level

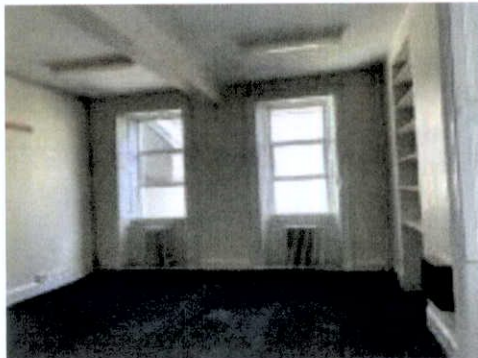
Plate 144: Later windows with original panelled shutters, exposed grid structure.

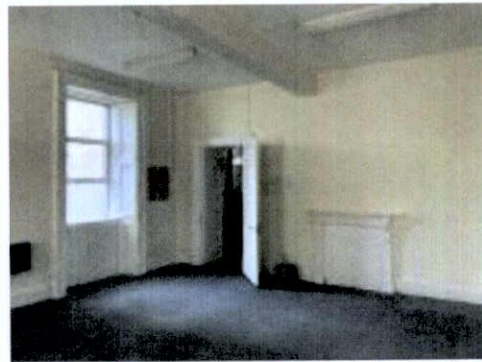
Plate 145: Corbelled chimneypiece within first floor of MPH rear extension.

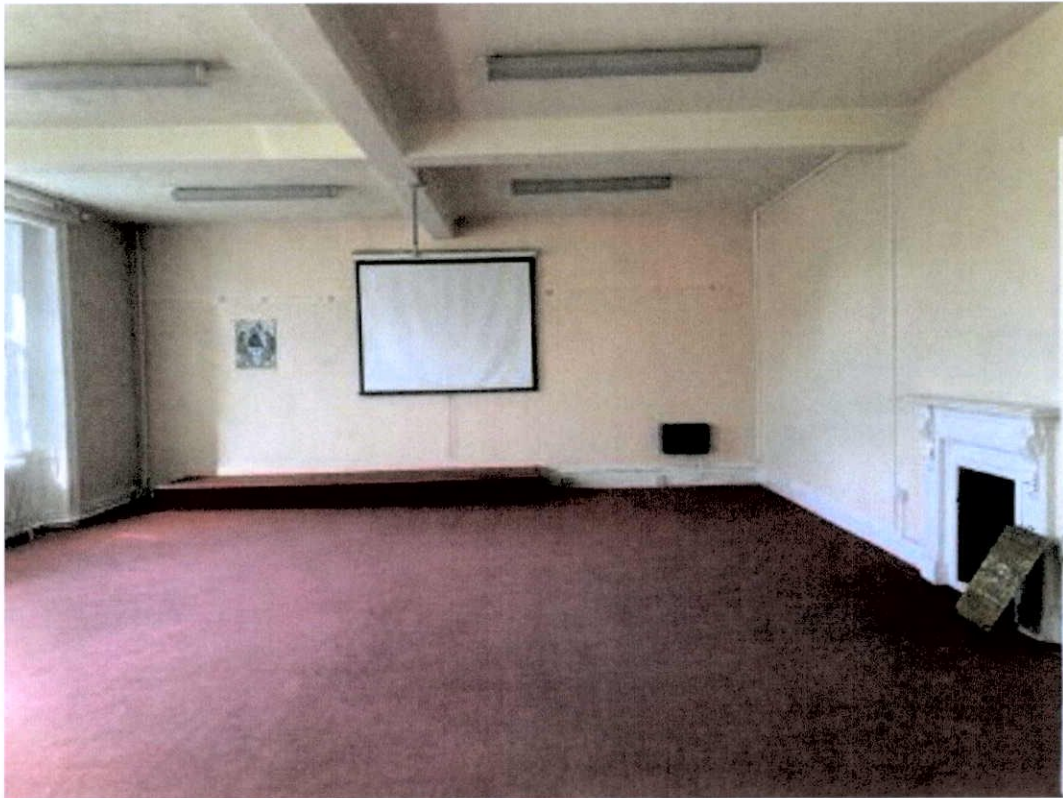
Plate 146: Lecture room within rear extension block at 1st floor level. Panelled door, sash windows with panelled shutters.

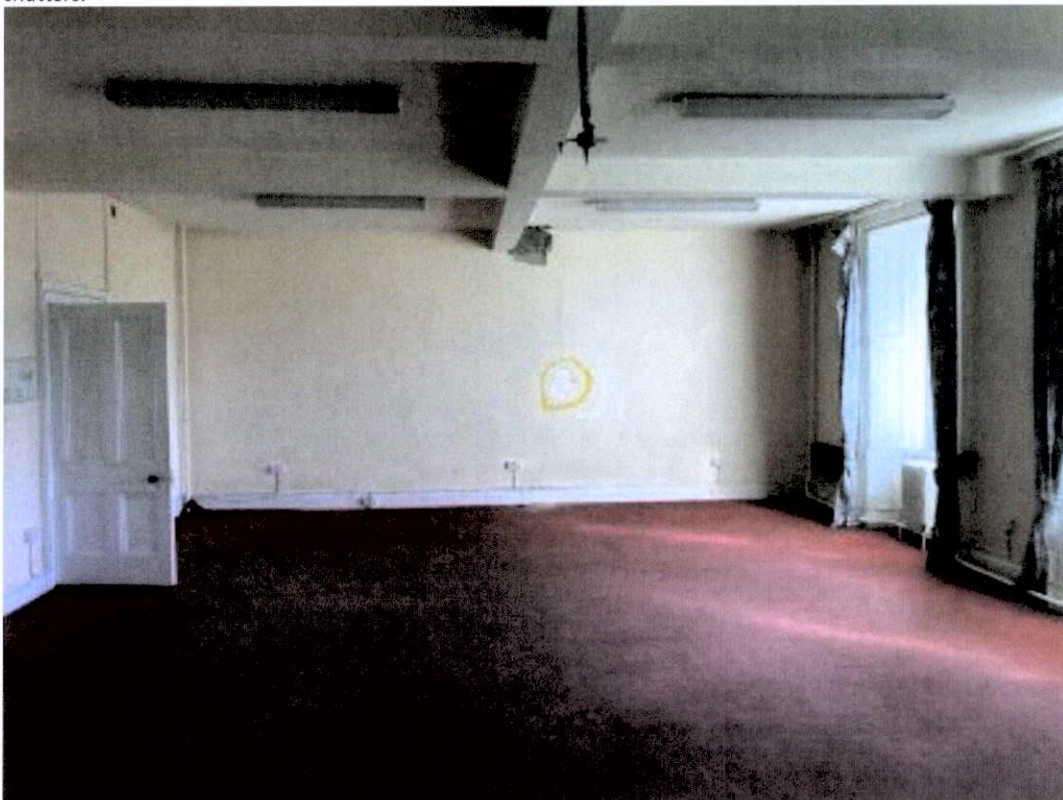
Plate 147: Exposed structural grid in rear extension.

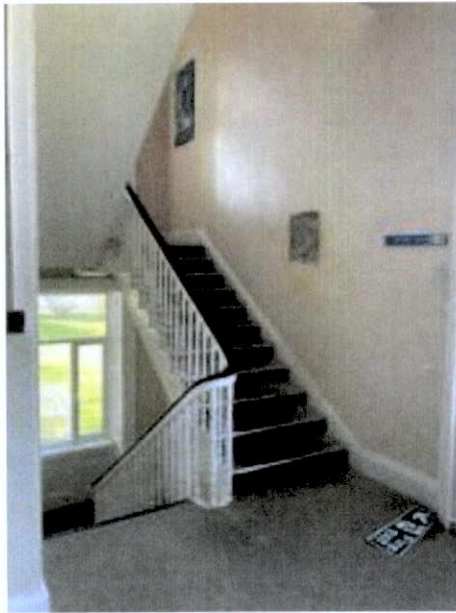
Plate 148: Stair linking 1st and entrance level of rear extension block

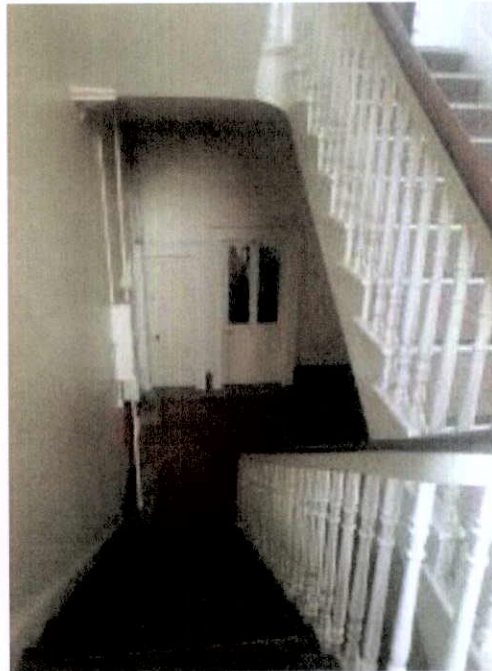
Plate 149: Stair linking 1st and entrance level of rear extension block

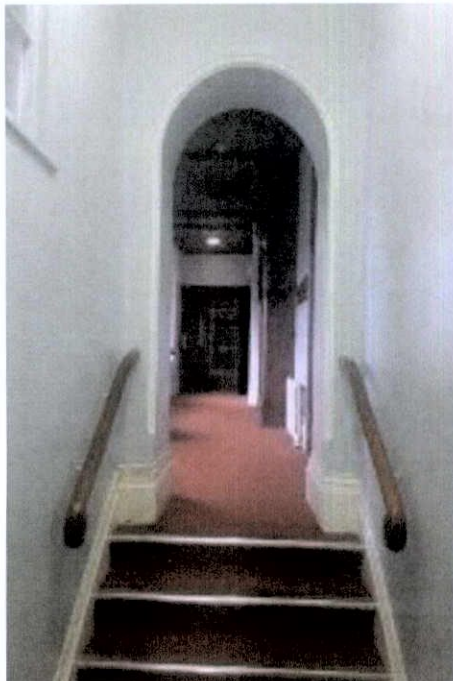
Plate 150: Stair access leading to a suite of rooms adjacent to the former domestic chapel at half level between entrance and 1st floor level of rear extension block

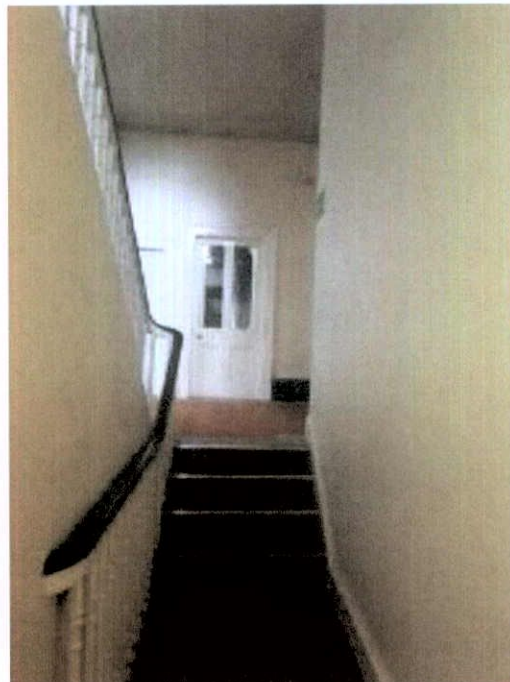
Plate 151: Alternative view of corresponding stair

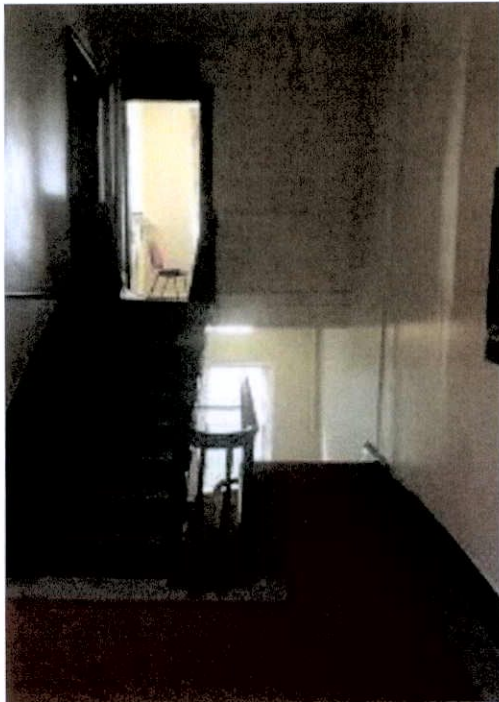
Plate 152: Stairs to rear of former chapel accessing the chapel ante-room

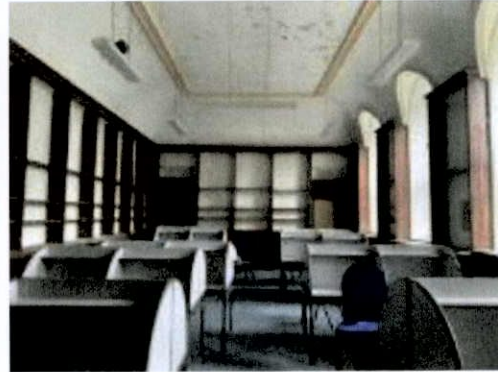
Plate 153: Former domestic chapel, now a reading room, accessed from a short flight within the entrance level corridor within rear extension block

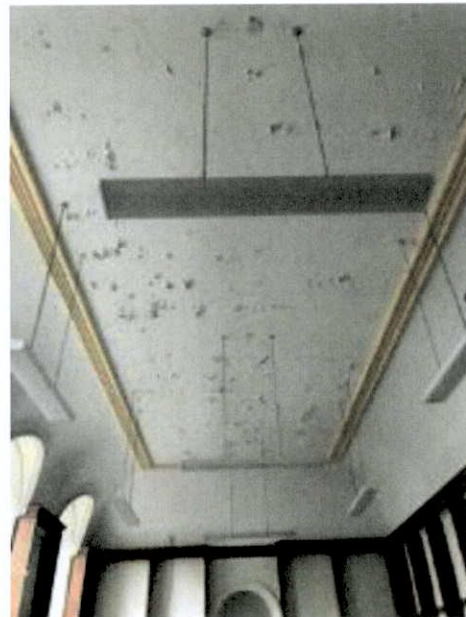
Plate 155: Coffered ceiling of former domestic Chapel.

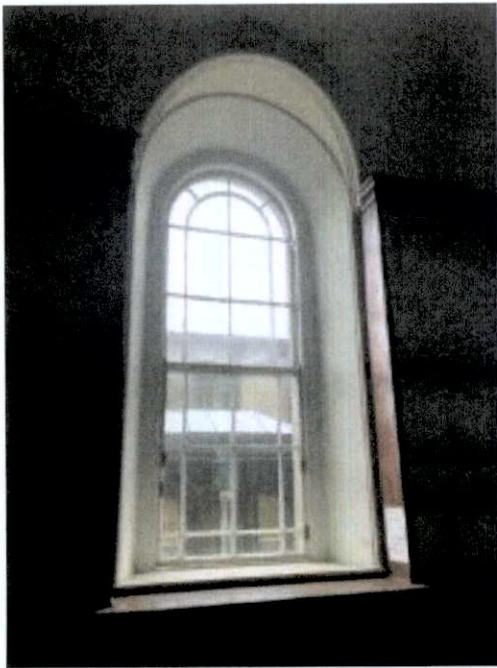
Plate 156: Round headed timber sash window with margin lights within former domestic Chapel.

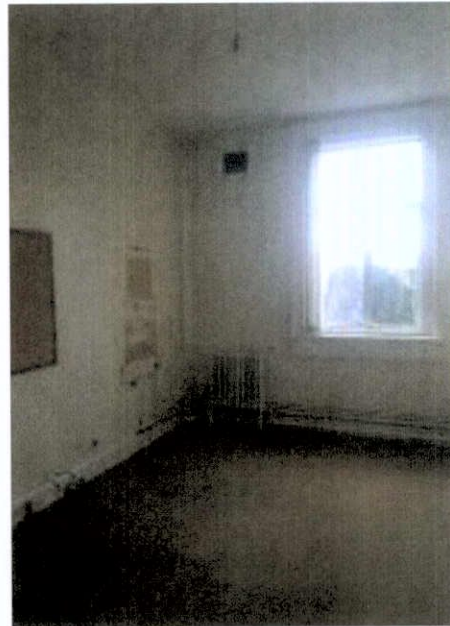
Plate 164: A typical dormitory. Exposed services.

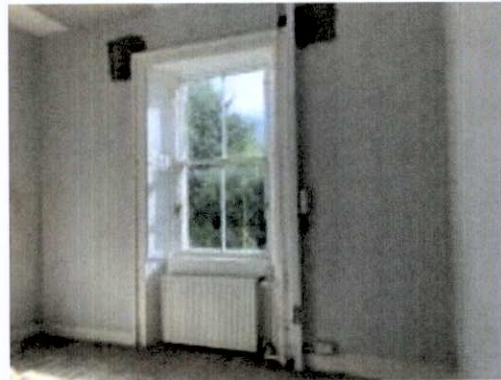
Plate 198: Two-over-two sash window, original shutters and architrave. Areas of plaster removed to reveal underlying masonry substrate.

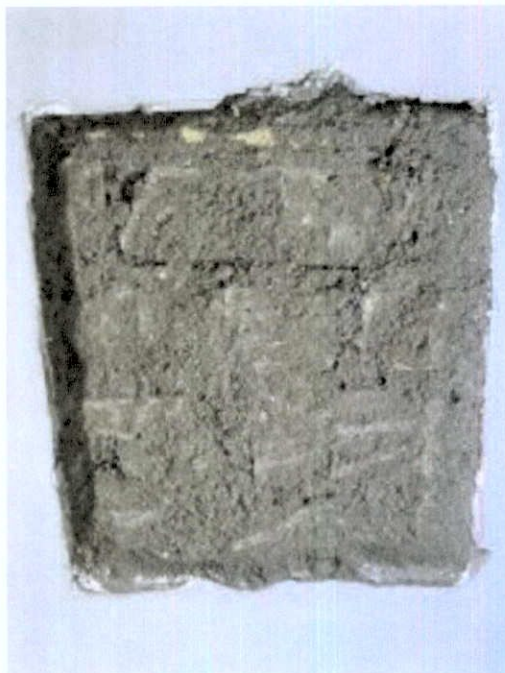
Plate 199: Section of plaster removed to reveal brick substrate.

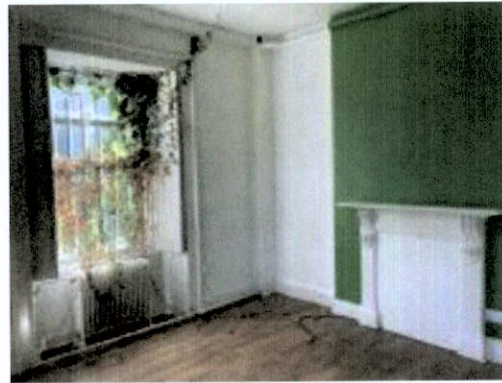
Plate 214: Overgrown vegetation within lower ground floor impacting original joinery fabric. Corbelled chimneypiece matching those on the entrance level.

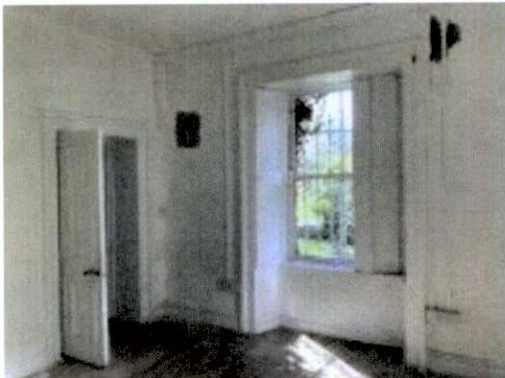
Plate 215: Original door and window joinery. Localised removal of internal render to inspect underlying masonry fabric.

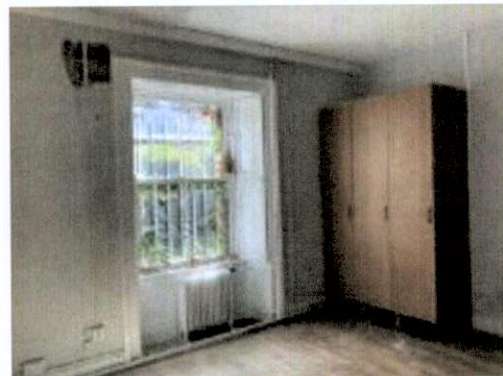
Plate 216: Overgrown vegetation impacting original joinery fabric.

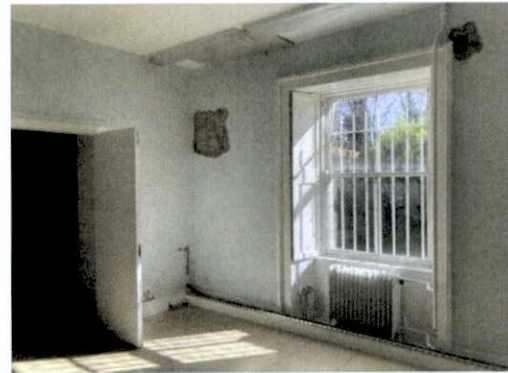
Plate 228: Localised removal of plasterwork to reveal underlying masonry fabric.

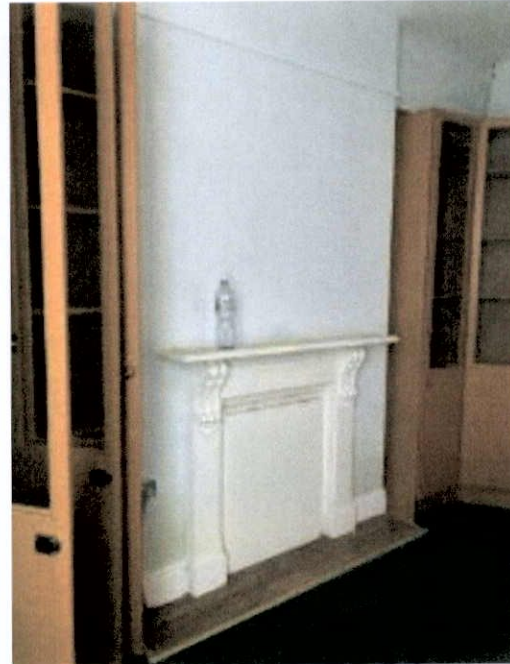
Plate 242: Original chimneypiece with scrolled corbels supporting mantel

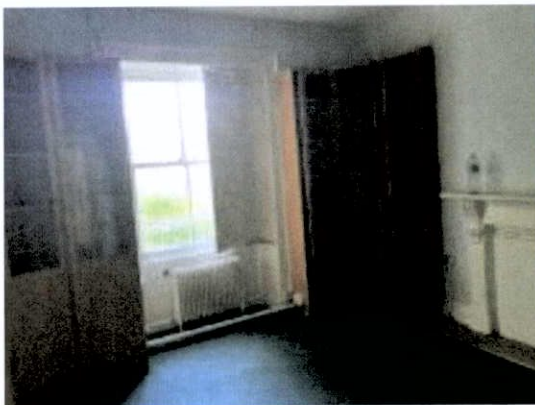
Plate 243: Contemporary fixtures and fittings and services. Original window joinery.

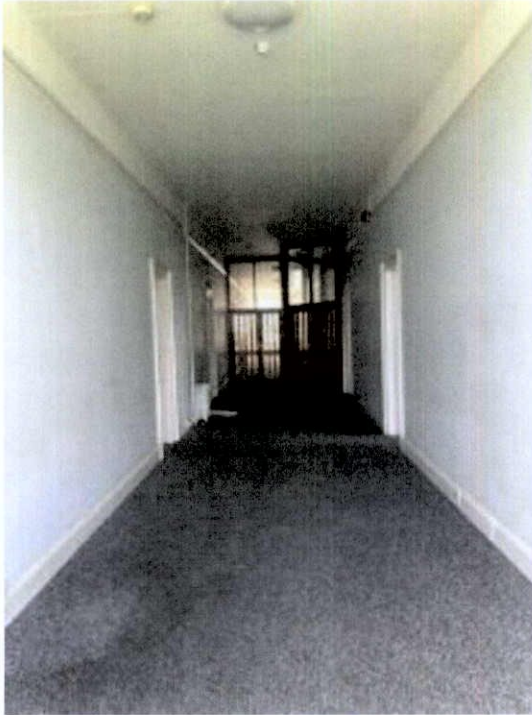
Plate 245: Central corridor with later fire-rated screens across corridors and enclosing stairs.

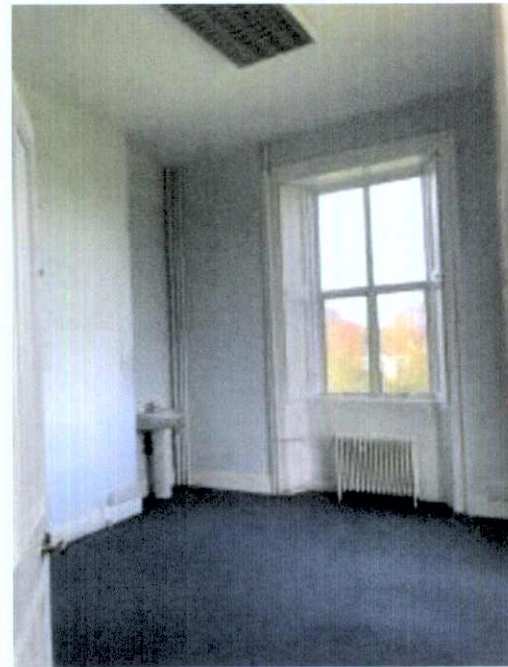
Plate 248: Typical first floor accommodation, original window-box with contemporary uPVC window. Exposed services, no decorative plasterwork.

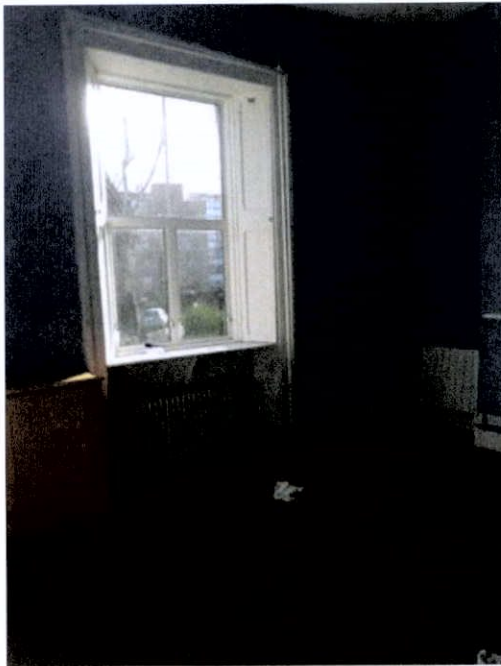
Plate 249: Dormitory facing south east, original window-box with contemporary uPVC window.

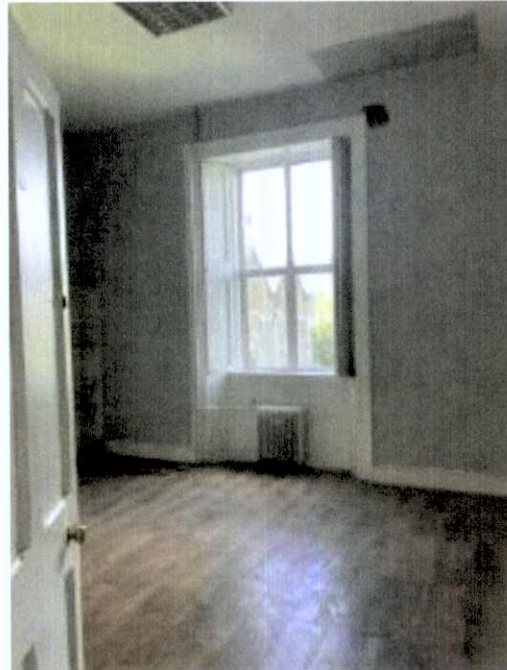
Plate 254: Original window boxes with contemporary uPVC window frame.

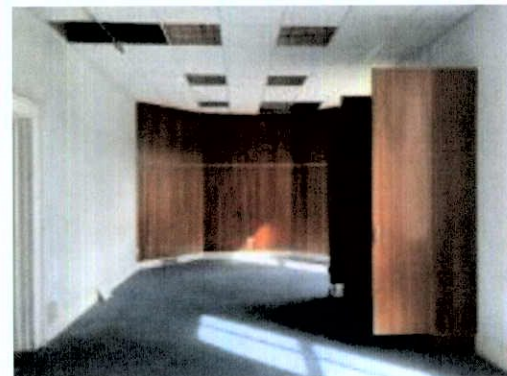
Plate 256: Contemporary fixtures and fittings and suspended ceilings.

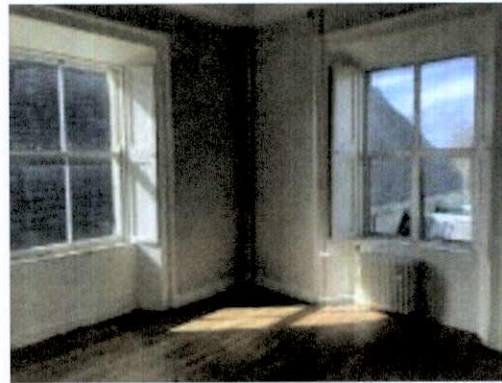
Plate 278: Original window joinery, with contemporary uPVC window frame in north elevation.

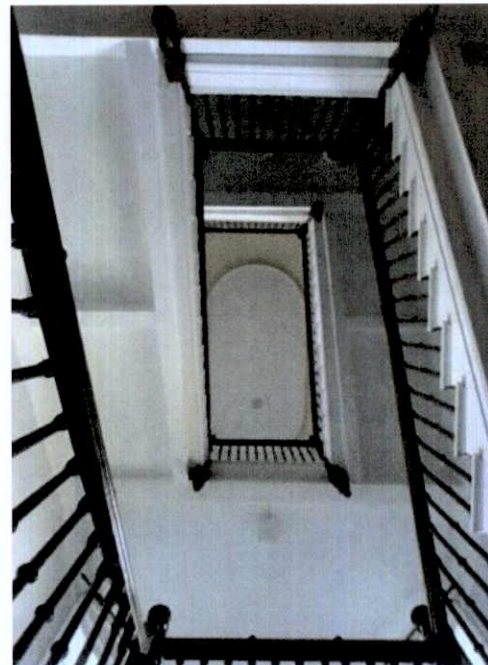
Plate 288: View up stair

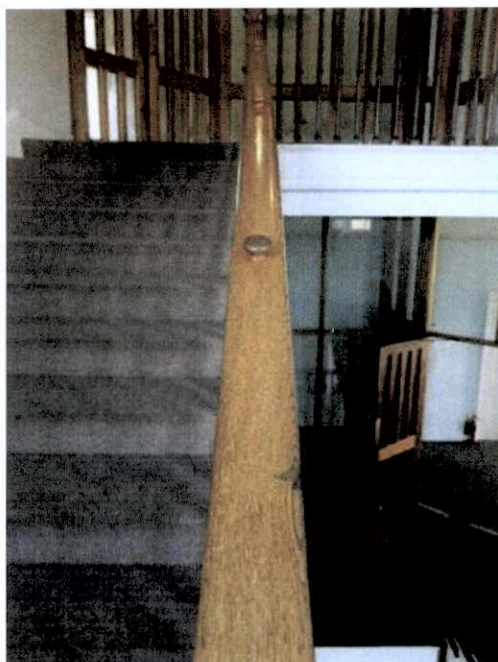
Plate 289: Detail of oak handrail

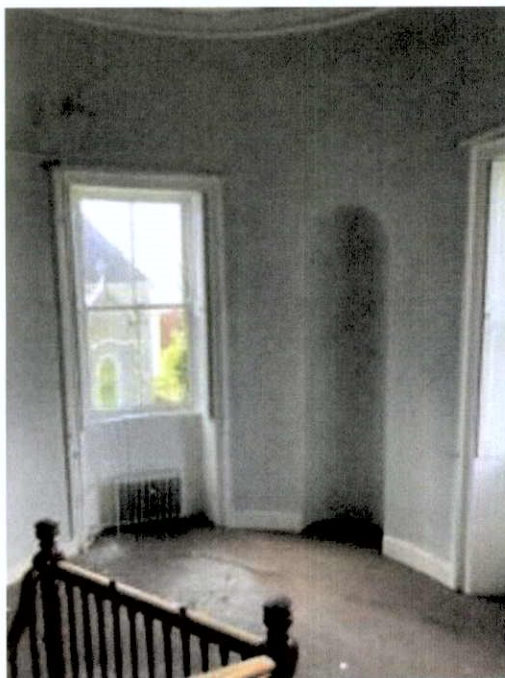
Plate 291: Rounded niche on half-landing flanked by a pair of two-over-two sash windows.

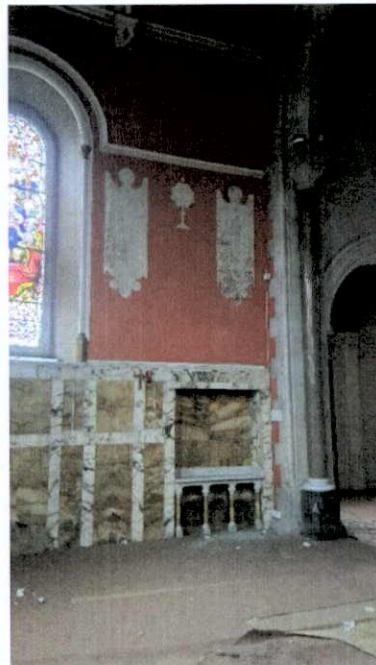
Plate 296: Scarred profile of position of Harry Clarke paintings

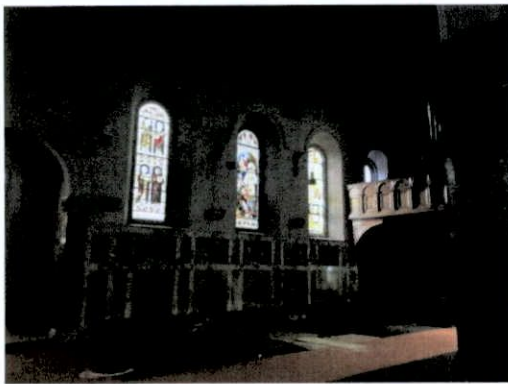
Plate 301: South wall of nave. Note the absence of the Stations of the Cross which were removed

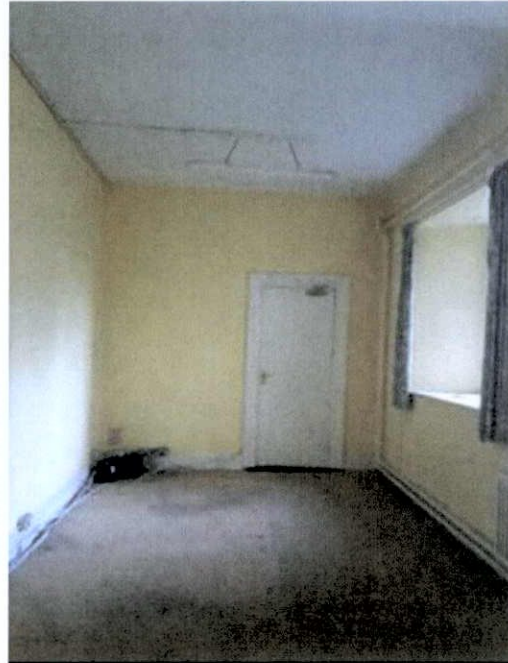
Plate 302: Evidence of water ingress at base of wall.

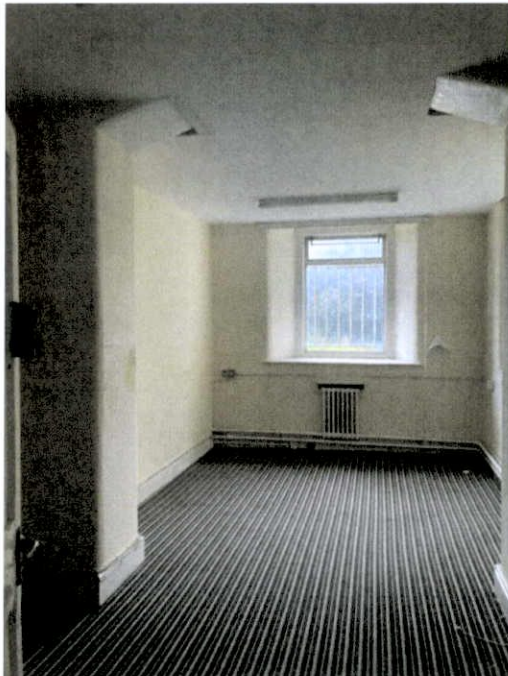
Plate 303: Lowered ceiling. Arched openings supporting columns in Chapel above. Contemporary windows. No decorative plasterwork.

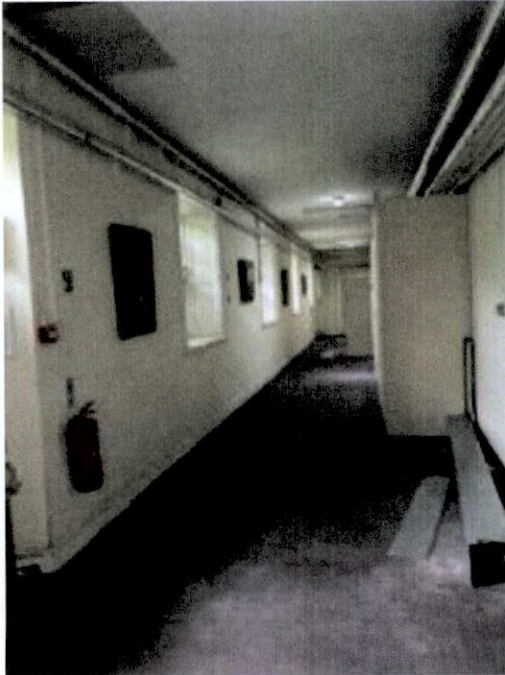
Plate 305: Lower ground floor corridor with exposed services. Original sash windows and shutters.

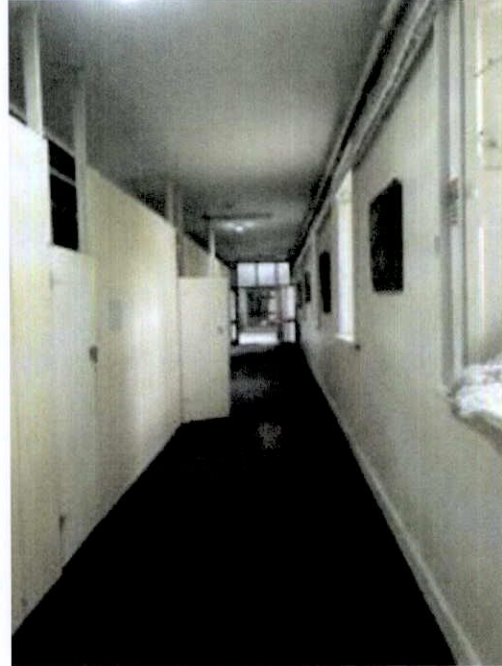
Plate 306: Lower ground floor corridor with later lightweight partition enclosures.

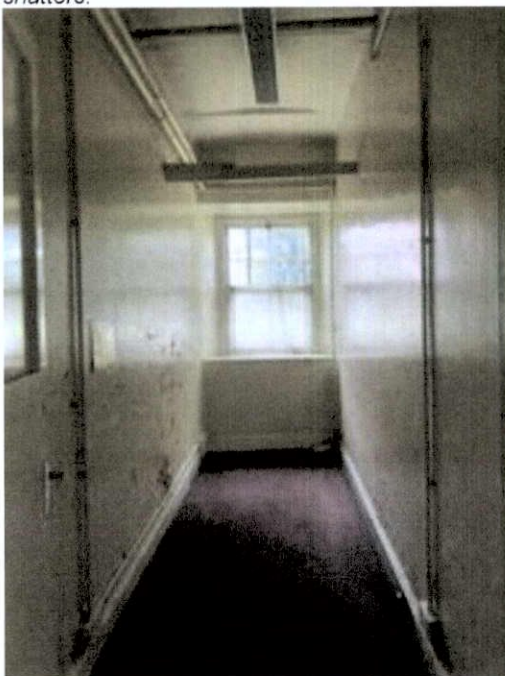
Plate 307: Lower ground floor corridor with two-over-two timber sash window, splayed plaster reveal.

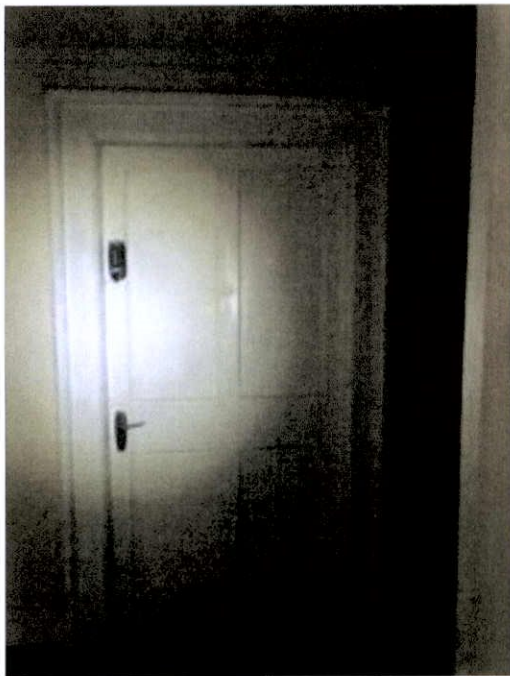
Plate 309: Typical panelled door and architrave at basement level.

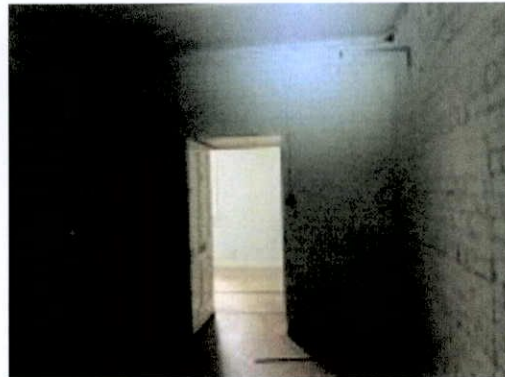
Plate 310: Plant room area, with exposed brick, painted finish.

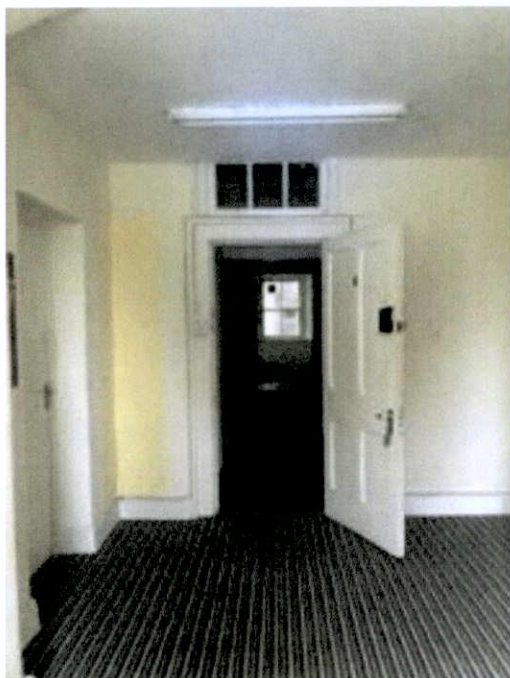
Plate 311: Panelled door with transom light over.
