APPENDIX A7.2.9

BUILDING A

MILLTOWN PARK HOUSE – INTERNAL IMAGES

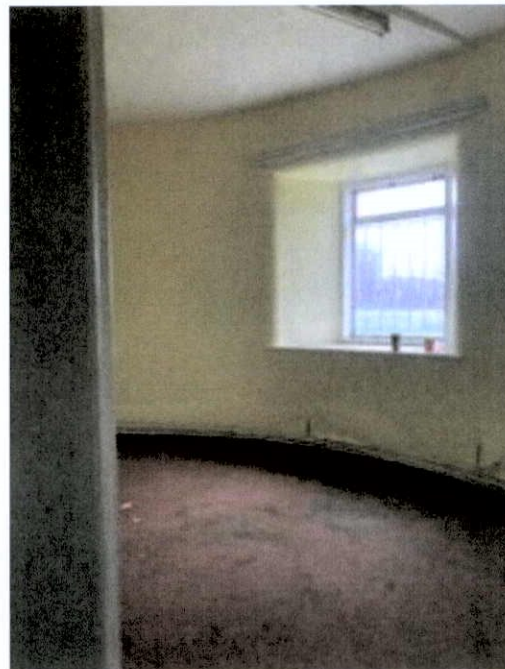
Plate 312: Lower ground floor, within rounded bay. Evidence of water ingress at base of walls.

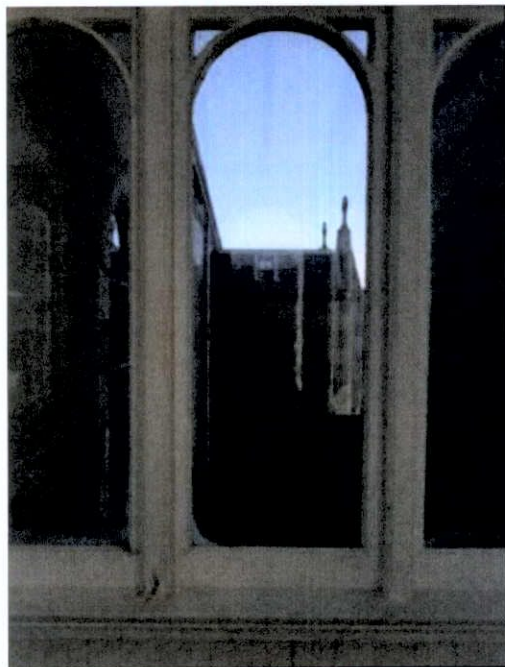
Plate 315: View west from linking corridor
