A4.7.3.2. Archival research describing the development on the site from 1916 to present

A4.7.3.3. Summary of forensic analysis findings

This report was prepared at the request of Molloy & Associates Conservation Architects to inform the Dublin Central Built Heritage Review for Hammerson Plc. The purpose of the work was to analyse the physical fabric of buildings on O'Connell Street, Parnell Street, Henry Street, Moore Street, Moore Lane and Henry Place; and to use the physical evidence gathered through study of the building materials to gain a better understanding of the significance and dating of each of the buildings. This report refers to buildings from Sites, 3,4 and 5 on Henry Street, Moore Street and Moore Lane¹.

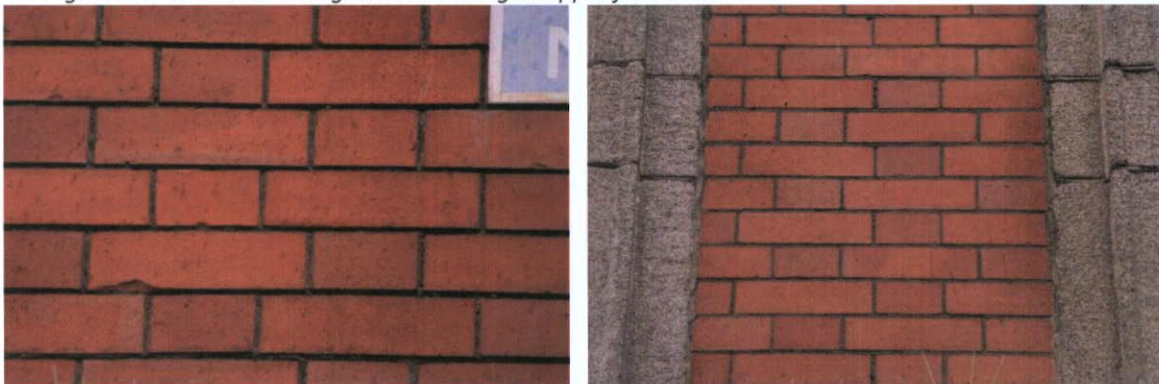
Fig.4.5.3: Detail of the c.1917-1920 brickwork at 41 Henry Street.
