4.9 5 Moore Street: The three-storey two-bay brick-fronted terraced building rising to a limestone frieze and cornice, built c.1917, has brick ‘soldier’ quoins and a modern shopfront at ground floor level. The architectural detail is uniform across the terrace, with identical limestone detailing at parapet and shopfront level, and with brick specials forming a string course between the first and second floor levels. The brickwork was finished with flush joints. No.5 was built c.1917 as part of a single build with Nos.3, 4 and 6 Moore Street.

4.10 6 Moore Street: The three-storey three-bay brick-fronted terraced building rising to a limestone frieze and cornice, built c.1917, has brick specials forming a string course between first and second floor levels, and with 'soldier' quoins farming the building, having a modern shopfront at ground floor level. The building forms part of a group with Nos.4,5,and 6 Moore Street.

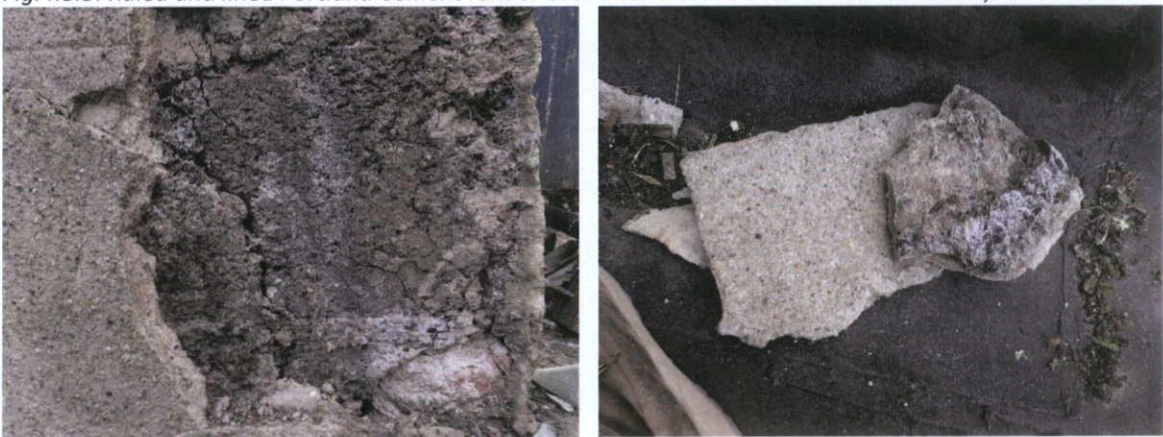
Fig.4.8.6: Concrete fabric beneath the Portland Cement render coat.

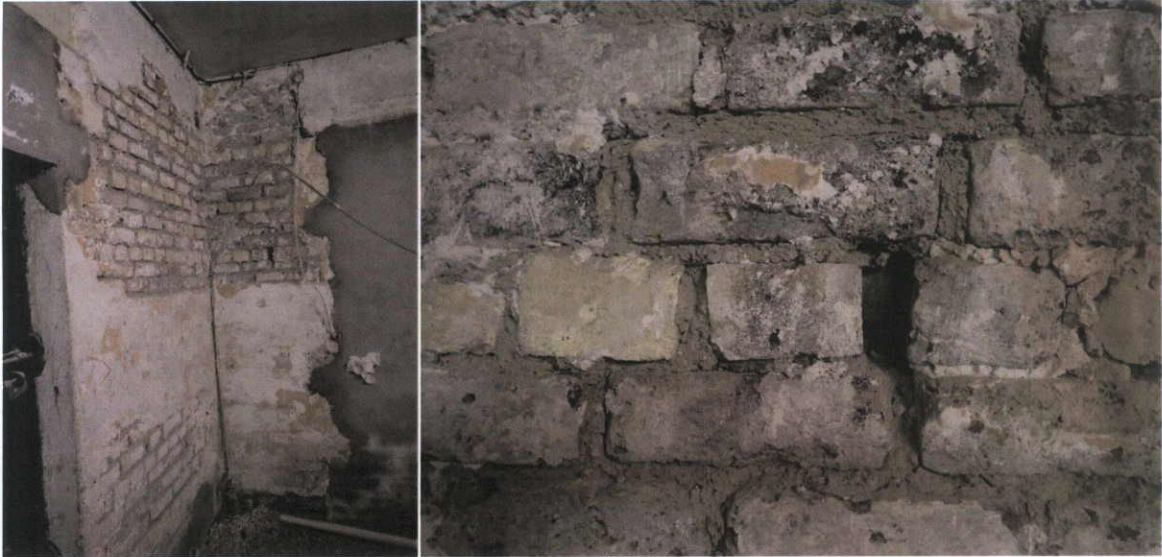
Fig.4.16.7: The north-east corner of the building formed of c.1920s yellow stock brick in a cementitious bedding mortar. There was no trace of any earlier brickwork in this part of the building.

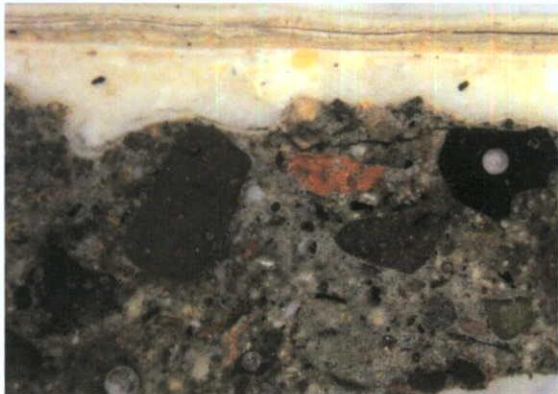
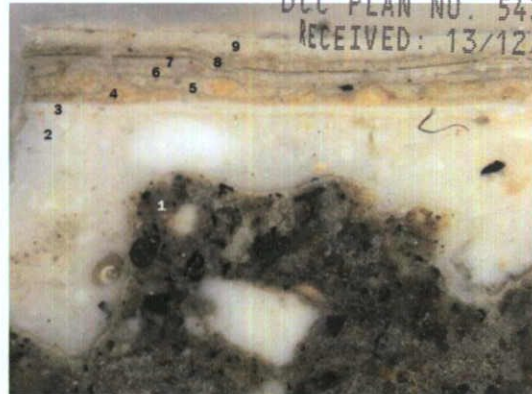
Fig.4.16.22: Detail of plaster, ground floor level, south end of the west wall. Some parts retain areas of haired lime, which were considered as trace remnants of the nineteenth century surface.

Fig.4.16.23: Most of the plaster on the internal wall surface along the west wall is composed of a cement binder with abundant crushed brick aggregate.

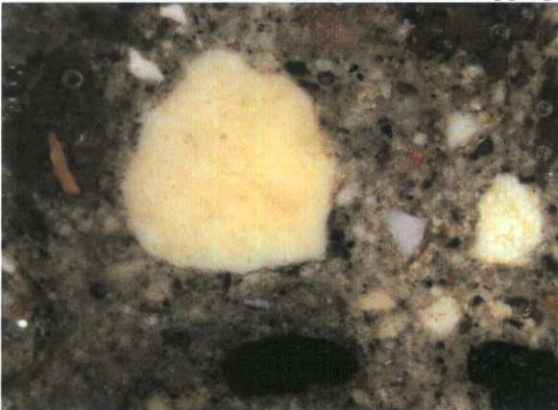
Fig.4.16.24: Cross-section of cementitious plastering mortar.

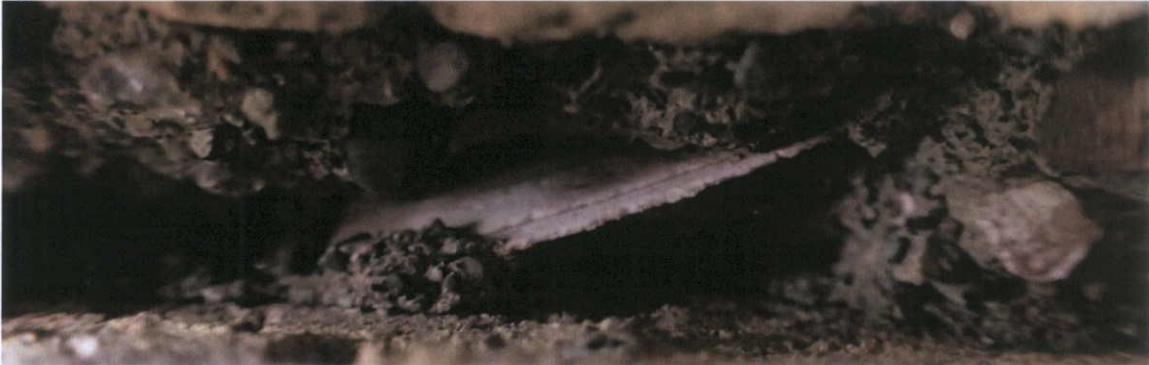
Fig. 4.17.6: Shell used as porous calcareous aggregate in the mortar.

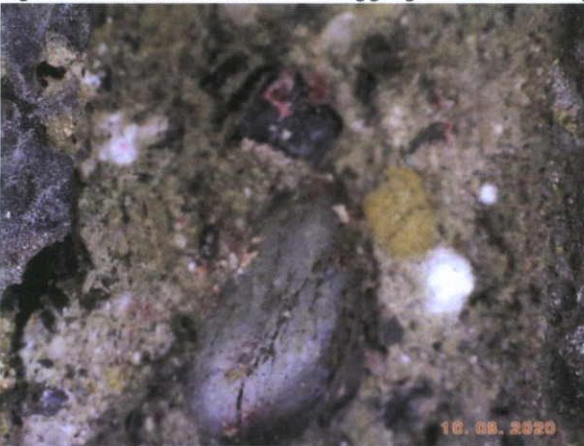
Fig. 4.17.8: Rounded limestone and crushed yellow brick aggregate

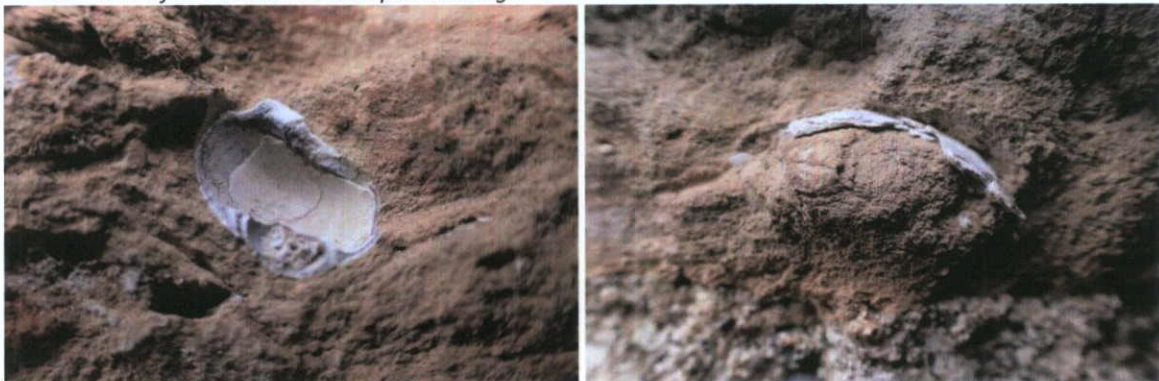
Shells are an uncommon find in historic Irish brick. The shells are partially calcined indicating that they were held within the brick at the time of firing. Shell can occur in raw brick clay in coastal areas (e.g. Lord Merrion's brick fields in Sandymount) due to occasional coastal flooding, or can occur as food waste. The shells exposed in the brickwork are consistent with food waste². The brickwork in Nos.10, 13 and 18 are certainly pre-1916, and may be examples of early brickwork on Moore Street.

Fig.5.1.8: Detail of brick from the north elevation of No.10 Moore Street showing examples of shell inclusions in the fired clay matrix.

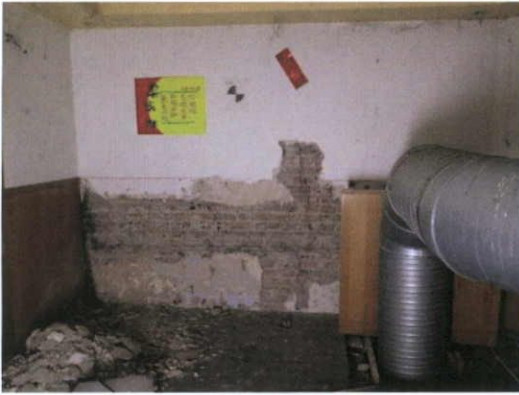
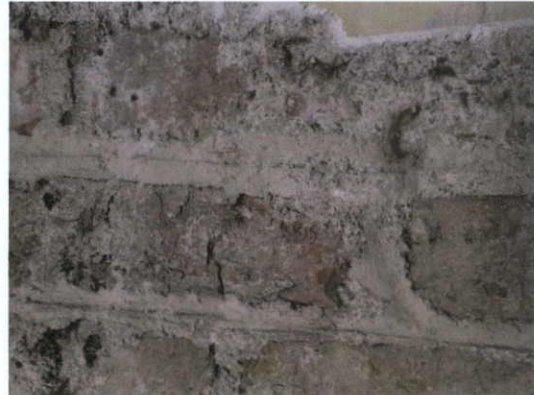
Fig.5.1.10: The party wall between Nos.10 and 11 Moore Street contains early brickwork with lime mortars struck in the same style as the internal walls of the mid-eighteenth century No.42 O'Connell Street.

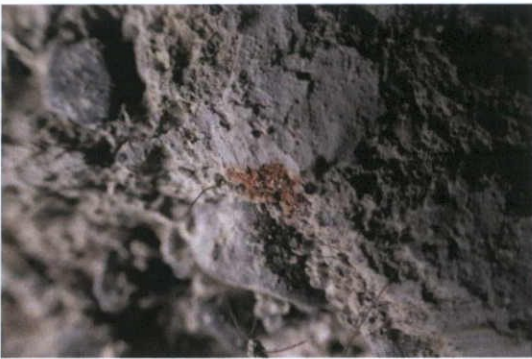
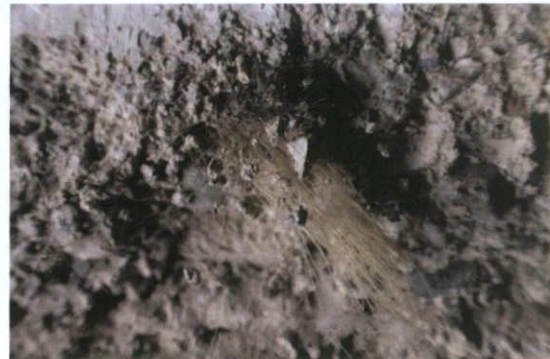
Fig.5.1.11: The bedding mortars of the party wall contains sub-rounded limestone aggregate and brick pozzolan (left); while the lime plasters on the wall have clumps of animal hair (right).

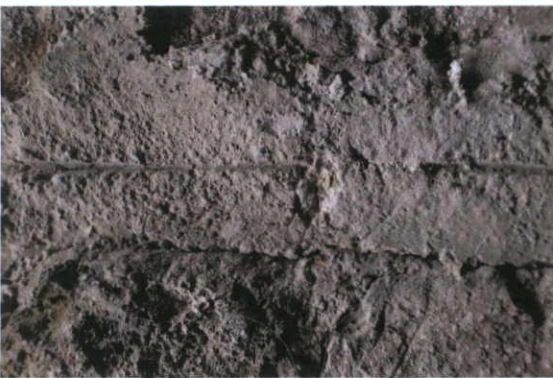
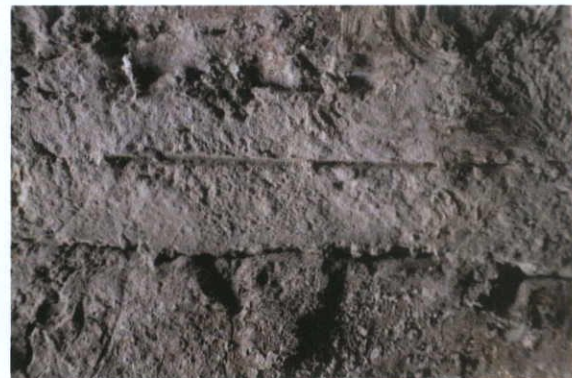
Fig.5.1.12: Lined mortar joint on the brick party wall between No.10 and 11 Moore Street, with traces of the animal hairs from the haired lime plaster adhering to the joint (right). This finish is also found on the eighteenth century internal walls of No.42 O'Connell Street.

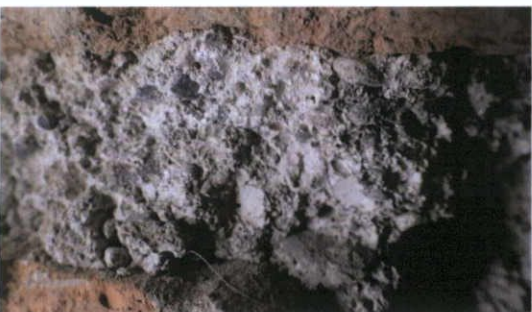
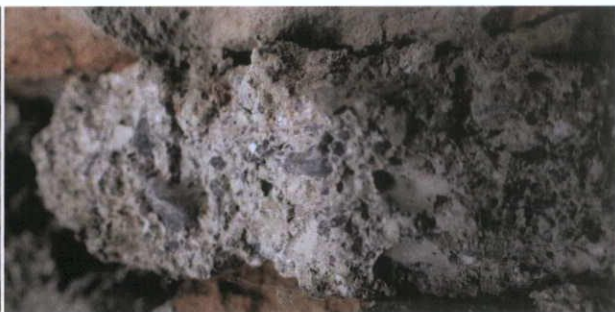
Fig.5.1.13: Poorly sorted bedding mortar containing limestone, chert and quartz aggregate.

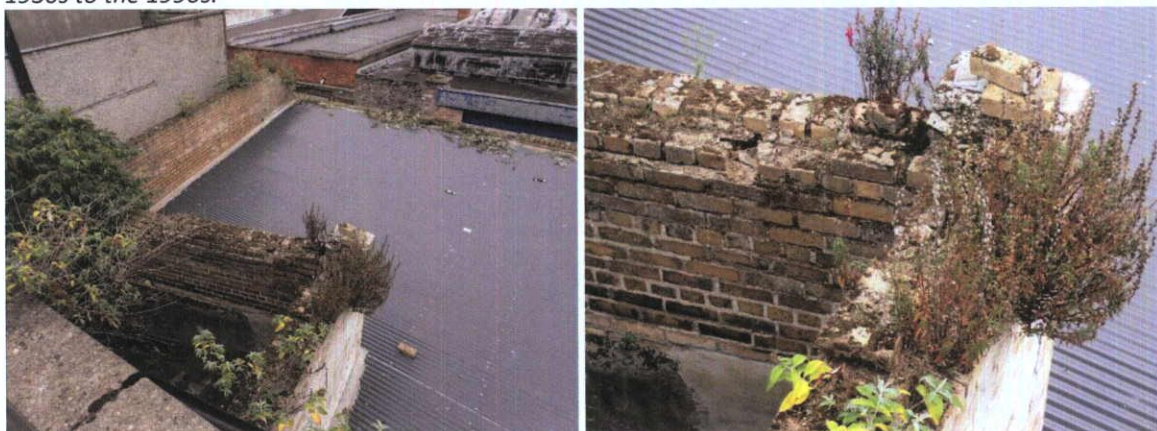
Fig.5.2.2: Yellow stock brick sampled from the rear return of No.12 Moore Street.

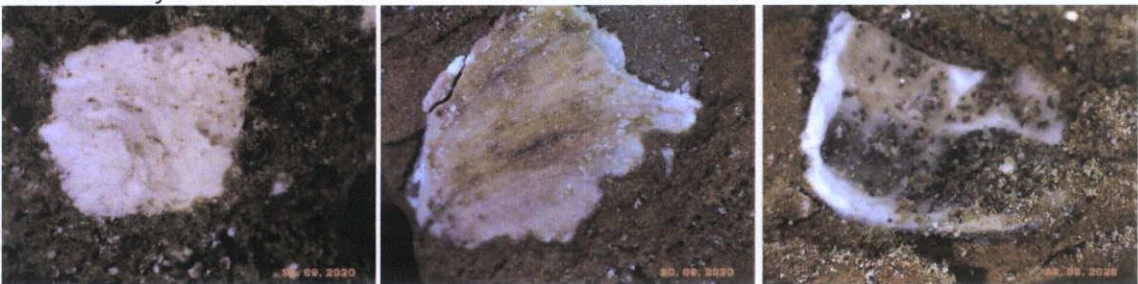
Fig.5.3.8: The late eighteenth/early nineteenth century mortars contain abundant lime limps (left) but no obvious porous brick aggregate or pozzolanic brick dust; while a proportion of the brick contain shell fragments as inclusions within the matrix – these are partially fired indicating that they were contained within the brick during manufacture.

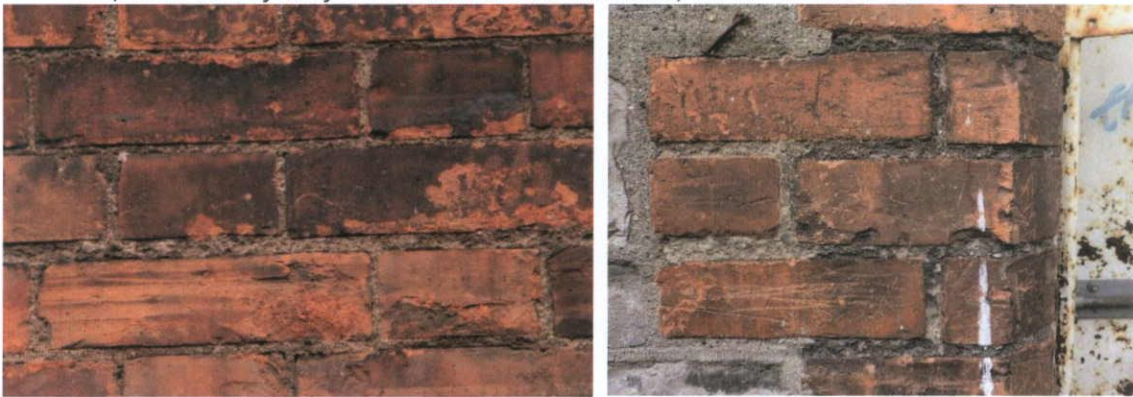
Fig.5.5.4: The brickwork was laid in a lime-based mortar finished flush.

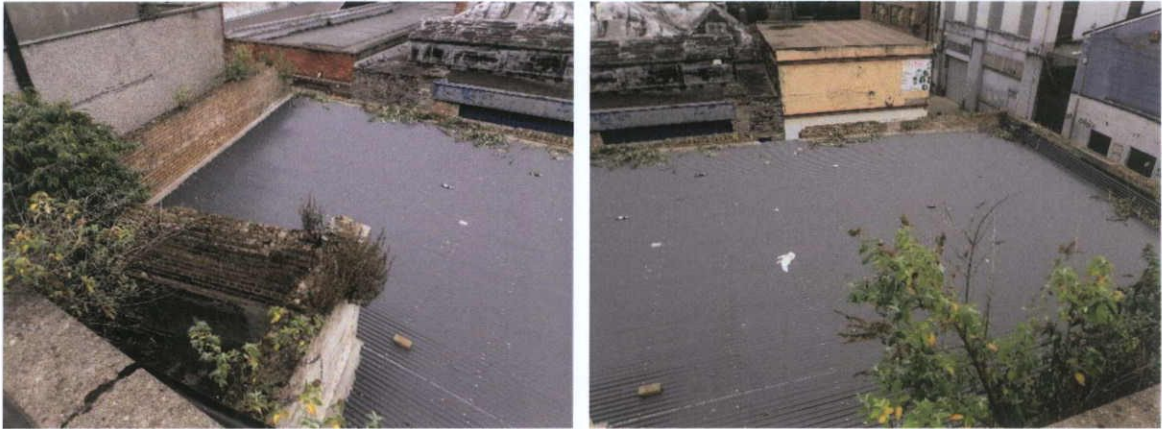
Fig.5.6.3: View of the roof from the west, with the inner leaf of yellow stock brick from the now lost first floor level visible at the wall tops.

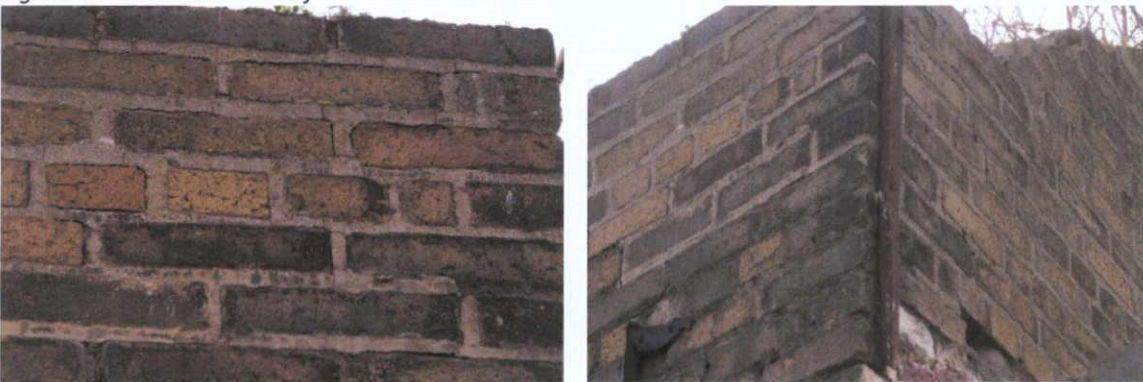
Fig.5.6.6: The yellow stock brick was used for the east (left) and north (right) elevations.

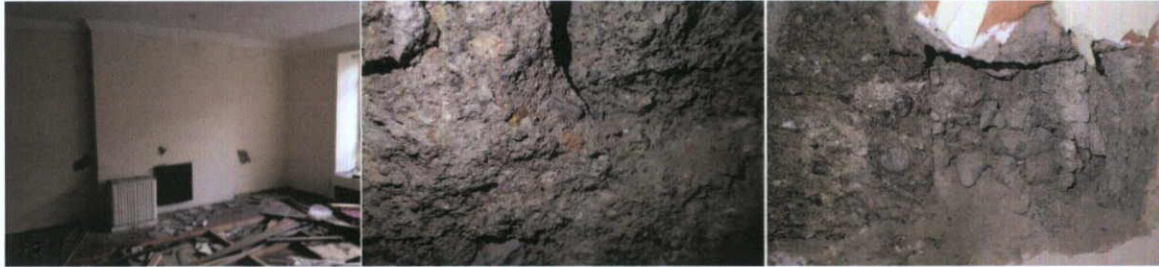
Fig.6.1.3: The south wall of the building (party wall with No.19 Moore Street) is of concrete construction.

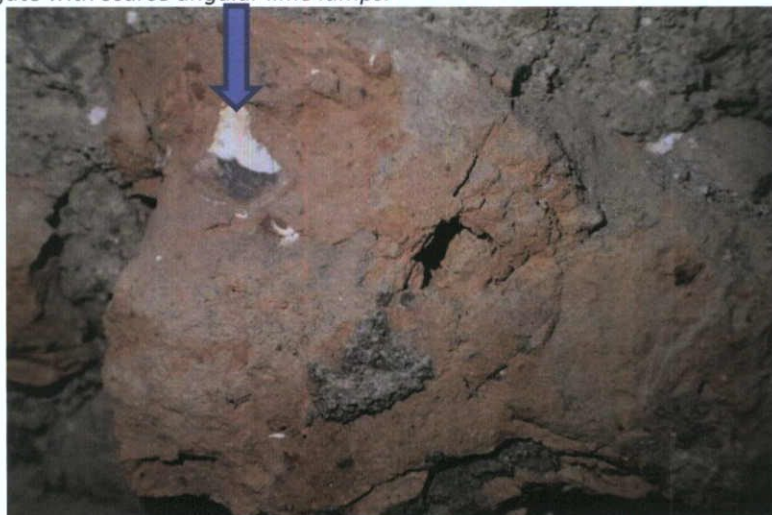
Fig.6.1.6: Shell (arrowed), partially fired, inclusion within the brick.

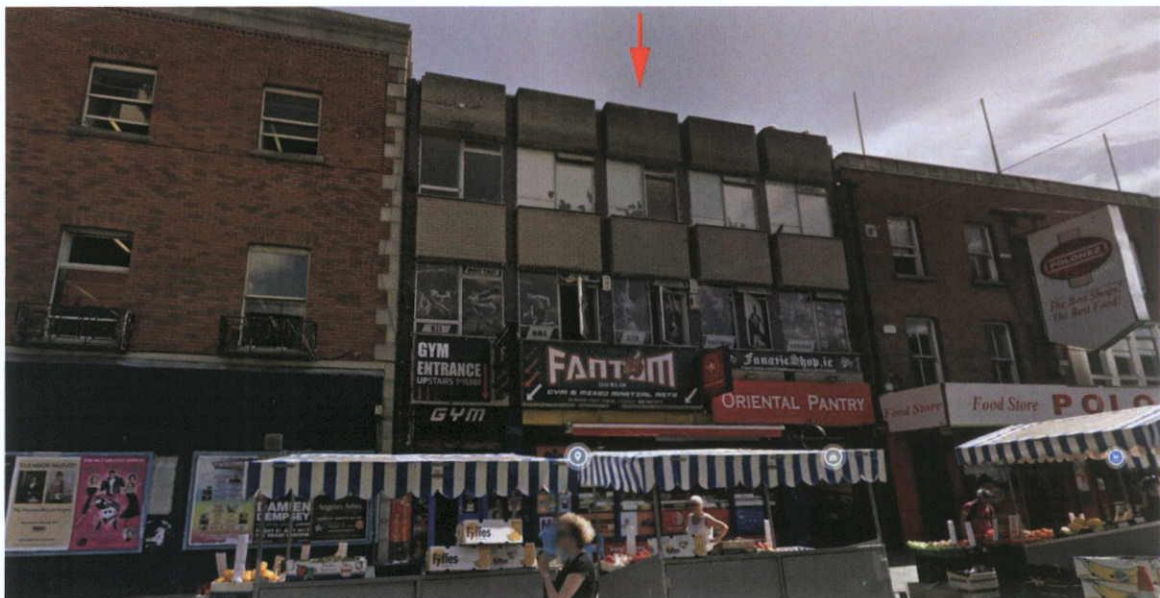
Fig.6.2.1: 22-23 Moore Street.
