**Appendix A6** Building Materials Analysis Report

This report was prepared at the request of Molloy & Associates Conservation Architects to inform the Dublin Central Built Heritage Review for Hammerson Plc. The purpose of the work was to analyse the physical fabric of buildings on O'Connell Street, Parnell Street, Henry Street, Moore Street, Moore Lane and Henry Place; and to use the physical evidence gathered through study of the building materials to gain a better understanding of the significance and dating of each of the buildings. This report is Volume 2 (of 2)<sup>1</sup> and focuses on the buildings contains in Sites 1 and 2 in the Dublin Central project.

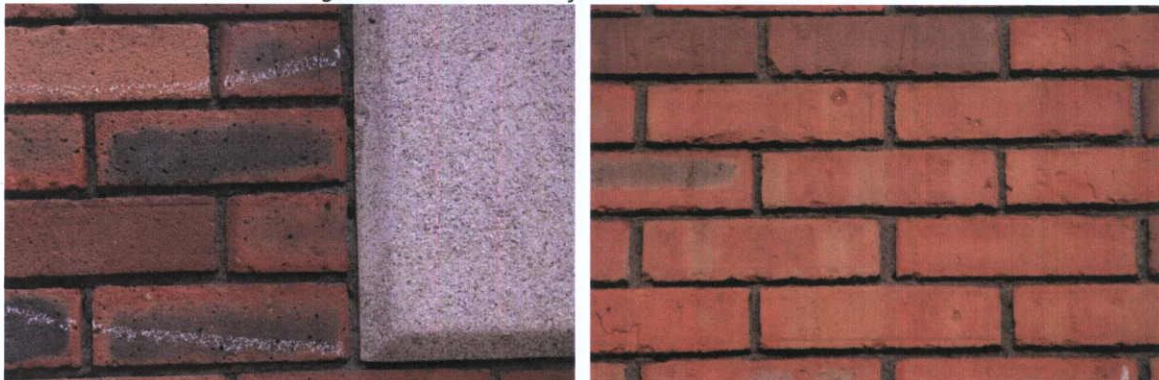
Fig.8.3.2: Detail of the brickwork and cast stone quoins.

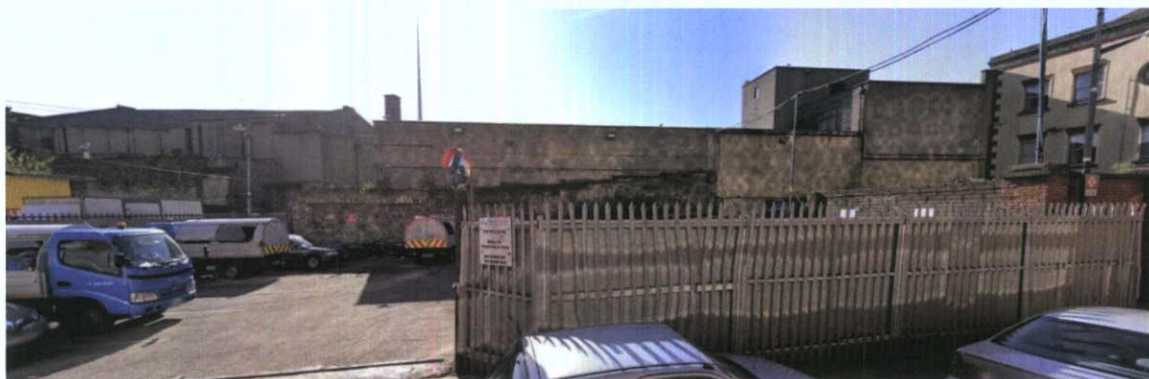
Fig.6.4.1: General view of 14 Moore Lane.

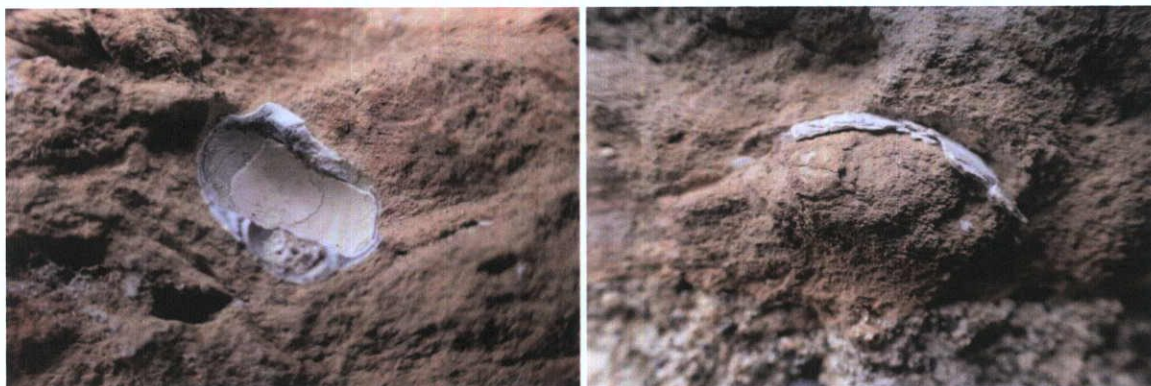
Fig.9.1.2: 'Shell brick' is found at a number of buildings on Moore Street including No.10 Moore

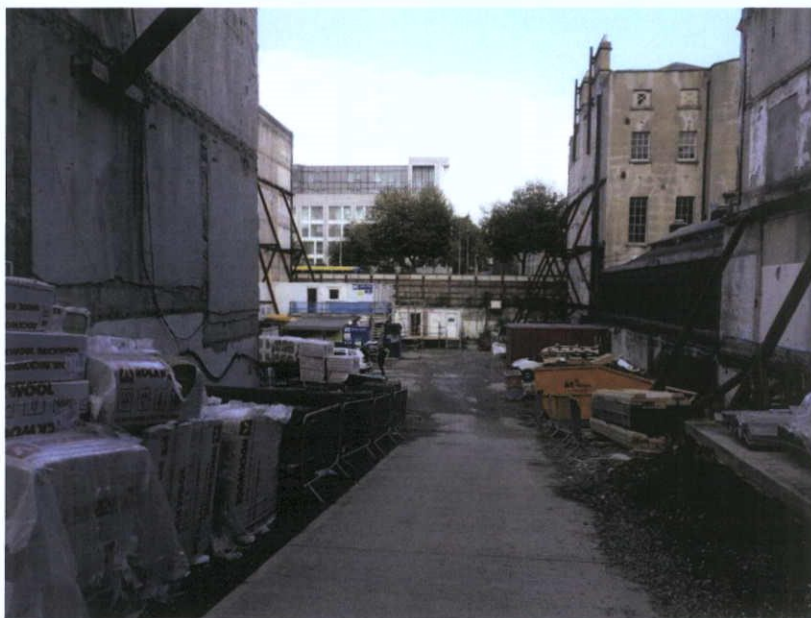
Fig.4.2.1: The vacant site of 40-41 O'Connell Street.

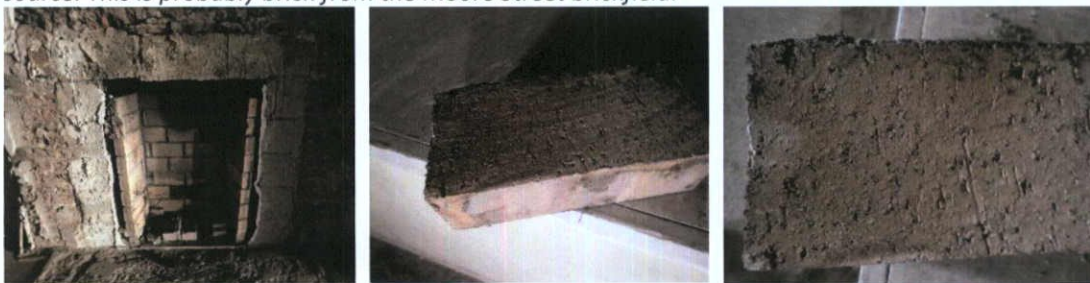
Fig.4.3.11: Wire-cut firebrick at ground floor level, north wall, rear (west) room.

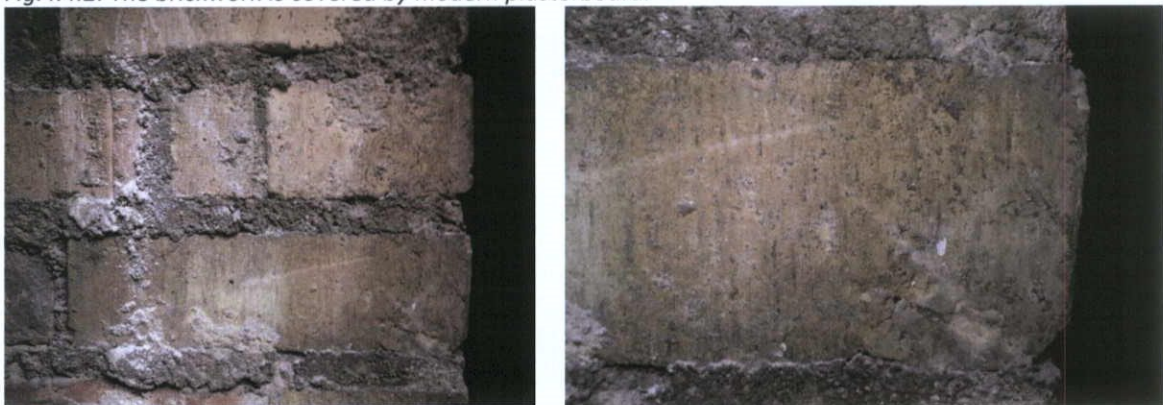
Fig.4.4.3: Yellow machine-cut yellow-stock brick in a lime bedding mortar.

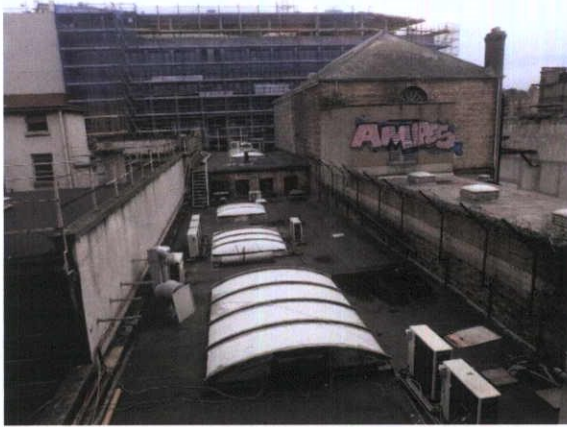
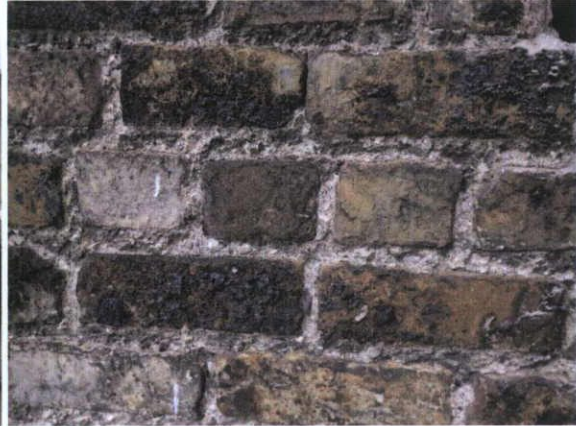
Fig.4.4.4: The boundary wall with No.43 O'Connell Street is formed of clamp-fired yellow stock brick and likely to be of nineteenth century date.

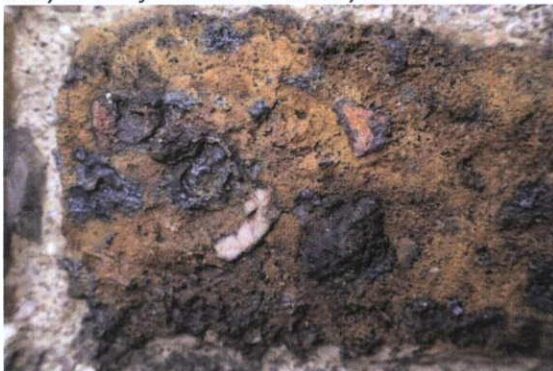
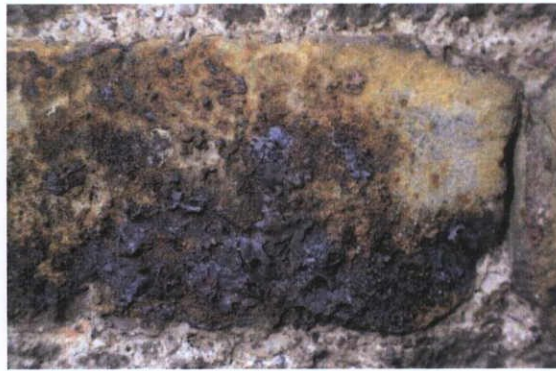
Fig.4.4.5: Overburnt clamp-fired yellow stock brick showing calcined stone and vitrified zones.

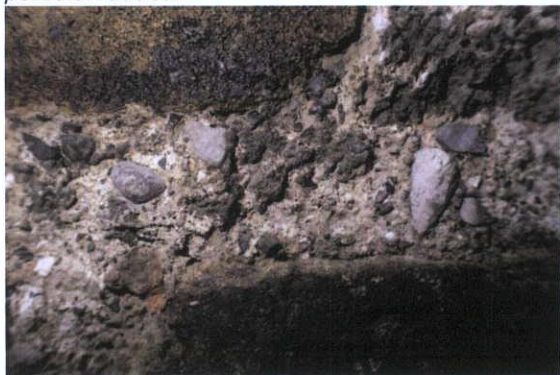
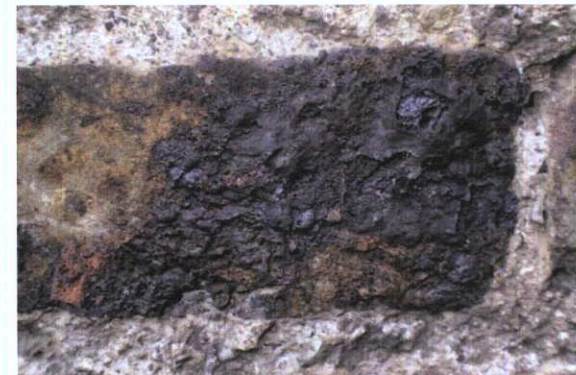
Fig.4.4.7: Coarse-grained limestone, quartz and chert with brick pozzolan and lime lumps.

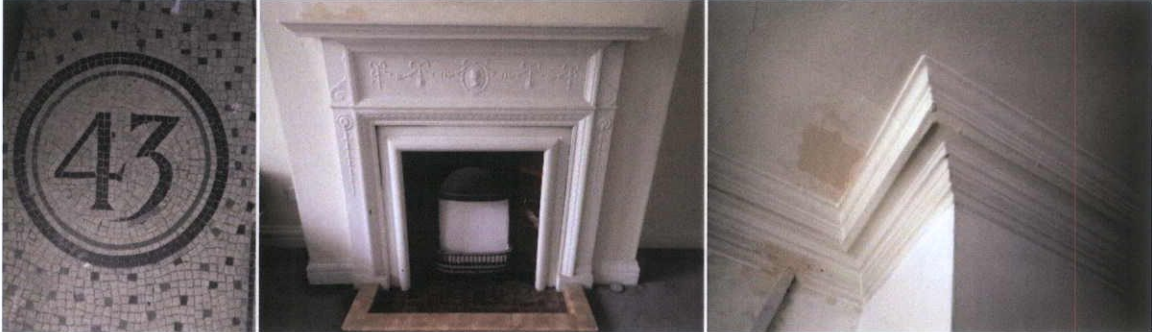
Fig.5.1.1: The interior shows 1920s décor and finishes.

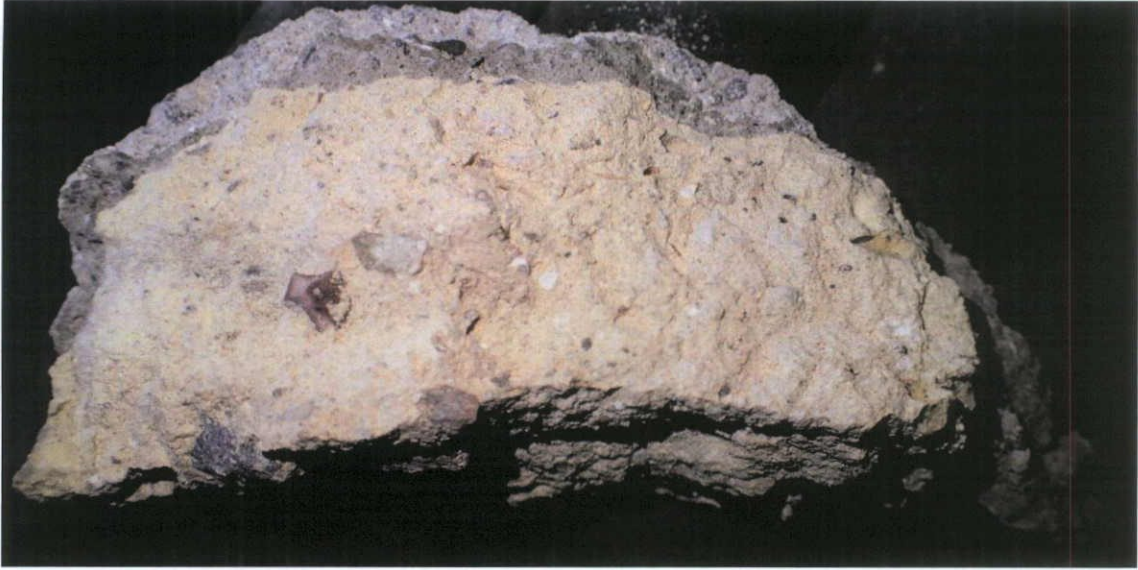
Fig.5.2.12: Yellow 1920s yellow stock brick in grey cementitious bedding mortar.

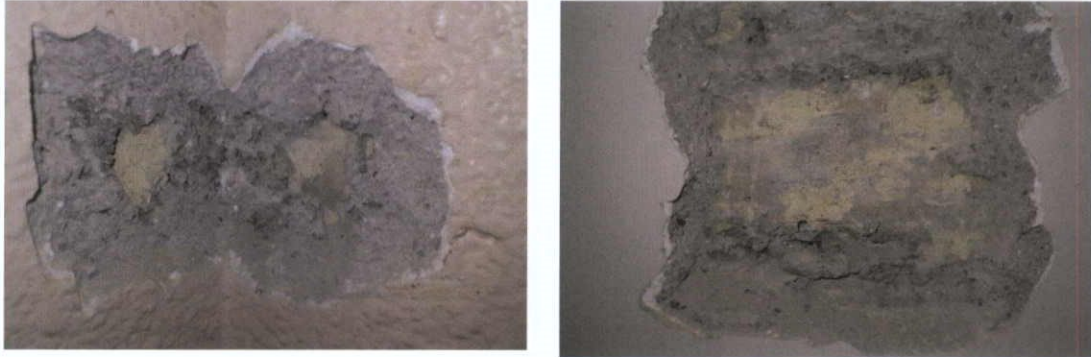
Fig.5.2.14: 1920s yellow stock brick in cementitious mortar exposed in the party walls of the south (left) and west (rear) walls of the first floor level.

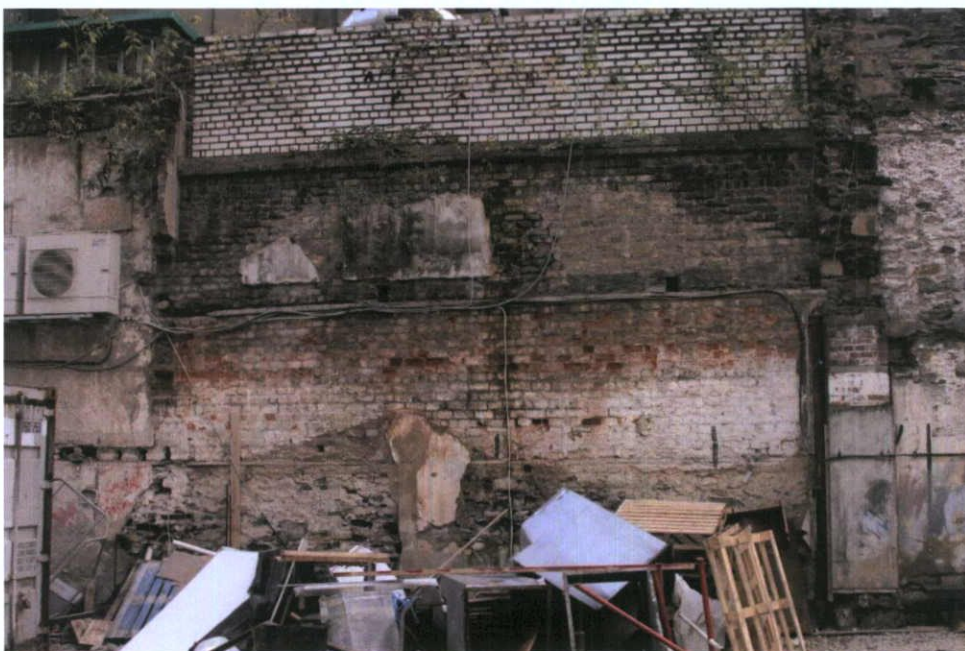
**Building D:** The wall stands in four 'lifts': Calp limestone masonry at the base; red stock brick; yellow stock brick; and white encaustic brick at the top of the wall. The white encaustic brick appears in the last quarter of the nineteenth century, but its use becomes more common in Dublin City in the Edwardian period at the beginning of the twentieth century. The yellow stock bricks appear similar to those seen on the north side of the site. The red brick has coarse pebbly inclusions, overpainted with a white paint (though deterioration including loss of fireskin has revealed the fabric of the bricks).

Fig.5.3.23: Section D, south side of the site.

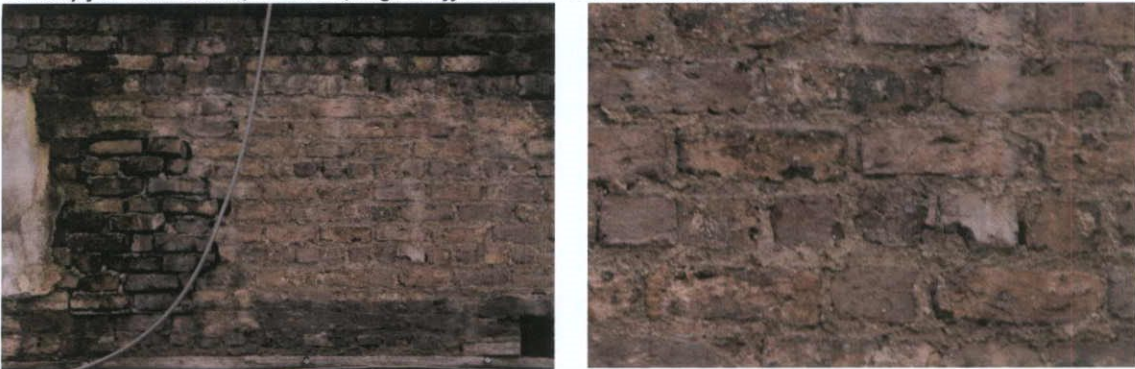
Fig.5.3.25: Yellow stock brick in lime bedding mortar.

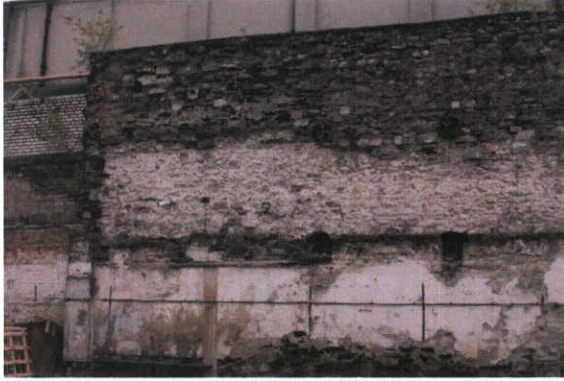
Fig.5.3.27: General view of Section E.

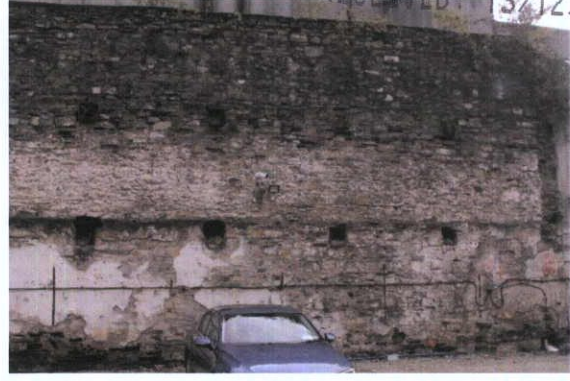
Fig.5.3.28: Calp limestone masonry.

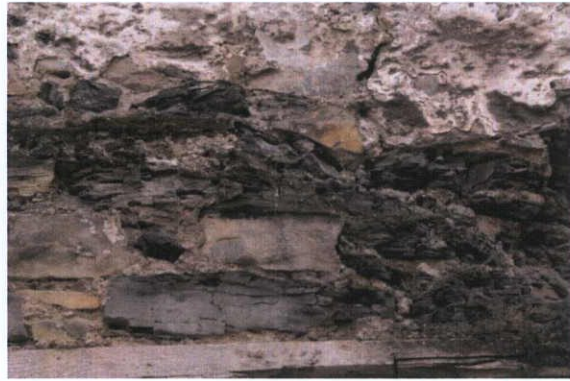
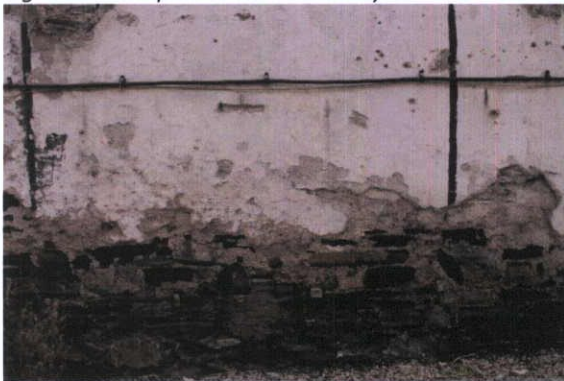
Fig.5.3.29: Detail of the plaster showing brick pozzolan and animal hair. The fine brick dust (& saturation) has contributed to the pinkish hue of this section of the mortar.

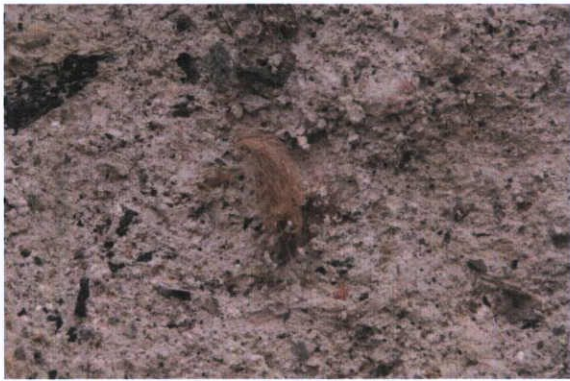
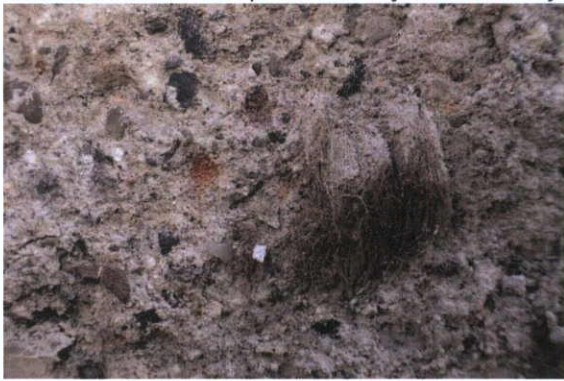
Fig.5.3.30: Detail of the surface of the exposed plaster showing limestone aggregate, occasional burnt fuel fragments, clumps of animal hair added to improve mechanical strength (but with poor craftsmanship as the hair is not teased through) and crushed brick (porous aggregate) and fine brick dust.
