BUILDING HISTORY

BUILDING SURVEY

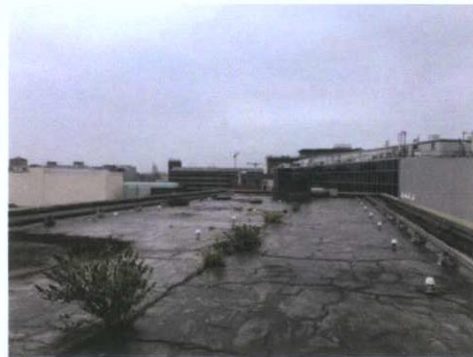
Plate 25: West roof — West

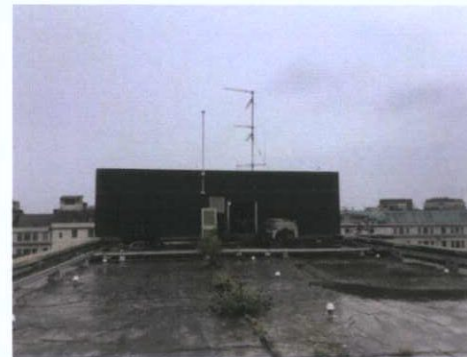
Plate 26: West roof — East

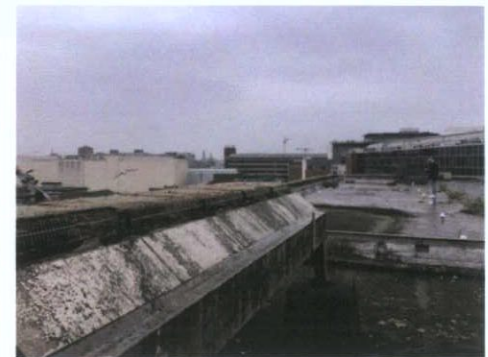
Plate 27: West roof — South

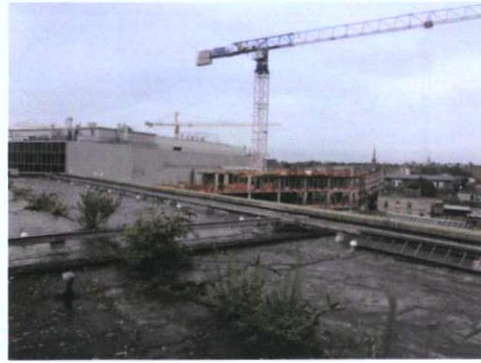
Plate 11: West roof — North

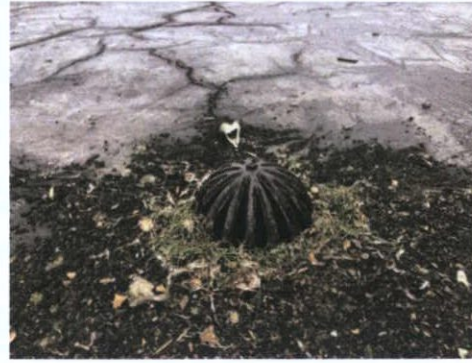
Plate 12: West roof — Drainage

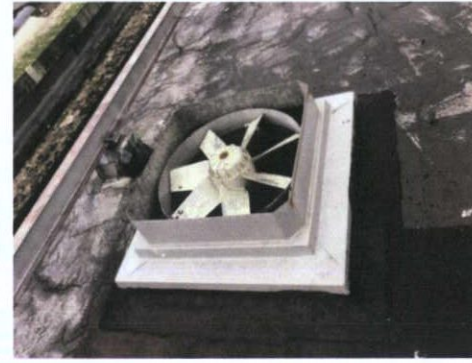
Plate 12: West roof — Ventilation fan

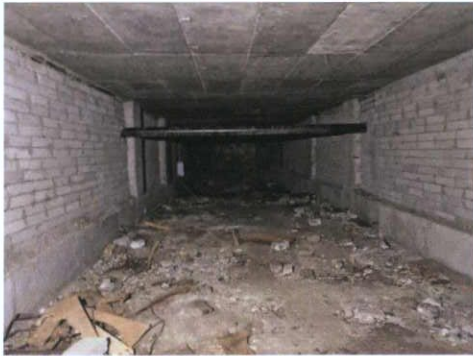
Plate 30: Concrete rising walls in basement

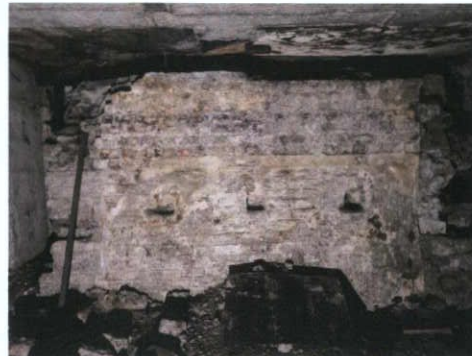
Plate 32: Brick end wall in basement

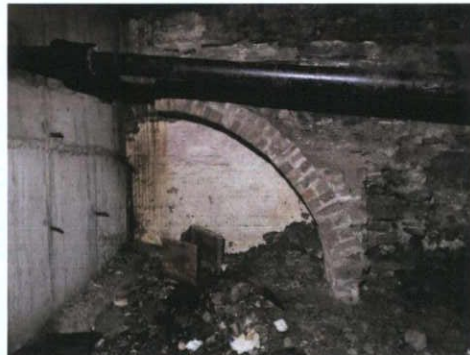
Plate 35: Brick vault and concrete wall

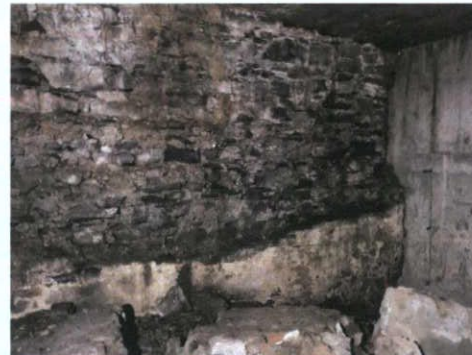
Plate 36: Calp limestone wall in basement

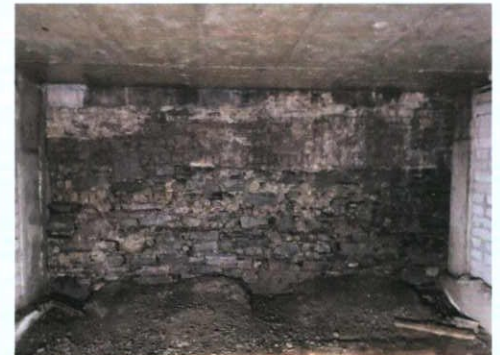
Plate 37: Calp limestone wall in basement

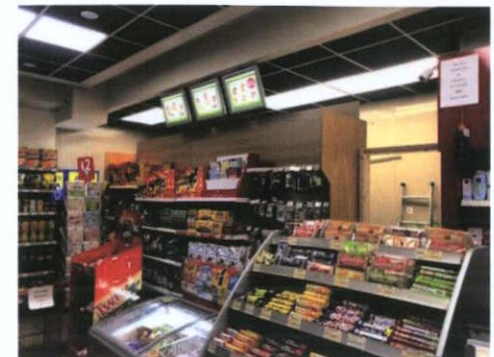
Plate 45: Temporary partition behind service counter

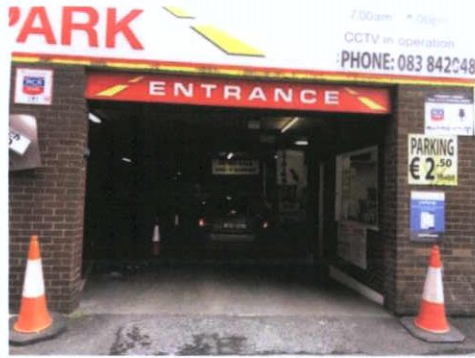
In use, in need of renovation

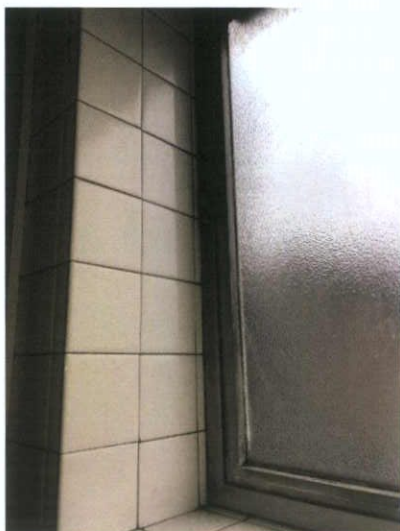
Plate 184: Single glazed aluminium windows open down on a horizontal hinge

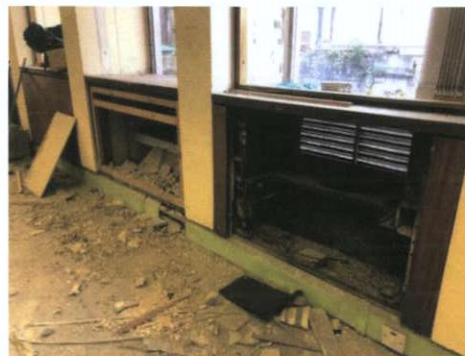
Plate 207: Ventilation units removed

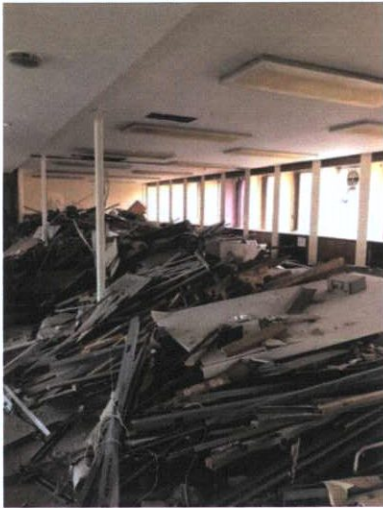
Plate 213: South section of main room used to store materials from demolition

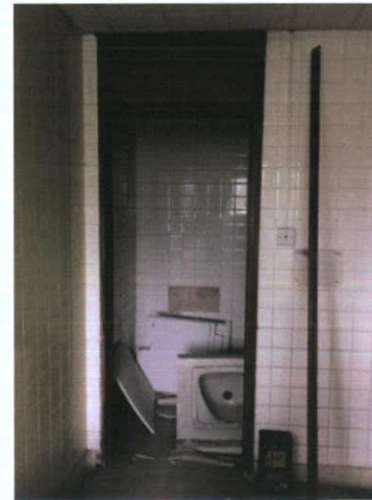
Plate 287: Male WC — West wall demolished wash hand basins

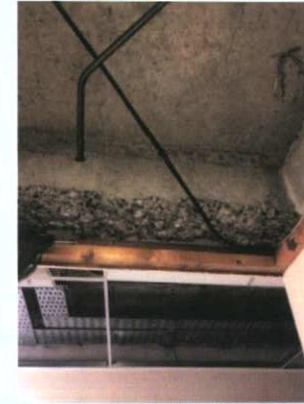
Plate 327: Main room - North wall

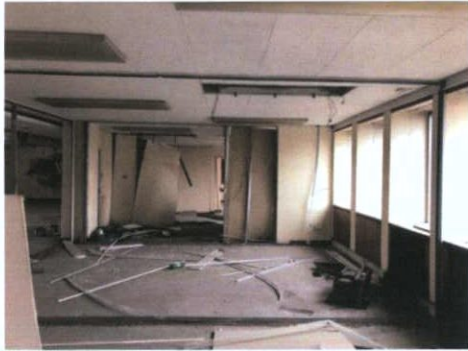
Plate 348: Room 4 — West wall with removed stud partitions
