EIAR Chapter 15 Cultural Heritage (Architectural)

Dublin Central Project – Site 2 & No.61 O'Connell Street Upper

Appendix 15.7 Building inventory, record and description for No.50-51 O'Connell Street Upper

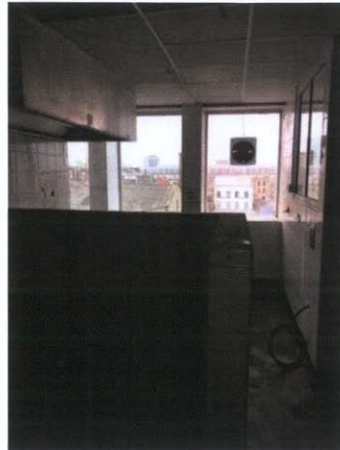
Plate 396: South wall of kitchen

A square kitchen with a tiled wall in the middle. Access for rooms 1-5 are through the kitchen. Wall tiles are still in place however the floor finish has been removed exposing the concrete floor. Leaking ceiling has caused fungal growth on floor.

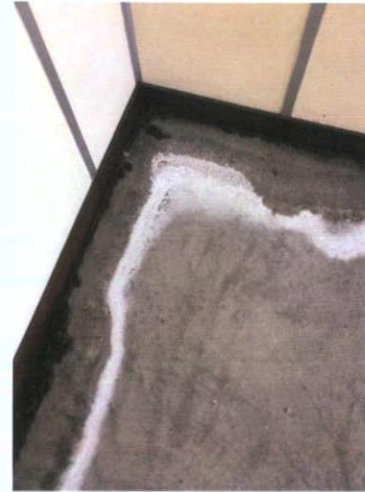
Plate 437: Room 9 — Carpet under partition

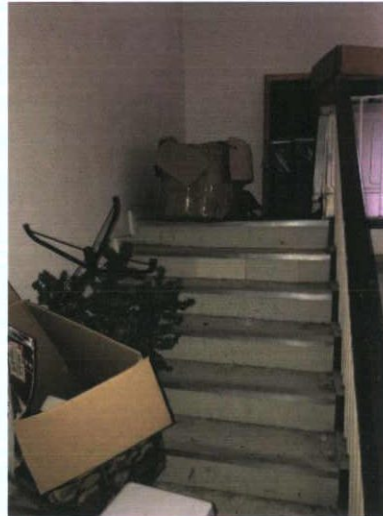
Mandy handrails are damaged and doors to floors are blocked by miscellaneous items. This stairwell is not fit for use as a fire escape in its current condition.

Plate 510: Storage on stair flight

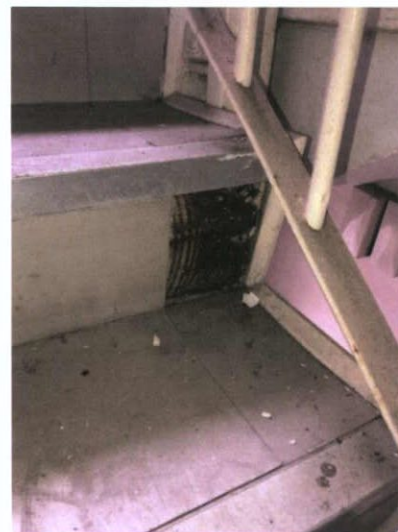
Plate 517: Typical stair tread, riser and handrail detail

The stair is still usable but shows signs of wear. It is not suitable for use as a fire escape as it is blocked by a locked door at level 1.

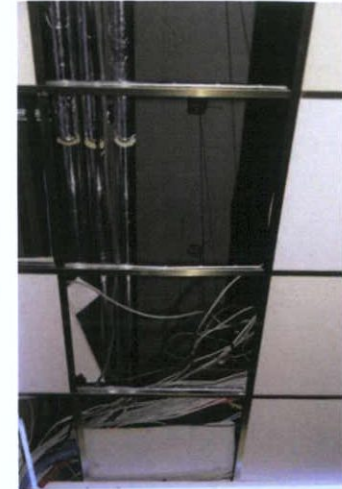
Plate 13: G-1 – Suspended ceiling

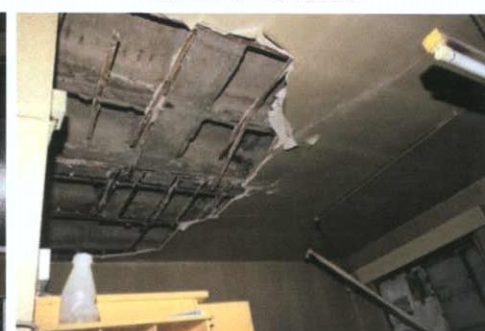
Room T-6: Accessed from second floor corridor. Plasterboard finish to ceiling; removed sections revealing cast concrete structure above. Plastered finish to walls. Original skirting boards with planar profile. Multi-pane cast-iron windows to east wall, with timber valances and narrow timber architraves. Concrete finish to floor.

Plate 51: T-6 - View to ceiling; concrete structural substrate
