A4.7.6.2. Summary of forensic analysis findings

A4.7.7 No 11 Moore Street**A4.7.7.1. Significance to 1916**

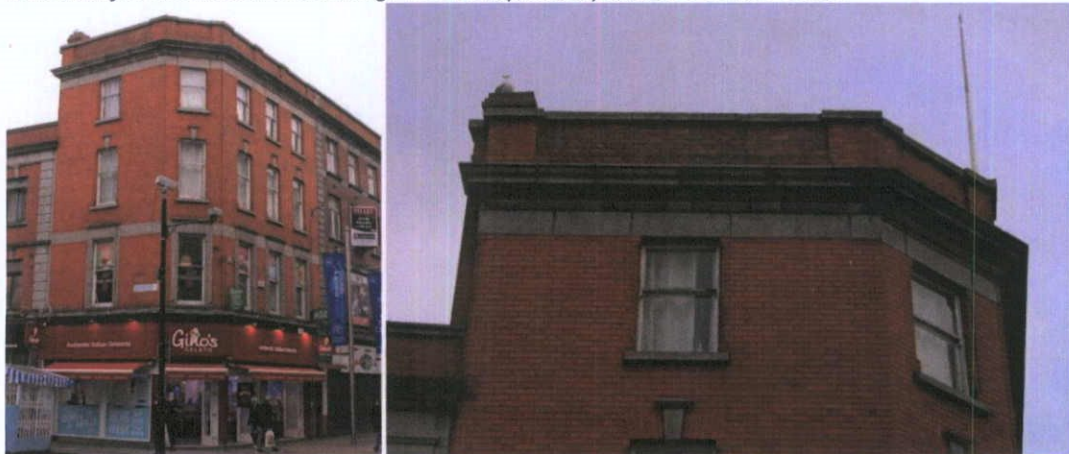
Fig.4.5.2: Soiled brick and granite detailing at upper floor level.

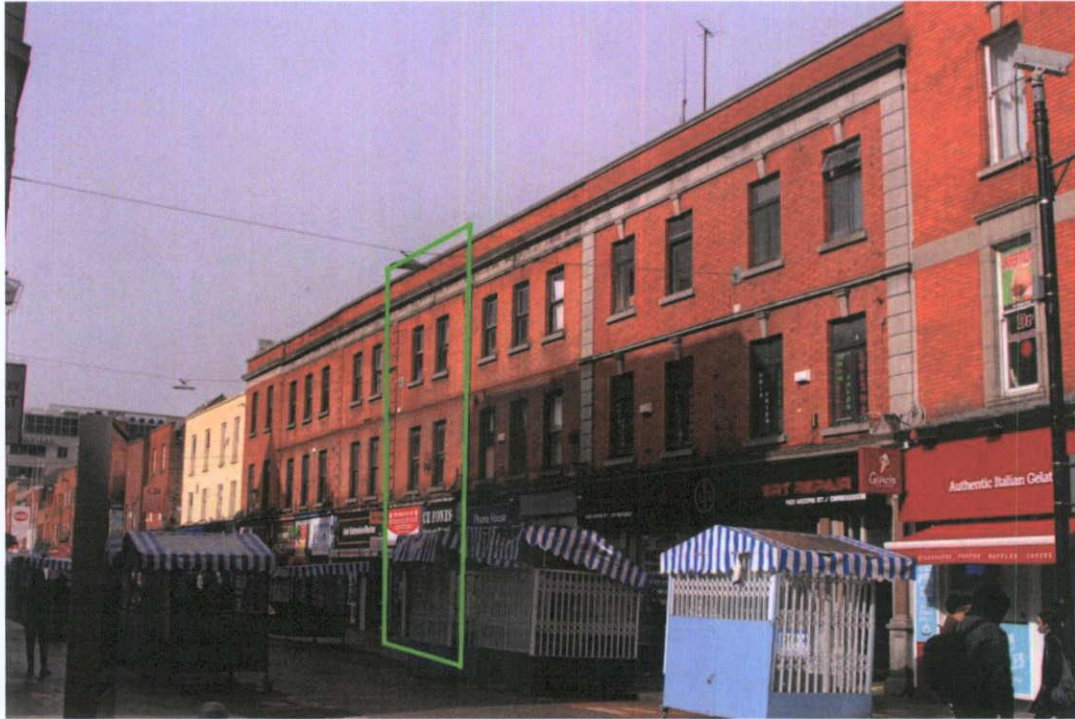
Fig.4.8.1: No.4 Moore Street, forming part of a terrace with Nos.3,5 and 6.

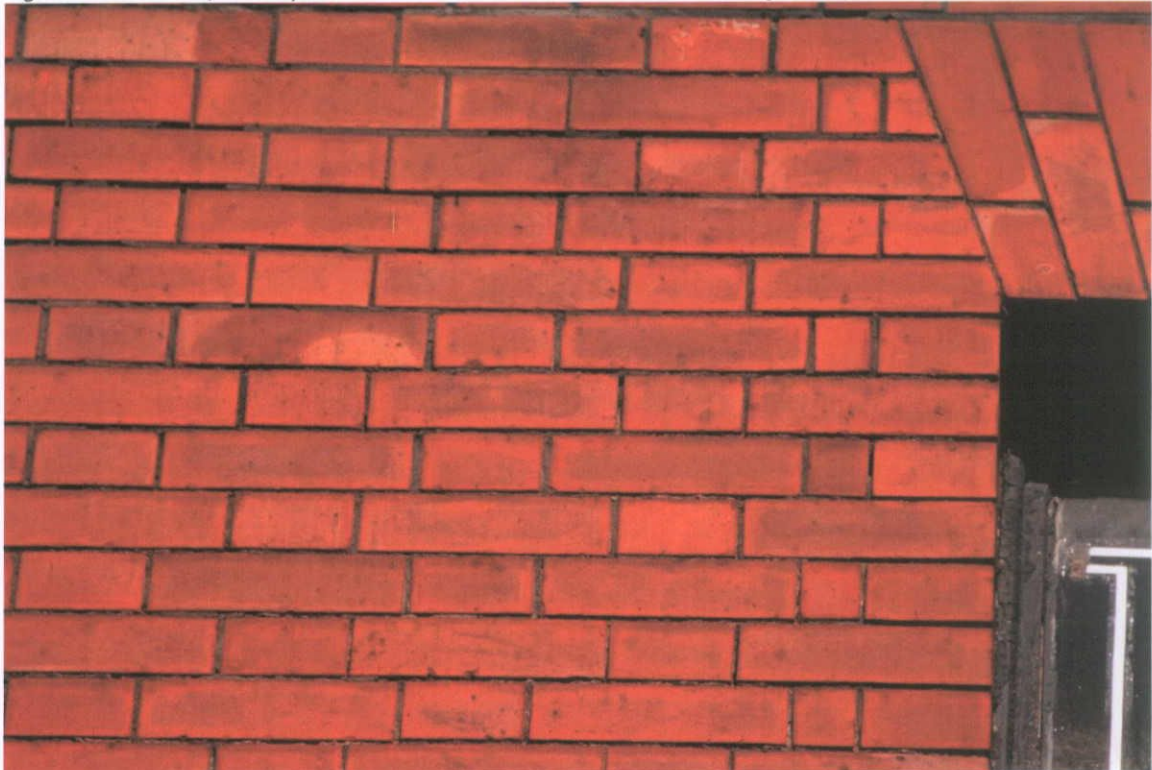
Fig.4.9.3: The surface of the brick shows subtle colour variations from the firing process.
