Interior – Ground Floor – Retail**Unit 2 – Fortune Terrace Restaurant****Outline of unit**

Unit 2 is the largest of the ground floor retail units. It houses The Fortune Terrace restaurant which also occupies the first floor of the building. The ground floor of the restaurant holds a front reception area, male, female and accessible WC's, security room, main dining area and ground floor kitchen. There is an emergency exit at the rear of the restaurant that leads out to the ground floor car park. There is a laminate floor to the front of the shop and a tiled floor to the rear. There are modern plaster finishes to the concrete walls, plasterboard ceiling finishes, and a number of light-weight partitions throughout, as well as a dumbwaiter within a lift shaft.

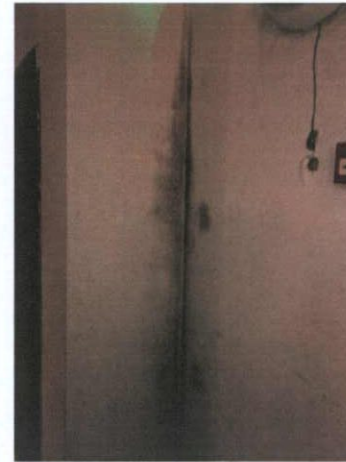
Plate 59: Signs of dampness and mould growth at rear of restaurant

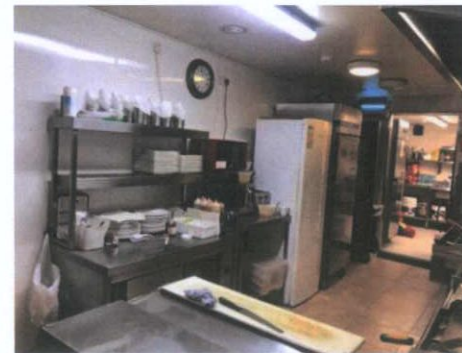
Plate 83: South wall of kitchen

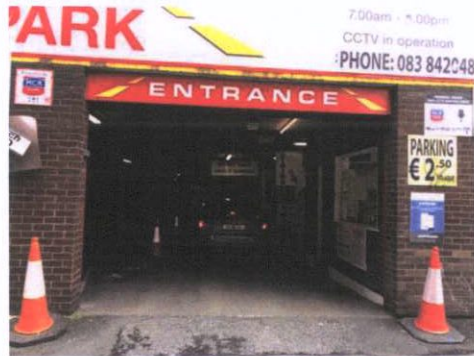
Plate 84: Car park ground level entrance

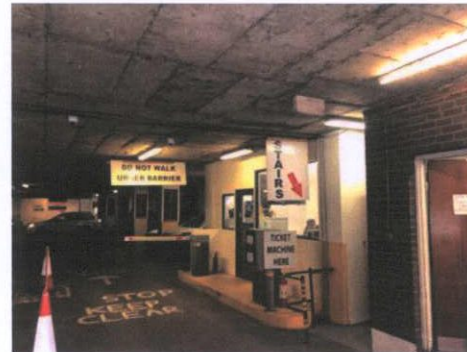
Plate 85: Entrance barrier, Stairs to upper floors and car park office

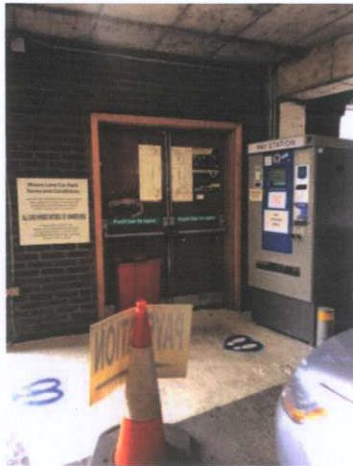
Plate 88: Emergency exit to Moore Lane

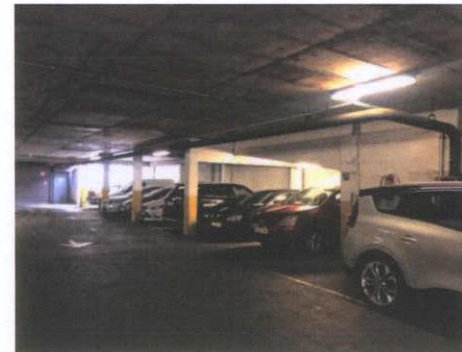
Plate 90: South wall

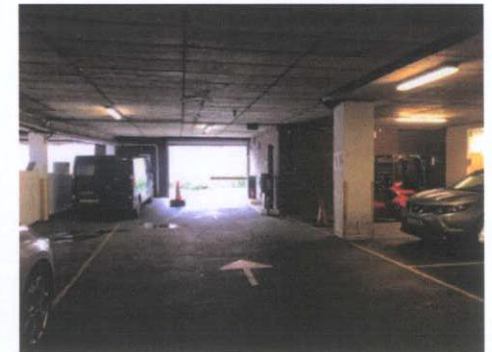
Plate 91: Exit to Moore Lane

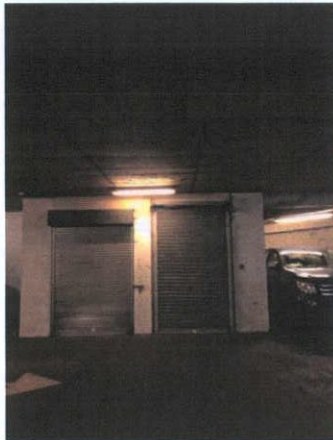
Plate 96: Storage area on north wall

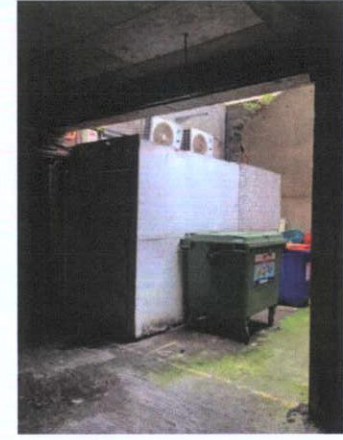
Plate 99: Waste area in south east corner

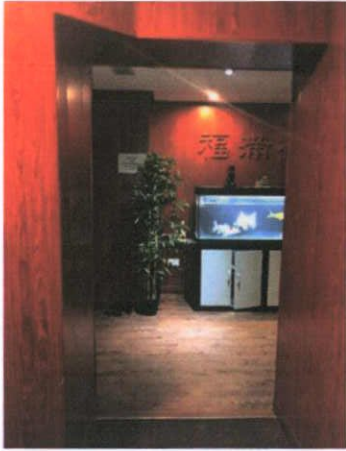
Plate 100: Entrance leading from staircase to level 1

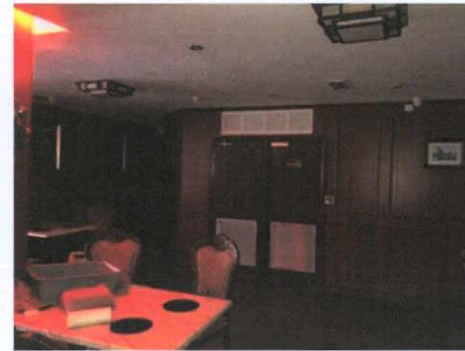
Plate 102: South wall — kitchen door

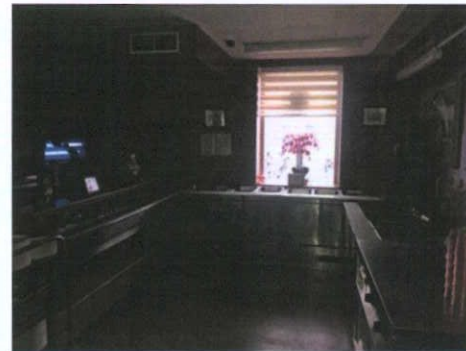
Plate 105: Bar area — West wall

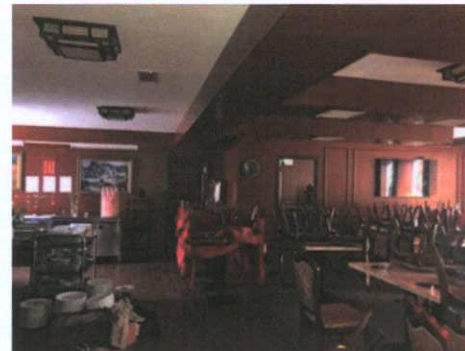
Plate 106: North facing wall — entrances to private dining rooms

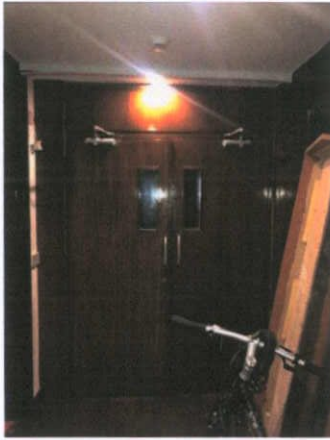
Plate 108: Entrance to WC hallway from main hallway

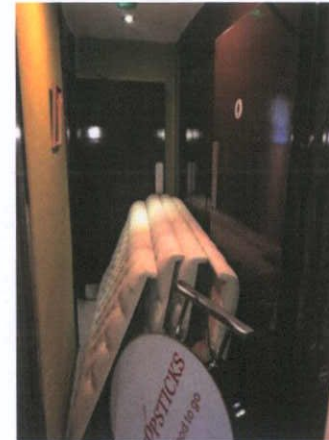
Plate 110: Entrance to Female WC

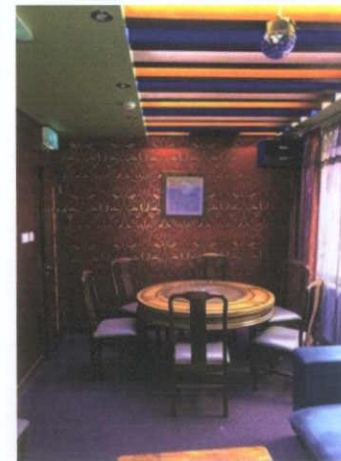
Plate 114: North wall of private room 1

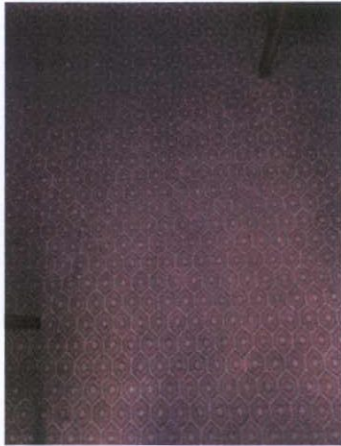
Plate 116: Carpet in private dining

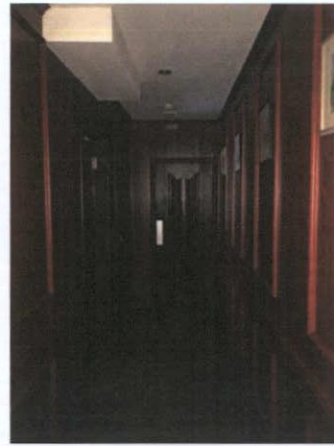
Plate 117: Hallway to private room 1

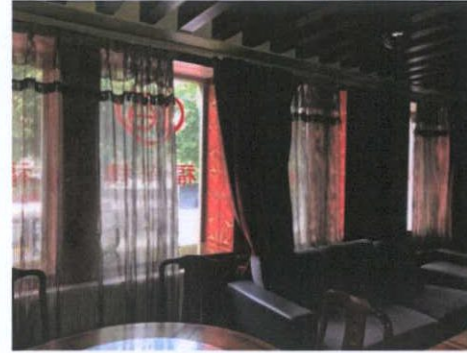
Plate 118: East wall of private room 1

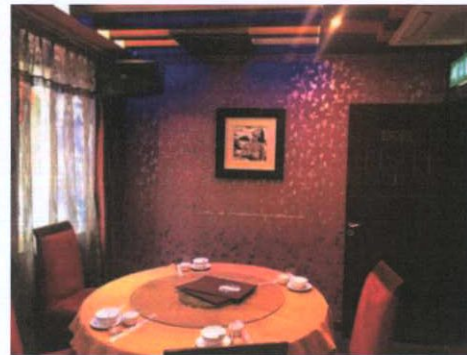
Plate 122: South wall in private room 2

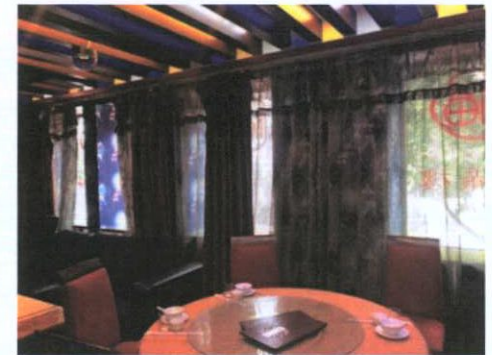
Plate 123: East wall in private room 2

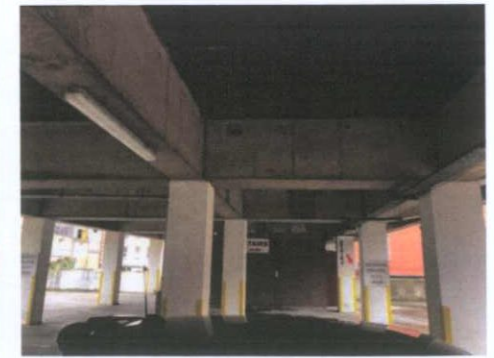
Plate 165: West boundary wall including west stair core

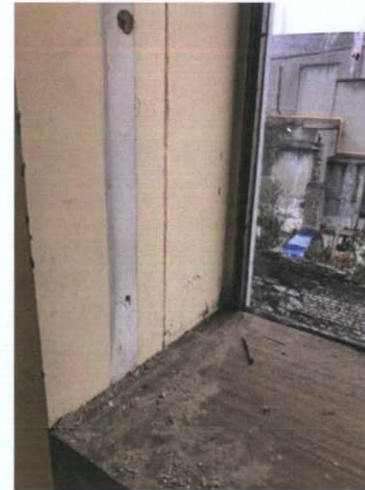
Plate 203: Image showing typical window cill

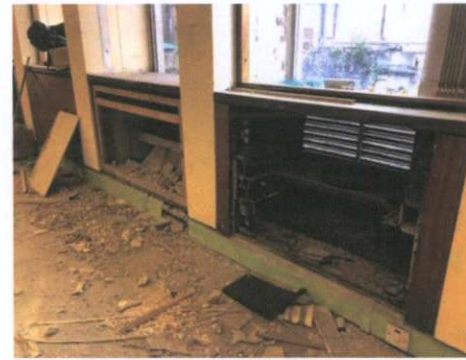
Plate 207: Ventilation units removed

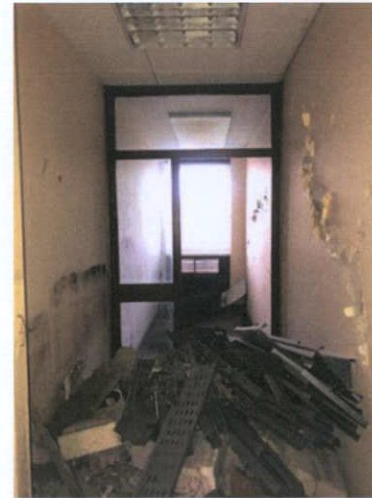
Plate 284: Room 16 — North wall — non accessible due to demolished materials

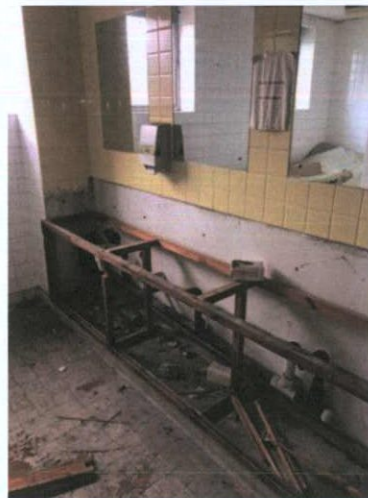
Plate 287: Male WC — West wall demolished wash hand basins

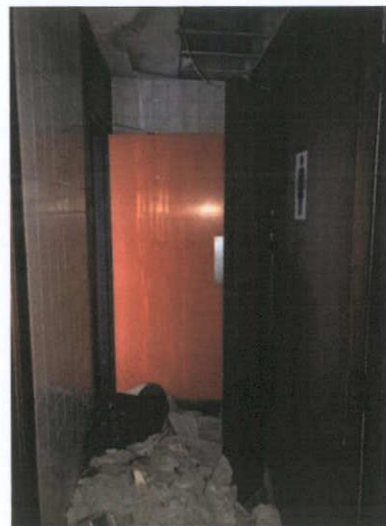
Plate 292: Female WC entry from main hallway- not accessible

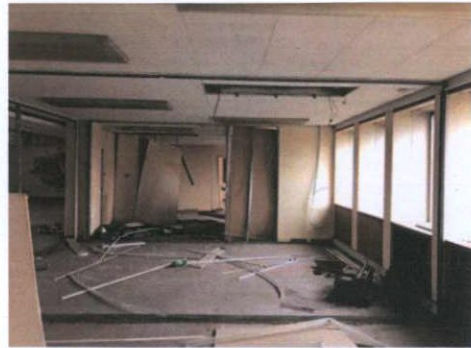
Plate 348: Room 4 — West wall with removed stud partitions

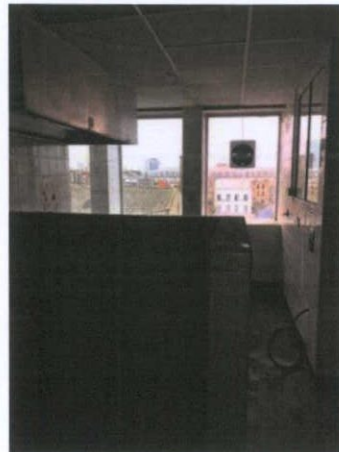
Plate 396: South wall of kitchen

A square kitchen with a tiled wall in the middle. Access for rooms 1-5 are through the kitchen. Wall tiles are still in place however the floor finish has been removed exposing the concrete floor. Leaking ceiling has caused fungal growth on floor.

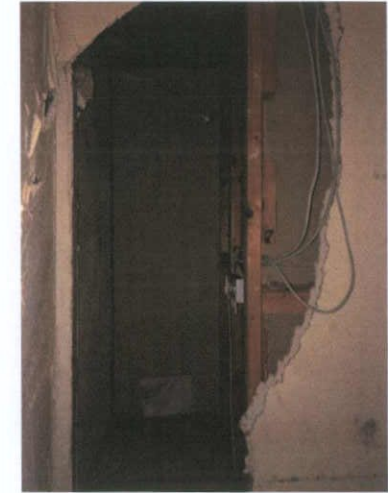
Plate 414: Room 3 — East wall alcove damage

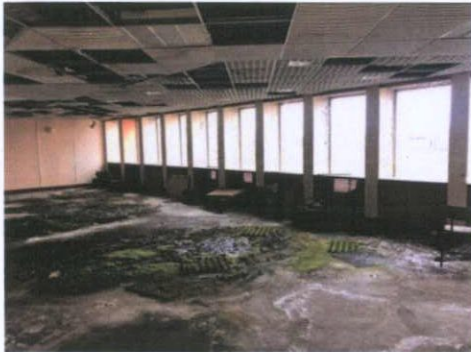
Plate 427: Room 8 — South wall

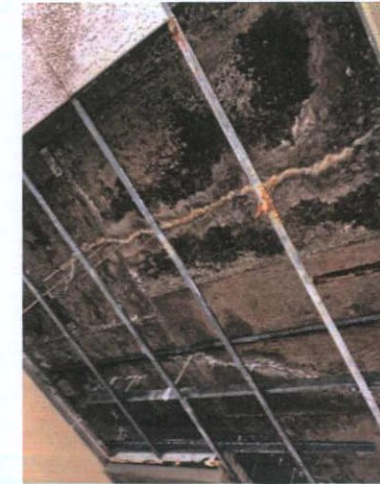
Plate 438: Room 9 — Suspended ceiling damage
