Environmental Impact Assessment Report

Appendix 19.2

Refurbishment & Demolition Asbestos Survey

Site Address	Dublin 3FM Masterplan Kilsaran Concrete Southbank Road Dublin Port	
Site Location		
Client	Name: Dublin Port Company Port Centre, Alexandra Road, Dublin Port, Dublin 1 Contact: Sean Reilly, Programme Management Office Tel: 01 8876043 Mob: 086 1035756	
Survey Dates	26/01/23	
Issue Date	30/01/23	
Surveyor(s)	John Kelleher, About Safety Ltd.

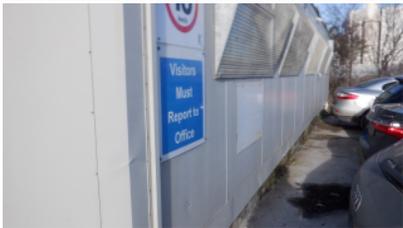
Ref No.	Building or Area of Site	Location or Functional Space	Sample No.	Material Description , surface treatment and condition	Extent	Asbestos identified (presumed, strongly presumed or identified)	Product type	Condition	Surface treatment	Asbestos type	Material assessment score	Recommendations	Photo
1.	Kilsaran Concrete	Office		Outer metal skin with plasterboard internal linings.		NAD

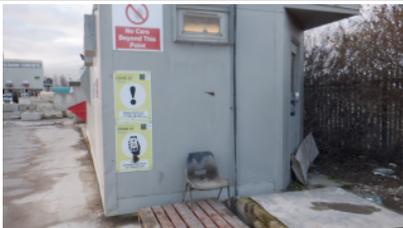
2.	Kilsaran Concrete	Welfare Bld.		Outer metal skin with plasterboard internal linings.		NAD

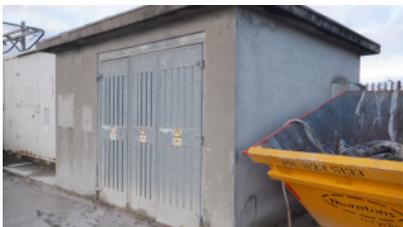
3.	Kilsaran Concrete	ESB substation.		Property of ESB.		Not accessible

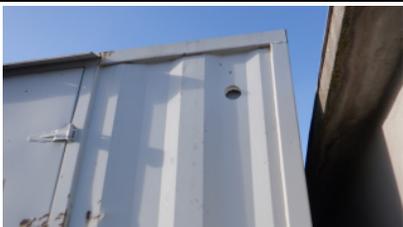
4.	Kilsaran Concrete	Kilsaran Switchroom		Polystyrene between outer steel casing and internal plywood linings.		NAD

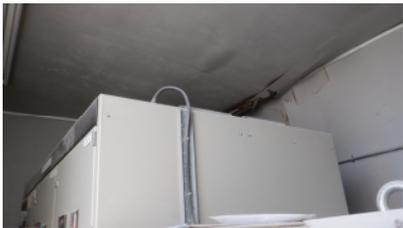
Ref No.	Building or Area of Site	Location or Functional Space	Sample No.	Material Description , surface treatment and condition	Extent	Asbestos identified (presumed, strongly presumed or identified)	Product type	Condition	Surface treatment	Asbestos type	Material assessment score	Recommendations	Photo
5.	Kilsaran Concrete	Kilsaran Switchroom		Plywood internal wall and ceiling linings. Modern electrical plant and equipment		NAD

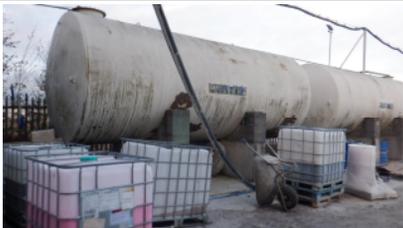
6.	Kilsaran Concrete	Kilsaran		Water storage vessels.		NAD

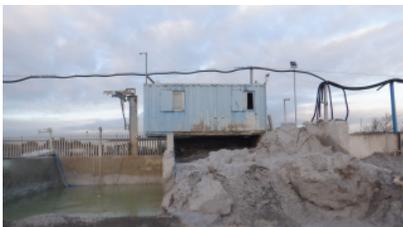
7.	Kilsaran Concrete	Kilsaran		Steel container hut		NAD

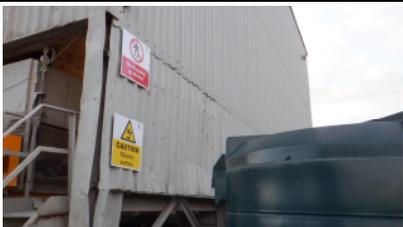
8.	Kilsaran Concrete	Kilsaran Conveyor shed		Single skin metal cladding over structural steel frame.		NAD

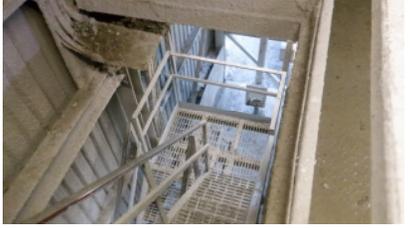
Ref No.	Building or Area of Site	Location or Functional Space	Sample No.	Material Description , surface treatment and condition	Extent	Asbestos identified (presumed, strongly presumed or identified)	Product type	Condition	Surface treatment	Asbestos type	Material assessment score	Recommendations	Photo
9.	Kilsaran Concrete	Kilsaran Readymix Loading shed		Structural steel frames. Outer metal cladding.		NAD

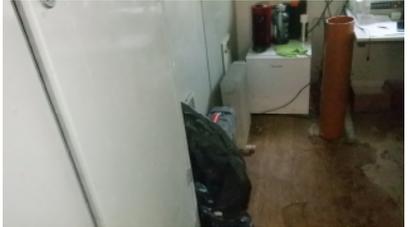
10.	Kilsaran Concrete	Kilsaran Readymix Loading shed Office		Modern electrical plant and equipment.		NAD

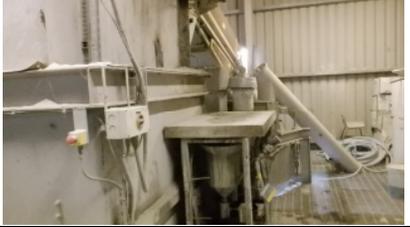
11.	Kilsaran Concrete	Kilsaran Readymix Loading shed Upper deck				NAD

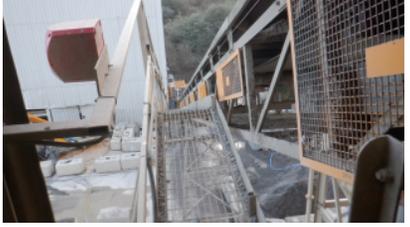
12.	Kilsaran Concrete	Kilsaran Readymix Conveyor				NAD

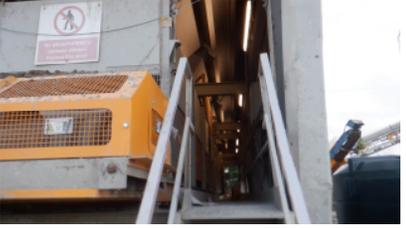
Ref No.	Building or Area of Site	Location or Functional Space	Sample No.	Material Description , surface treatment and condition	Extent	Asbestos identified (presumed, strongly presumed or identified)	Product type	Condition	Surface treatment	Asbestos type	Material assessment score	Recommendations	Photo
13.	Kilsaran Concrete	Conveyor Shed		Outer metal skin on structural steel frames. Conveyor system		NAD

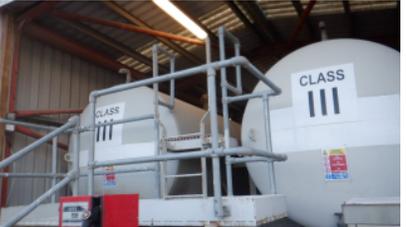
14.	Kilsaran Concrete	Fuel store		Outer metal skin on structural steel frames.		NAD S

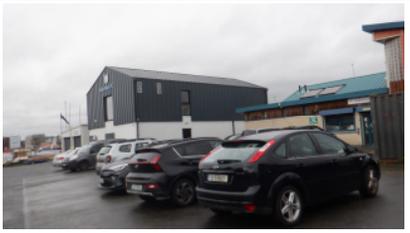
Ref No.	Building or Area of Site	Location or Functional Space	Sample No.	Material Description , surface treatment and condition	Extent	Asbestos identified (presumed, strongly presumed or identified)	Product type	Condition	Surface treatment	Asbestos type	Material assessment score	Recommendations	Photo
1.	Stella Maris Rowing Club	Stella Maris Rowing Club		Constructed Circa 3 to 4 years ago.		NAD

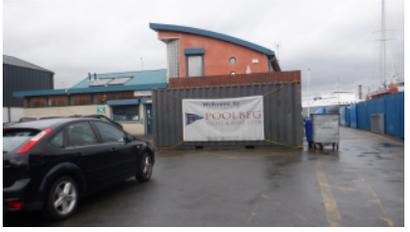
2.	Poolbeg Yacht Club	Poolbeg Sailing Club roofs				NAD

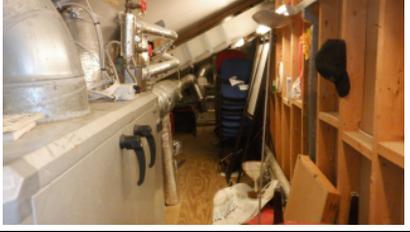
3.	Poolbeg Yacht Club	Poolbeg Sailing Club Attic void		Modern AH ductwork and plant		NAD

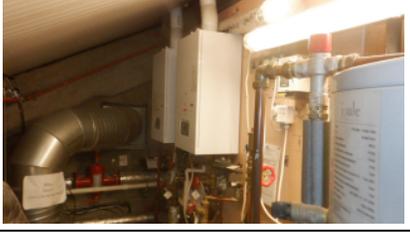
4.	Poolbeg Yacht Club	Poolbeg Sailing Club Attic void		Modern wall mounted gas boilers and assemblies		NAD

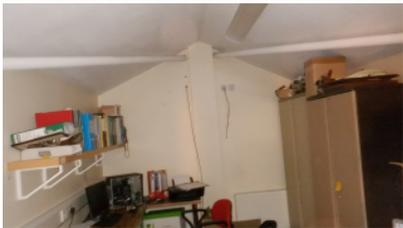
Ref No.	Building or Area of Site	Location or Functional Space	Sample No.	Material Description , surface treatment and condition	Extent	Asbestos identified (presumed, strongly presumed or identified)	Product type	Condition	Surface treatment	Asbestos type	Material assessment score	Recommendations	Photo
5.	Poolbeg Yacht Club	Poolbeg Sailing Club Attic void		Plasterboard to ceilings and walls. Timber flooring		NAD

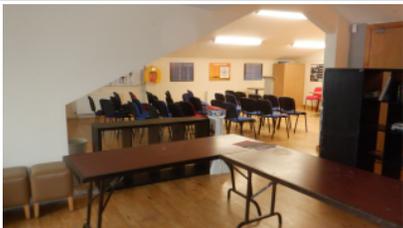
6.	Poolbeg Yacht Club	Poolbeg Sailing Club 1 st floor Assembly room		Plasterboard to ceilings and walls. Timber flooring		NAD

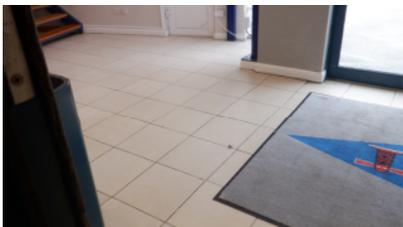
7.	Poolbeg Yacht Club	Poolbeg Sailing Club Ground floor Reception		New build		NAD

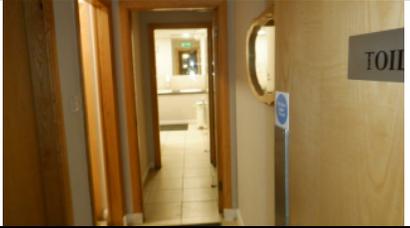
10.	Poolbeg Yacht Club	Poolbeg Sailing Club Ground floor		Modern refurb.		NAD

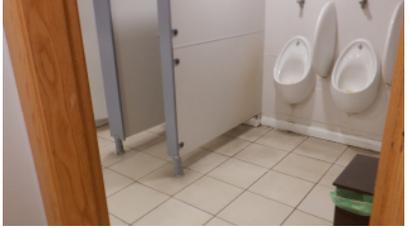
11.	Poolbeg Yacht Club	Poolbeg Sailing Club Ground floor		Modern refurb.		NAD

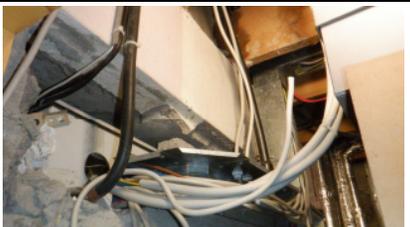
12.	Poolbeg Yacht Club	Poolbeg Sailing Club Ground floor Hallway Store		Modern refurb.		NAD

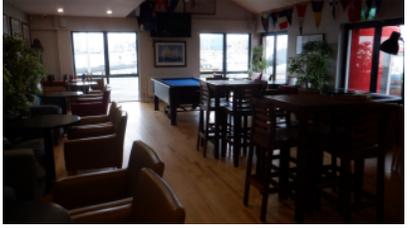
Ref No.	Building or Area of Site	Location or Functional Space	Sample No.	Material Description , surface treatment and condition	Extent	Asbestos identified (presumed, strongly presumed or identified)	Product type	Condition	Surface treatment	Asbestos type	Material assessment score	Recommendations	Photo
13.	Poolbeg Yacht Club	Poolbeg Sailing Club Ground floor		Timber floor		NAD

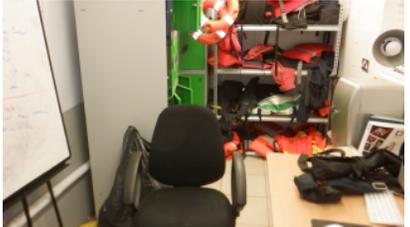
14.	Poolbeg Yacht Club	Poolbeg Sailing Club Ground floor				NAD

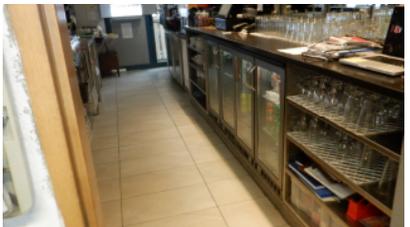
15.	Poolbeg Yacht Club	Poolbeg Sailing Club Ground floor		Ceramic tiles on bar floor.		NAD

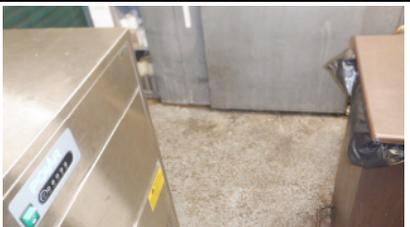
16.	Poolbeg Yacht Club	Poolbeg Sailing Club Ground floor		Concrete floor		NAD

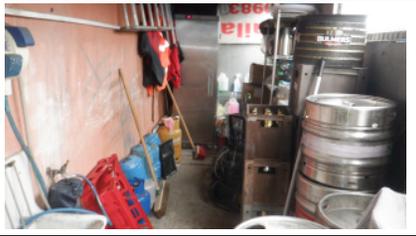
Ref No.	Building or Area of Site	Location or Functional Space	Sample No.	Material Description , surface treatment and condition	Extent	Asbestos identified (presumed, strongly presumed or identified)	Product type	Condition	Surface treatment	Asbestos type	Material assessment score	Recommendations	Photo
17.	Poolbeg Yacht Club	Poolbeg Sailing Club Lean-to store area				NAD

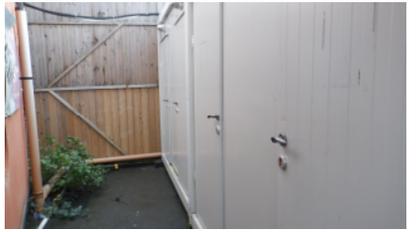
18.	Poolbeg Yacht Club	Poolbeg Sailing Club 24 hour WC's		Modern facilities		NAD

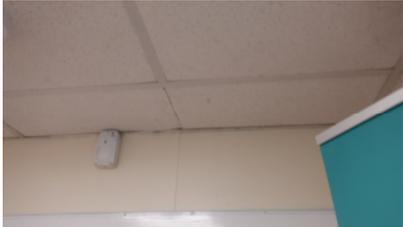
2.	MTL Depot	Peel Ports Main office		Original mineral fibre tiles in lobby ceiling		NAD

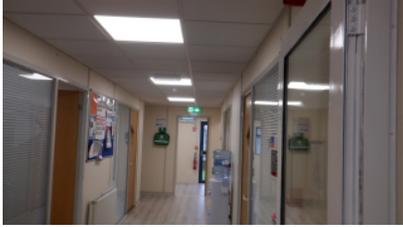
3.	MTL Depot	Peel Ports Main offices		Modern drop ceilings with lay-in ceiling tiles.		NAD

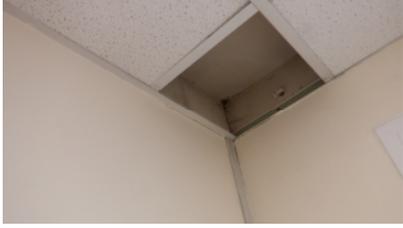
4.	MTL Depot	Peel Ports Main office		Plasterboard ceilings over drop ceilings		NAD

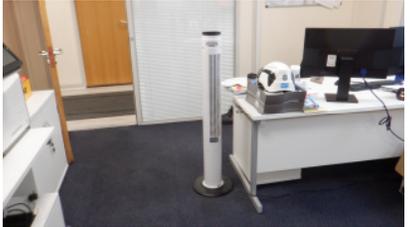
6.	MTL Depot	Peel Ports Main office				NAD

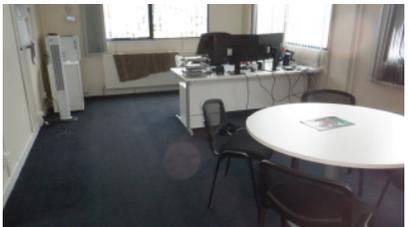
7.	MTL Depot	Peel Ports Main office				NAD

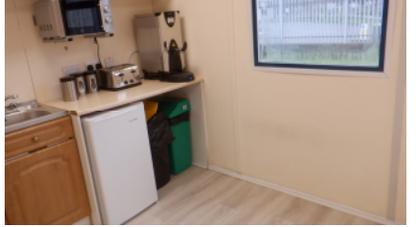
10.	MTL Depot	Peel Ports Main office Kitchen				NAD

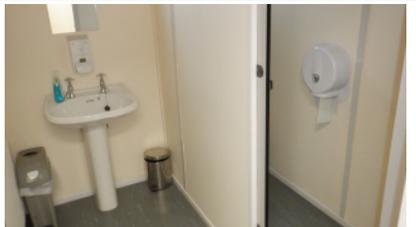
11.	MTL Depot	Peel Ports Main office WC's				NAD

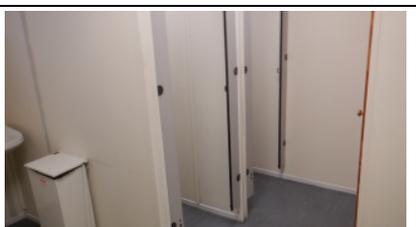
12.	MTL Depot	Peel Ports Main office WC				NAD

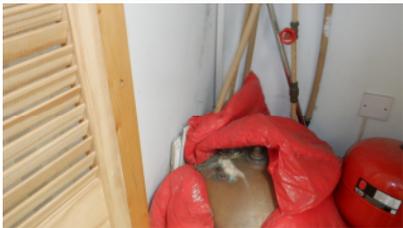
Ref No.	Building or Area of Site	Location or Functional Space	Sample No.	Material Description , surface treatment and condition	Extent	Asbestos identified (presumed, strongly presumed or identified)	Product type	Condition	Surface treatment	Asbestos type	Material assessment score	Recommendations	Photo
13.	MTL Depot	Peel Ports Main office		Hotpress		NAD

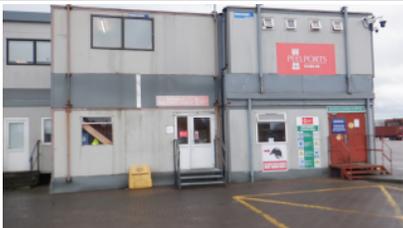
14.	MTL Depot	Peel Ports 2 storey office building.				NAD

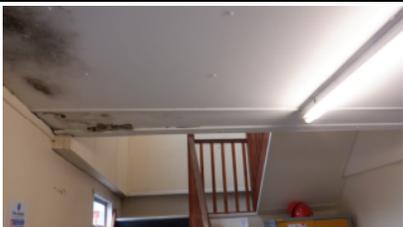
16.	MTL Depot	Peel Ports 2 storey office bld. lobby		Plasterboard internal linings.		NAD

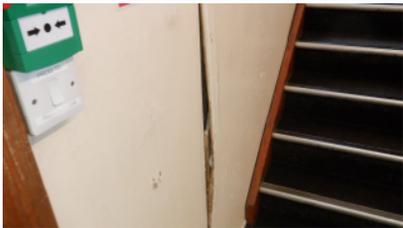
Ref No.	Building or Area of Site	Location or Functional Space	Sample No.	Material Description, surface treatment and condition	Extent	Asbestos identified (presumed, strongly presumed or identified)	Product type	Condition	Surface treatment	Asbestos type	Material assessment score	Recommendations	Photo
17.	MTL Depot	Peel Ports 2 storey office bld.		MMMF insulation in wall cavities		NAD

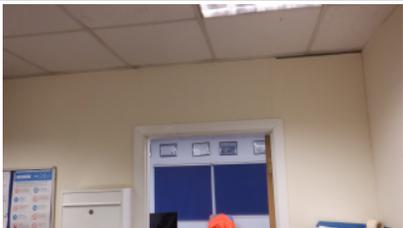
18.	MTL Depot	Peel Ports 2 storey office bld. Internal offices		Modern drop ceilings with lay-in ceiling tiles.		NAD

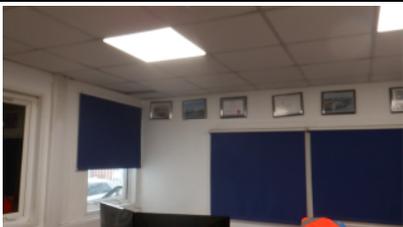
20.	MTL Depot	Peel Ports 2 storey office bld. Ground floor offices		Modern drop ceilings with lay-in ceiling tiles.		NAD

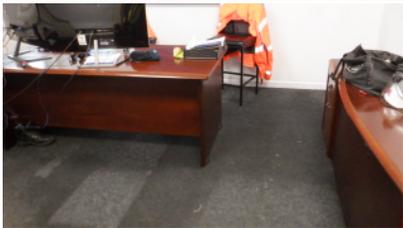
Ref No.	Building or Area of Site	Location or Functional Space	Sample No.	Material Description , surface treatment and condition	Extent	Asbestos identified (presumed, strongly presumed or identified)	Product type	Condition	Surface treatment	Asbestos type	Material assessment score	Recommendations	Photo
21.	MTL Depot	Peel Ports 2 storey office bld. Ground floor offices				NAD

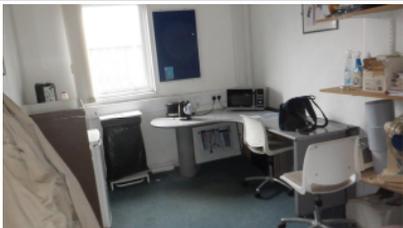
22.	MTL Depot	Peel Ports 2 storey office bld. Ground floor Canteen				NAD

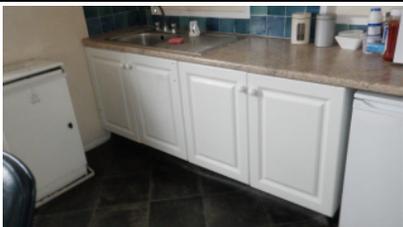
24.	MTL Depot	Peel Ports 2 storey office bld. Ground floor Kitchen				NAD

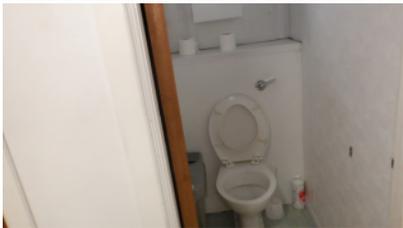
Ref No.	Building or Area of Site	Location or Functional Space	Sample No.	Material Description , surface treatment and condition	Extent	Asbestos identified (presumed, strongly presumed or identified)	Product type	Condition	Surface treatment	Asbestos type	Material assessment score	Recommendations	Photo
25.	MTL Depot	Peel Ports 2 storey office bld. Ground floor WC's				NAD

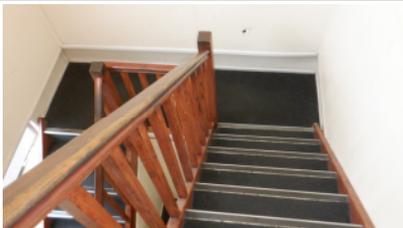
26.	MTL Depot	Peel Ports 2 storey office bld. 1st Floor				NAD

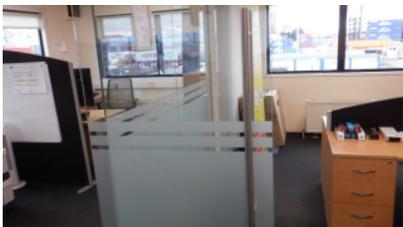
27.	MTL Depot	Peel Ports 2 storey office bld. 1st Floor		Plywood under carpets. Modern drop ceilings with lay-in ceiling tiles.		NAD

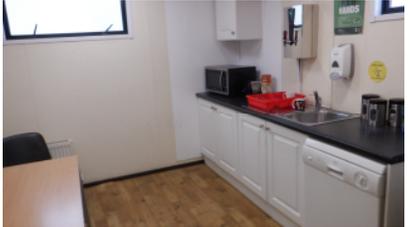
30.	MTL Depot	Peel Ports 2 storey office bld. 1 st Floor				NAD

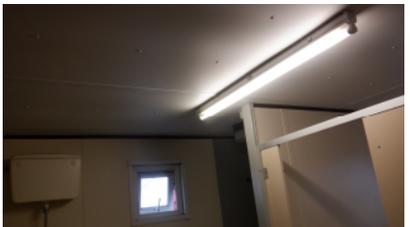
31.	MTL Depot	Peel Ports 2 storey office bld. 1 st Floor WC's				NAD

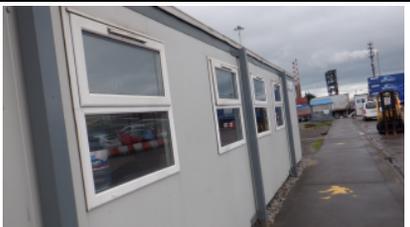
32.	MTL Depot	Peel Ports 2 storey office bld. Welfare building		Modern unit		NAD

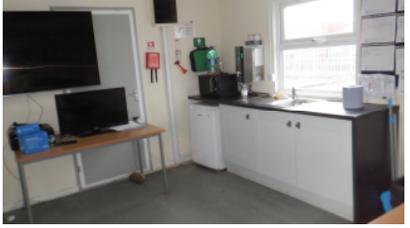
Ref No.	Building or Area of Site	Location or Functional Space	Sample No.	Material Description , surface treatment and condition	Extent	Asbestos identified (presumed, strongly presumed or identified)	Product type	Condition	Surface treatment	Asbestos type	Material assessment score	Recommendations	Photo
33.	MTL Depot	Peel Ports 2 storey office bld. Welfare building				NAD

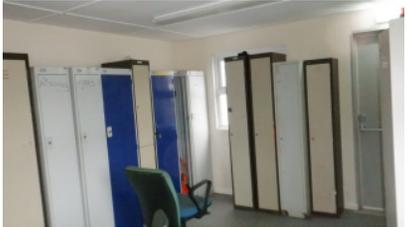
34.	MTL Depot	Peel Ports 2 storey office bld. Welfare building				NAD

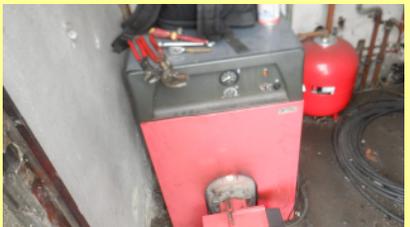
Ref:	Presumed/Strongly Presumed Asbestos [Requires investigation by the competent or specialist asbestos contractor prior to work likely to cause disturbance.]
35	Boiler room - Integral areas of the old boiler are presumed to contain asbestos. Intact.
36	Boiler room - Circulation pump flange gaskets are presumed to contain asbestos.

35.	MTL Depot	Peel Ports Boiler room		Integral areas of the boiler		NAD						Dismantling and investigation by a competent asbestos contractor prior to disposal.

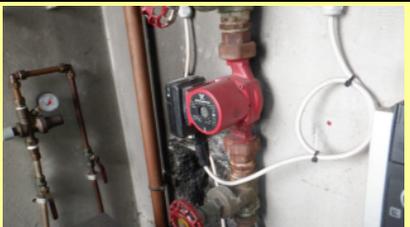
36.	MTL Depot	Peel Ports Boiler room		Circulation pump gaskets.		NAD						Dismantling and investigation by a competent asbestos contractor prior to disposal.

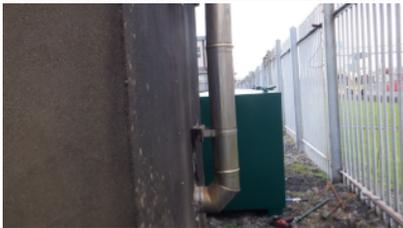
Ref No.	Building or Area of Site	Location or Functional Space	Sample No.	Material Description , surface treatment and condition	Extent	Asbestos identified (presumed, strongly presumed or identified)	Product type	Condition	Surface treatment	Asbestos type	Material assessment score	Recommendations	Photo
37.	MTL Depot	Peel Ports Boiler room		Insulated double flue		NAD

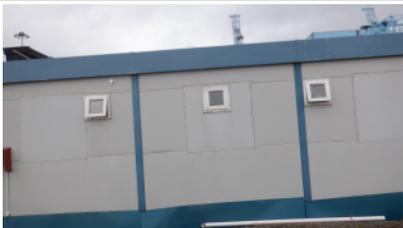
38.	MTL Depot	Peel Ports Welfare Bld.				NAD

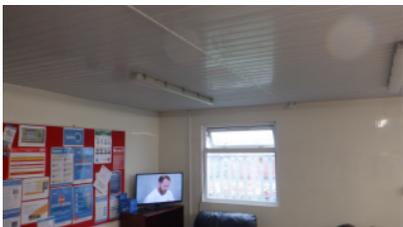
39.	MTL Depot	Peel Ports Welfare Bld.				NAD

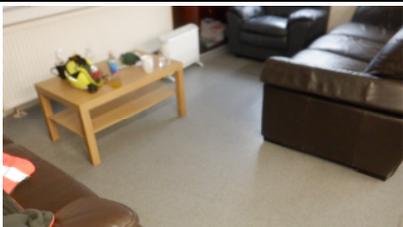
40.	MTL Depot	Peel Ports Welfare Bld.				NAD

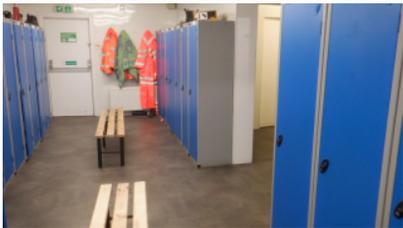
Ref No.	Building or Area of Site	Location or Functional Space	Sample No.	Material Description , surface treatment and condition	Extent	Asbestos identified (presumed, strongly presumed or identified)	Product type	Condition	Surface treatment	Asbestos type	Material assessment score	Recommendations	Photo
41.	MTL Depot	Peel Ports Welfare Bld.				NAD

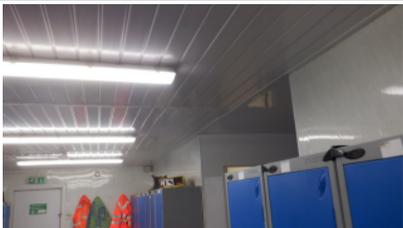
42.	MTL Depot	Peel Ports Welfare Bld.		PVC cladding on roof		NAD

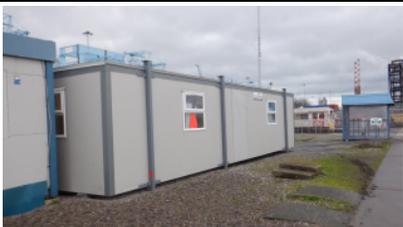
44.	MTL Depot	Peel Ports Welfare Bld.		New prefab building		NAD

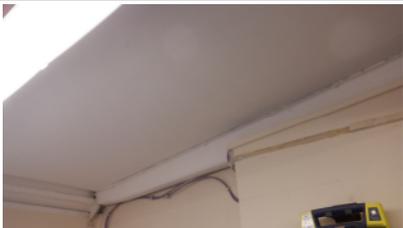
46.	MTL Depot	Security Hut				NAD

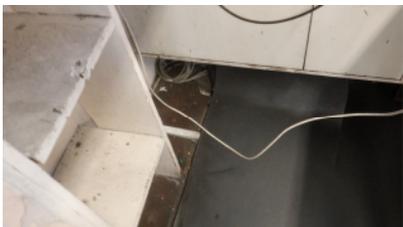
47.	MTL Depot	Security Hut Kitchen	2301004	Brown lino over plywood.		NAD

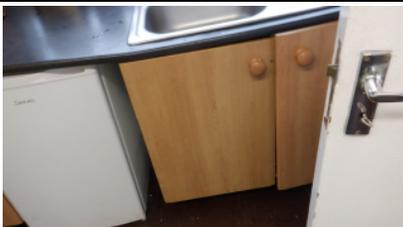
48.	MTL Depot	Security Hut	2301005	Sink pad		NAD

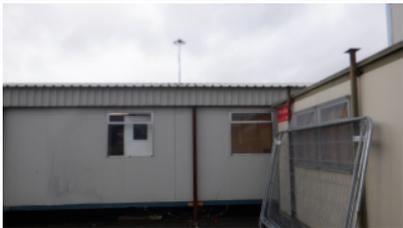
Ref No.	Building or Area of Site	Location or Functional Space	Sample No.	Material Description , surface treatment and condition	Extent	Asbestos identified (presumed, strongly presumed or identified)	Product type	Condition	Surface treatment	Asbestos type	Material assessment score	Recommendations	Photo
49.	MTL Depot	Maintenance Offices				NAD

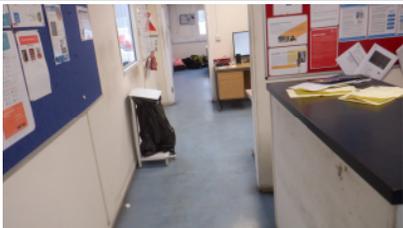
50.	MTL Depot	Maintenance Offices				NAD

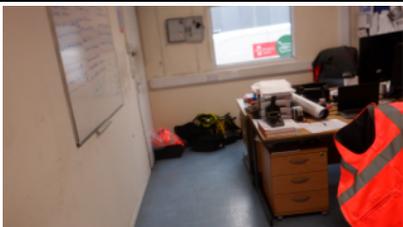
52.	MTL Depot	Maintenance Offices				NAD

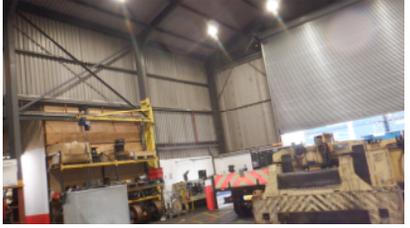
Ref No.	Building or Area of Site	Location or Functional Space	Sample No.	Material Description, surface treatment and condition	Extent	Asbestos identified (presumed, strongly presumed or identified)	Product type	Condition	Surface treatment	Asbestos type	Material assessment score	Recommendations	Photo
53.	MTL Depot	Maintenance workshop				NAD

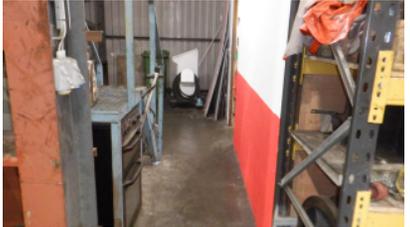
54.	MTL Depot	Maintenance workshop				NAD

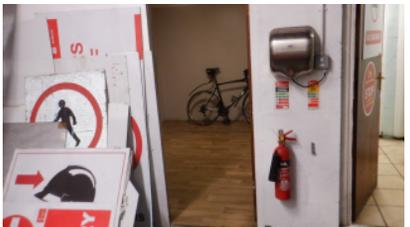
55.	MTL Depot	Maintenance workshop		Modern lino to floor		NAD

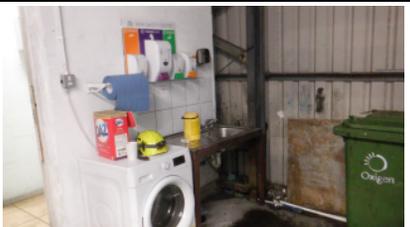
56.	MTL Depot	Maintenance workshop				NAD

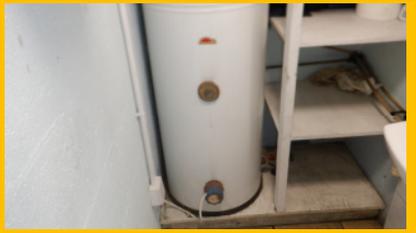
Ref No.	Building or Area of Site	Location or Functional Space	Sample No.	Material Description , surface treatment and condition	Extent	Asbestos identified (presumed, strongly presumed or identified)	Product type	Condition	Surface treatment	Asbestos type	Material assessment score	Recommendations	Photo
57.	MTL Depot	Maintenance workshop	2301006	Immersion flange gaskets to calorifer	2 gaskets	Chrysotile	1	0	0	1	2	Manage in place. Removal by a competent asbestos contractor prior to work likely to cause disturbance.

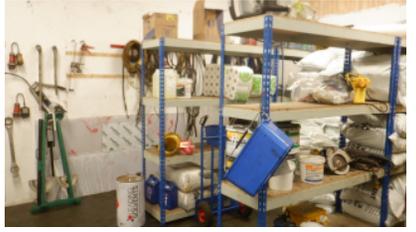
58.	MTL Depot	Maintenance workshop				NAD

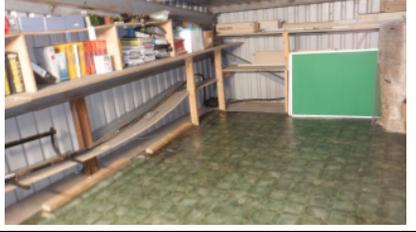
59.	MTL Depot	Maintenance workshop		Modern lino.		NAD

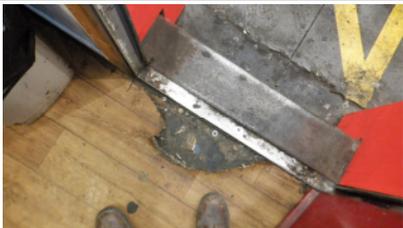
Ref No.	Building or Area of Site	Location or Functional Space	Sample No.	Material Description , surface treatment and condition	Extent	Asbestos identified (presumed, strongly presumed or identified)	Product type	Condition	Surface treatment	Asbestos type	Material assessment score	Recommendations	Photo
62.	MTL Depot	Maintenance workshop	2301007	Old Linos		NAD

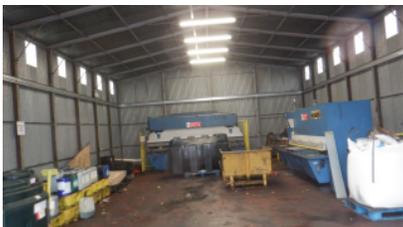
63.	MTL Depot	Maintenance Storeroom		Galvanized steel structure.		NAD

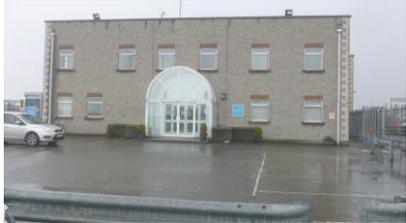
Ref No.	Building	Location or Functional Space	Sample No.	Material Description , surface treatment and condition	Extent	Asbestos identified (presumed, strongly presumed or identified)	Product type	Condition	Surface treatment	Asbestos type	Material assessment score	Recommendations	Photo / Image
1	P&O Admin Building	Facades		Modern stone facades. Building constructed circum. Early 1990's		NAD

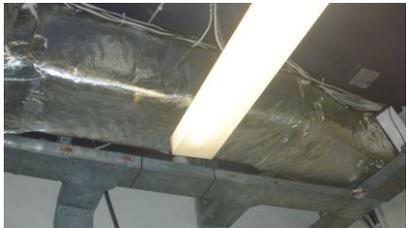
4	P&O Admin Building	Ground Floor Comms room		MMMF insulation to AH ductwork in ceilings		NAD

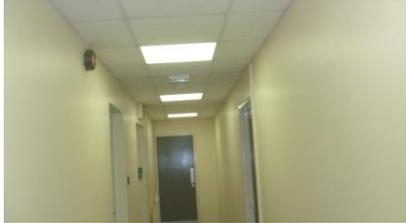
Ref No.	Building	Location or Functional Space	Sample No.	Material Description , surface treatment and condition	Extent	Asbestos identified (presumed, strongly presumed or identified)	Product type	Condition	Surface treatment	Asbestos type	Material assessment score	Recommendations	Photo / Image
5	P&O Admin Building	Ground Floor Circulation corridors				NAD

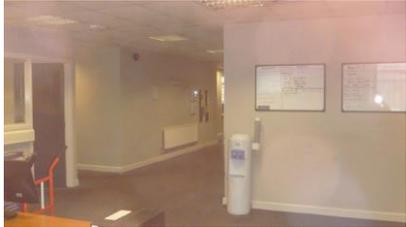
6	P&O Admin Building	Ground Floor Rear of building				NAD

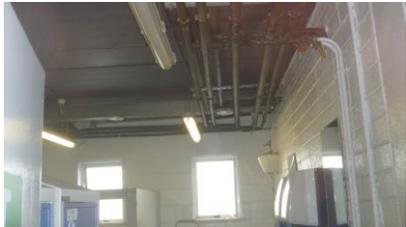
7	P&O Admin Building	Ground Floor Rear of building		M&E services on ceilings.		NAD

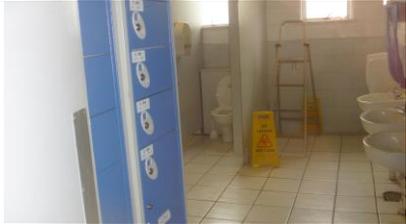
8	P&O Admin Building	Ground Floor WC's		Ceramic tiles to floors		NAD

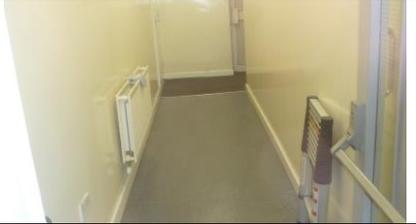
Ref No.	Building	Location or Functional Space	Sample No.	Material Description , surface treatment and condition	Extent	Asbestos identified (presumed, strongly presumed or identified)	Product type	Condition	Surface treatment	Asbestos type	Material assessment score	Recommendations	Photo / Image
9	P&O Admin Building	Ground floor Corridor		Common grey VFT and adhesive		NAD

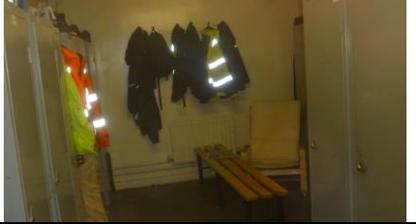
10	P&O Admin Building	Ground floor Locker room				NAD

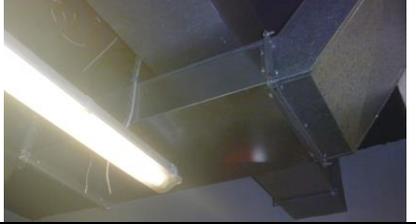
11	P&O Admin Building	Ground floor Locker room				NAD

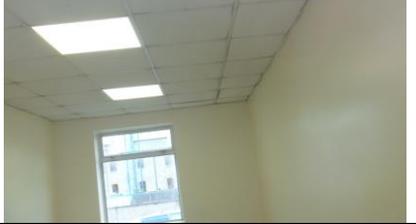
12	P&O Admin Building	Ground floor 1 st floor		Drop ceilings with lay-in ceiling tiles under concrete slab.		NAD

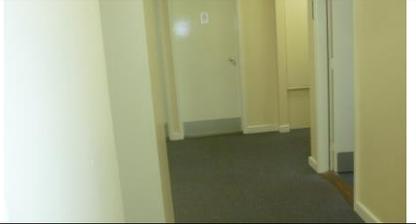
Ref No.	Building	Location or Functional Space	Sample No.	Material Description , surface treatment and condition	Extent	Asbestos identified (presumed, strongly presumed or identified)	Product type	Condition	Surface treatment	Asbestos type	Material assessment score	Recommendations	Photo / Image
13	P&O Admin Building	1 st floor Circulation corridors				NAD

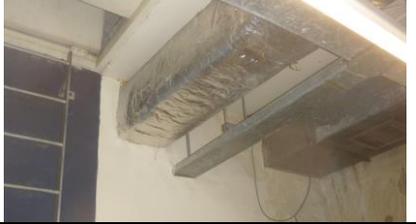
14	P&O Admin Building	1 st floor Plantroom		MMMF to AH ductwork		NAD

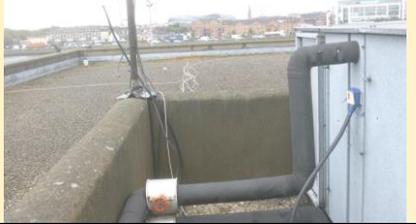
16	P&O Admin Building	Roof Plant		Pipework flange gaskets		Presumed asbestos						Investigation by a competent contractor prior to works likely to cause disturbance.

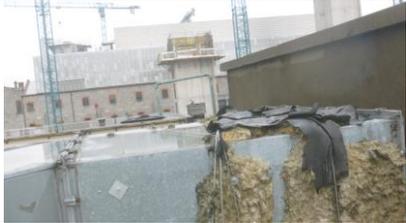
Ref No.	Building	Location or Functional Space	Sample No.	Material Description , surface treatment and condition	Extent	Asbestos identified (presumed, strongly presumed or identified)	Product type	Condition	Surface treatment	Asbestos type	Material assessment score	Recommendations	Photo / Image
17	P&O Admin Building	Roof Plant		MMMF to AH ductwork		NAD

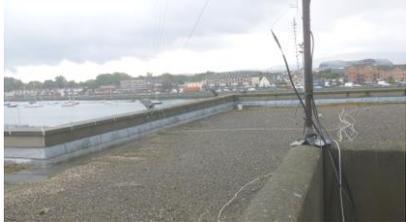
18	P&O Admin Building	Roof				NAD

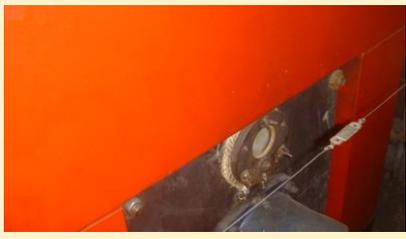
19	P&O Admin Building	Boiler room Chappee boiler		Gasket to eyeglass		Presumed to contain asbestos						Investigation by a competent contractor prior to works likely to cause disturbance.

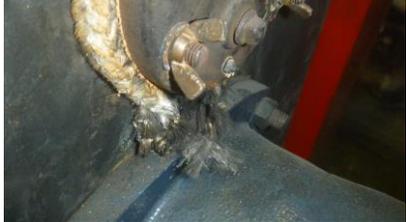
20	P&O Admin Building	Boiler room Chappee boiler	1825702	Nylon woven rope gasket behind eyeglass flange.		NAD

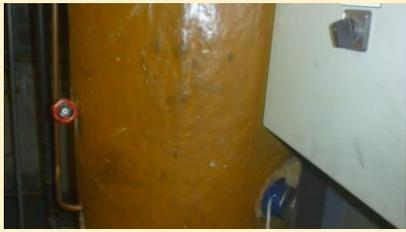
22	P&O Admin Building	Boiler room Calorifer		Immersion flange gaskets		Presumed to contain asbestos						Investigation by a competent contractor prior to works likely to cause disturbance.

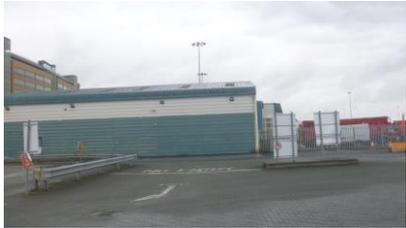
23	Workshop Building	Garage Externally		Metal cadding to roof and sides.		NAD

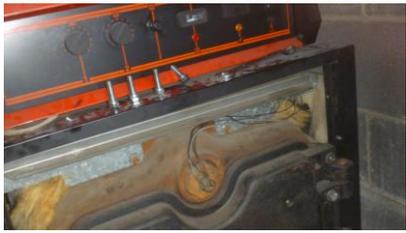
Ref No.	Building	Location or Functional Space	Sample No.	Material Description , surface treatment and condition	Extent	Asbestos identified (presumed, strongly presumed or identified)	Product type	Condition	Surface treatment	Asbestos type	Material assessment score	Recommendations	Photo / Image
25	Workshop Building	Garage Boiler room		MMMF insulation around boiler.		NAD

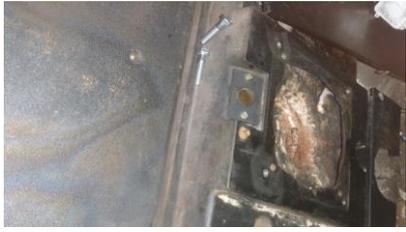
26	Workshop Building	Garage Boiler room		Ceramic fibre type packing inside boiler		NAD

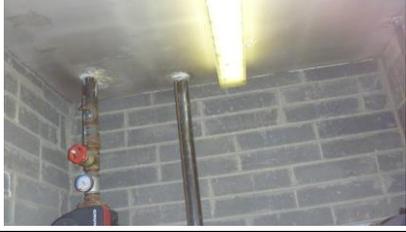
27	Workshop Building	Garage		Plasterboard to boiler ceiling		NAD

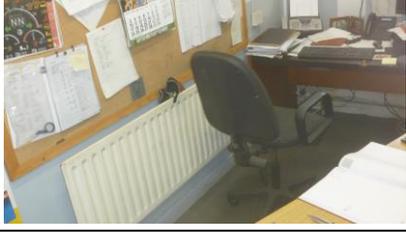
28	Workshop Building	Workshop office		Common grey VFT and Evode		NAD

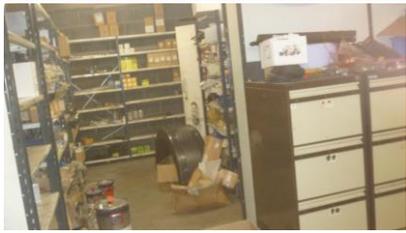
Ref No.	Building	Location or Functional Space	Sample No.	Material Description , surface treatment and condition	Extent	Asbestos identified (presumed, strongly presumed or identified)	Product type	Condition	Surface treatment	Asbestos type	Material assessment score	Recommendations	Photo / Image
29	Workshop Building	Worshop store room				NAD

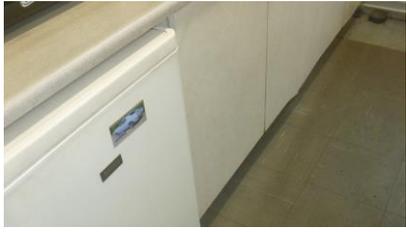
30	Workshop Building	Workshop canteen		Common grey VFT and Evode		NAD

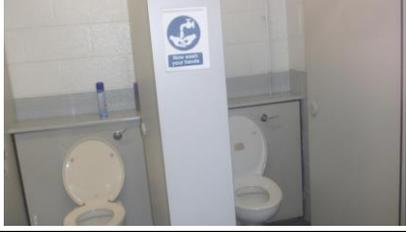
31	Workshop Building	Workshop WC's		Common grey VFT and Evode		NAD

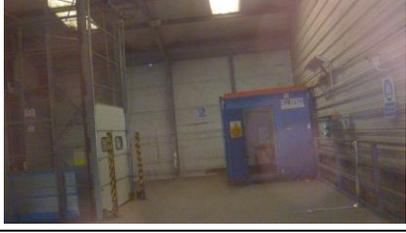
32	Workshop Building	Workshop Loading Bay Room				NAD

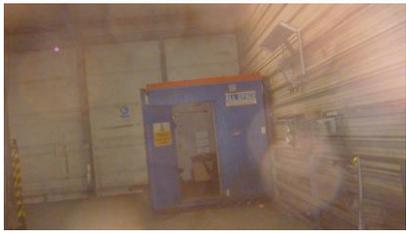
Ref No.	Building	Location or Functional Space	Sample No.	Material Description , surface treatment and condition	Extent	Asbestos identified (presumed, strongly presumed or identified)	Product type	Condition	Surface treatment	Asbestos type	Material assessment score	Recommendations	Photo / Image
33	Workshop Building	Workshop Loading Bay Room All Space Office				NAD

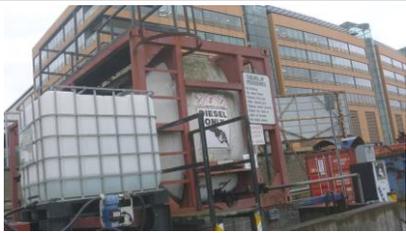
34	Workshop Building	Workshop Fuel Tank				NAD

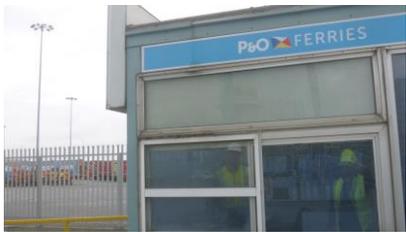
35	Cabin	Yard Area Old Security Hut				NAD

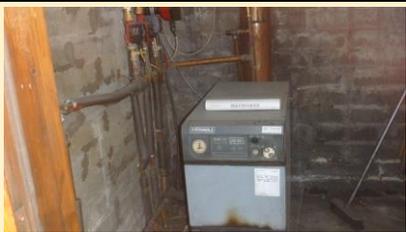
36	Freight Drivers Terminal	External boiler room		Integral areas of the old boiler		Presumed to contain asbestos						Presumed to contain asbestos

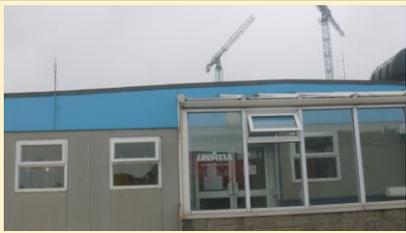
38	Freight Drivers Terminal	Roof		Substrate roofing felt		Presumed asbestos until proven otherwise						Sampling and investigation prior to demolition.

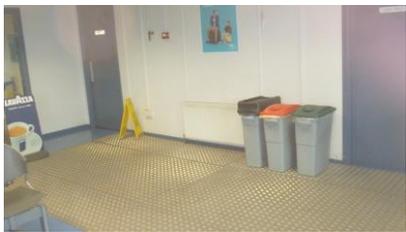
39	Freight Drivers Terminal	Lobby		Common grey VFT under flooring		NAD

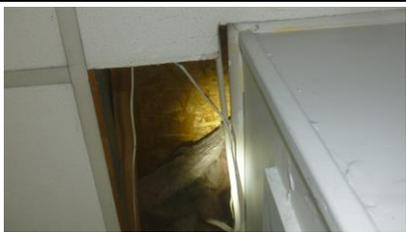
40	Freight Drivers Terminal	Lobby		MMMF insulation over drop ceilings		NAD

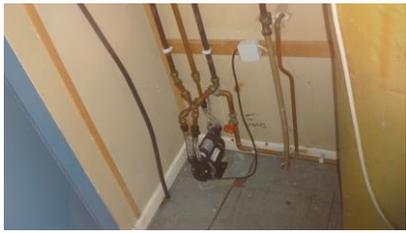
Ref No.	Building	Location or Functional Space	Sample No.	Material Description , surface treatment and condition	Extent	Asbestos identified (presumed, strongly presumed or identified)	Product type	Condition	Surface treatment	Asbestos type	Material assessment score	Recommendations	Photo / Image
41	Freight Drivers Terminal	Lobby store	1825703 1825704	1825703		NAD

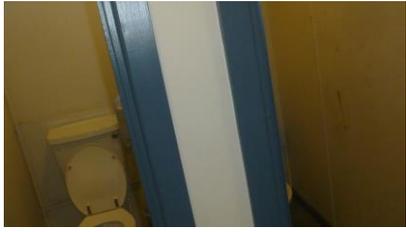
42	Freight Drivers Terminal	Ladies WC				NAD

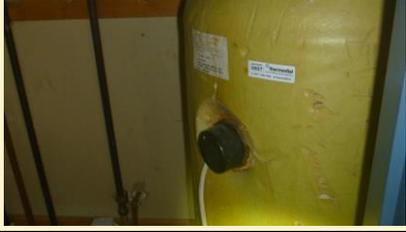
43	Freight Drivers Terminal	Hotpress		Immersion flange gaskets		Presumed asbestos						Sampling and investigation prior to demolition.

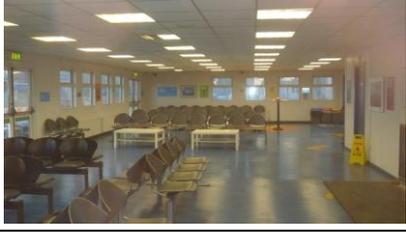
44	Freight Drivers Terminal	Waiting room				NAD

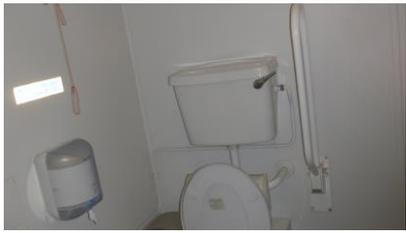
Ref No.	Building	Location or Functional Space	Sample No.	Material Description , surface treatment and condition	Extent	Asbestos identified (presumed, strongly presumed or identified)	Product type	Condition	Surface treatment	Asbestos type	Material assessment score	Recommendations	Photo / Image
45	Freight Drivers Terminal	Disabled WC				NAD

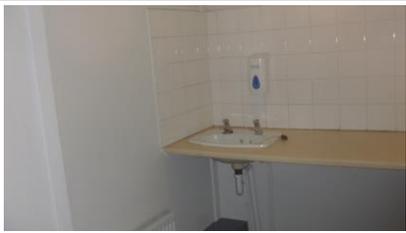
46	Freight Drivers Terminal	Changing room				NAD

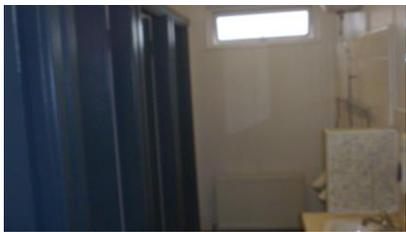
47	Freight Drivers Terminal	Gents WC				NAD

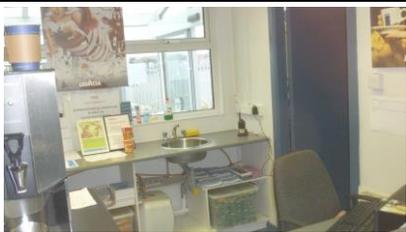
48	Freight Drivers Terminal	Kitchen areas				NAD

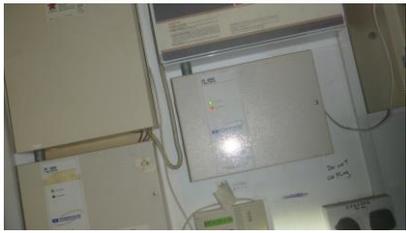
Ref No.	Building	Location or Functional Space	Sample No.	Material Description , surface treatment and condition	Extent	Asbestos identified (presumed, strongly presumed or identified)	Product type	Condition	Surface treatment	Asbestos type	Material assessment score	Recommendations	Photo / Image
49	Freight Drivers Terminal	Electrical cupboard at kitchen				NAD

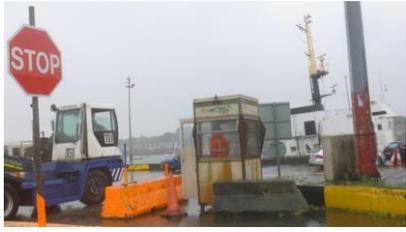
50	Loading Ramp	Security Hut 1		Metal skin with polyurethane insulation		NAD

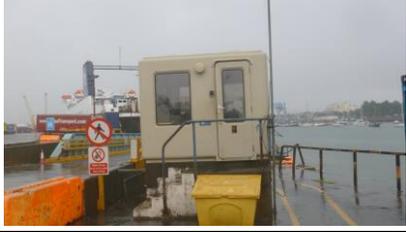
51	Loading Ramp	Security Hut 2		Fiberglass molded unit		NAD

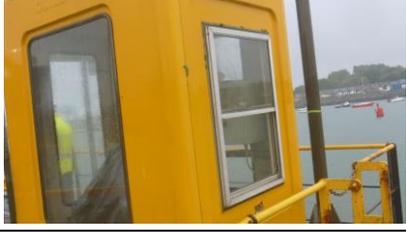
52	Loading Ramp	Security Hut 3		Fiberglass molded unit		NAD

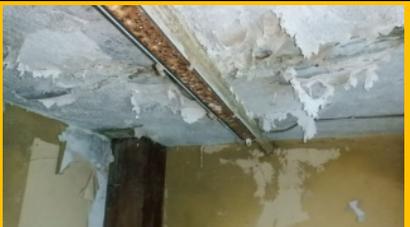
Ref:	Confirmed Asbestos [Requires removal and disposal as asbestos waste by a competent asbestos contractor prior to work likely to cause disturbance.]
2	Asbestos containing textured paint to the ceiling of the old DCC Jetty Head hut. Circa 5 square meters. Delaminating and flaking in areas. Statutory notification of 14 days is required to be given by the appointed contractor.
7, 8	Asbestos containing textured paint to the ceiling of the old DCC pumping station building. Circa 300 square meters. Delaminating and flaking in areas. Statutory notification of 14 days is required to be given by the appointed contractor.
18	Asbestos containing flange gaskets to old plant on the Jetty Head. Presumed in all similar valve and pipework assemblies. Trade standard at the time of construction.
20, 21, 22	Asbestos containing vinyl floor tiles and/or adhesive in the Hetty Head office building. Circa 30 square meters.

2.	Sludge Jetty	Jetty Head building	2302501	Textured paint to ceiling	Circa 5 SM	Chrysotile	1	2	2	1	6	Removal and disposal as asbestos waste by a specialist asbestos contractor under fully controlled conditions. Statutory notification of 14 days to H.S.A.

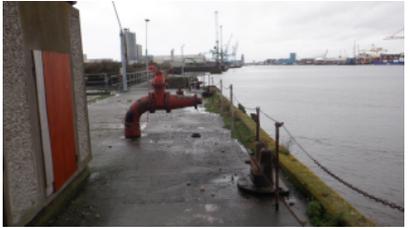
3.	Sludge Jetty	Jetty Head		Rubber gaskets to fire hydrant and plant		NAD

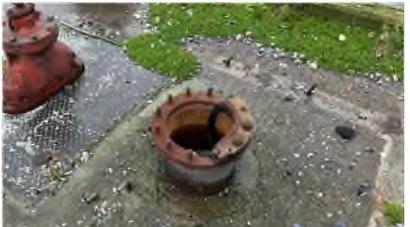
4.	Sludge Jetty	Jetty Head		Rubber gaskets to fire hydrant and plant		NAD

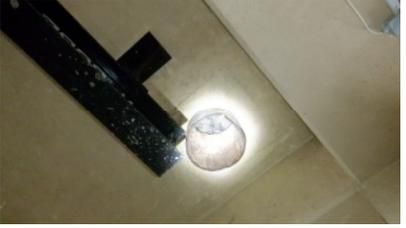
Ref No.	Building or Area of Site	Location or Functional Space	Sample No.	Material Description, surface treatment and condition	Extent	Asbestos identified (presumed, strongly presumed or identified)	Product type	Condition	Surface treatment	Asbestos type	Material assessment score	Recommendations	Photo
9.	Sludge Jetty	DCC Pumphouse Ceiling		Old pipework in ceiling		NAD

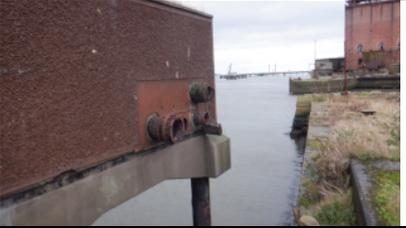
10.	Sludge Jetty	DCC Pumphouse External facades				NAD

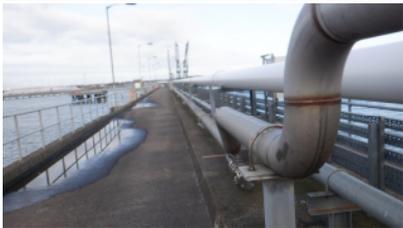
Ref No.	Building or Area of Site	Location or Functional Space	Sample No.	Material Description , surface treatment and condition	Extent	Asbestos identified (presumed, strongly presumed or identified)	Product type	Condition	Surface treatment	Asbestos type	Material assessment score	Recommendations	Photo
13.	ESB Jetty	Jetty Pier		Pipework runs		NAD

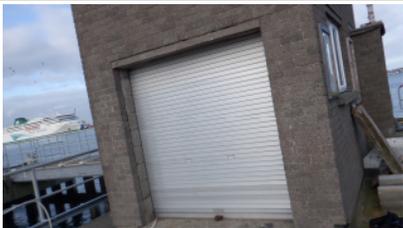
14.	ESB Jetty	Jetty Head Loading Platform Storeroom		Concrete floor.		NAD

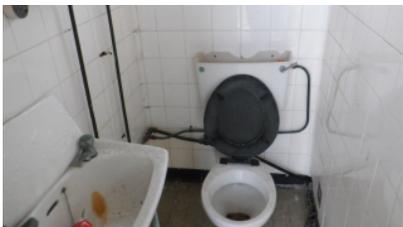
15.	ESB Jetty	Jetty Head Loading Platform WC		Ceramic floor tiles and toilet ware		NAD

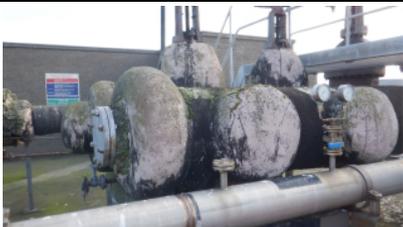
16.	ESB Jetty	Jetty Head Loading Platform	2302503	Pink plaster over MMMF		NAD

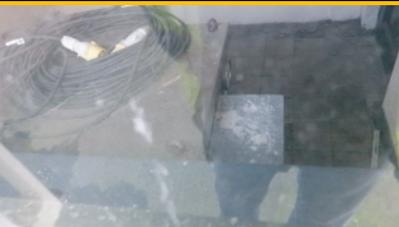
22.	ESB Jetty	Jetty Head Office 1 Floor	2302508	VFT and adhesive. Lifting	Circa 8 SM	Chrysotile	1	1	0	1	3	Removal and disposal as asbestos waste by a competent asbestos contractor prior to work likely to cause disturbance.

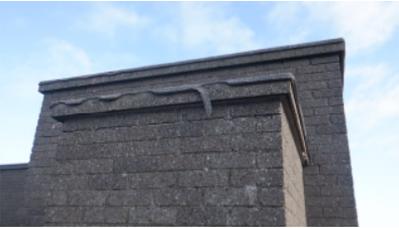
23.	ESB Jetty	Jetty Head Offices Roof		Bitumen asphalt over concrete		NAD

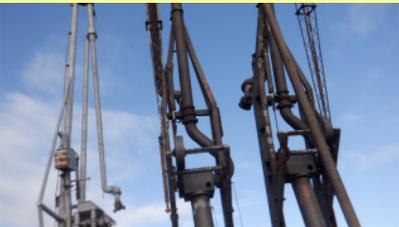
24.	ESB Jetty	Jetty Head Marine Loading Arms		Flange gaskets		Presumed asbestos	1	0	0	1	2	Investigation by a competent contractor prior to work likely to cause disturbance.

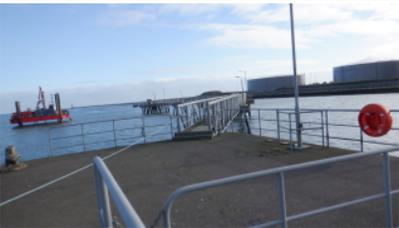
Ref No.	Building or Area of Site	Location or Functional Space	Sample No.	Material Description , surface treatment and condition	Extent	Asbestos identified (presumed, strongly presumed or identified)	Product type	Condition	Surface treatment	Asbestos type	Material assessment score	Recommendations	Photo
25.	ESB Jetty	East finger Berthing and Mooring Dolphins		Concrete construction		NAD

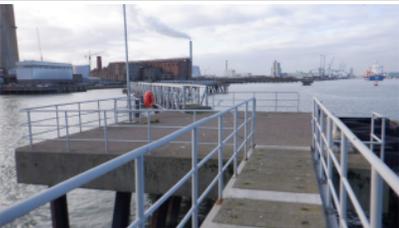
26.	ESB Jetty	West finger Berthing and Mooring Dolphins		Concrete construction		NAD

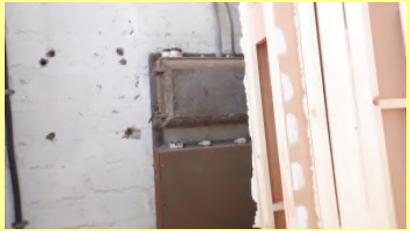
6.	South Port 3FM Project	Old ESB Laboratory Bottom stores building		Integral areas of old electrical panels behind store materials		Presumed asbestos materials	2	2	2	2	8	Investigation and sampling of suspect materials prior to any work undertaken.

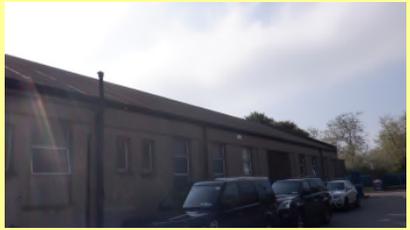
7.	South Port 3FM Project	Old ESB Laboratory Upper office building Roof		Felt to profile steel sheeting		Presumed asbestos	1	0	0	1	2	Investigation and sampling of suspect materials prior to any work undertaken.

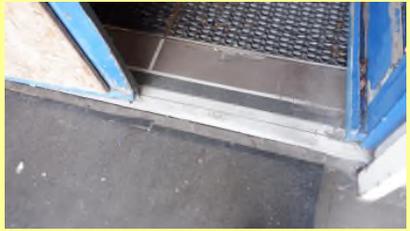
8.	South Port 3FM Project	Old ESB Laboratory And Offices Entrance lobby		Thread nosings		Presumed asbestos	1	0	0	1	2	Investigation and sampling of suspect materials prior to any work undertaken.

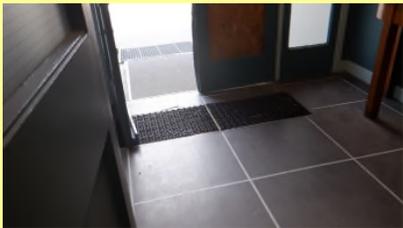
9.	South Port 3FM Project	Old ESB Laboratory And Offices Entrance lobby		VFT and adhesive		Presumed asbestos	1	0	0	1	2	Investigation and sampling of suspect materials prior to any work undertaken.

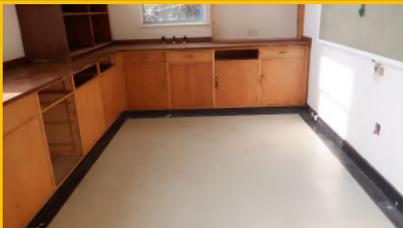
10.	South Port 3FM Project	Old ESB Laboratory And Offices Laboratory		Common VFT and adhesive. Intact		Chrysotile	1	0	0	1	2	Removal and disposal as asbestos waste by a competent person prior to work likely to cause disturbance.

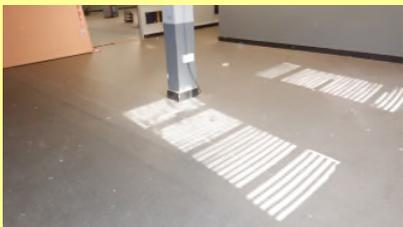
11.	South Port 3FM Project	Old ESB Laboratory And Offices Laboratory		Old common VFT and/or adhesive.		Presumed under lino	1	0	0	1	2	Investigation and sampling of suspect materials prior to any work undertaken.

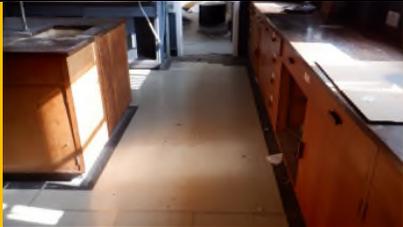
12.	South Port 3FM Project	Old ESB Laboratory And Offices Laboratory		Common VFT and adhesive. Lifting and breaking locally		Chrysotile	1	1	0	1	3	Removal and disposal as asbestos waste by a competent person prior to work likely to cause disturbance.

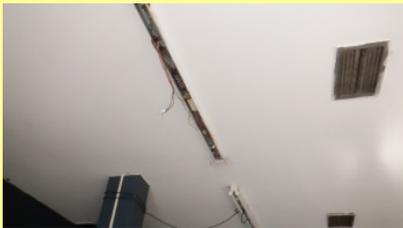
13.	South Port 3FM Project	Old ESB Laboratory And Offices Laboratory		Ventilation ductwork in ceiling void		Presumed asbestos seals	1	0	0	1	2	Investigation and sampling of suspect materials prior to any work undertaken.

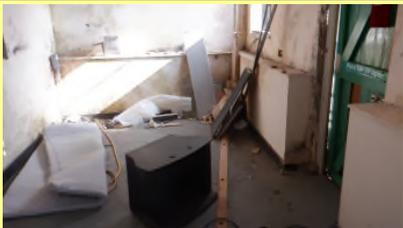
14.	South Port 3FM Project	Old ESB Laboratory And Offices Lobby at exit door		Old common VFT and/or adhesive.		Presumed under lino	1	0	0	1	2	Investigation and sampling of suspect materials prior to any work undertaken.

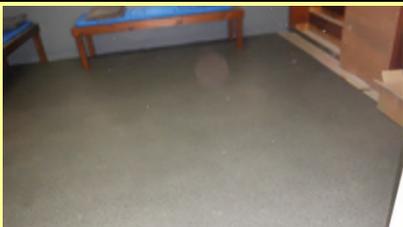
16.	South Port 3FM Project	Old ESB Laboratory And Offices Film set room		Old common VFT and/or adhesive.		Presumed under lino	1	0	0	1	2	Investigation and sampling of suspect materials prior to any work undertaken.

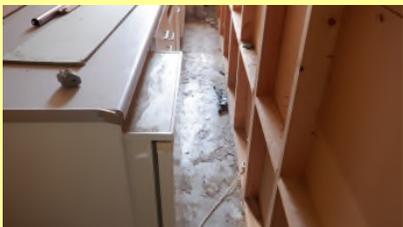
19.	South Port 3FM Project	Old ESB Laboratory And Offices Old laboratory storage area.		Old common VFT and/or adhesive.		Presumed under lino	1	0	0	1	2	Investigation and sampling of suspect materials prior to any work undertaken.

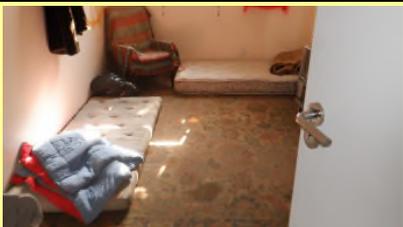
20.	South Port 3FM Project	Old ESB Laboratory And Offices Film set		Old common VFT and/or adhesive.		Presumed under lino/carpet.	1	0	0	1	2	Investigation and sampling of suspect materials prior to any work undertaken.

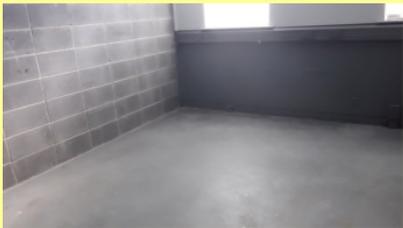
21.	South Port 3FM Project	Old ESB Laboratory And Offices Film set		Old common VFT and/or adhesive.		Presumed under lino.	1	0	0	1	2	Investigation and sampling of suspect materials prior to any work undertaken.

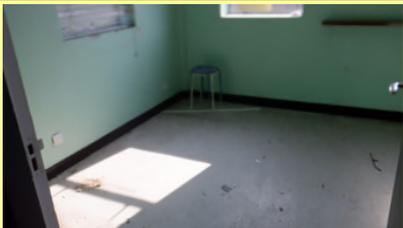
22.	South Port 3FM Project	Old ESB Laboratory And Offices Film set		Old common VFT and/or adhesive.		Presumed under lino.	1	0	0	1	2	Investigation and sampling of suspect materials prior to any work undertaken.

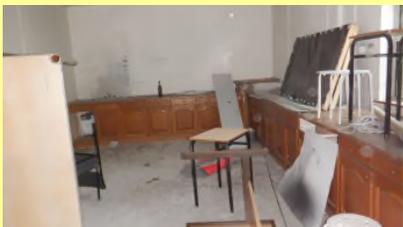
23.	South Port 3FM Project	Old ESB Laboratory And Offices Kitchen		Old common VFT and/or adhesive.		Presumed under lino.	1	0	0	1	2	Investigation and sampling of suspect materials prior to any work undertaken.

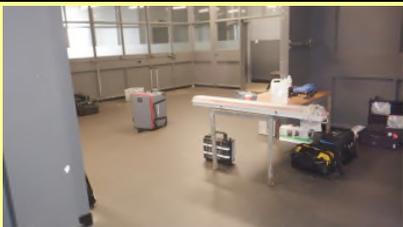
24.	South Port 3FM Project	Old ESB Laboratory And Offices Film set storage room		Old common VFT and/or adhesive.		Presumed under lino.	1	0	0	1	2	Investigation and sampling of suspect materials prior to any work undertaken.

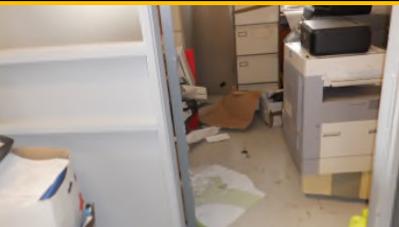
26.	South Port 3FM Project	Old ESB Laboratory And Offices Individual offices		Common VFT and adhesive in office corridor		Chrysotile	1	0	0	1	2	Removal and disposal as asbestos waste by a competent person prior to work likely to cause disturbance.

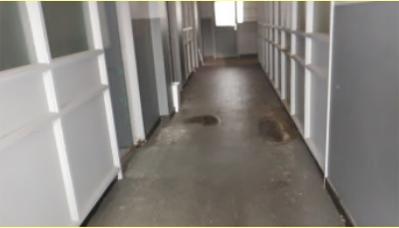
27.	South Port 3FM Project	Old ESB Laboratory And Offices Corridor		Old common VFT and/or adhesive.		Presumed under lino.	1	0	0	1	2	Investigation and sampling of suspect materials prior to any work undertaken.

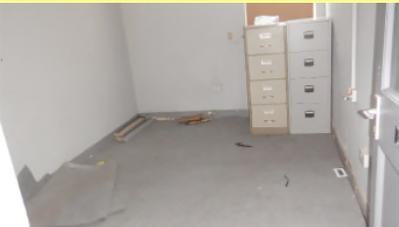
28.	South Port 3FM Project	Old ESB Laboratory And Offices Individual offices		Old common VFT and/or adhesive.		Presumed under lino.	1	0	0	1	2	Investigation and sampling of suspect materials prior to any work undertaken.

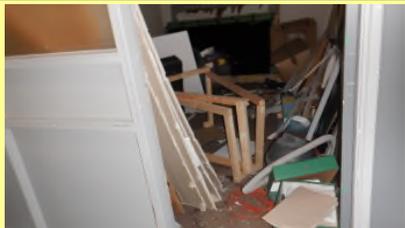
30.	South Port 3FM Project	Old ESB Laboratory And Offices Individual offices		Old common VFT and/or adhesive.		Presumed under carpet.	1	0	0	1	2	Investigation and sampling of suspect materials prior to any work undertaken.

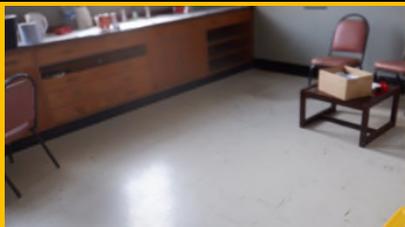
32.	South Port 3FM Project	Old ESB Laboratory And Offices Film crew canteen		Common VFT and adhesive. Intact		Chrysotile	1	0	0	1	2	Removal and disposal as asbestos waste by a competent person prior to work likely to cause disturbance.
