Environmental Impact Assessment Report

Appendix 19.2

Refurbishment & Demolition Asbestos Survey

Site Address	Dublin 3FM Masterplan Kilsaran Concrete Southbank Road Dublin Port	
Site Location		
Client	Name: Dublin Port Company Port Centre, Alexandra Road, Dublin Port, Dublin 1 Contact: Sean Reilly, Programme Management Office Tel: 01 8876043 Mob: 086 1035756	
Survey Dates	26/01/23	
Issue Date	30/01/23	
Surveyor(s)	John Kelleher, About Safety Ltd.

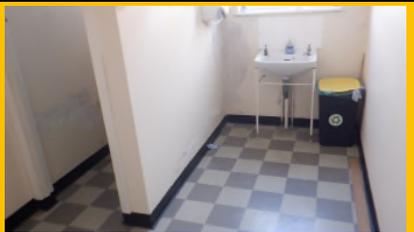
36.	South Port 3FM Project	Old ESB Laboratory And Offices Ladies WC		Common VFT and adhesive. Intact		Chrysotile	1	0	0	1	2	Removal and disposal as asbestos waste by a competent person prior to work likely to cause disturbance.

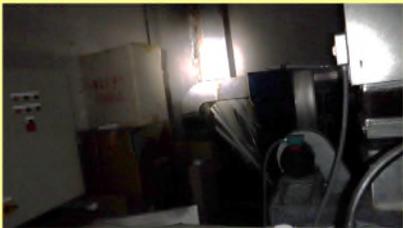
37.	South Port 3FM Project	Old ESB Laboratory And Offices		Evidence of previous asbestos removal work in this area		Presumed asbestos residues	2	2	2	2	8	Investigation and sampling of suspect materials prior to any work undertaken.

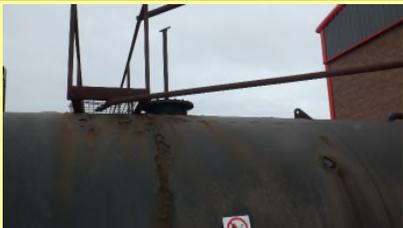
2.	Hammond Lane	Fuel Bunded area		Flange gaskets to storage vessel		Presumed asbestos						Investigate prior to work likely to cause disturbance.

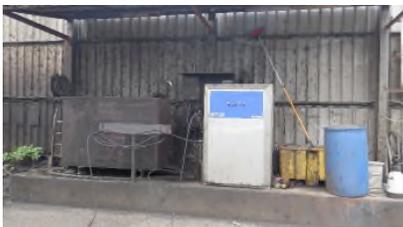
3.	Hammond Lane	Vehicle wash area				No visible asbestos containing materials identified.

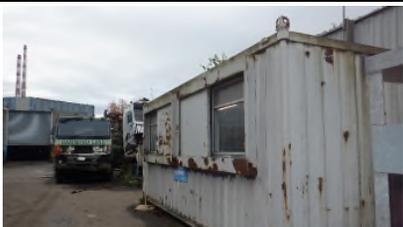
4.	Hammond Lane	Old container offices				No visible asbestos containing materials identified.

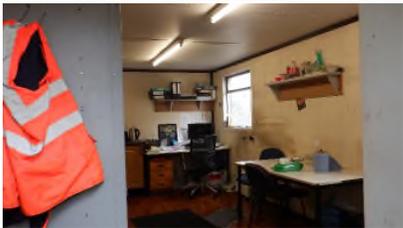
5.	Hammond Lane	Old container offices		Plasterboard internal linings		No visible asbestos containing materials identified.

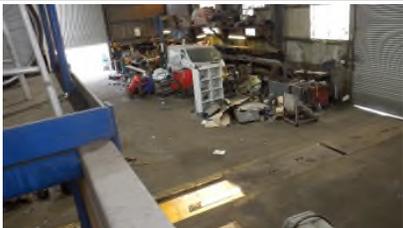
6.	Hammond Lane	Garage		Profile steel cladding to roof and sides over mass concrete walls.		No visible asbestos containing materials identified.

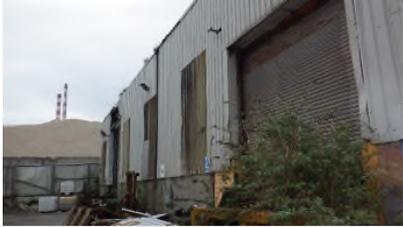
7.	Hammond Lane	Garage		Profile steel cladding to roof and sides over mass concrete walls.		No visible asbestos containing materials identified.

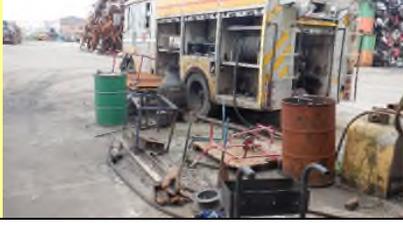
8.	Hammond Lane	Garage		Old vehicles		Presumed asbestos brake shoes and flange gaskets to engines.						Investigate prior to work likely to cause disturbance.

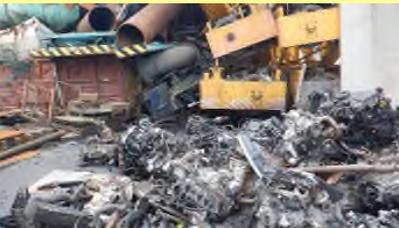
9.	Hammond Lane	Metal Pile East side of site		Old baled engines		Presumed asbestos gaskets.						Investigate prior to work likely to cause disturbance.

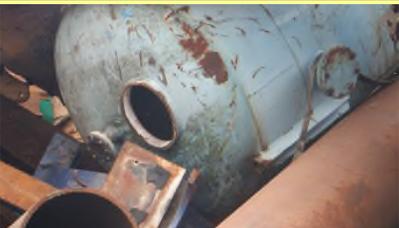
10.	Hammond Lane	Metal Pile East side of site		Flange gaskets on old tank vessel		Strongly presumed						Investigate prior to work likely to cause disturbance.

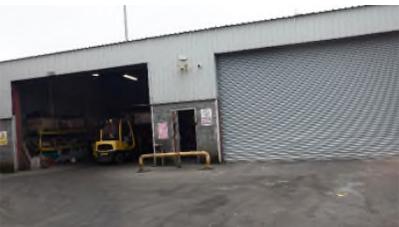
11.	Hammond Lane	Small garage North East		Profile steel sheeting on roof and over block wall.		No visible asbestos containing materials identified.

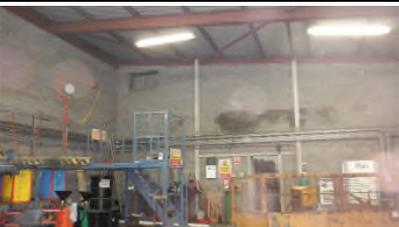
12.	Hammond Lane	Small garage North East		Internal areas.		No visible asbestos containing materials identified.

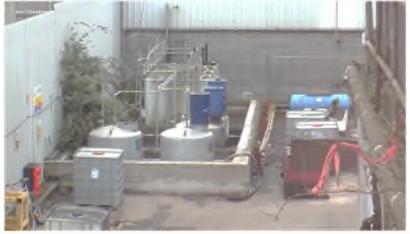
Ref No.	Building or Area of Site	Location or Functional Space	Sample No.	Material Description , surface treatment and condition	Extent	Asbestos identified (presumed, strongly presumed or identified)	Product type	Condition	Surface treatment	Asbestos type	Material assessment score	Recommendations	Photo
13.	Hammond Lane	Small garage North East		Bunded area		No visible asbestos containing materials identified.

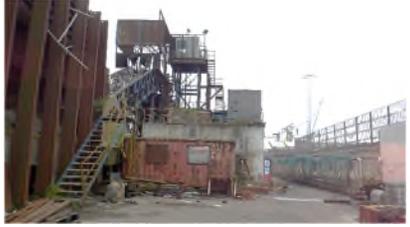
14.	Hammond Lane	Scrap handling area		Conveyors		No visible asbestos containing materials identified.

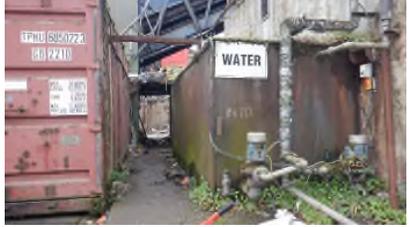
15.	Hammond Lane	Scrap handling area Water Tank areas		Plastic pipework.		No visible asbestos containing materials identified.

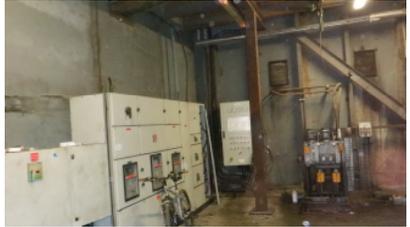
16.	Hammond Lane	Power House No. 2		Electrical plant and assemblies.		No visible asbestos containing materials identified.

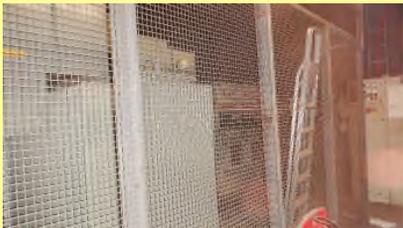
Ref No.	Building or Area of Site	Location or Functional Space	Sample No.	Material Description , surface treatment and condition	Extent	Asbestos identified (presumed, strongly presumed or identified)	Product type	Condition	Surface treatment	Asbestos type	Material assessment score	Recommendations	Photo
17.	Hammond Lane	Scrap Handling area P&E023		Transformer 1		Presumed asbestos gaskets						Investigate prior to work likely to cause disturbance.

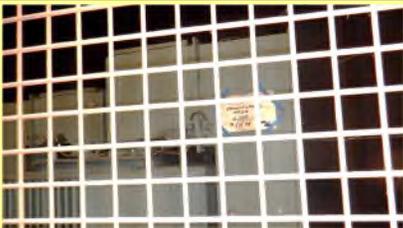
18.	Hammond Lane	Scrap Handling area P&E023		Transformer 2 (made live in 1998)		Presumed asbestos gaskets						Investigate prior to work likely to cause disturbance.

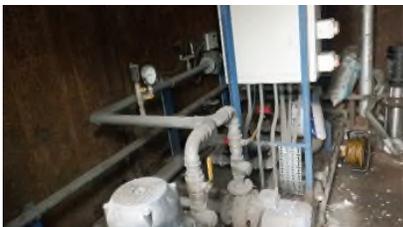
19.	Hammond Lane	Scrap Handling area Roof deck		Pumping station in container		No visible asbestos containing materials identified.

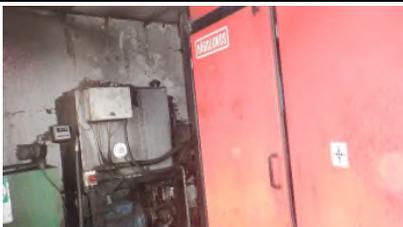
20.	Hammond Lane	Scrap Handling area Roof deck Plantroom				No visible asbestos containing materials identified.

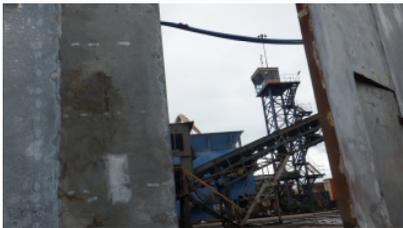
Ref No.	Building or Area of Site	Location or Functional Space	Sample No.	Material Description , surface treatment and condition	Extent	Asbestos identified (presumed, strongly presumed or identified)	Product type	Condition	Surface treatment	Asbestos type	Material assessment score	Recommendations	Photo
21.	Hammond Lane	Scrap Recycling area		Viewing tower and plant		No visible asbestos containing materials identified.

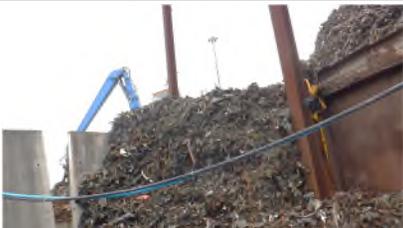
22.	Hammond Lane	Scrap Recycling area		Recycled materials		Presumed asbestos

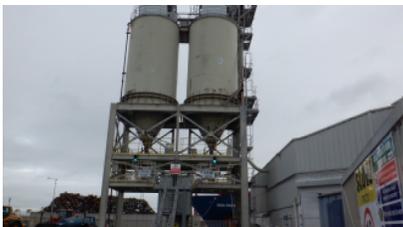
23.	Hammond Lane	Silos		Relativel modern plant		No visible asbestos containing materials identified.

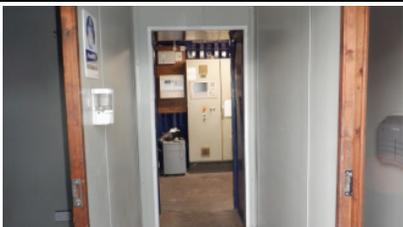
24.	Hammond Lane	First Aid Cabin		Plasterboard internal linings		No visible asbestos containing materials identified.

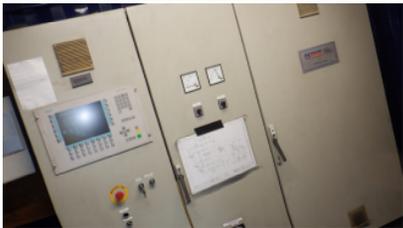
Ref No.	Building or Area of Site	Location or Functional Space	Sample No.	Material Description , surface treatment and condition	Extent	Asbestos identified (presumed, strongly presumed or identified)	Product type	Condition	Surface treatment	Asbestos type	Material assessment score	Recommendations	Photo
25.	Hammond Lane	First Aid Cabin Electrical room		Modern electric panels		No visible asbestos containing materials identified.

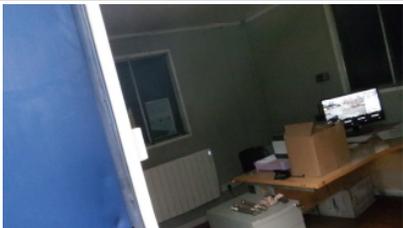
26.	Hammond Lane	Reception office				No visible asbestos containing materials identified.

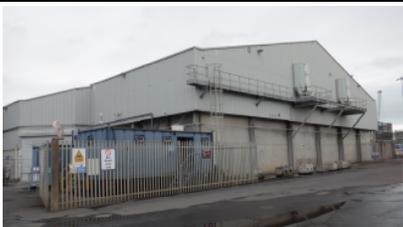
28.	Hammond Lane	Silo Building		Relatively modern construction.		No visible asbestos containing materials identified.

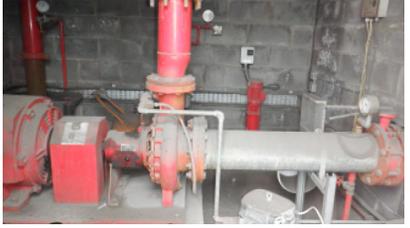
Ref No.	Building or Area of Site	Location or Functional Space	Sample No.	Material Description , surface treatment and condition	Extent	Asbestos identified (presumed, strongly presumed or identified)	Product type	Condition	Surface treatment	Asbestos type	Material assessment score	Recommendations	Photo
29.	Hammond Lane	Water Pump House				No visible asbestos containing materials identified.

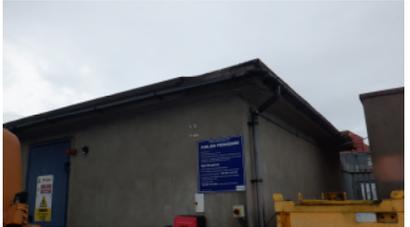
30.	Hammond Lane	Electrical substation		Bitumen asphalt to roof		No visible asbestos containing materials identified.

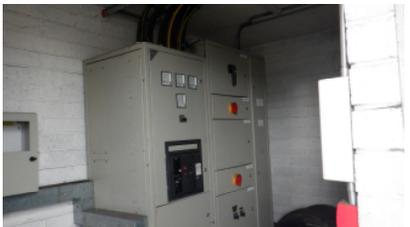
31.	Hammond Lane	Electrical substation		Modern panels and assemblies.		No visible asbestos containing materials identified.

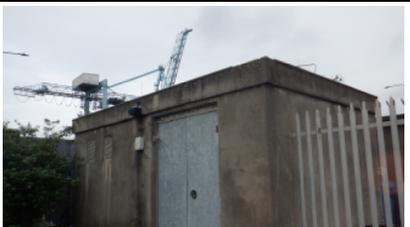
32.	Hammond Lane	ESB substation		ESB networks access only.		Outside scope of survey
