**Report on Investigations into Planning,  
Environmental Compliance and General Nuisances  
Associated with a Quarry Operated**

**P. McCaffrey & Sons Ltd.  
Ballymagroarty,  
Ballintra,  
Co. Donegal**

**REPORT**

December, 2000

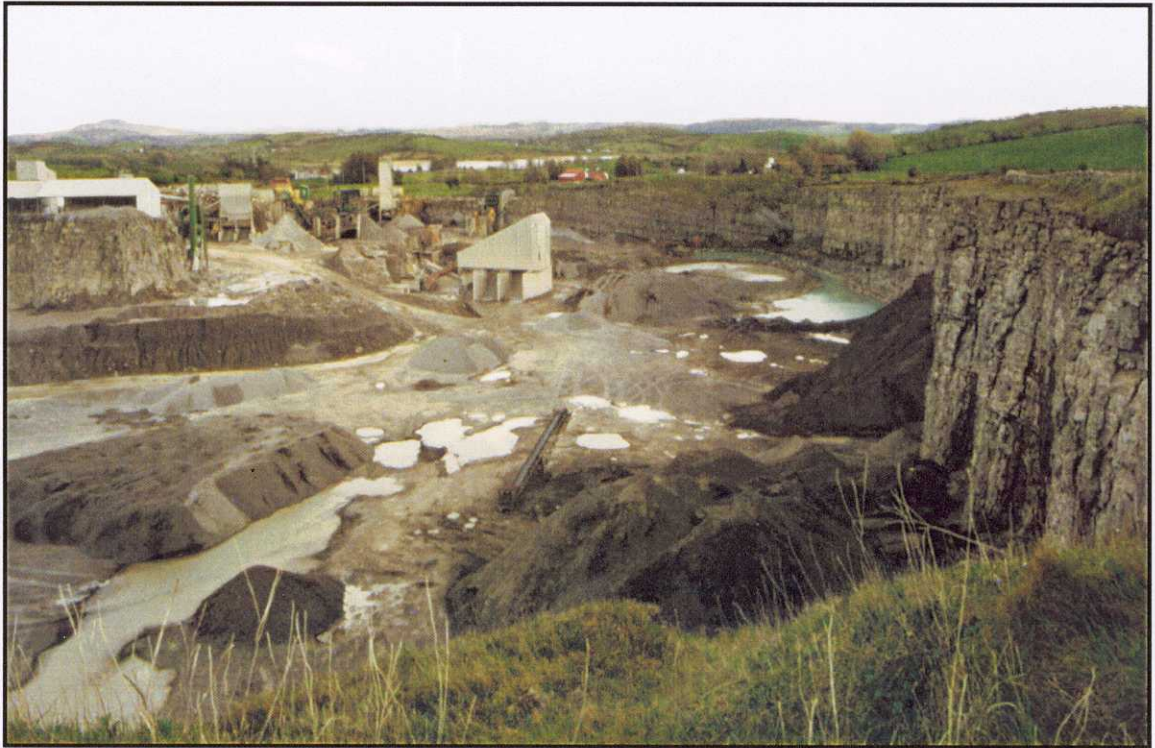
Quarry No. 1.

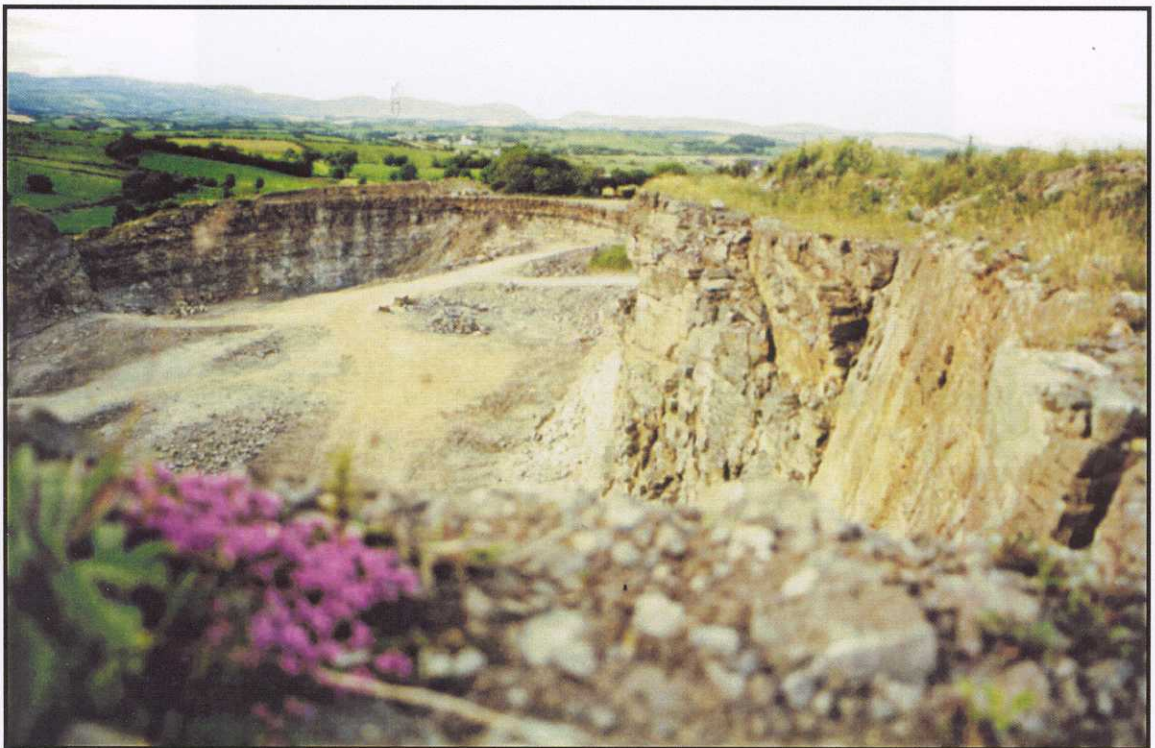
Quarry No. 2.

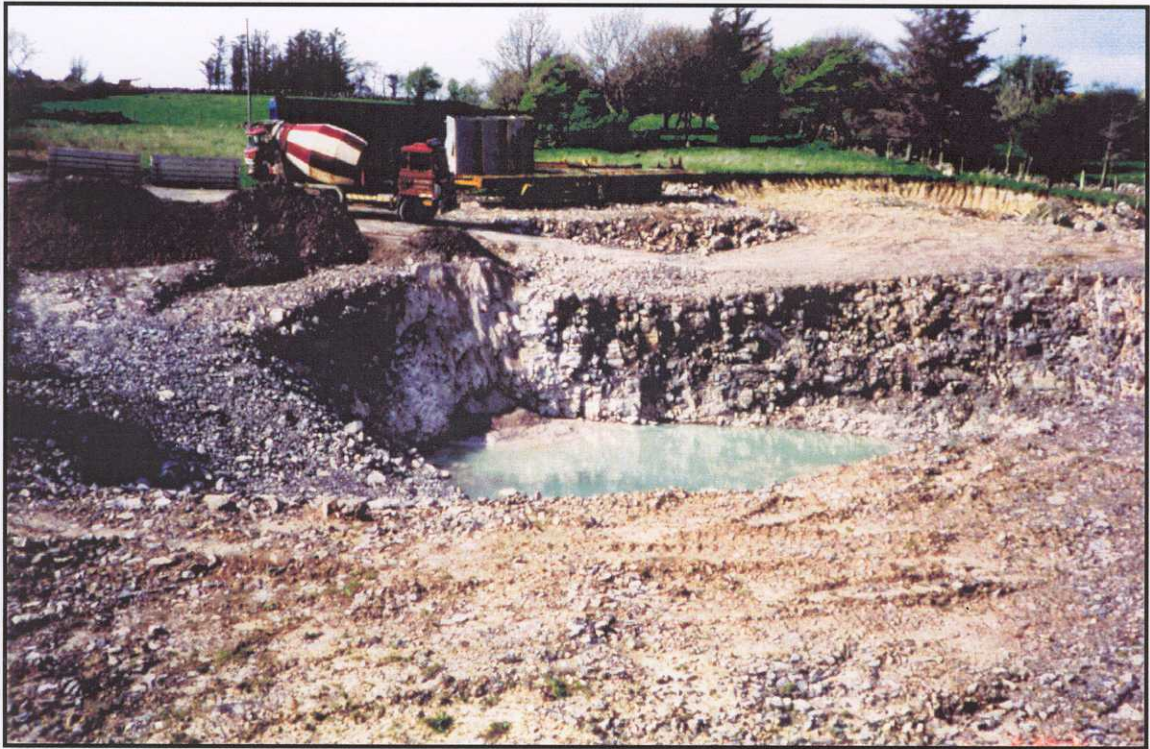
Quarry No. 3.

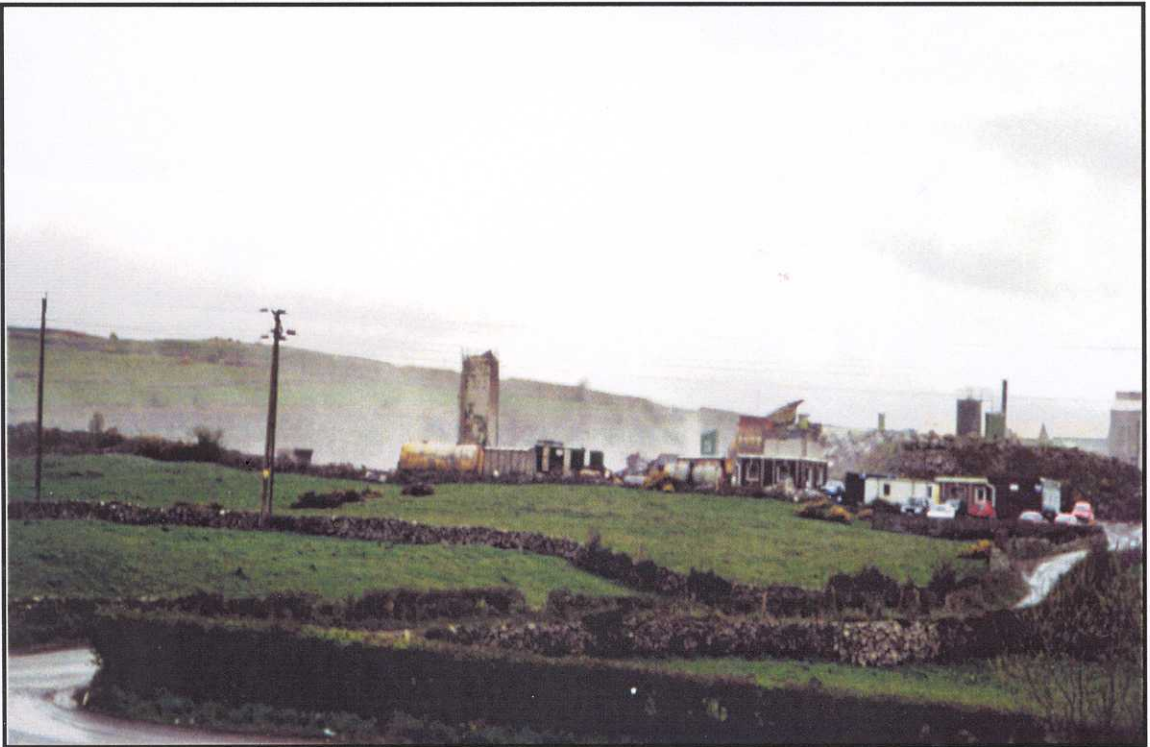
An examination of the Gorman land and photographs presented by the Gorman's clearly indicate in our opinion problems with dust pollution from McCaffrey's quarry. Photographs 5 to 9 attached confirm this observation. A visual inspection of the quarry from the perimeter of the site identified the following dust sources:

Dust emissions from quarry operations.

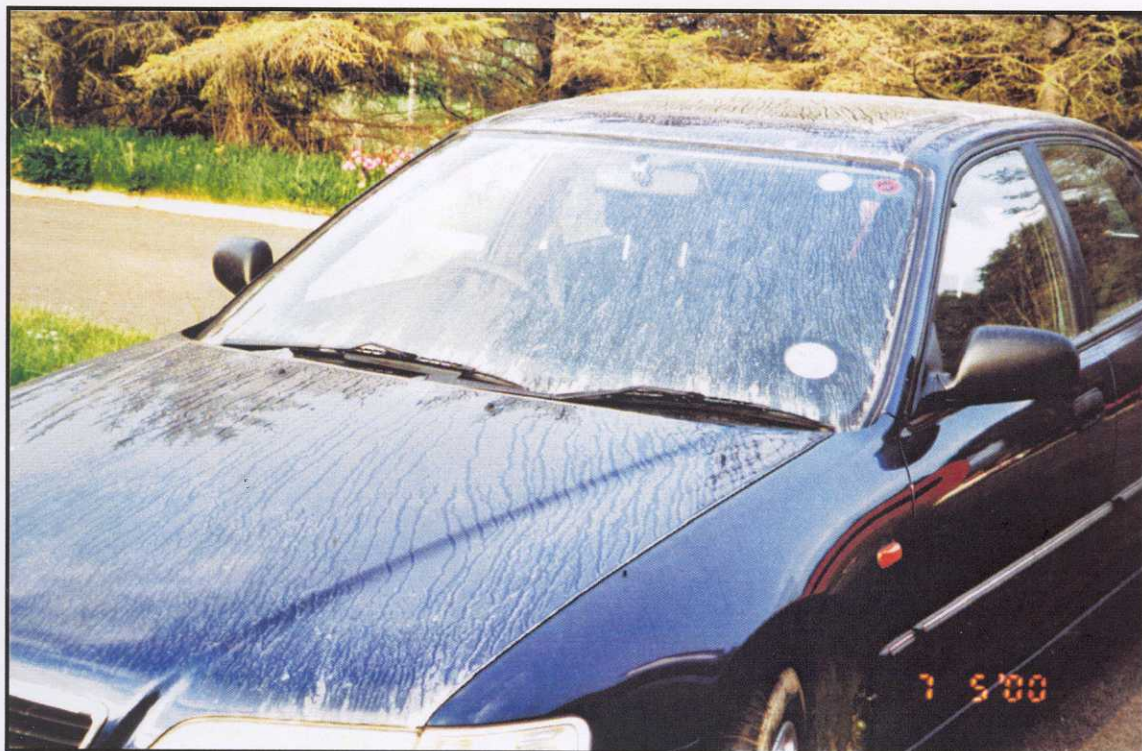
Dust deposition on Gorman car.

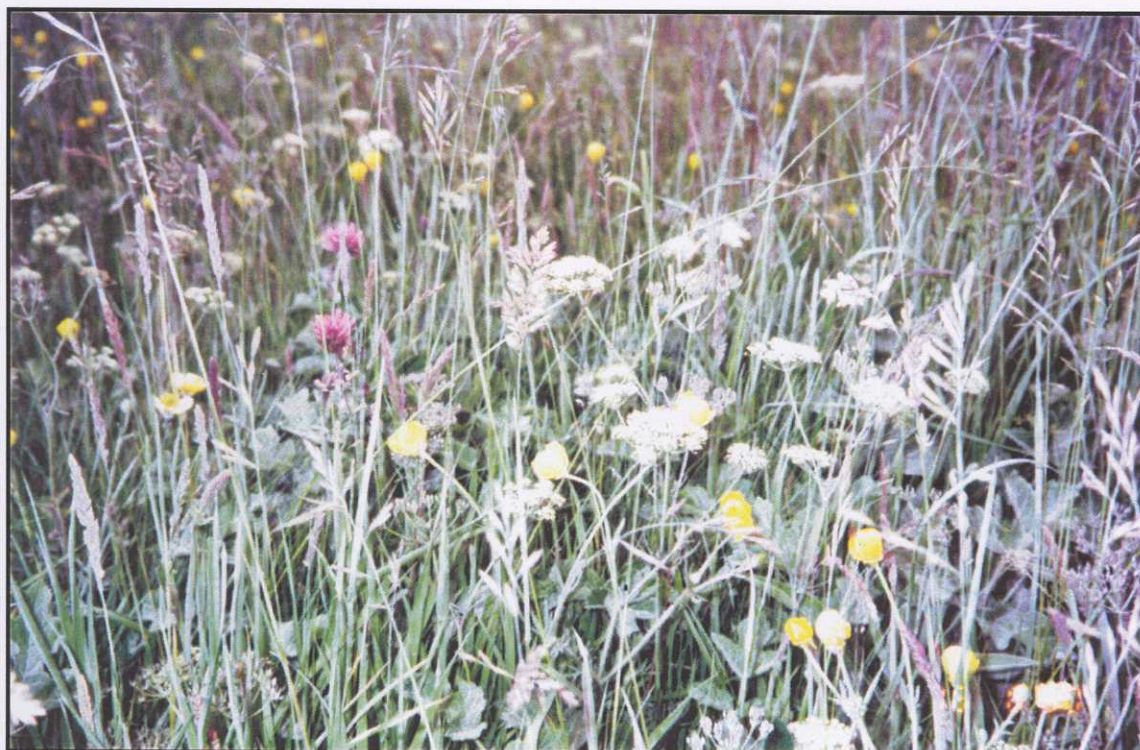
Dust deposition on vegetation.

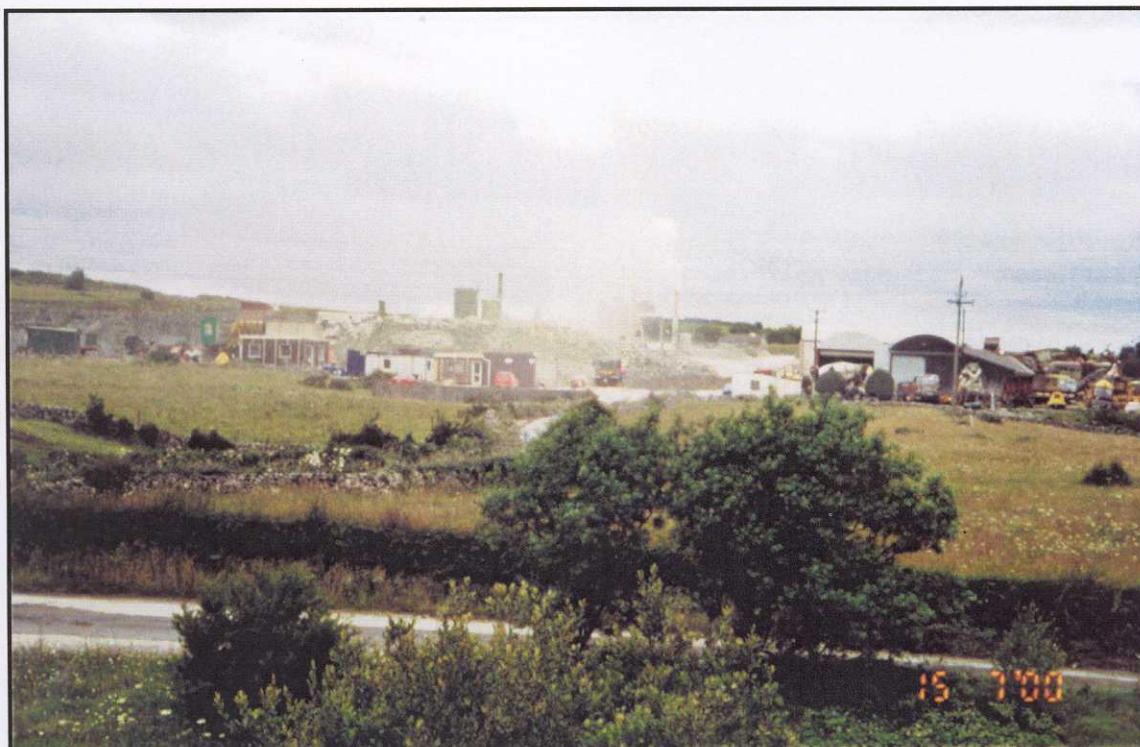
No mitigation measures for visual impact / dust emissions.

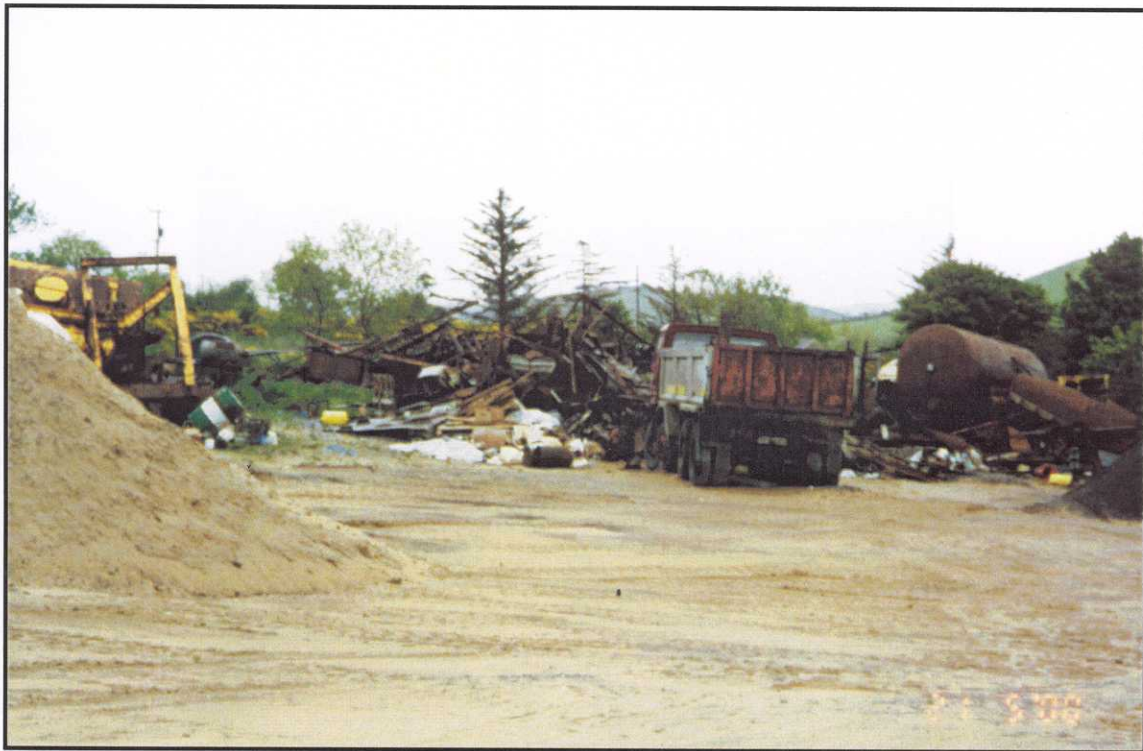
Photographs 15 to 18 attached show that large volumes of waste are disposed of in one corner of the site in an area adjoining the Gorman's land. Because of the location of the on-site waste disposal facility it is a major eye sore to the Gormans. An examination of the waste shows that it contains old machinery, old drums, pallets, plastic, oil filters, oils and grease, batteries, scrap metal, wheel rims and tyres. In effect rubbish is disposed off in an on-site landfill.

On site waste disposal.

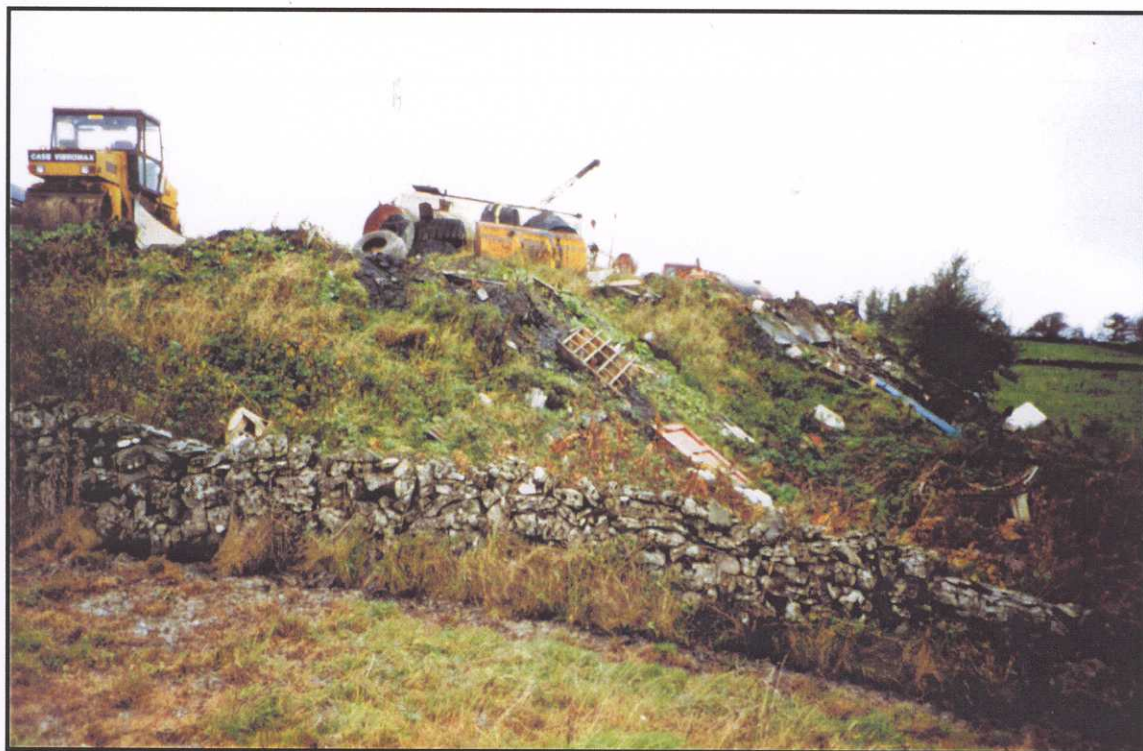
Waste disposal area adjoining the Gorman land.

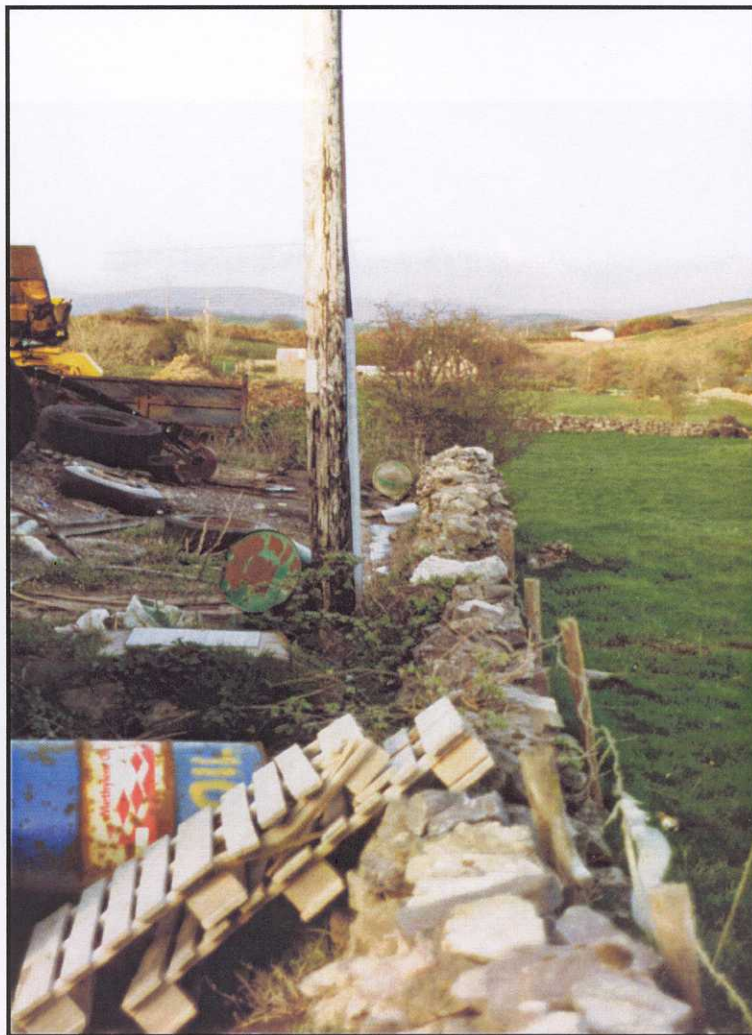
Waste disposal area adjoining the Gorman land.

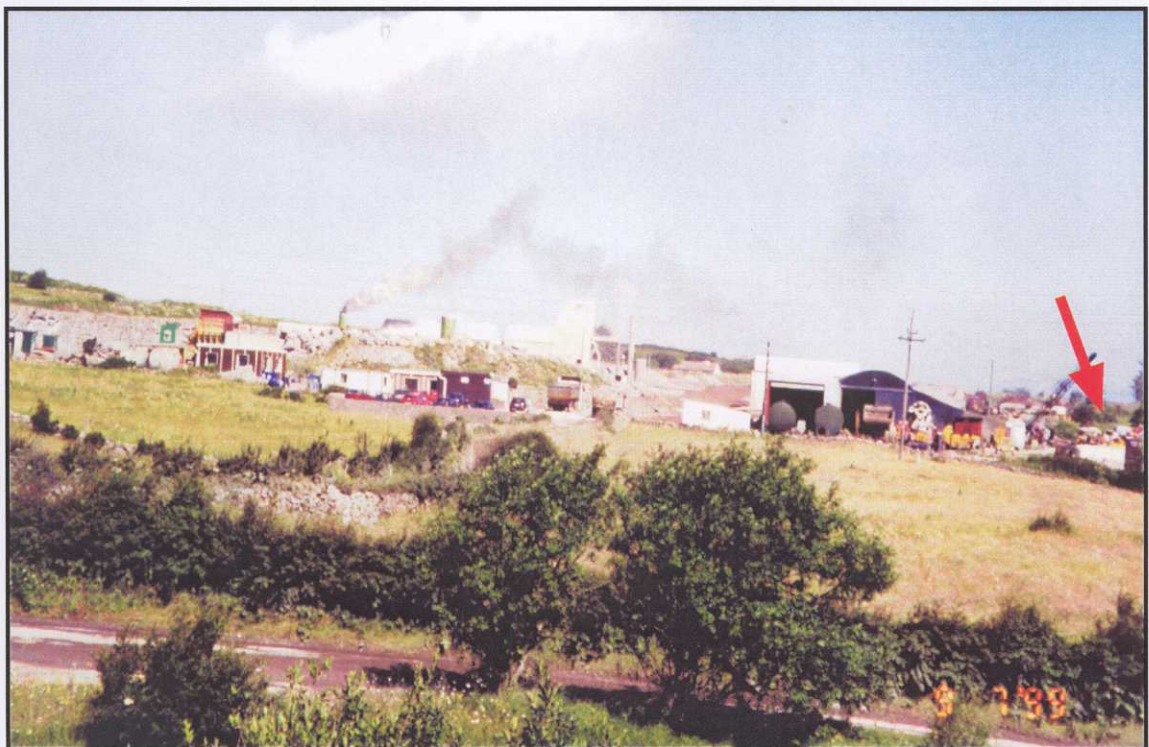
View from the N15 road showing visual impact and waste disposal area

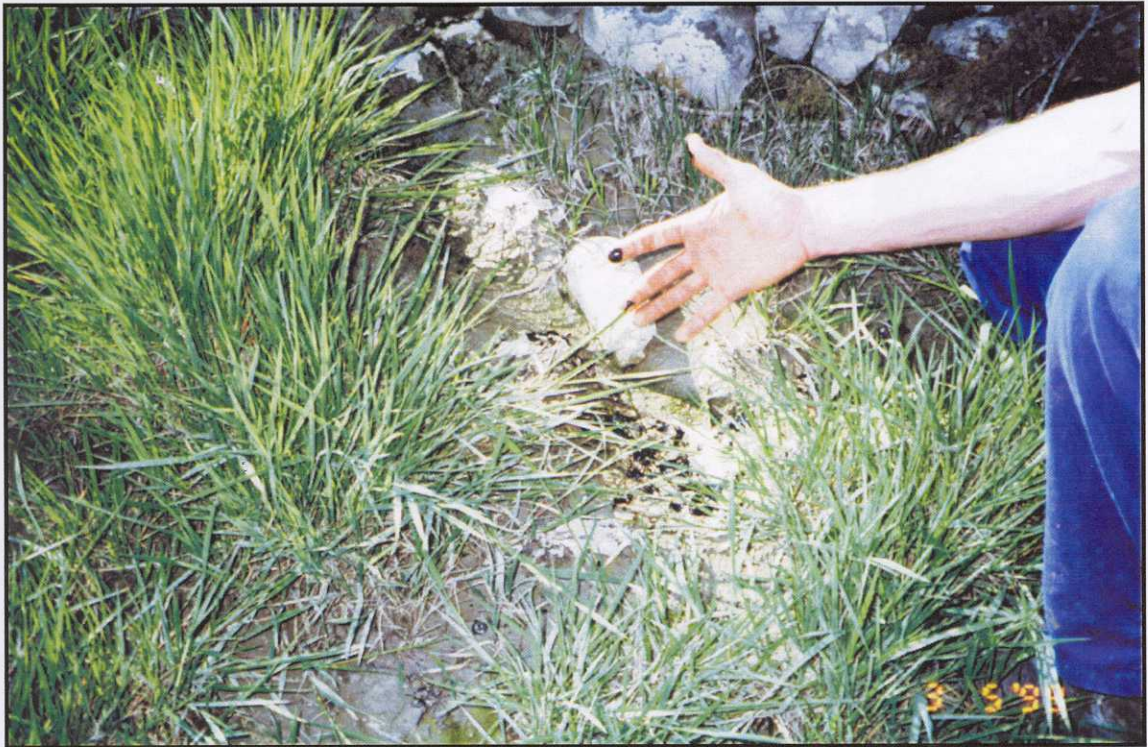
Bitumen residues that have flowed into the Gorman land.

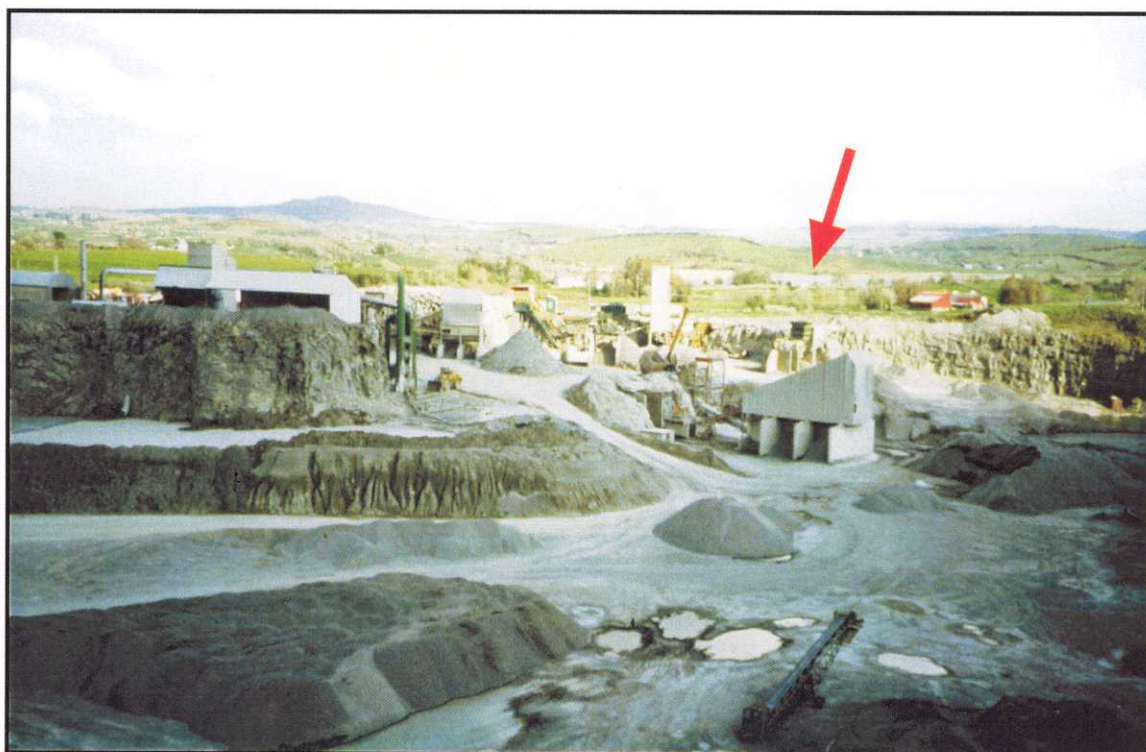
Lough Gorman located downgradient from quarry.
