Quarry at Glasbolie, Ballintra, Co. Donegal

SU0128

Review Comments¹ on the Hydrogeological Sections of:

- 1. Environmental Impact Statement Section 37L Application; and
- 2. Revised Remedial Environmental Impact Statement

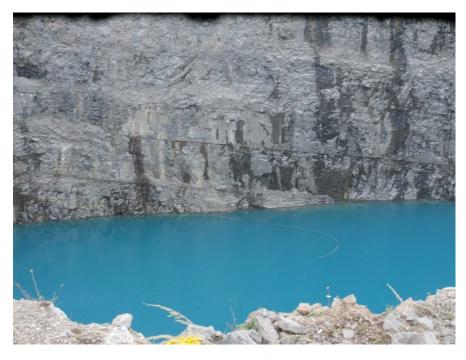
- a) Shallow groundwater flow (> 50 mOD) takes place near and at the quarry, as evidenced by multiple seeps and discharges along the exposed faces of the quarry walls;
- b) Groundwater flow in karst systems occurs via fractures and open conduits which have complex and unpredictable geometries. In the case of Lough Gorman, a shallow flow system in the direction of the lake from the general direction of the quarry is present, as documented herein. Thus, any pollutants that are discharged would pose a risk of impact to the lake and its associated habitats.

North quarry—south face—seeps/discharges along multiple bedding horizons

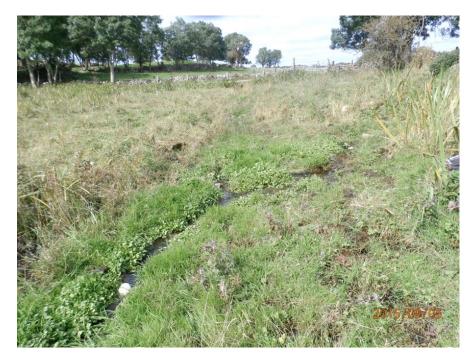
Spring to the northwest of Lough Gorman (water cress vegetation, characteristic of karst limestone water)

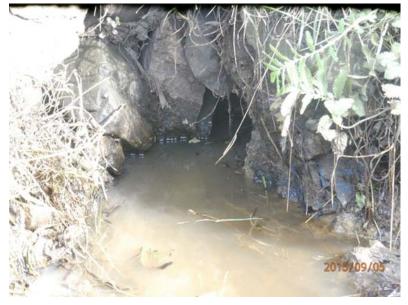
Active swallow hole, in ponded/flooded area, to the east of the N15 and east of the Gorman residence

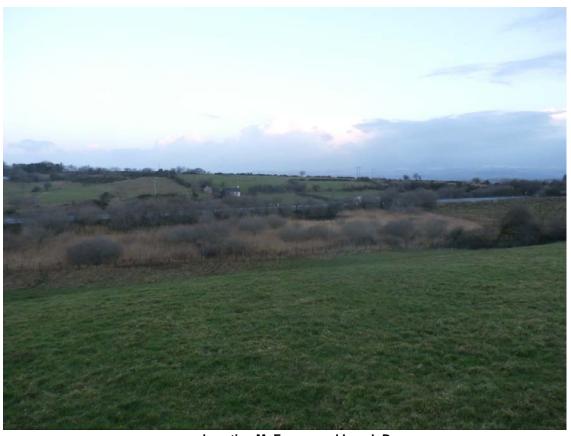
Location M: Fen around Lough Doo

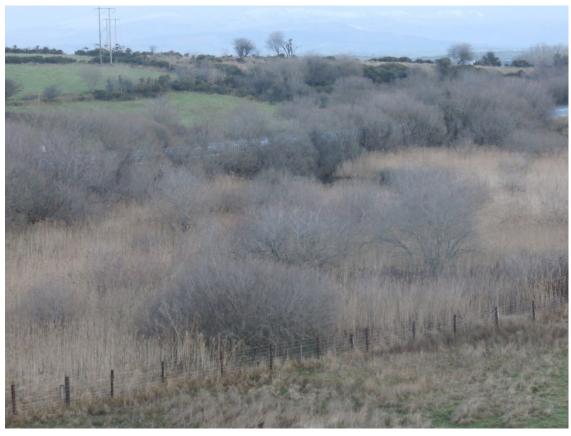
Location M - Fen around Lough Doo

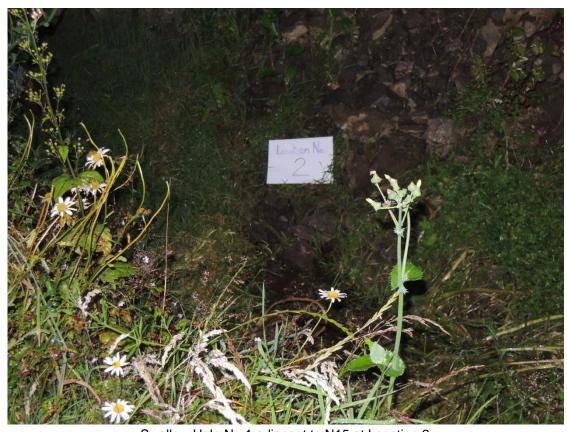
Swallow Hole No 1 adjacent to N15 at Location 2 Cotton Wool sample installed to establish background readings Collecting: 14/08/2015

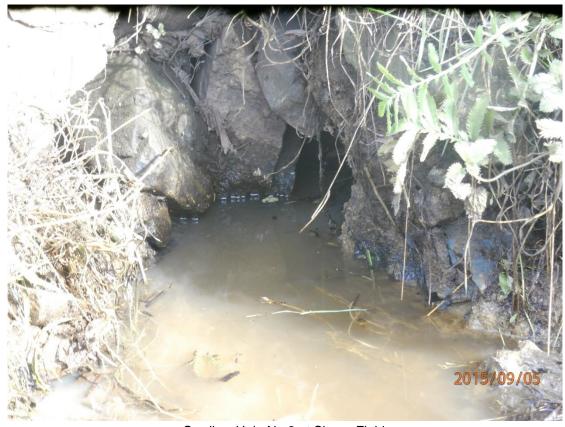
Swallow Hole No 2 at Sheep Field

12.5 litres of ultrabrite poured in Swallow Hole No 2 at 16:00 hours on Saturday 05th September 2015

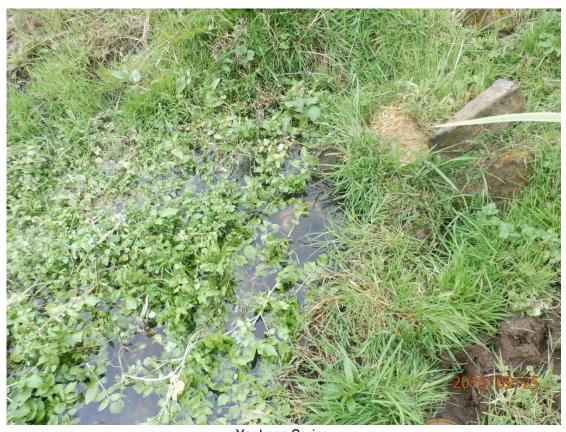
Yankees Spring
Cotton Wool sample collected to establish groundwater flow from Swallow Hole No 2
Collecting: 25/09/2015

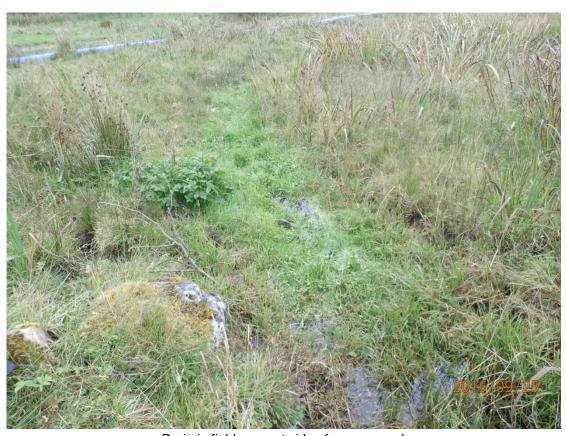
Drain in field on west side of access road
Cotton Wool sample collected to establish groundwater flow from Swallow Hole No 2
Collecting: 25/09/2015

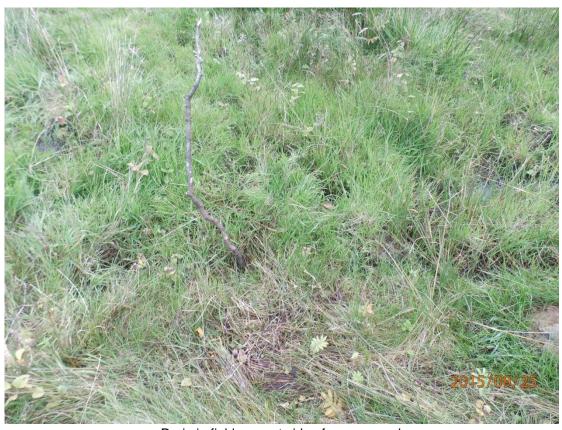
Drain in field on east side of access road

Cotton Wool sample collected to establish groundwater flow from Swallow Hole No 2

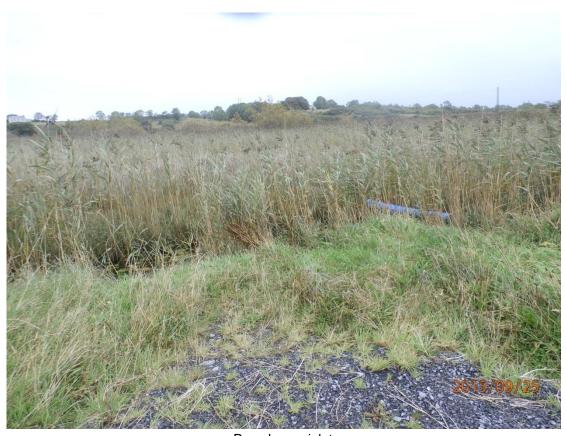
Pumphouse inlet
Cotton Wool sample collected to establish groundwater flow from Swallow Hole No 2
Collecting: 25/09/2015

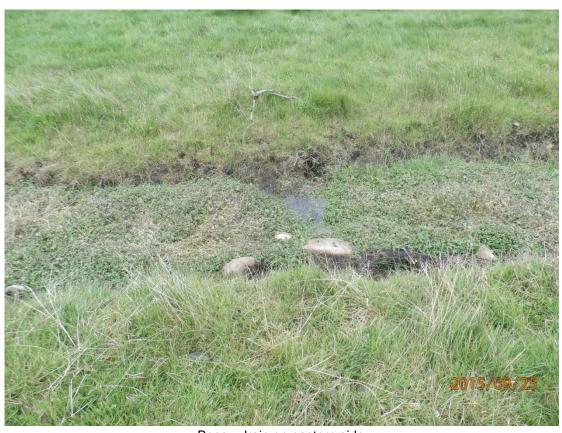
Bogs - drain on eastern side Cotton Wool sample collected to establish groundwater flow from Swallow Hole No 2 Collecting: 25/09/2015

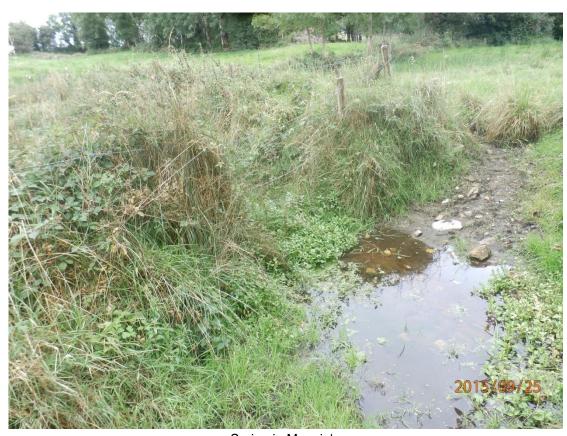
Spring in Maggie's
Cotton Wool sample collected to establish groundwater flow from Swallow Hole No 2
Collecting: 25/09/2015

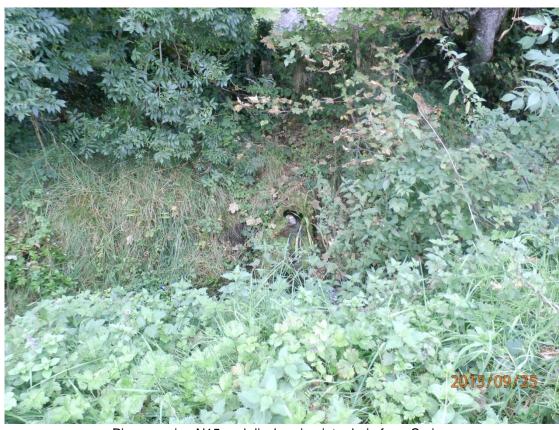
Pipe crossing N15 and discharging into drain from Spring
Cotton Wool sample collected to establish groundwater flow from Swallow Hole No 2
Collecting: 25/09/2015

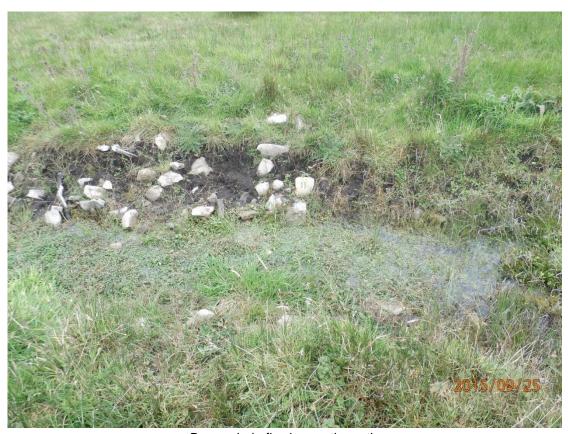
Bogs - drain flowing north south Cotton Wool sample collected to establish groundwater flow from Swallow Hole No 2 Collecting: 25/09/2015

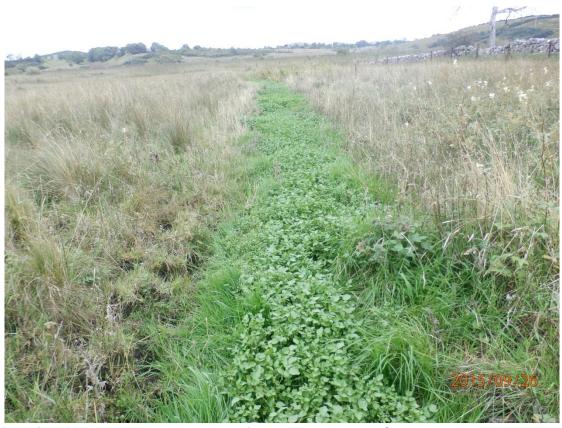
Drain from Yankee's spring at Location 4 flowing towards Lough Gorman – taken at stone ditch Colour and type of vegetation indicates ground water

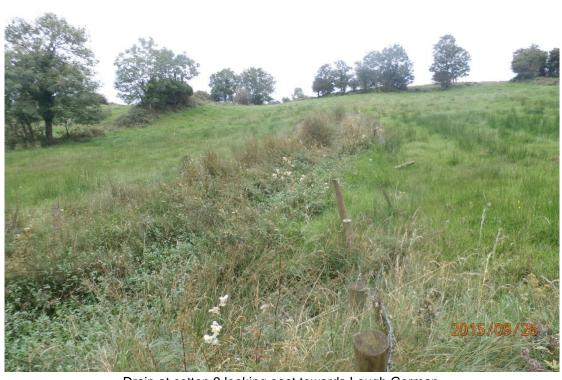
Drain at cotton 9 looking east towards Lough Gorman

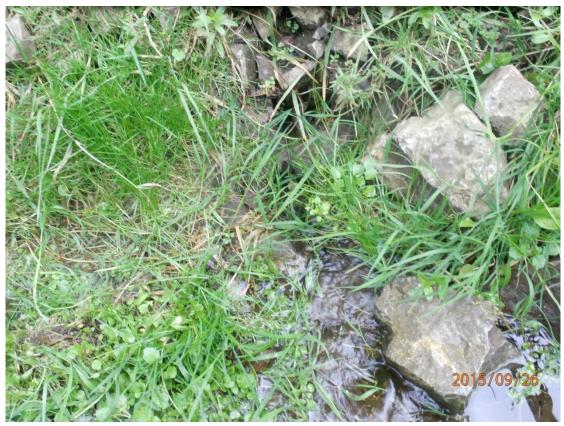
Swallow Hole No 1 (invert level 83.266mOD)

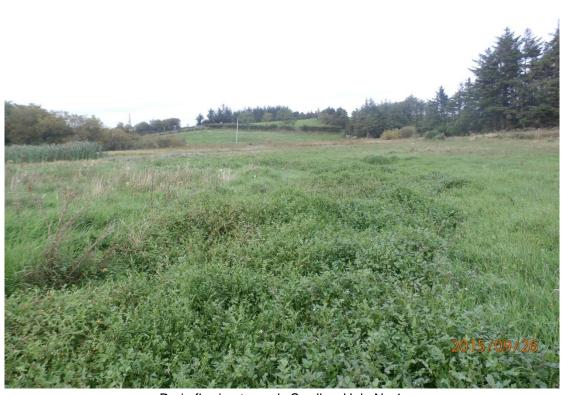
Drain flowing towards Swallow Hole No 1 Colour and type of vegetation indicates ground water

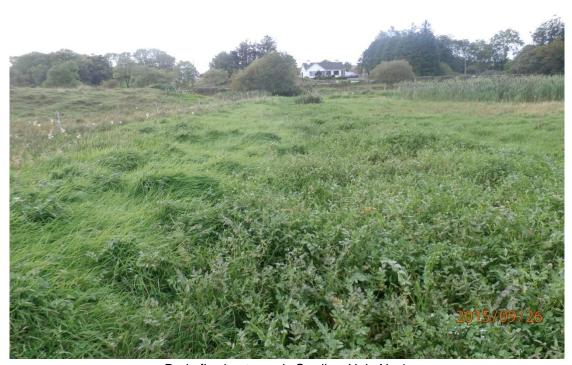
Drain flowing towards Swallow Hole No 1
Colour and type of vegetation indicates ground water

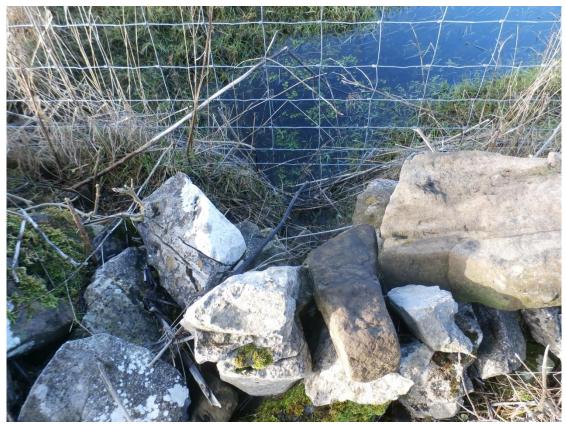
Swallow Hole No 2 at Sheep Field - January 2015

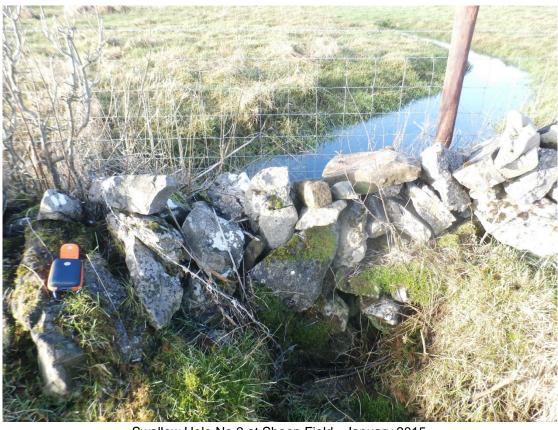
Swallow Hole No 2 at Sheep Field - January 2015

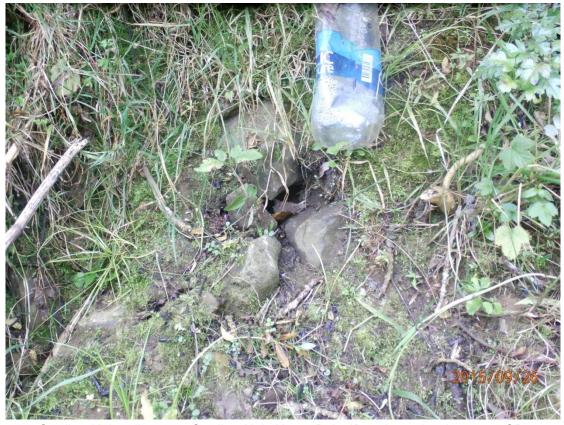
Swallow Hole adjacent to Swallow Hole No 1- Point ID 81 invert level 83.481mOD Swallow Hole dry on 26th September 2015

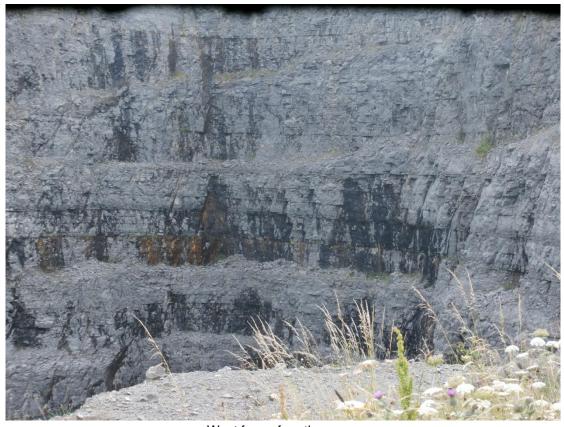
West face of north quarry 07/08/2015

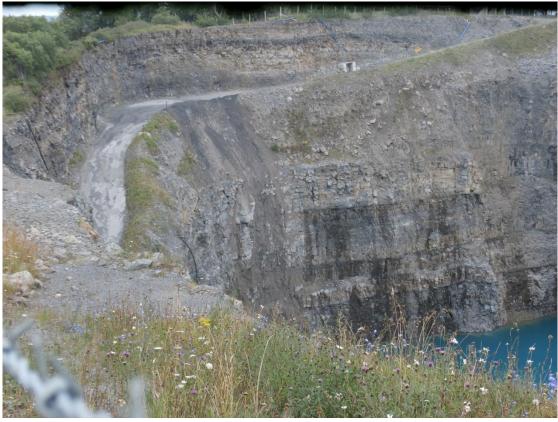
Access road into north quarry with deposition from unauthorised dumping on cliff face 07/08/2015

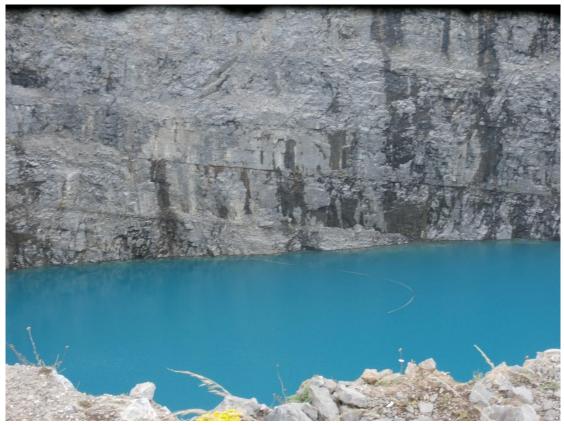
South face of north quarry 07/08/2015

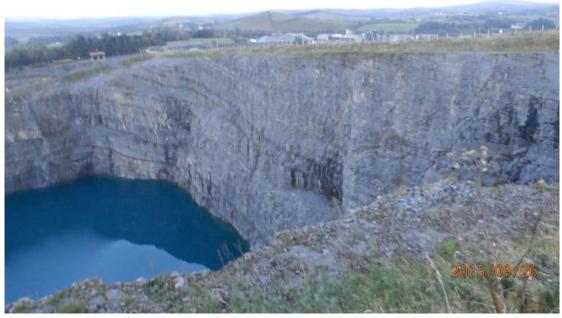
North Quarry water level

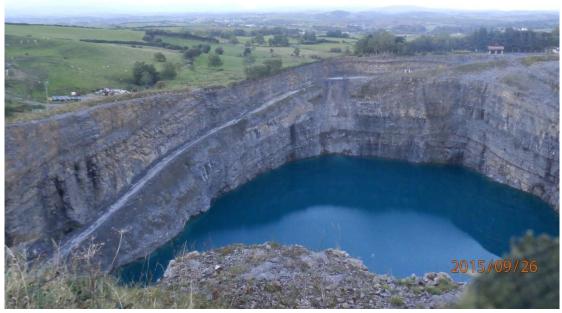
North Quarry water level

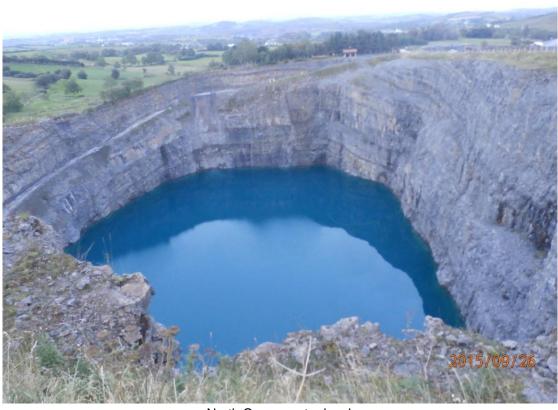
North Quarry water level

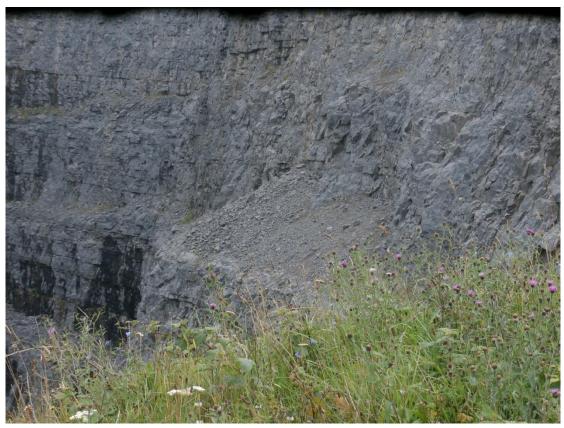
West face of north quarry 07/08/2015

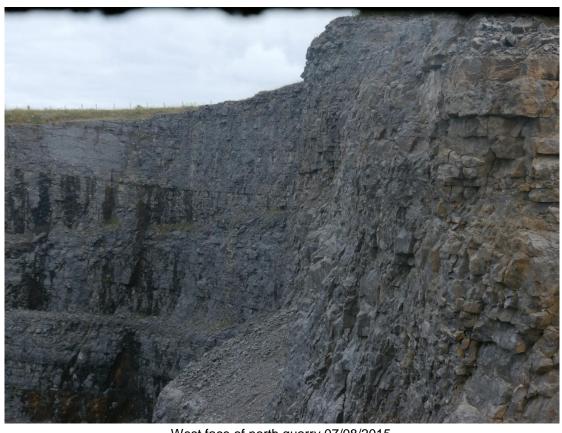
West face of north quarry 07/08/2015

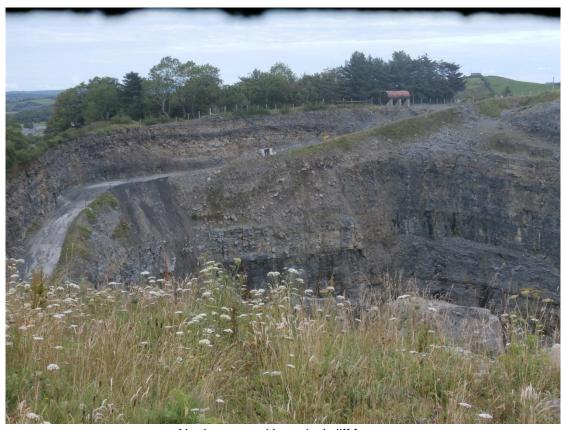
North quarry with vertical cliff faces 07/08/2015

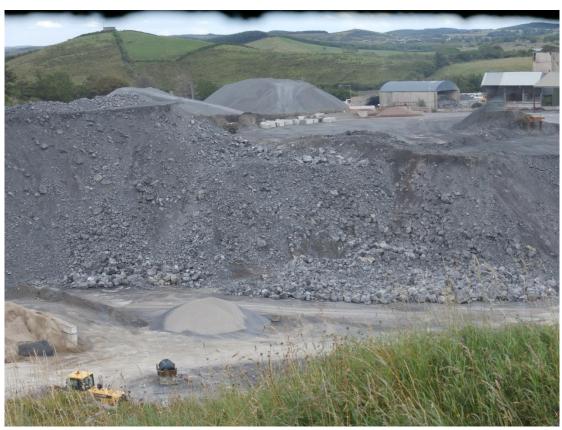
South Quarry 07/08/2015

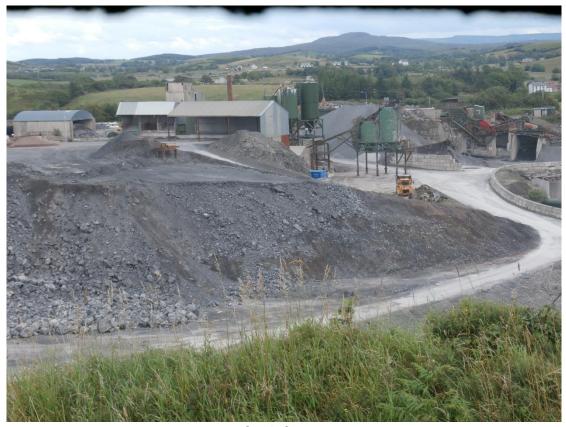
South Quarry 07/08/2015

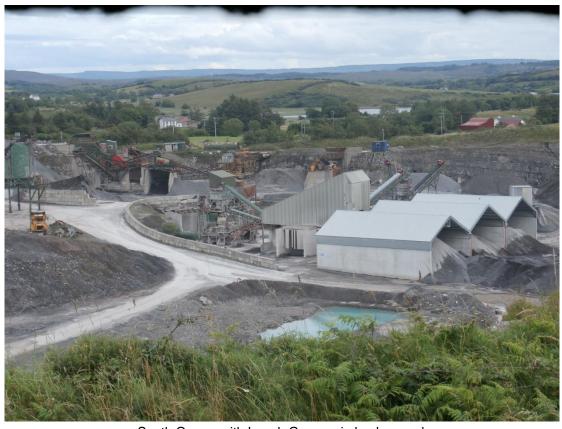
South Quarry with Lough Gorman in background 07/08/2015

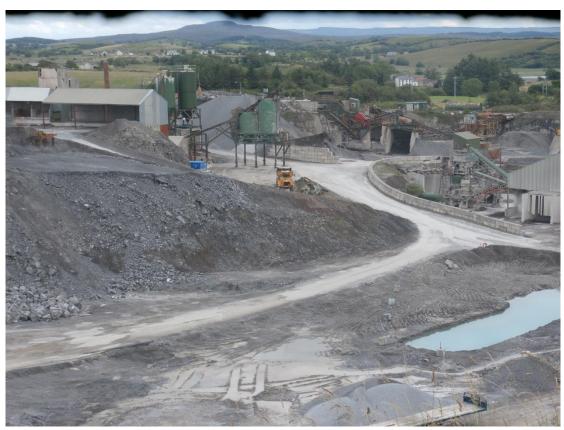
South Quarry 07/08/2015

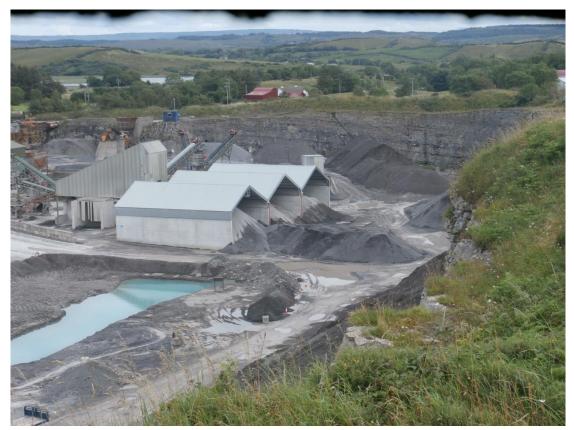
South Quarry 07/08/2015

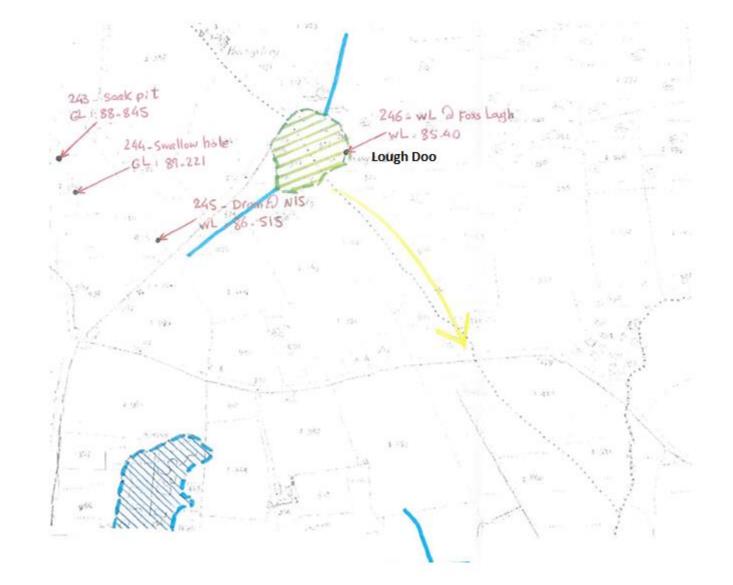
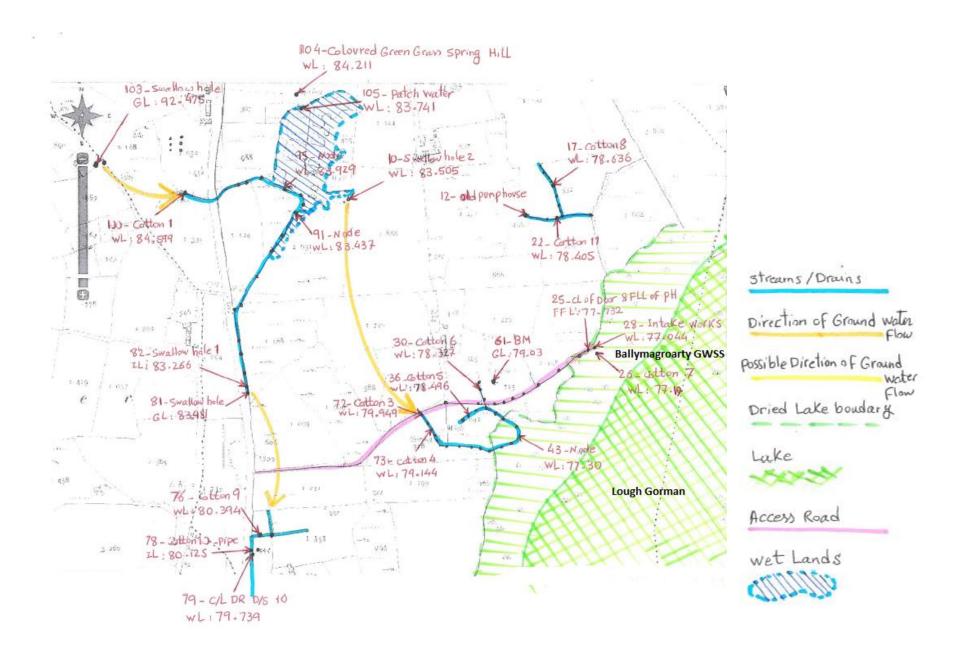
The purpose of the survey was to establish groundwater flows in the vicinity of P McCaffrey & Sons Ltd Quarry. Cottons were placed in streams and springs to first determine background levels of detergents in the water which may cause the cottons to glow and interfere with the test results. The cottons were left in place for a number of days and removed and examined under ultraviolet light. Twelve and a half litres of Ultrabrite was poured into two swallow holes during two different test periods, the ultrabrite flows in the direction of the groundwater and is collected in the cottons. These cottons glow when examined under ultraviolet light and this confirms the direction of groundwater flow. The report includes coordinates and photographs of a number of water features in the locality. The results of the tests are shown plotted on the maps overleaf.
